Butte Site Relocation

Study Report

Air Quality Division

Air Monitoring
&
Quality Assurance
Program

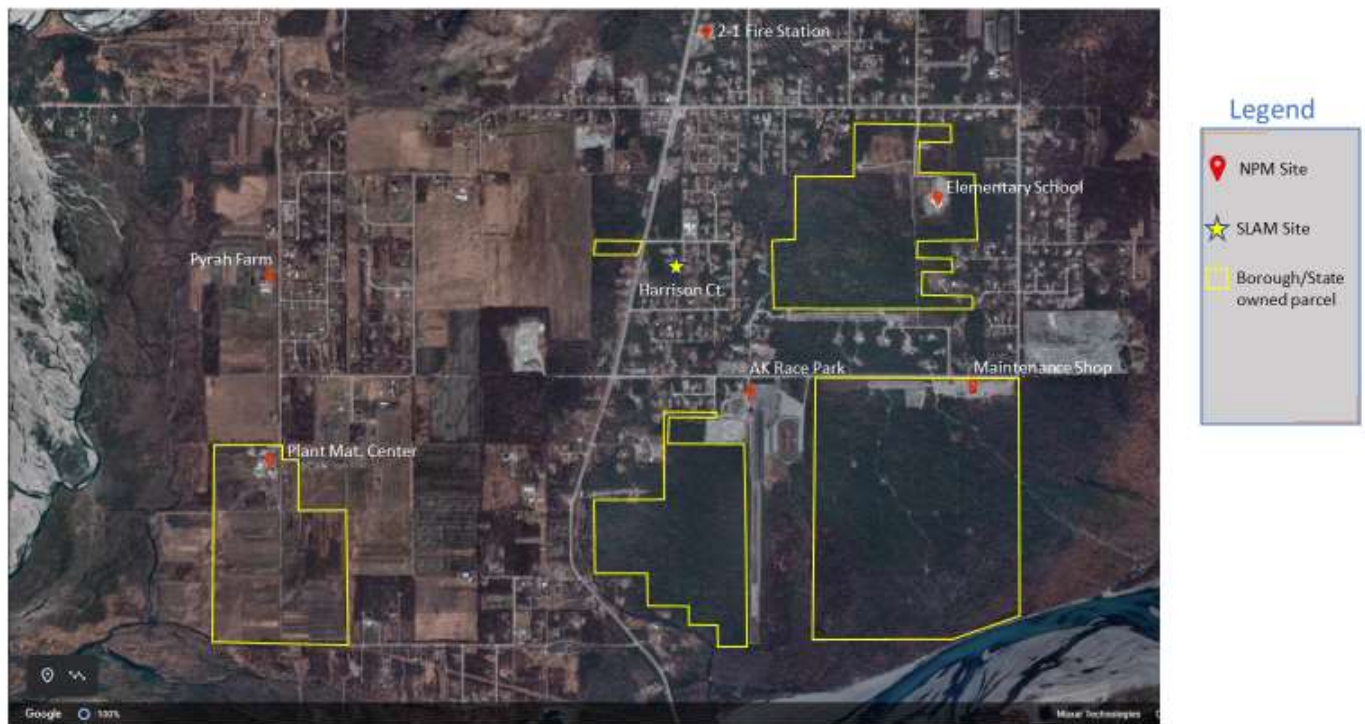
Figure 1: Neighborhood monitor locations. Red pins are NPM site locations, and the yellow star indicates the current SLAMS site. The yellow borders represent public parcels of land.

DEC designed a saturation study using a network of six low-cost fine particulate matter (PM_{2.5}) monitors throughout the central Butte area as shown in **Figure 1**. The Air Monitoring and Quality Assurance Program (AMQA) of the Air Quality Division chose the Met One Neighborhood Particulate Monitor (NHM) for measuring PM_{2.5}.

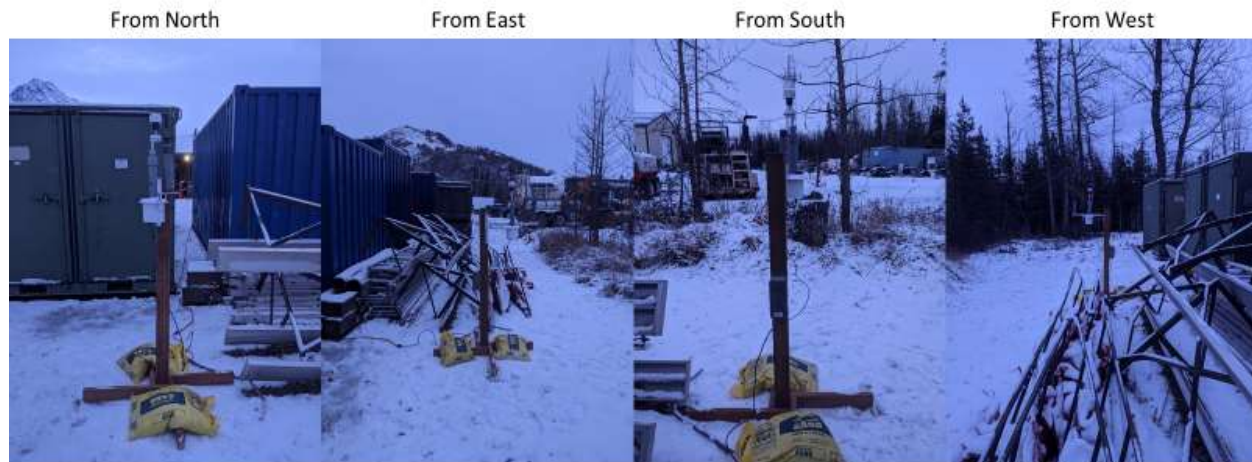
Figure A-3: Photos of the 2-1 Fire Station site from the cardinal directions looking towards the sensor.

Located approximately 0.8 miles to the north of the current SLAMS site, the fire station was chosen to collect samples to the north, for ease of access, and coordination with the Mat-Su Borough (MSB). Live fire training exercises are performed at the station; however, no live fire exercises were performed during the duration of this study. During winter months, the fire engines are regularly left idling to ensure smooth operation and fast response to emergencies. The NHM site was located on the corner of the property furthest away from the garage bays to minimize impact on the sensor's readings. There were three deciduous trees to the north of the sensor. They were sparsely spaced and did not scavenge particulates in the sample pathway. There were two shipping containers more than 2 m south of the sensor. Scaffolding to the west of the sensor laid below the sample inlet height, and the tree line to the east of the sensor was more than 10 m away

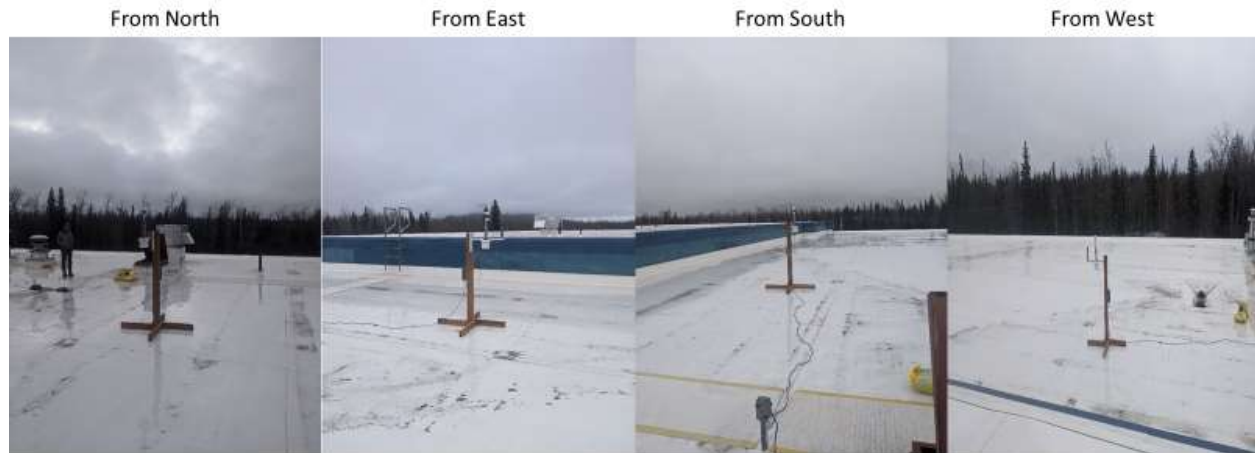
Figure A-4: Photos of the Elementary School site from the cardinal directions looking towards the sensor.

Located approximately 1 mile to the northeast of the current SLAMS site, the Butte Elementary School was chosen due to its proximity to a sensitive group as per AQI classifications, ease of access and coordination with the MSB. The NHM sensor was located on the roof of the school for security purposes to prevent vandalism, tampering, or damaged equipment. There were no obstructions near the inlet. A wall was located more than 2 m to the west of the sensor and laid below the sample inlet; all trees are more than 10 m away from the inlet.

In terms of siting, the Elementary school may have recorded lower values during particulate matter events as it was located on a second story rooftop and may have sampled above trapped particulates on days with a strong inversion. All the other sites were located at or near ground level.

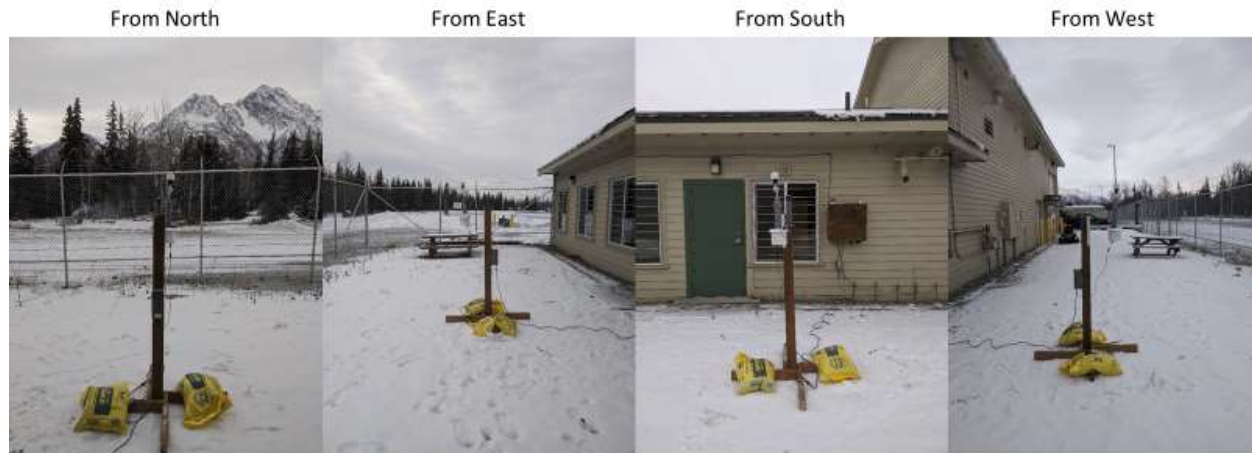
Figure A-5: Photos of the Maintenance Shop site from the cardinal directions looking towards the sensor.

Located approximately 1.2 miles southeast of current SLAMS site, the MSB Maintenance Shop was chosen for its geographic location in relation to the current site, its ease of access and coordination with the MSB, and security. The site was located on a large gravel pad behind an electric fence. There was a campground containing roughly nine campsites to the south of the sensor. The closest campsite and treeline were approximately 25 m from the sensor. To the west of the site there was a large gravel parking lot, and approximately 300 m from the sensor there were 18 RV campsites. North of the sensor was the maintenance shop building. The wall was more than 2 m away from the sample inlet. The gravel pad was frozen and covered with snow for the duration of the study and the campgrounds were out of season.

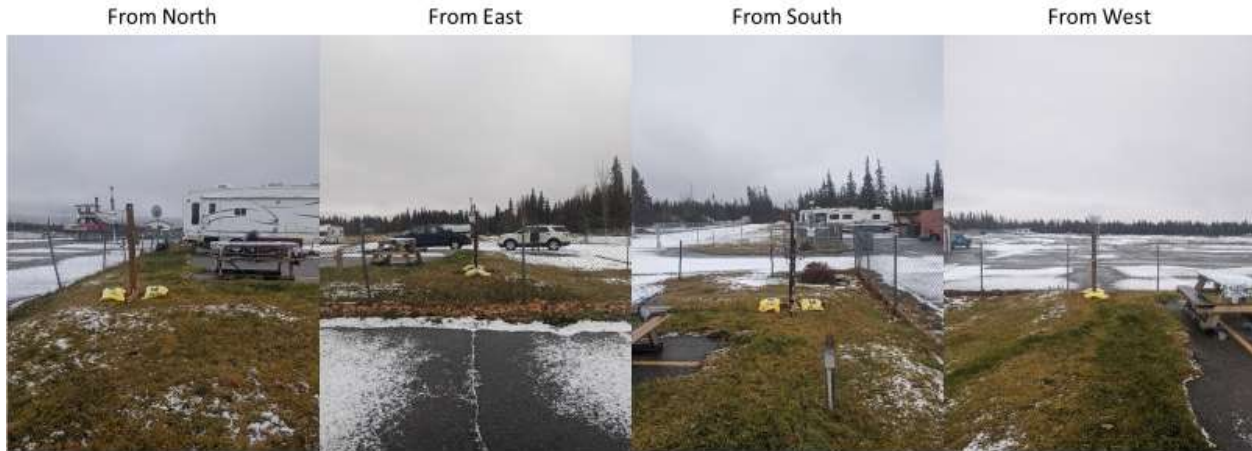
Alaska Raceway Park (ARP)

Figure A-6: Photos of the Alaska Raceway Park site from the cardinal directions looking towards the sensor.

Located approximately 0.6 miles southeast of the current SLAMS site, the Alaska Raceway Park was chosen due to its southerly bearing to the current site. The nearest trees were more than 10 m to the northwest of the sensor. There was a chain-link fence approximately 4 m to the east of the sample inlet. The sensor was surrounded by a large paved parking lot. The drag race strip and racetrack were closed for the duration of this study. There was a gravel quarry approximately 165 m to the southwest of the sensor, it was covered with snow for the duration of this study.

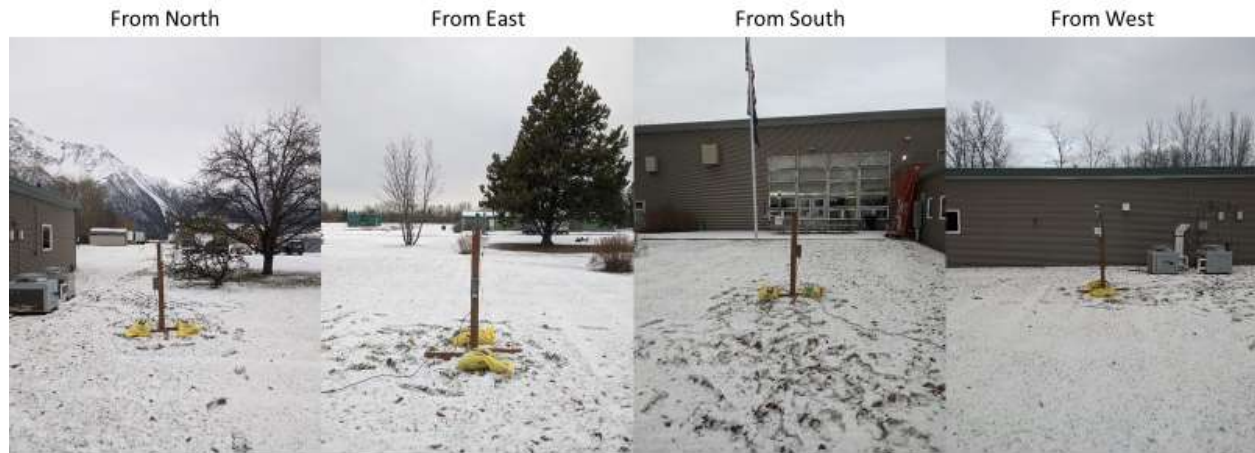
Figure A-7: Photos of the Plant Material Center site from the cardinal directions looking towards the sensor.

Located approximately 1.67 miles to the southwest of the current SLAMS site, the Plant Material Center was chosen due to its geographic bearing in relation to the current Butte site, ease of access, coordination with the State of Alaska Department of Natural Resources, and siting criteria. There was a building wall more than 2 m to the east of the sample inlet, and greater than 10 m to the north. There was one deciduous tree and one decorative shrub approximately 8 m away from the sampling inlet.

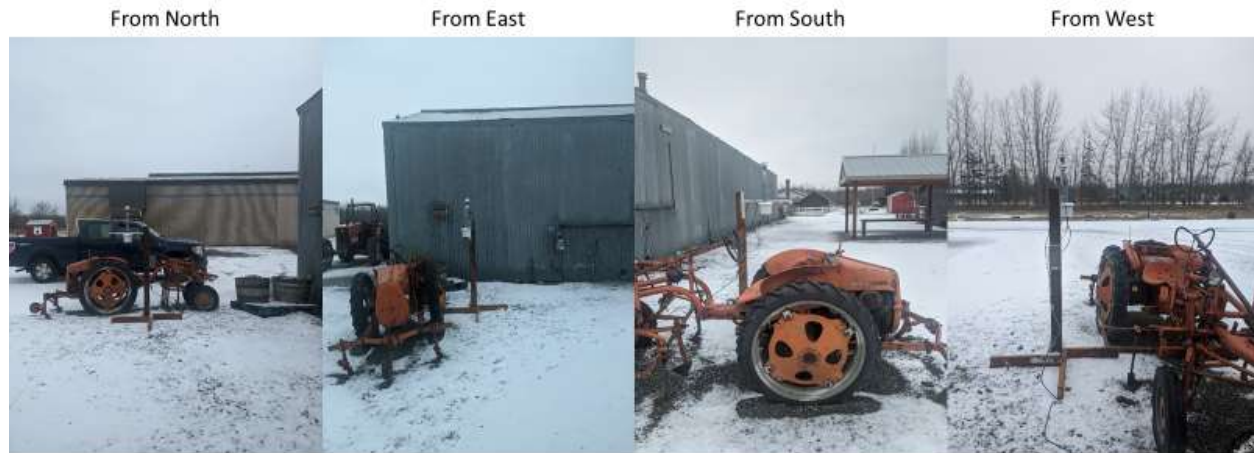
Figure A-8: Photos of the Pyrah Farm site from the cardinal directions looking towards the sensor.

Located approximately 1.5 miles to the west of the current SLAMS site, Pyrah farms was chosen primarily for its geographic bearing in relation to the current site and closer proximity to neighborhoods when compared to the Plant Material Center. There was a wall more than 2 m west of the sample inlet. There was a paved parking lot approximately 5 m to the east and south of the sample inlet. The treeline was more than 10 m to the east of the sampling inlet. There was one decorative tractor less than 1 m away from the sensor; The tractor laid below the sampling inlet height.
