RUBY ROAD DUST  
PM<sub>10</sub> MONITORING  
2015-2016  
RUBY, ALASKA

Department of Environmental Conservation  
Division of Air Quality  
555 Cordova Street  
Anchorage, AK 99501  
<http://dec.alaska.gov/air>

August 2017

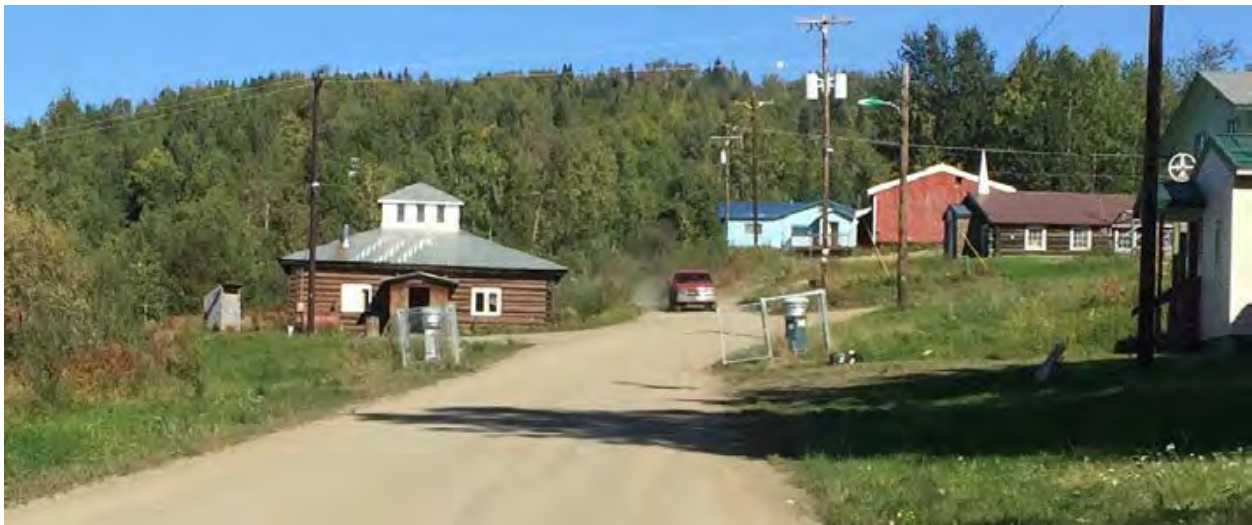
An additional pair of samplers was placed on each side of Good Time Road with a separation distance of approximately 30 feet between them. The sampler on the north side of Good Time Road was named the "Don Jr's House" site and the sampler located on south side of Good Time Road was named the "Church" sample site.

*Figure 3. Good Time Road – Don Jr's House site (on left); Church site (on right)*

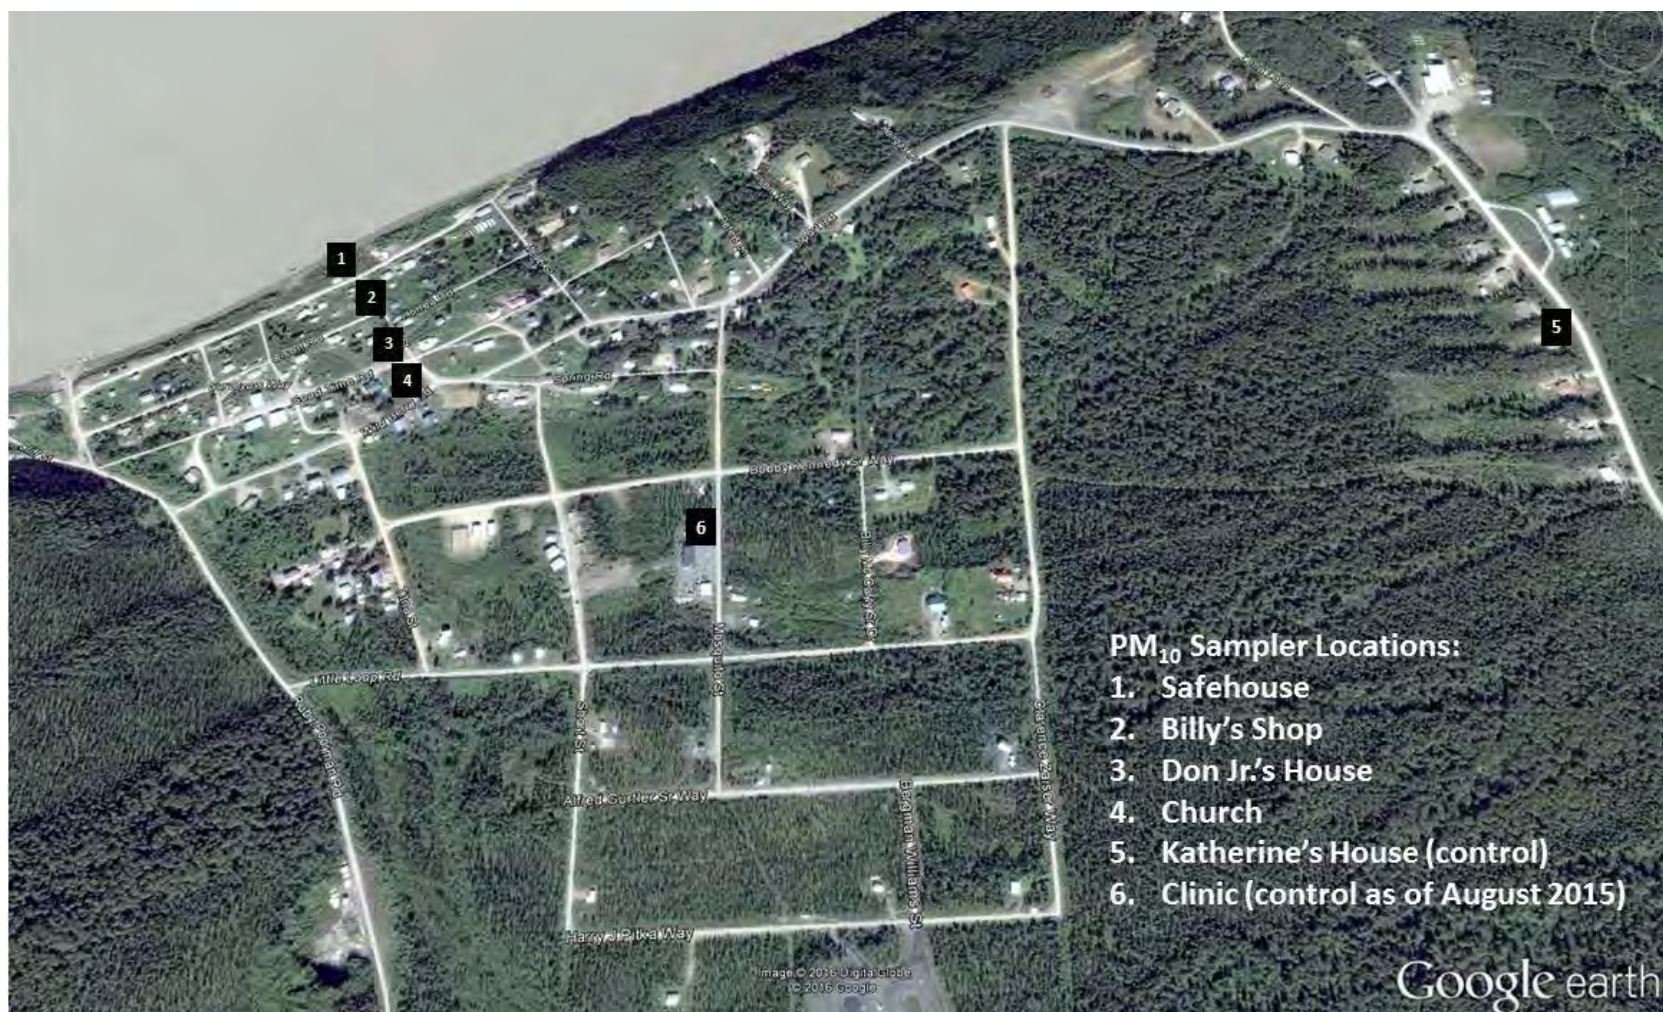
Figure 4. Map of PM<sub>10</sub> monitoring sites. The Safehouse and Billy's Shop are located on River Road (1&2). Don Jr.'s House and the Church are located on Good Time Road (3 & 4), Katherine's House is located on Airport Road (5), and the Clinic is located on Mosquito Street (6).

The original control site was located near Katherine's house on Airport Road from May 30<sup>th</sup>, 2015 through August 22<sup>nd</sup>, 2015. The control site was intended to remain next to an untreated roadway so that it could be used as a benchmark to measure the effectiveness of the palliative on the treated roads. The "Katherine's House" site was originally chosen as the control site because its proximity to Airport Rd (a high traffic route) as well as being a location where children frequently play. It was moved in late August 2015 to a new untreated roadway location on the east side of Mosquito St, adjacent to the parking lot of the Ruby Health Clinic, after DEC learned that the application of palliative had been extended just beyond Katherine's house. The new "Clinic" control site sampler was re-calibrated upon relocation. See Figure 4 below for locations of the control site at the Katherine's House site during 2015 and the new Clinic control site location used for the 2016 sample season.

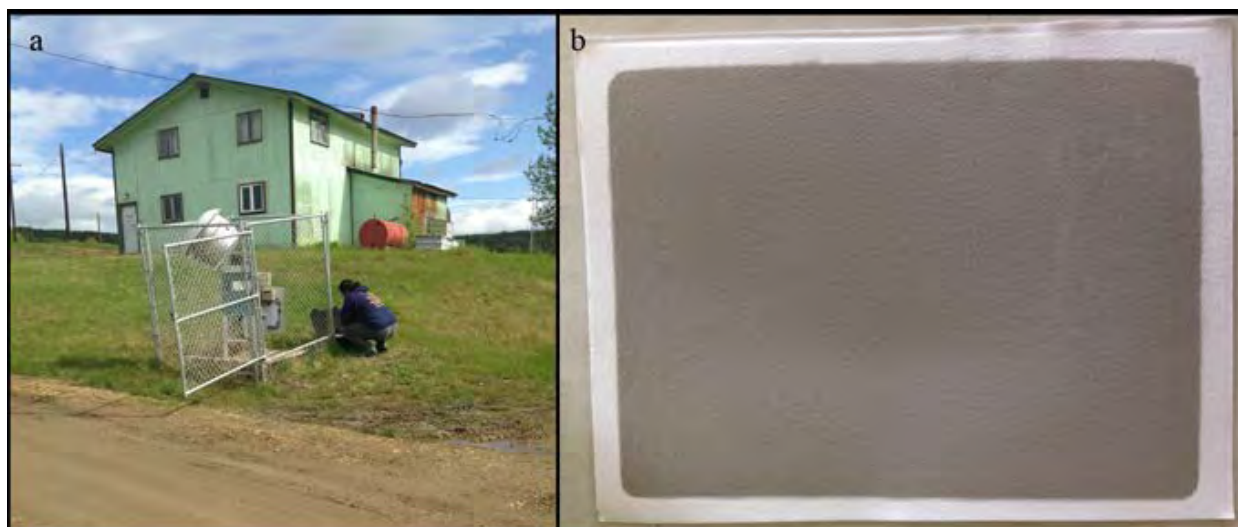
Figure 6. (a) Tribal staff member changing filter at Church site. (b) Filter run for 24-hours with PM<sub>10</sub> deposited on surface.

DEC was responsible for instrument maintenance, calibrations, and quality control (QC) checks. Ruby Tribal staff completed the day-to-day operation of the samplers, changing the filters after each run, recording the flow reading from the instrument's mass flow controller, and recording the number of minutes elapsed during each sample run. Figure 6a shows a PM<sub>10</sub> high-volume sampler with the sample chamber open. Figure 6-b is an example of an exposed PM<sub>10</sub> sample filter loaded with PM<sub>10</sub> particulate matter.

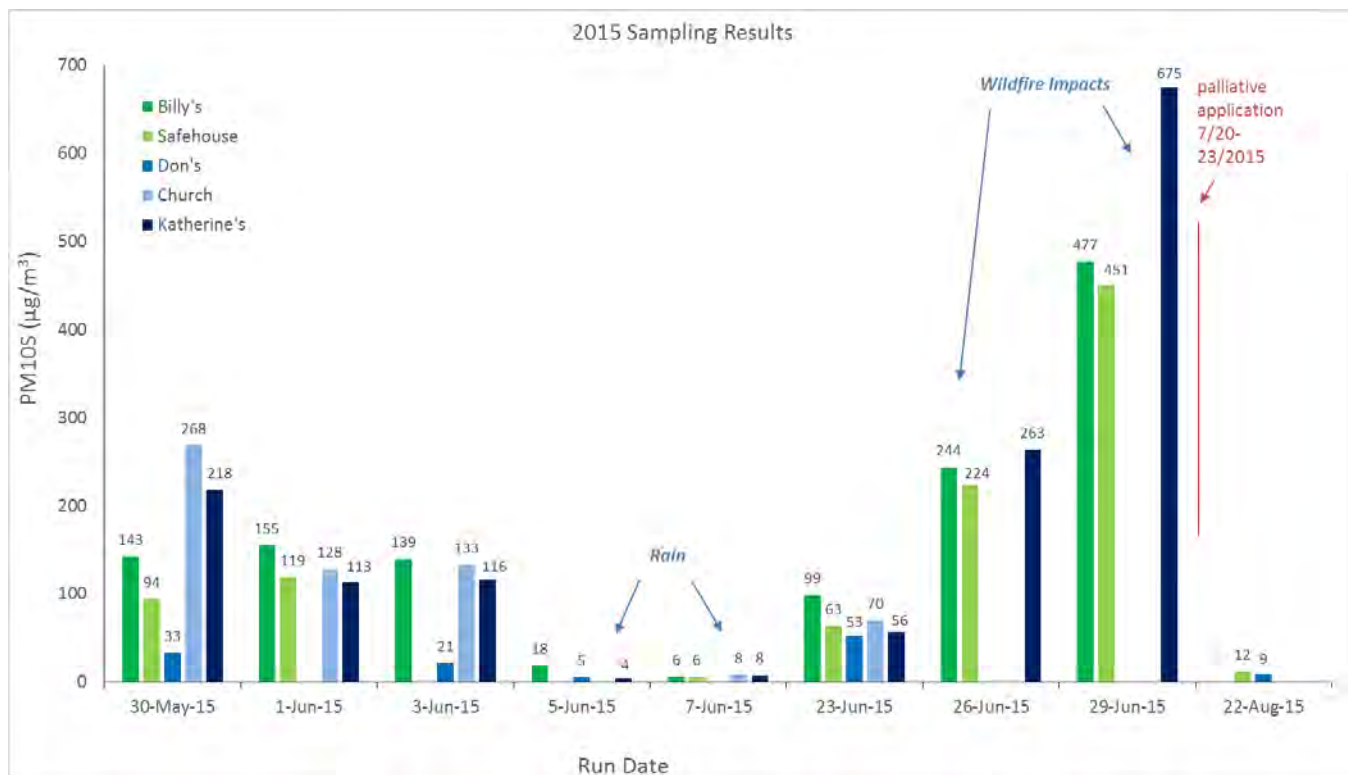
Figure 7. 2015 Sample Season Results

DEC received 44 sample filters collected by Ruby staff over nine sample days between May 30<sup>th</sup> and August 22<sup>nd</sup>, 2015 for all five sampling sites combined. DEC found 32 of those samples valid according to EPA validation criteria. Eleven samples were void because sample collection duration did not fall within the acceptable range of 23 to 25 hours. One additional sample was void due to a filter weighing error. PM<sub>10</sub> measurement above the NAAQS (150 µg/m<sup>3</sup>) were observed on three of the eight valid sample days during the 2015 sample season. Results from the June 26<sup>th</sup> and 29<sup>th</sup>, 2015 sampling events were likely impacted by wildfire smoke which would indicate that the exceedances recorded on those days cannot be attributed to road dust alone. In each instance, exceedance values were observed concurrently at two or more sampling locations. The 2015 valid sample results appear below in Figure 7 with the full data set included as a Microsoft Excel file attached to this report.

During the two year monitoring period, Ruby Tribal Staff encountered sample collection challenges due to weather, staffing shortages, and wildfires. Smoke odor was first noted in field logs on June 26<sup>th</sup>, 2015 and sampling was suspended after June 29<sup>th</sup> due to a significant quantity of airborne ash. Wildfire smoke and ash continued to impact the Village of Ruby throughout July 2015. Abbreviated sample schedules resulted in fewer than anticipated PM<sub>10</sub> sampling events in both 2015 and 2016. Due to variable precipitation occurring over relatively few sample events DEC staff could not reasonably control for the variation in weather patterns when comparing the data from each sample season. When DEC needed to select a new control site for the Summer-2016 sample season, loss of continuity in the control site between the 2015 and 2016 sample seasons prevented DEC from normalizing treated road data for each sample season relative to the same benchmark control site. Consequently, DEC could not confidently quantify reductions in PM<sub>10</sub> attributable solely to the road dust palliative treatments.

With exception of the high measurement of PM<sub>10</sub> at the Church site in 2016, PM<sub>10</sub> concentrations measured at both treated and control sites alike appear largely reflective of road surface dryness as explained by the amount of precipitation received and cloud cover present during each sample event and the prior day or two. An analysis of the data in respect to wind speed and directions did not yield any conclusive results. Overall, the daily particulate concentration is a function of many factors including wind direction and wind speed, the temperature and precipitation, i.e. dryness of the road, and passing vehicle traffic, both in numbers and in type. Tables of hourly precipitation and daily meteorological conditions at the Ruby airport for each day during May and July of 2015 and 2016 are provided in the appendix of this report. Although wind direction and wind speed at the Ruby Airport may have been different than conditions at each PM<sub>10</sub> sampling location due to topographical differences, observations of sky conditions, such as cloud cover, and the amounts of precipitation measured each day are likely to have been very similar throughout the general area.

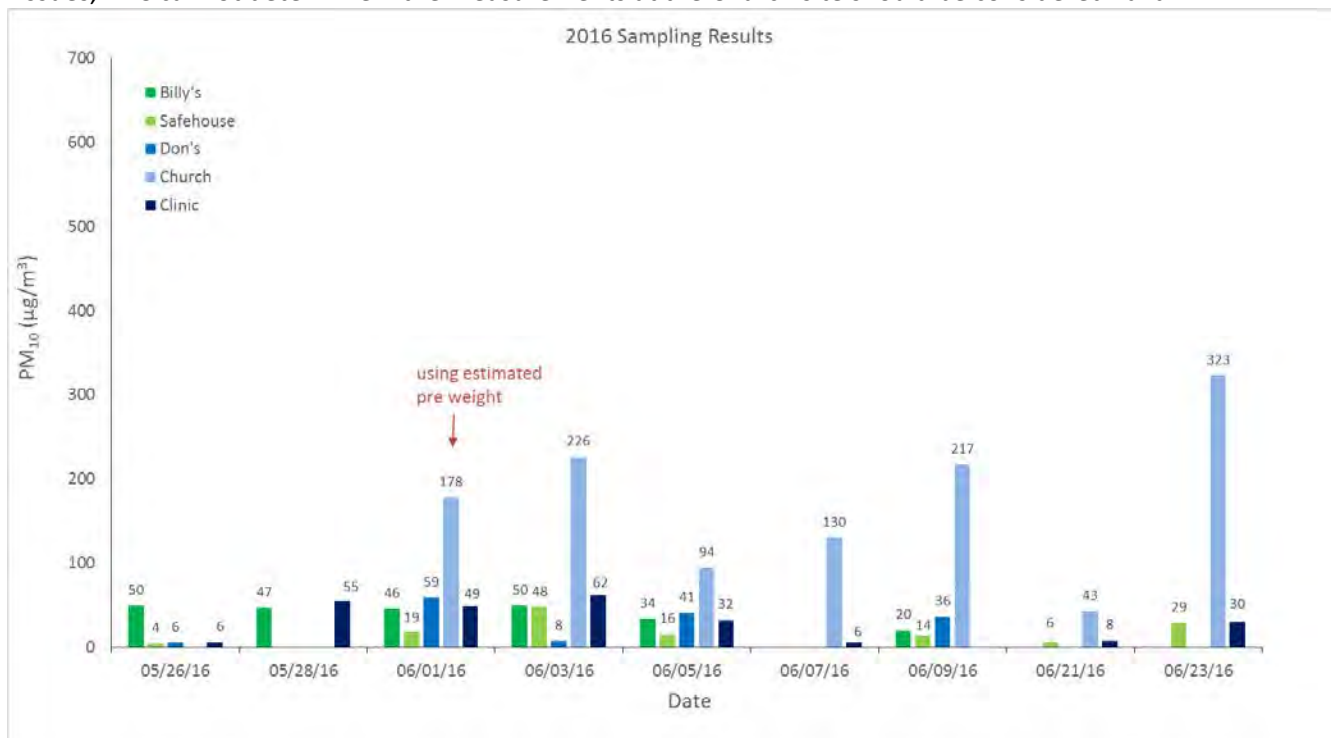
Figure 8. 2016 Sample Season Results

DEC received 55 filters collected by Ruby staff over 10 sample days occurring between May 26<sup>th</sup> and June 23<sup>rd</sup>, 2016 for the five sampling sites combined. DEC was able to validate 32 of those samples via the same EPA validation criteria. Due to instrument malfunction 18 of the sample runs did not meet the required sampling time allowed of 23-25 hours from midnight to midnight. An additional five samples were invalid due to filter weighing errors. PM<sub>10</sub> measurements in excess of the PM<sub>10</sub> NAAQS were observed on five of the 10 sample days during the 2016 sample season; however, all five exceedance values were obtained solely at the Church site. The 2016 valid sample results appear in Figure 8 with the full data set included as an Attachment to this report.

The June 1<sup>st</sup>, 2016 sample had an unusual pre-sample weight, much lower than the other filters from the same batch. No obvious weighing error had been documented, but DEC decided to use the average of the pre-sampling weight from the filters at that site to estimate the concentration for that day. The concentration would calculate to 2152 µg/m<sup>3</sup> if the pre weight from the lab was used, versus an estimated concentration of 178 µg/m<sup>3</sup>, which seems more reasonable compared to the other measurements for this site. While the Church site results for 2016 seem to be in the range of the 2015 pre-palliative application values, they appear significantly higher than the concurrent sample results from all other sampler locations. No procedural or calibration error was found to account for the uncommonly high PM<sub>10</sub> results obtained from the Church sampler. The Church site and Don Jr's House site are approximately 25 feet apart from each other, on either side of Good Time Road. While the Church site results in themselves might be consistent, they do not match all the other sites, which all have generally similar values for the 2016 sampling period. The high concentration may be a result of some systematic error, some measurement inaccuracy or another unknown issue. Due to lack of sufficient data and information to compare the results or another study to investigate specific site issues, DEC cannot determine if the measurements at the Church site should be considered valid.
