FINAL SUBSURFACE EXPLORATION AND FOUNDATION RECOMMENDATIONS

NULLAGVIK HOTEL KOTZEBUE, ALASKA

June 4, 2008 W.O. D58405A Area 8 Report No. 4747

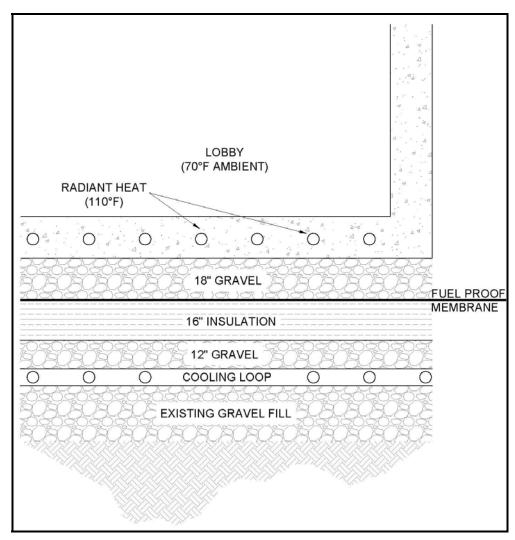
Figure 2: Typical Detail

The permafrost should be protected from degradation by a flat loop cooling system designed by Arctic Foundations, Inc. The system will likely consist of 3/4-inch diameter steel pipe, four to six feet on center. The flat loops will be connected to the laterals that maintain a minimum one foot vertical for 30 feet horizontal (1:30 slope) or connect directly into risers, followed by the condensers. A fuel proof membrane should be placed below the lobby, above the insulation and sloped away from the building. Figure 2 is a preliminary sketch of the pad below the lobby. The final design of the pad will vary and will be based on the design assumptions above as well the design degree days.

The thermopile foundation system keeps the soils below the structure frozen. A thermopile is a load bearing two-phase passively refrigerated pile with rings around the perimeter. Each pile location is pre-drilled about six inches larger than the diameter of the piles, including the

Building Pad. The building pad should be constructed prior to installing the thermopiles and in the early summer when the ground is still frozen. As the site is already covered in a gravel fill material, the pad can be constructed by removing some thickness of gravel such that insulation is located 18 inches below finish grade, placing two inches of rigid closed cell extruded polystyrene on the exposed soils, and backfilling with the excavated, non-organic granular material. The insulation should extend outward 12 feet from the edge of the building. If 2009/2010 construction is planned, the insulation should be installed in April, May, or early June 2009.

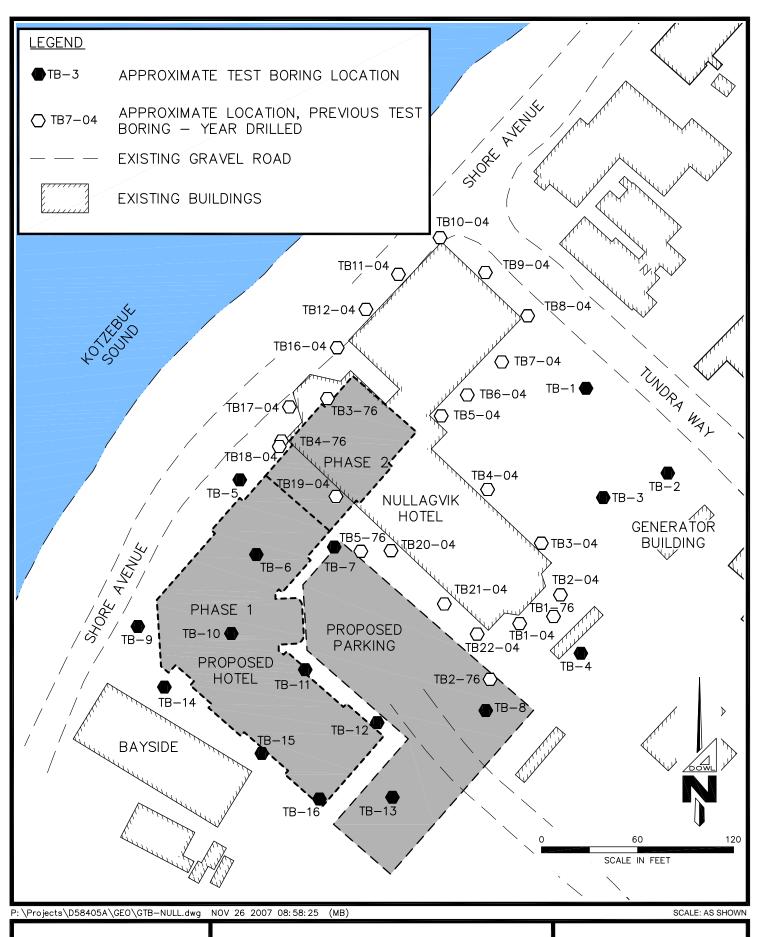
FIGURE A-1

Test Boring Location Map NULLAGVIK HOTEL Kotzebue, Alaska

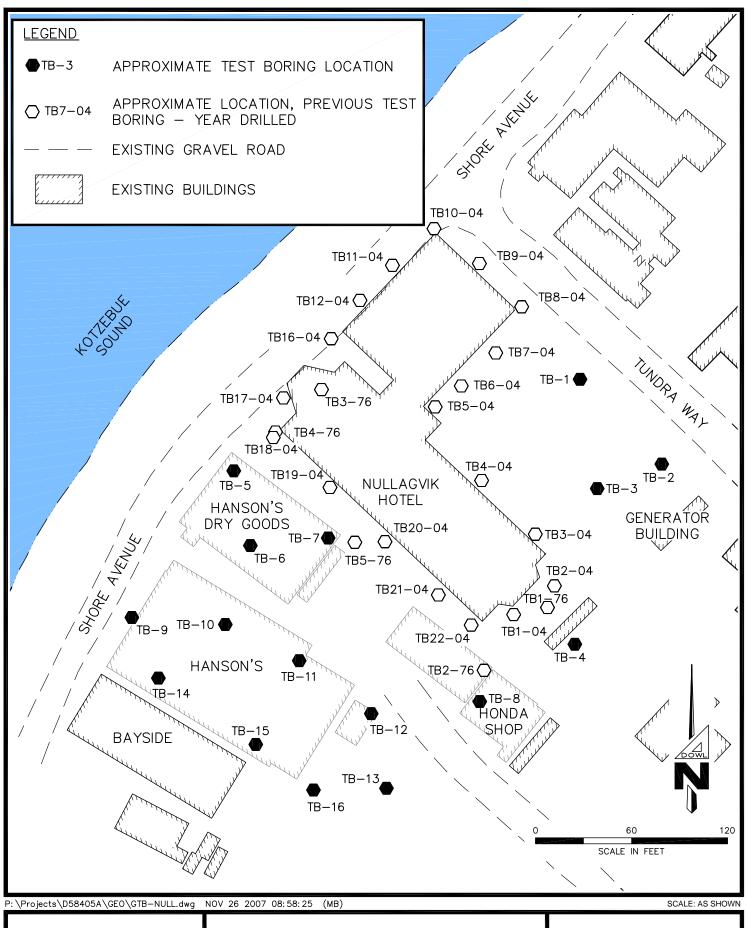
Test Boring Location Map - Prior Conditions
NULLAGVIK HOTEL
Kotzebue, Alaska

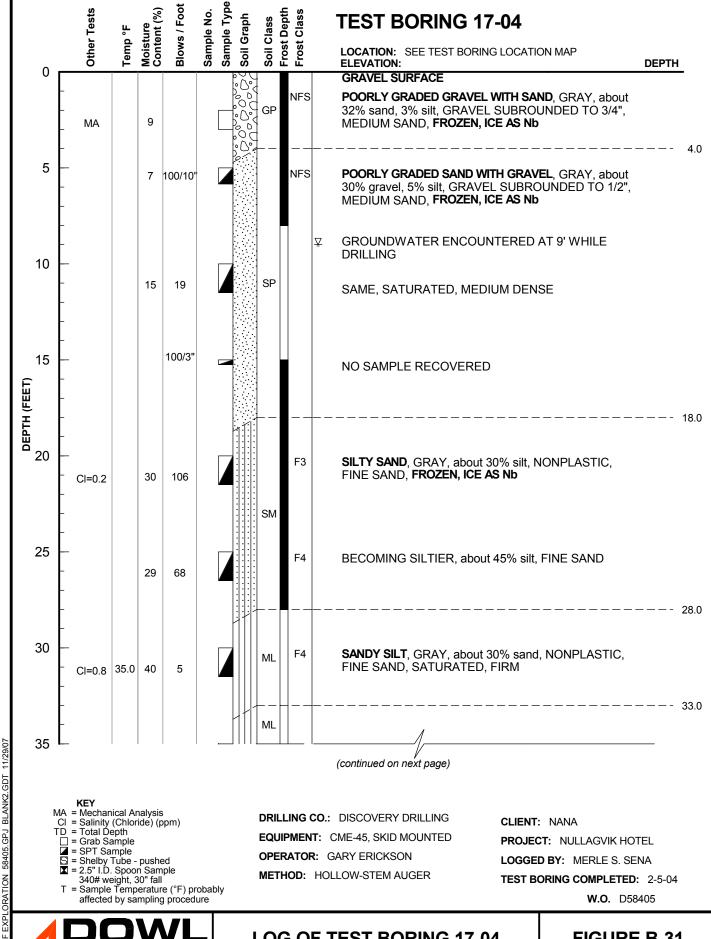
FIGURE B-31

LOG OF TEST BORING 17-04

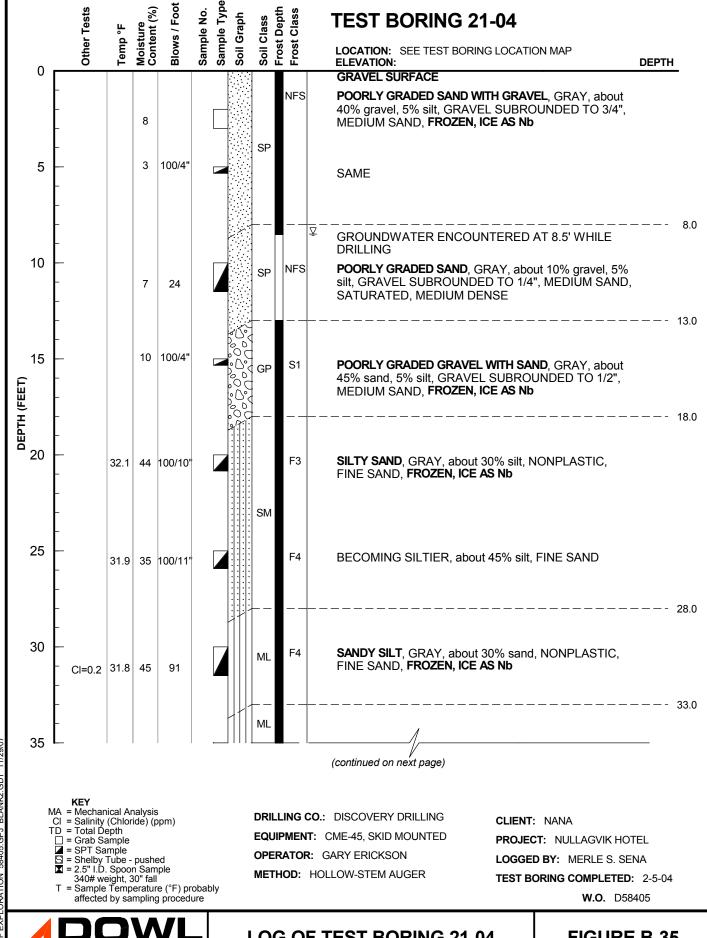
FIGURE B-35

LOG OF TEST BORING 21-04

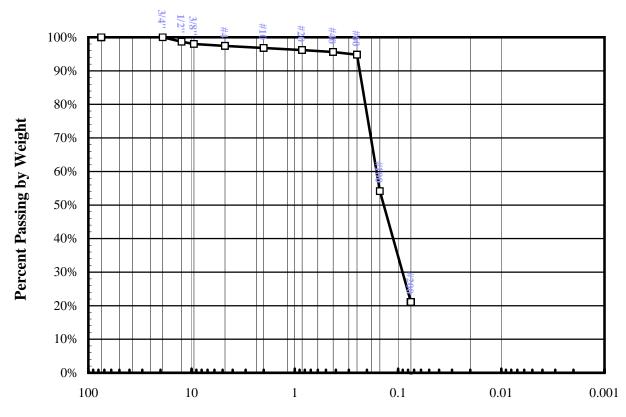
Engineering Classification: Silty SAND, SM

Frost Classification: Not Measured

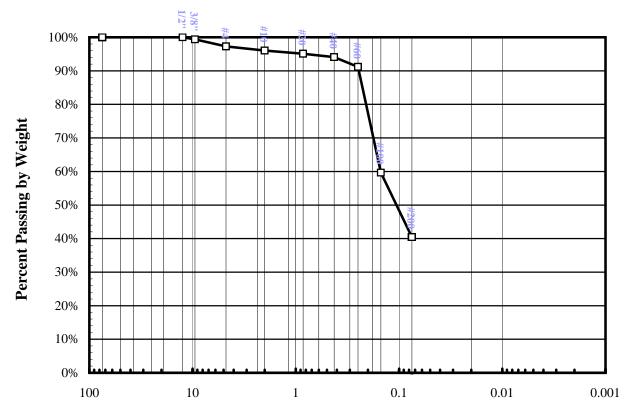
Engineering Classification: Silty SAND, SM

Frost Classification: Not Measured

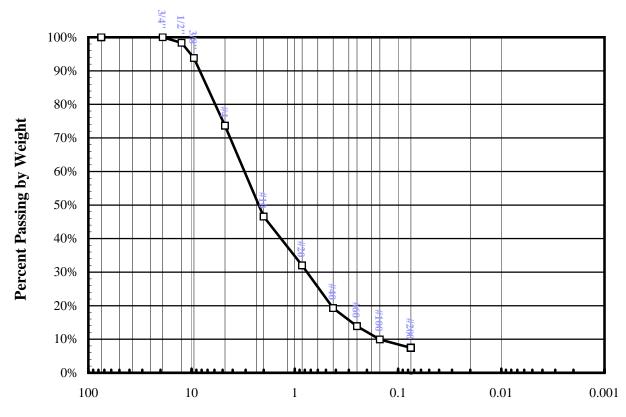
Engineering Classification: Well Graded SAND with Silt and Gravel, SW-SM

Frost Classification: Not Measured

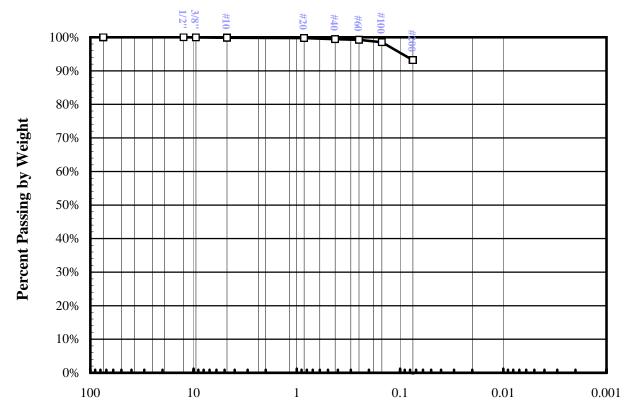
Engineering Classification: SILT, ML

Frost Classification: F4

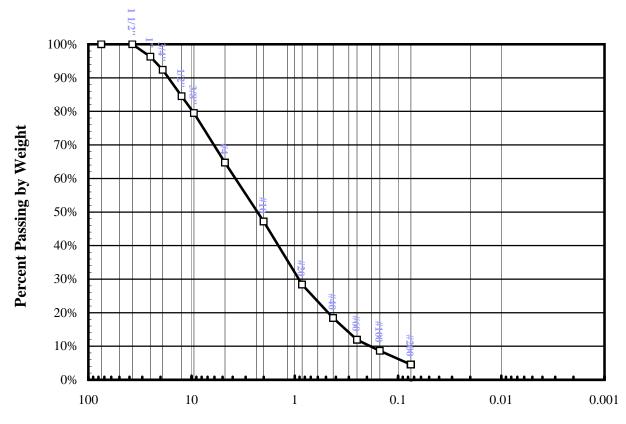
Engineering Classification: Well Graded SAND with Gravel, SW

Frost Classification: Not Measured

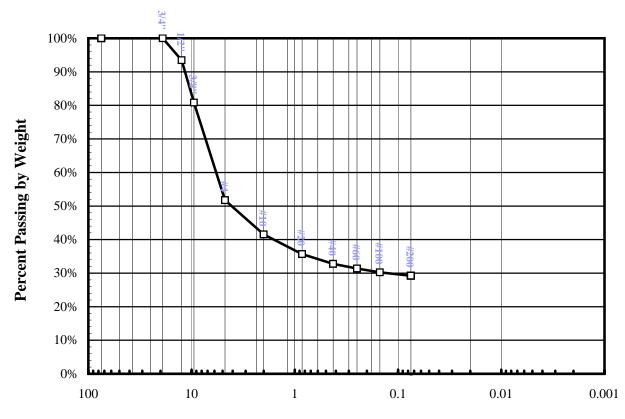
Engineering Classification: Silty GRAVEL with Sand, GM

Frost Classification: Not Measured

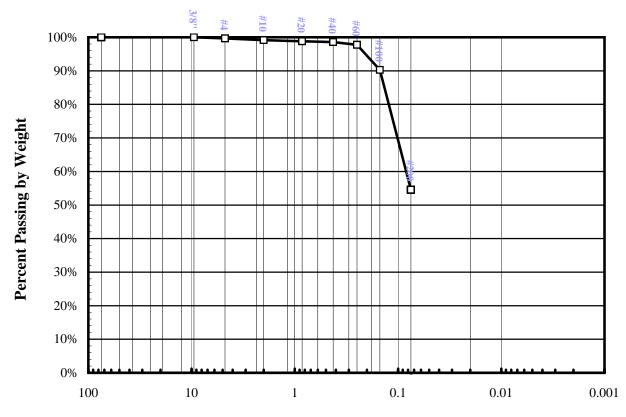
Engineering Classification: Sandy SILT, ML

Frost Classification: F4

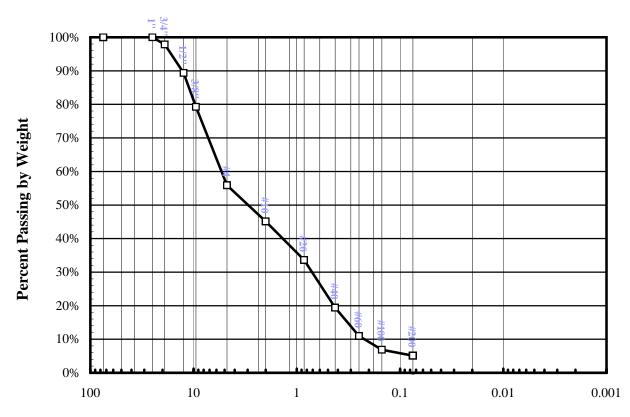
Engineering Classification: Poorly Graded SAND with Silt and Gravel, SP-SM

Frost Classification: Not Measured

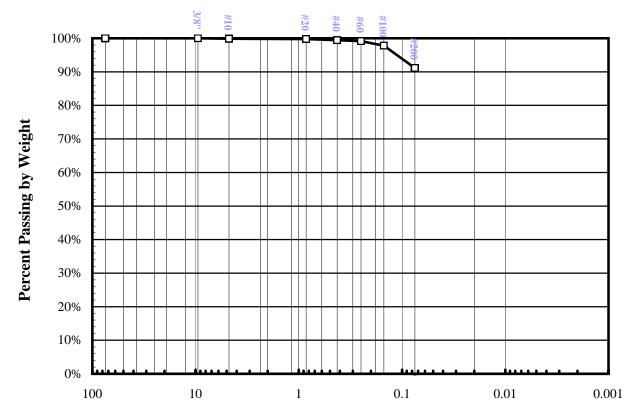
Engineering Classification: SILT, ML

Frost Classification: F4

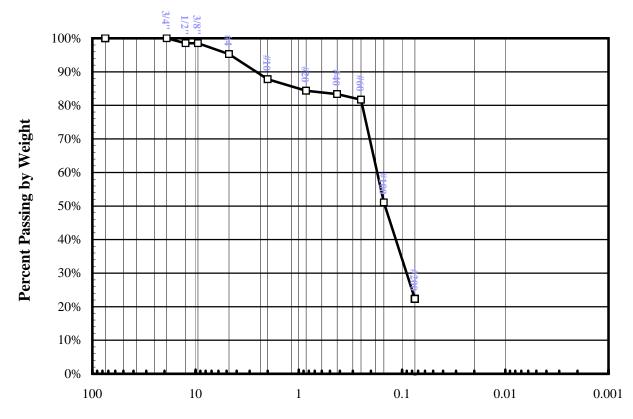
Engineering Classification: Silty SAND, SM

Frost Classification: Not Measured

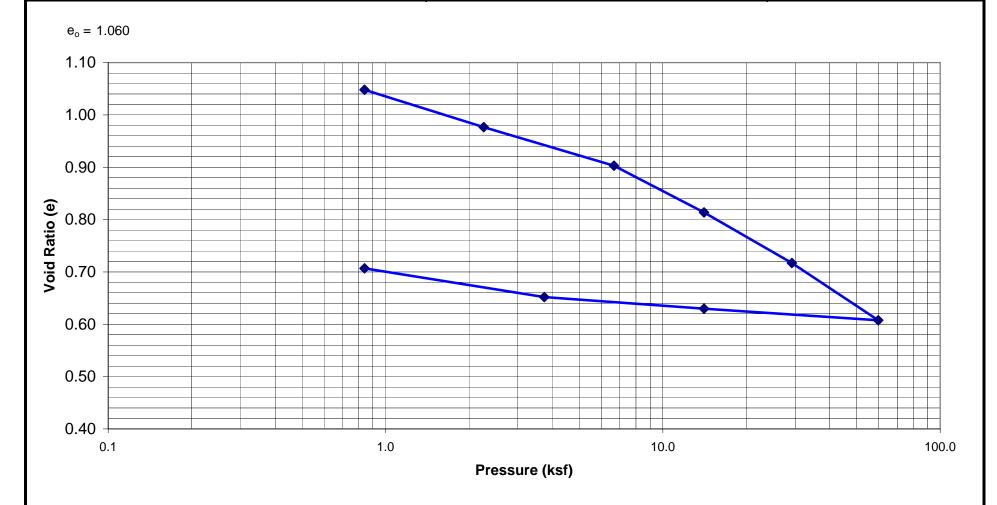
Boring: 5
Sample # 10
Depth: 40

Wet Unit Weight (pcf)= 111.9
