June 12, 2009
W.O. D58405

Subject: New Nullagvik Hotel
Findings of Environmental Field Work

This letter report summarizes the findings of environmental field work conducted at the New Nullagvik Hotel Site between February and May 2009. Earlier reports dated April 9, 2009, discussed soil sampling during the thermopile installation in February and March 2009. This report includes that information and also expands to include samples taken near Shore Avenue and on stockpiled drill cuttings in May 2009.

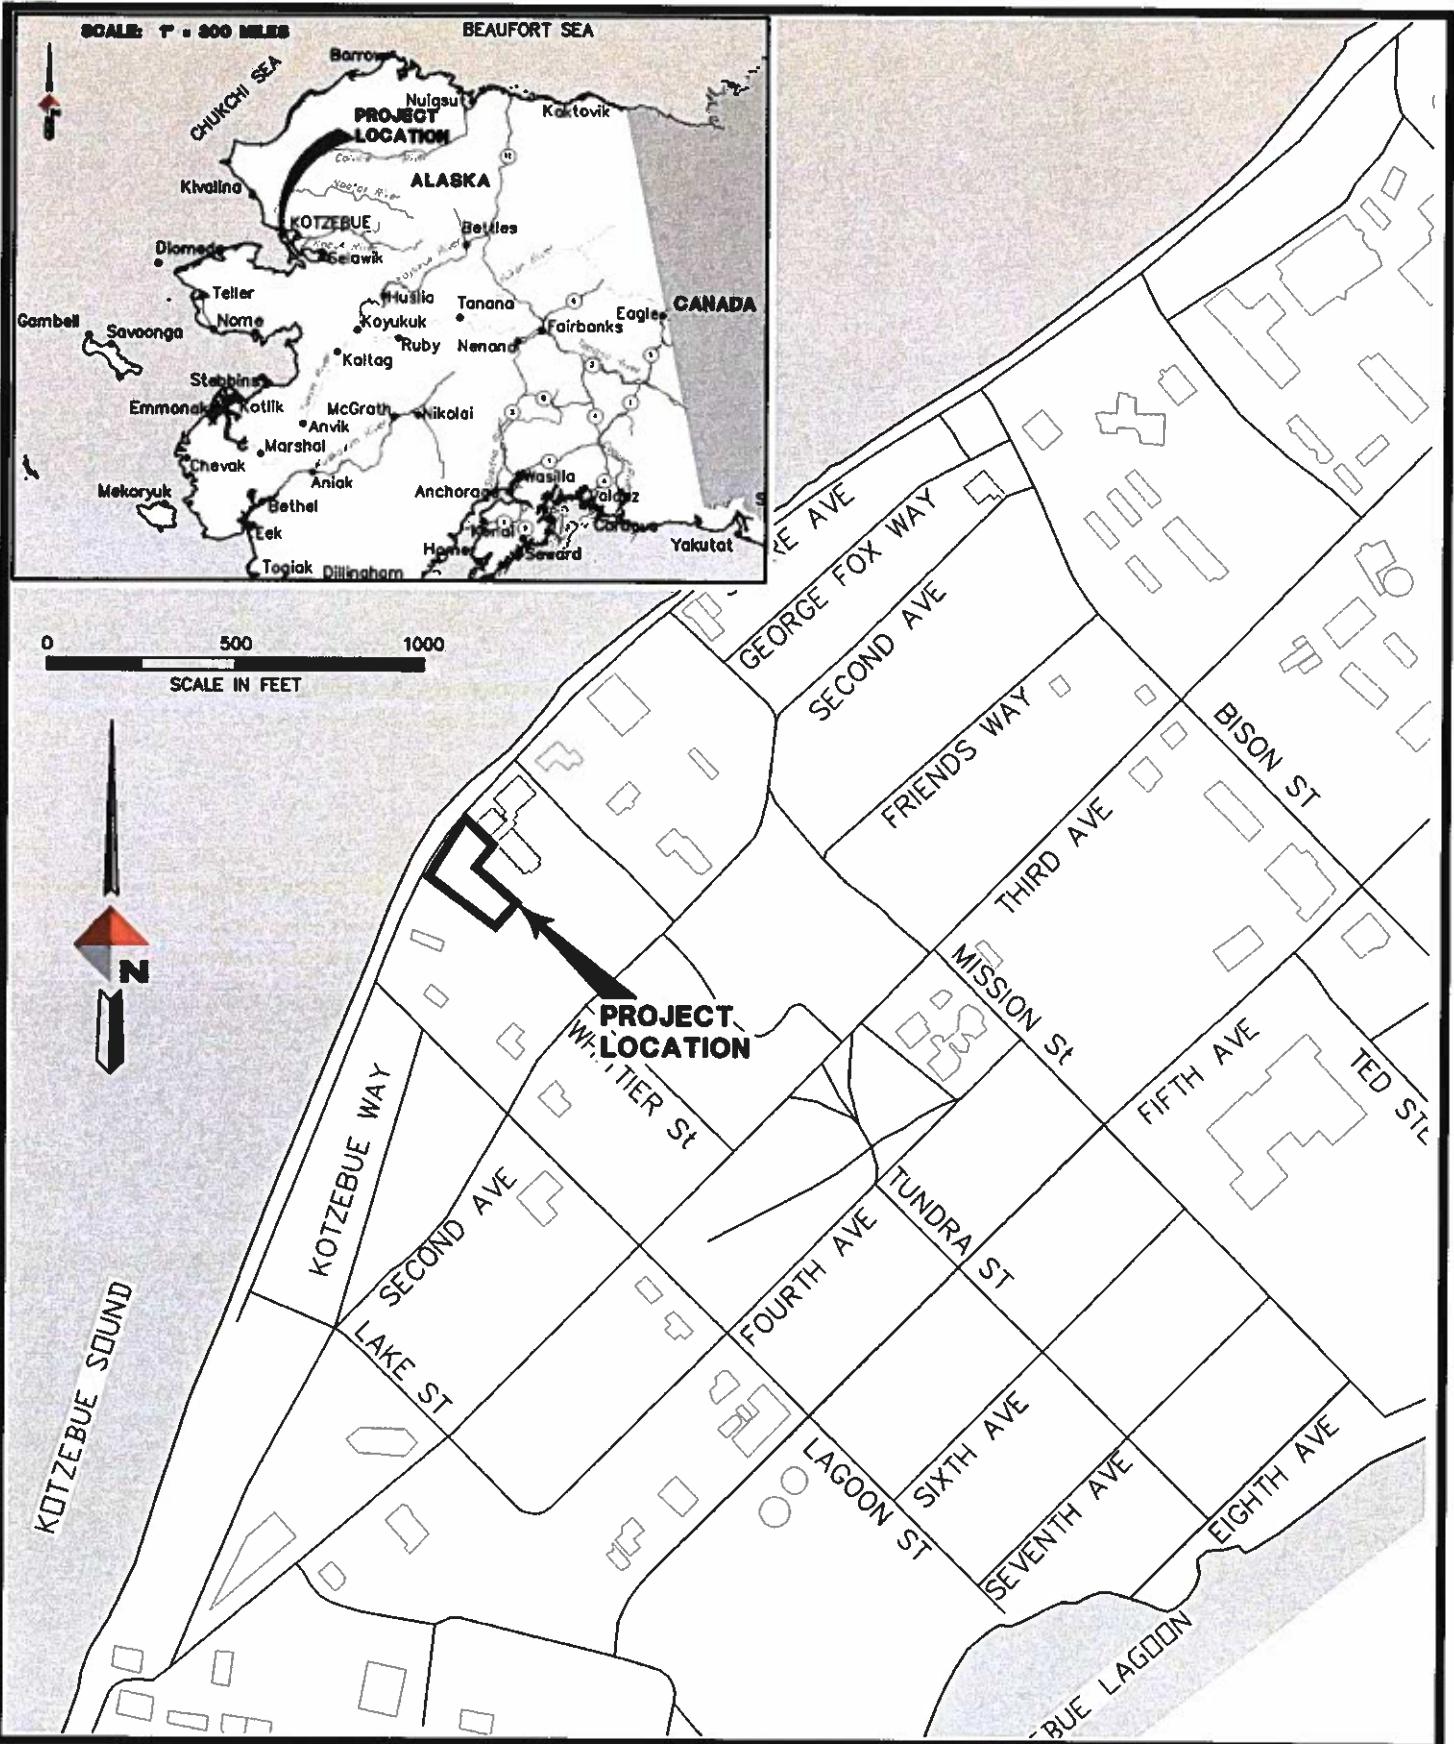
FIGURE 1

Vicinity Map
NEW NULLAGVIK HOTEL
Kotzebue, Alaska

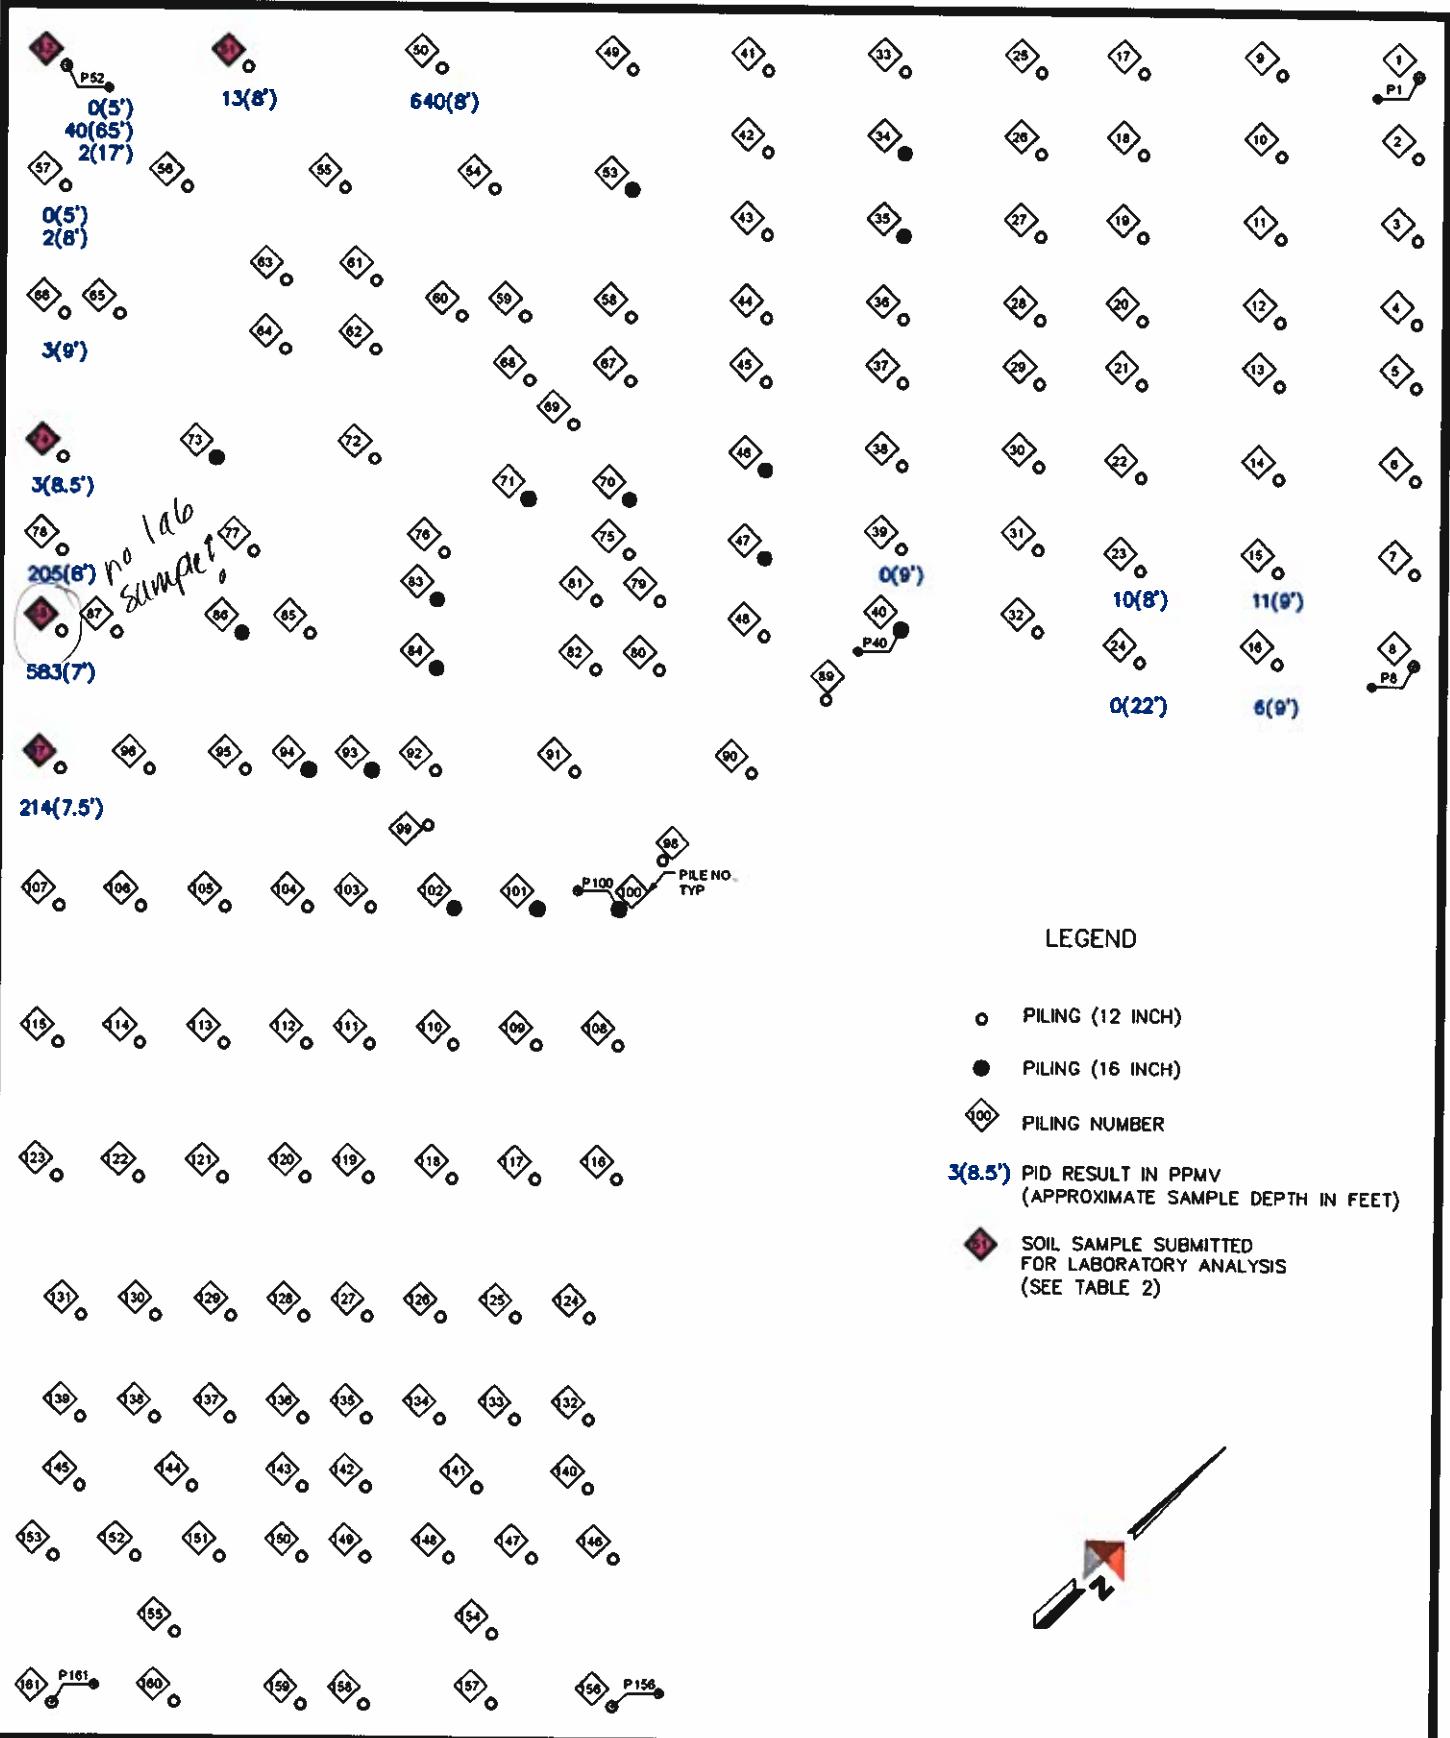
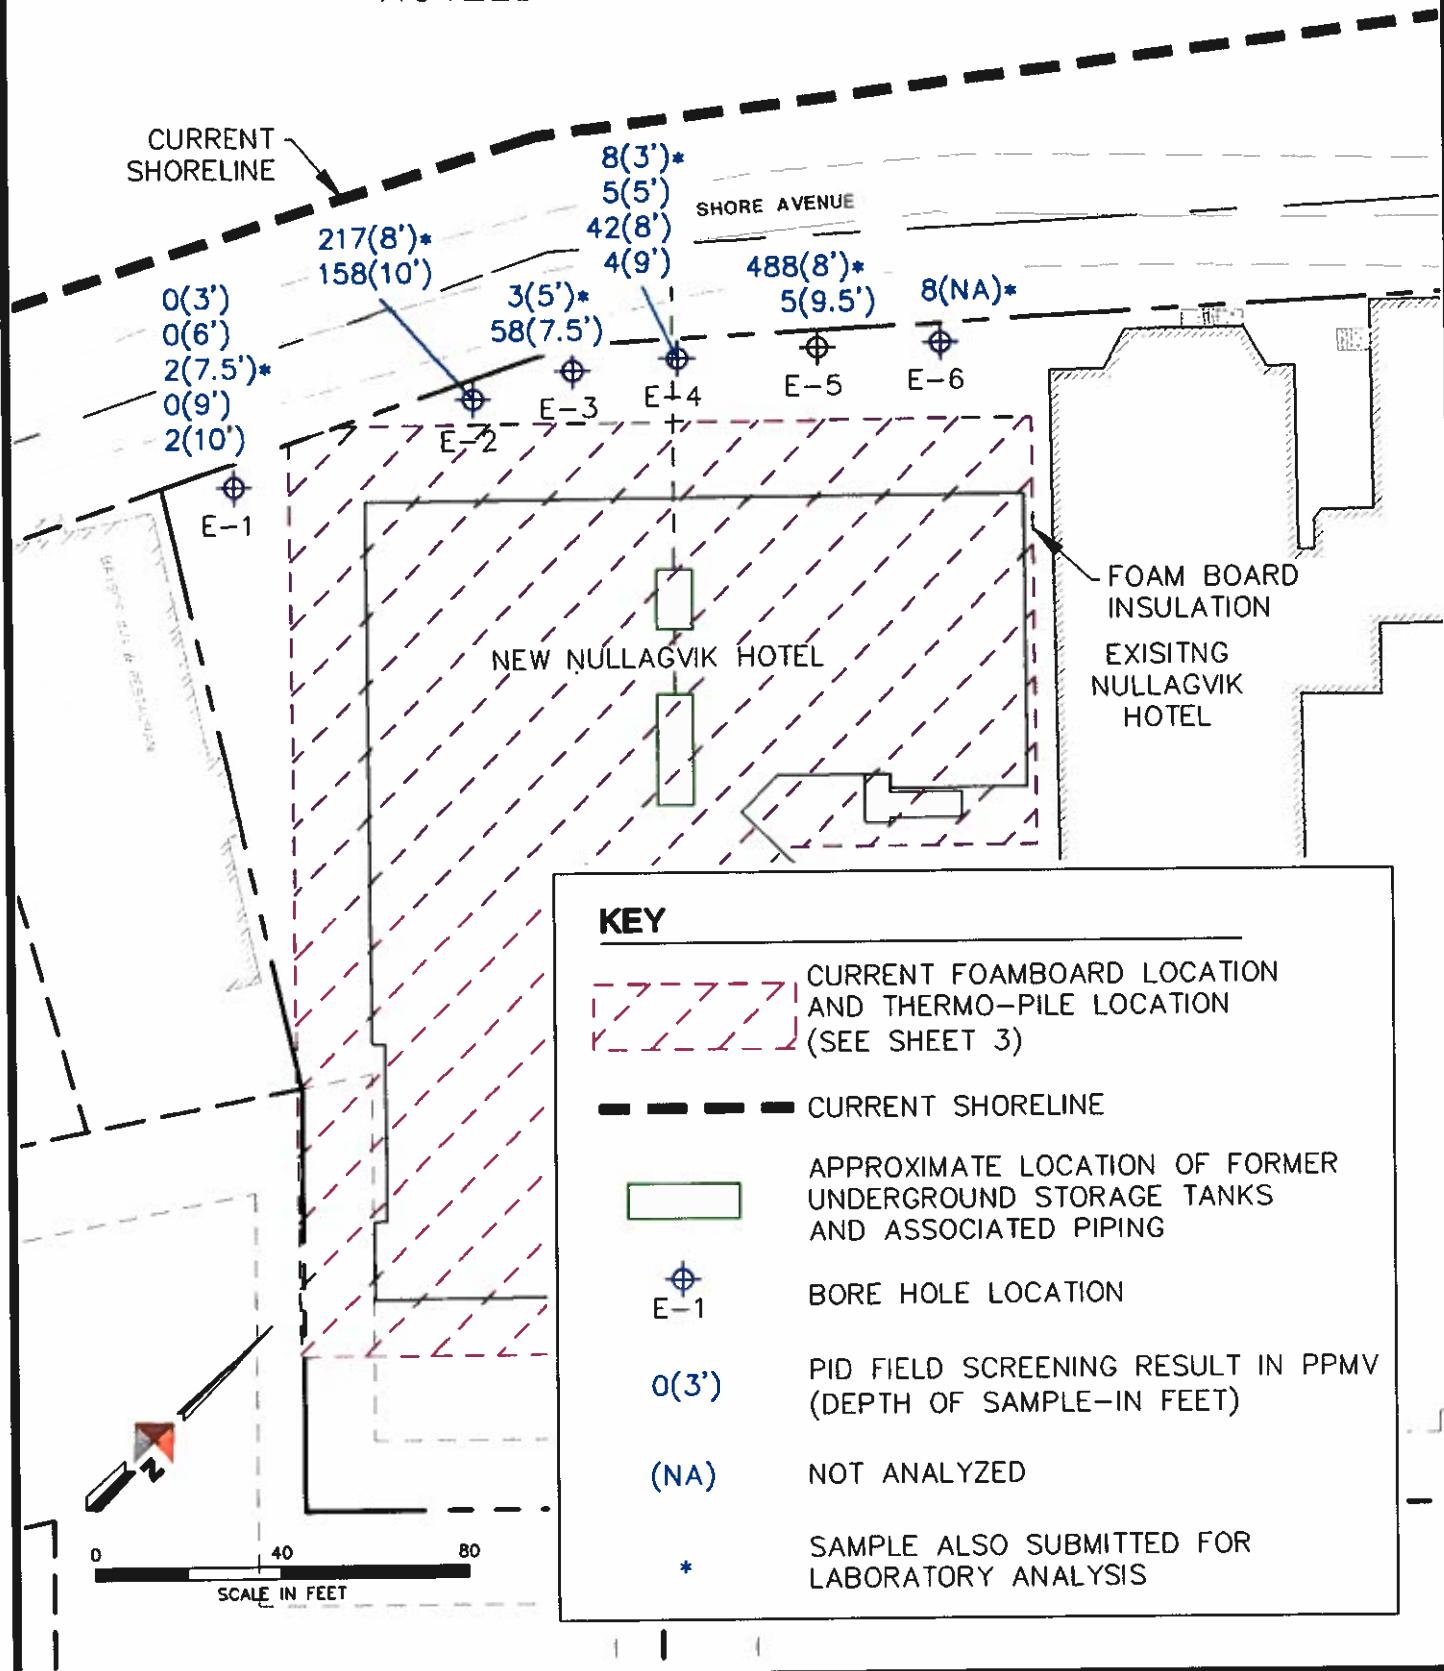
Table 1 lists the location, depth, and PID readings of the field screening samples. Figure 3 displays the location of pilings.

PID and analytical results from the soil samples taken during the thermopile installation identified two potentially isolated spots of contaminated soil: one on the southwest side of new hotel site, near Bayside Inn and one on the northwest side of the new hotel site, near Shore Avenue.

Analytical results indicate that the spot on the southwest side is likely due to diesel fuel contamination, while the spot near Shore Avenue is of unknown origin. Former gasoline underground storage tanks and piping used for the old fueling dispenser were located nearby (Figure 2).
