**RE: CONTAMINATED SOIL STOCKPILE SAMPLING, KOBUK ABANDONED  
TANK FARM, KOBUK, ALASKA; ADEC HAZARD ID 4615**

This letter report presents the results of our soil stockpile sampling activities at the Kobuk Abandoned Tank Farm in Kobuk, Alaska. The purpose of this project is to collect soil samples from the contaminated soil stockpile with an objective of determining whether it is appropriate to utilize the stockpile as daily landfill cover.

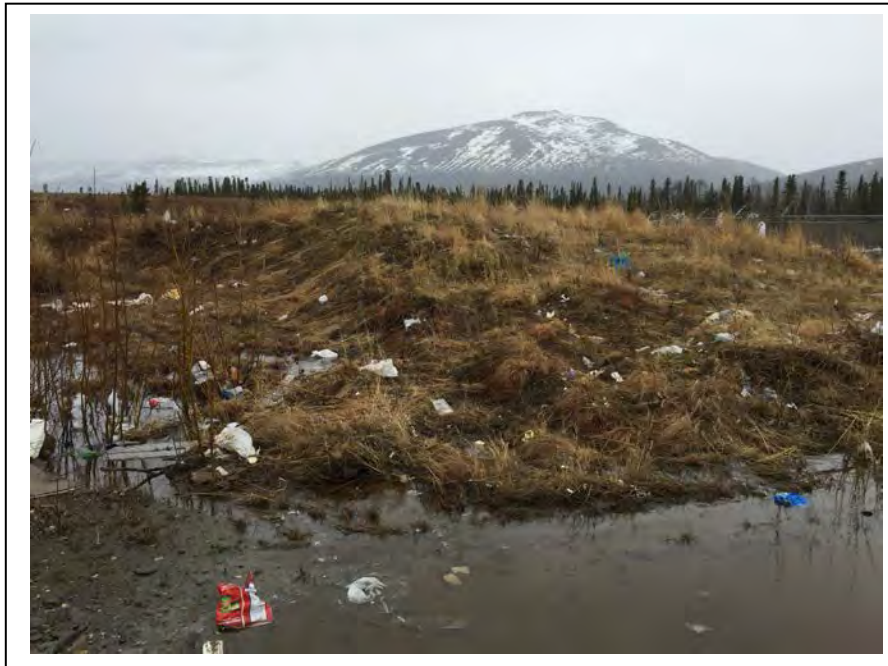
At the time of the site visit, the stockpile had vegetation growing on it (Photo 1) and the top liner of the stockpile was weathered and deteriorating (Photo 2). Based on a screening frequency of at least one screening sample per 10 cy of soil, 20 test pits were advanced using a shovel. The soil screening samples were collected at approximately 1.5 to 1.7 feet beneath the stockpile surface. One screening sample was collected from each test pit. The soil samples were evaluated in the field using visual descriptions and semi-quantitative headspace screening. Headspace screening was conducted in accordance with ADEC guidelines using an OVM 580B photoionization detector (PID) calibrated with 100 parts per million (ppm) isobutylene standard gas. The field screening samples were collected in re-sealable bags, warmed, and tested within 60 minutes of collection.

Photo 1: Looking north at the stockpile. (May 14, 2015)

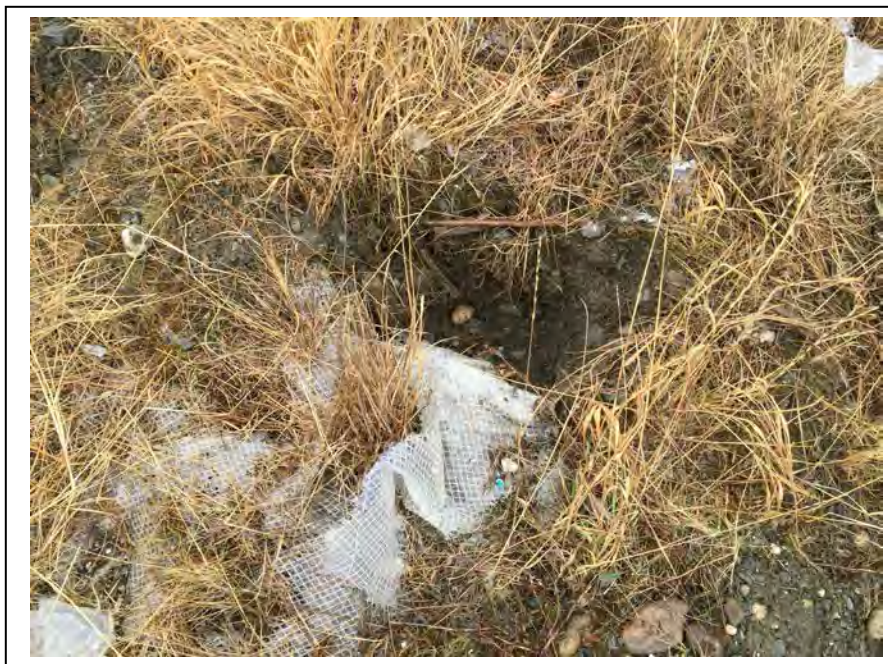
Photo 2: Deteriorating liner towards the north end of the stockpile. (May 14, 2015)
