July 9, 2010

Susan Schrader  
Alaska Railroad Corporation  
P.O. Box 107500  
Anchorage, Alaska 99510

**Re: UST Removal Report  
CF/SBS Building  
Anchorage, Alaska**

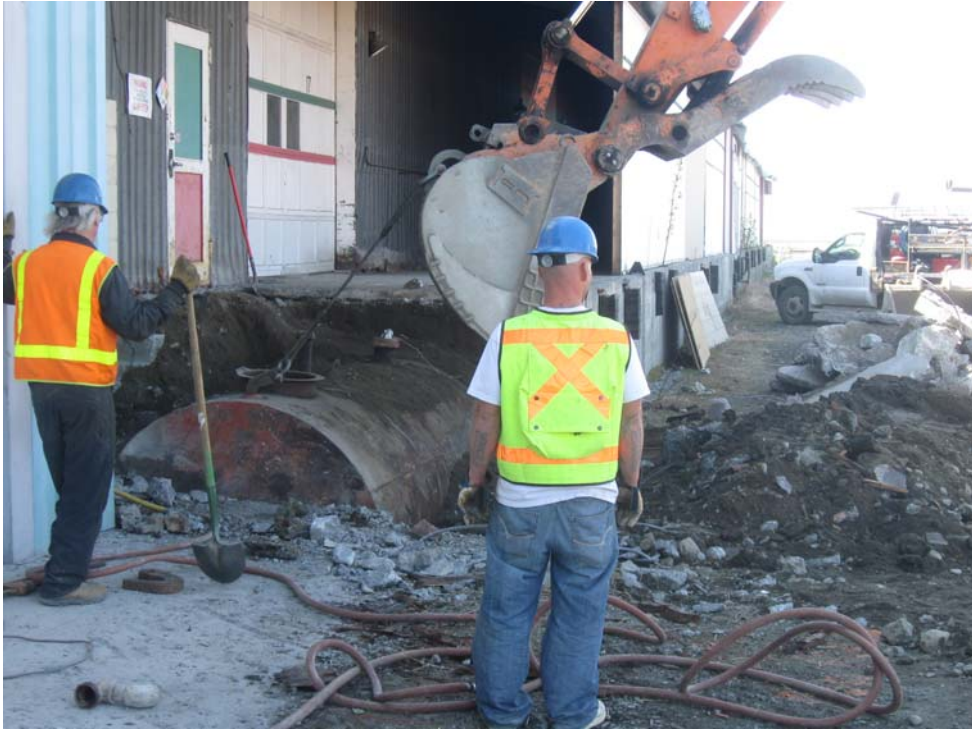
B C Excavating removed the UST on May 4, 2010. The fill port was located directly on top of the UST and the supply and return lines were located on the west end of the UST and entered the building under the concrete floor slab. The concrete wall on the north side of the UST was removed to grade (Attachment A, Photograph 1). The footing of the wall extended below grade and below the groundwater level (3.5 feet). This section of the wall (below grade) was left in place.

Photograph 1: Concrete walls removed and underground storage tank (UST) ready for removal. View looking west

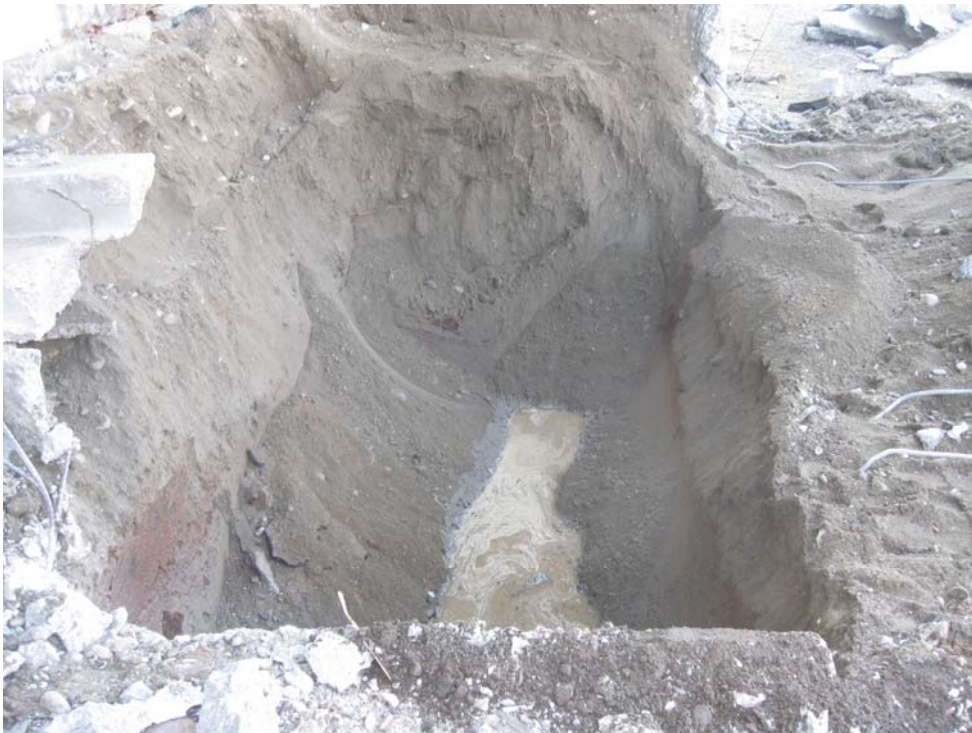
Limited petroleum-impacted soil was removed from the UST excavation; however, no additional soil was removed because further excavation had potential of undermining the structure. Two soil samples (and a duplicate, EX3) were collected from the excavation for submittal to the laboratory for analyses. These two samples (EX1 and EX2) were collected from the excavated area impounded by footing walls. The samples were collected from the sidewalls due to the presence of groundwater at 3.5 feet below grade (Photograph 2).

Photograph 2: Location of former UST. Groundwater at 3.5 feet below grade. View looking west.

We recommend that no further action be required at this time. We recommend that if the building were to be demolished, the DRO-impacted soils be excavated and disposed of at that time.
