# Suntrana Tipple PCB Cleanup Report

*Clarus Environmental Services, LLC  
11901 Business Blvd., Suite 105  
Eagle River, Alaska 99577*

*October 21, 2005*

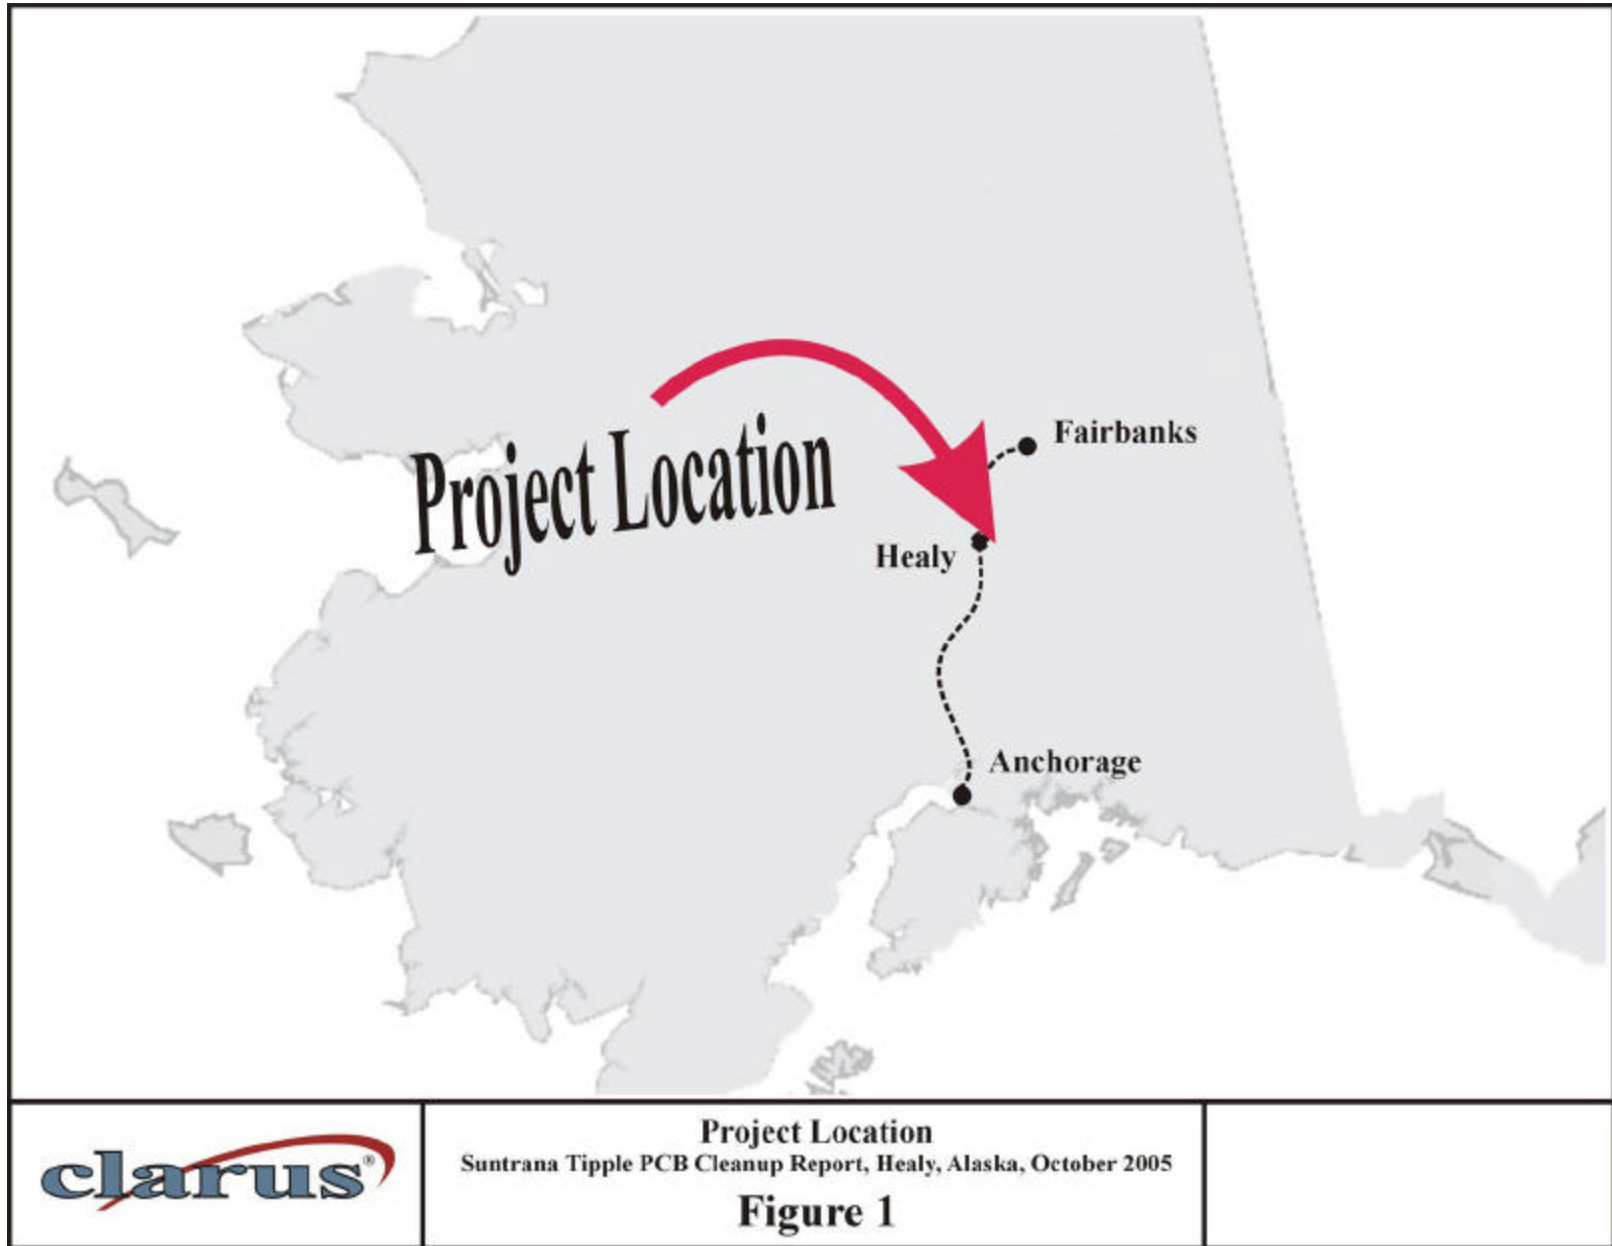
The Suntrana coal facility is bordered on the north, east, and west by the foothills of the Alaska Range, and the south by Healy Creek. Nortech and ADNR MLW originally divided the areas into sites, and the area of concern for this remediation was given the name "Site P". For consistent reference, this will continue to be the name of this site. Site P lies about 200 feet west of the main conveyor (figure 2). The sampling area occupies approximately 150 square feet (ft<sup>2</sup>) within this site. (See photographic log at Appendix A.)

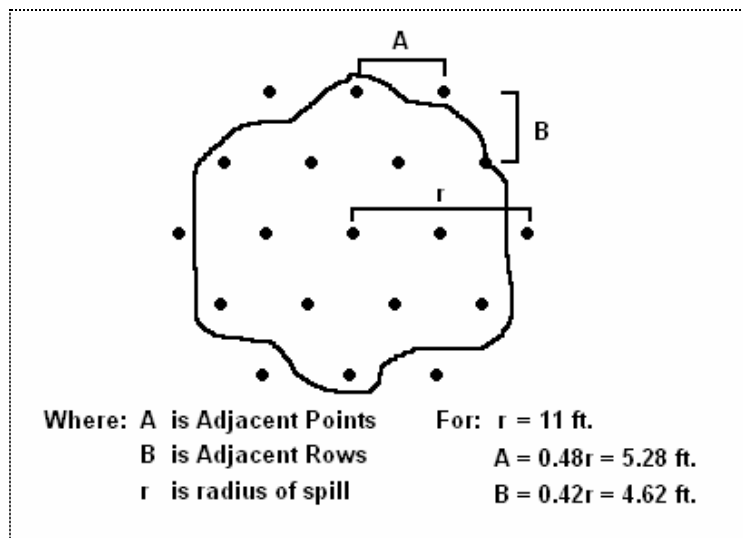
**Figure 3 - Construction of Sampling Grid Points**

The design of the sampling grid was taken from The Environmental Protection Agency (EPA)'s 'Field Manual for Grid Sampling of PCB Spill Sites to Verify Cleanup', May 1986, EPA-560/5-85-017. This design uses a known radius of a spill to layout sampling points of equidistance in a grid to verify a site that has been remediated. Using statistical results, this design maximizes the probability of finding PCB contaminated soil above the action level. EPA recommends a 19 point grid for spills similar in size to that of Site P, estimated to have an 11 ft. radius. Figure 3 shows the initial 19 point grid and the equations used to determine distance between the points of the equilateral layout.

All sampling was done on this grid pattern in the X and Y plane with the exception of one background sample (Sample # BKG) taken 25 ft. to the north, and one sample (Sample # 0827-26) taken 10 ft. to the west. Sample 0827-26 was taken after original 19 samples to see if sands washed downgradient to the west carried with it a measurable concentration of PCB.

Positioning of the 19 point sampling grid was accomplished by using Nortech's previous sampling markers (a few of which were still present) and the previous laboratory analyses. The epicenter of the release was estimated from measurements and the center point of the new sampling grid was established. To encompass the surface contamination after the first 19 samples were screened, the original grid was expanded to the northwest. This was accomplished by measuring from the original grid and creating more points in the same equilateral pattern.

After the surface contamination was determined, 12 inches of soil was removed and placed into super sacks. The next set of samples was taken at the same X and Y coordinates 12 inches bgs. These samples retained their original sample number and a suffix was attached indicating the depth bgs. Therefore, Sample # 0830-09-24 was taken on August 30<sup>th</sup>, at 09 original X, Y coordinate, and 24 inches below grade surface.

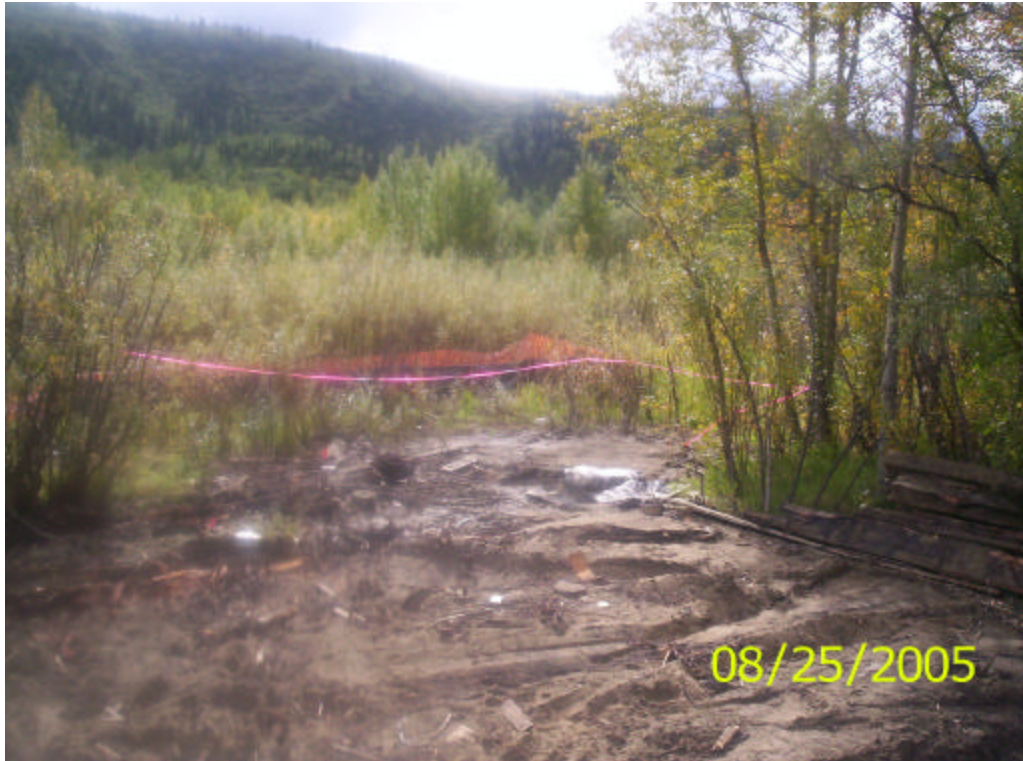
**Photo 1.** Area of contamination upon arrival.

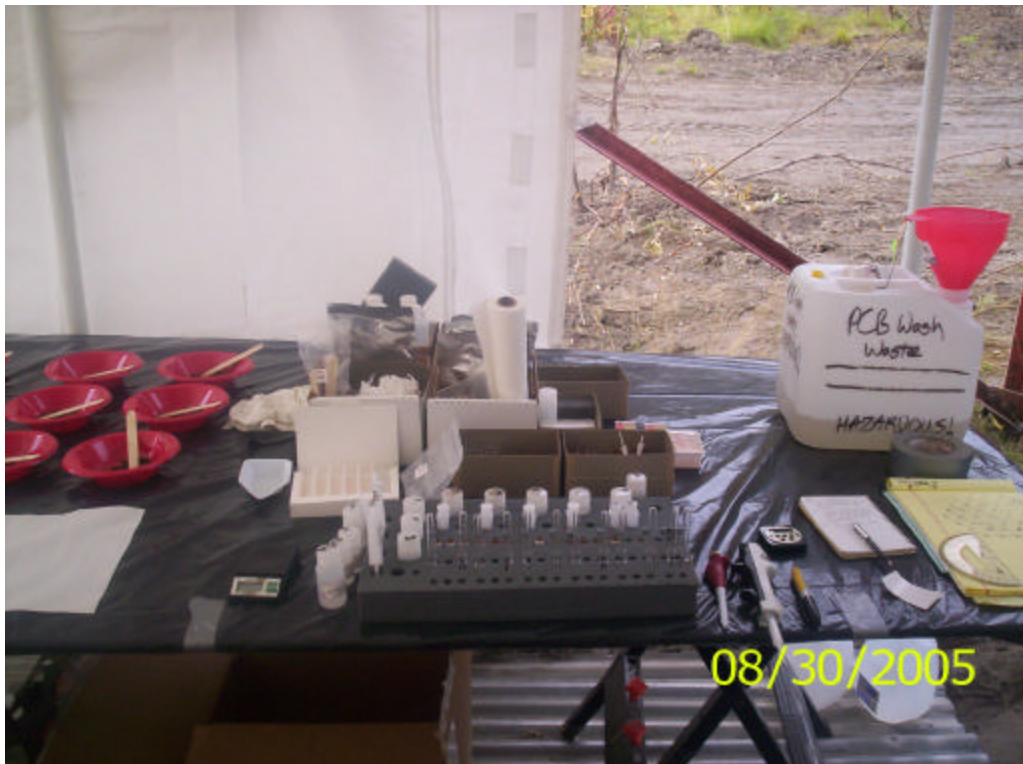
**Photo 2.** Lab setting where samples were screened.

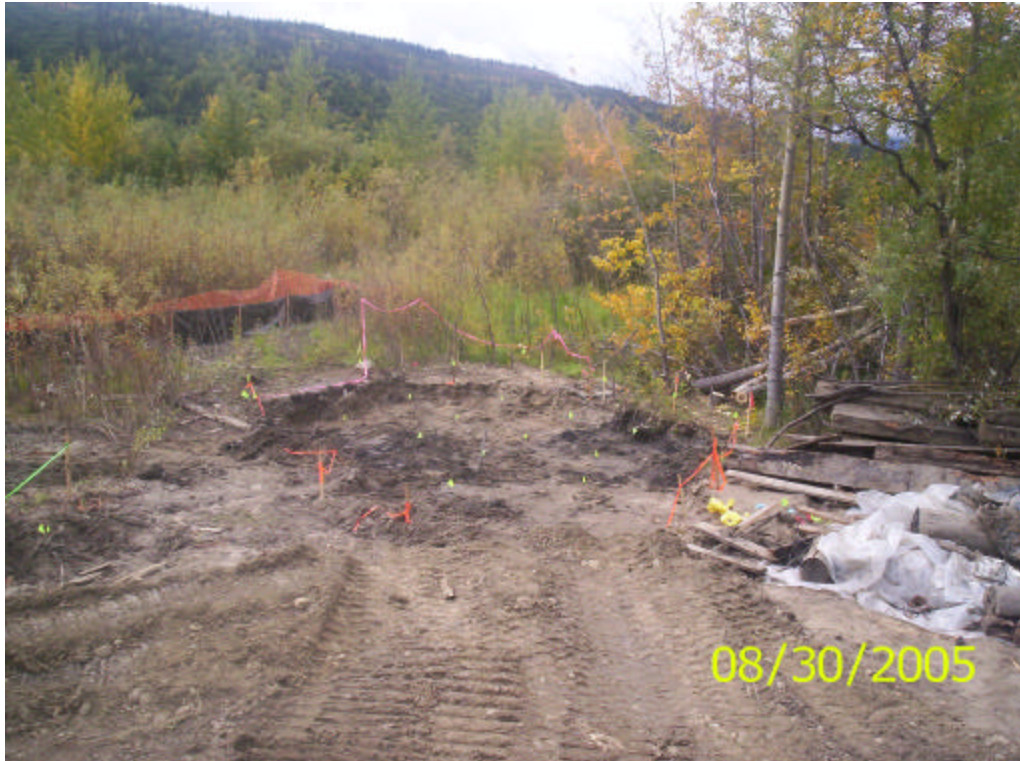
**Photo 3.** Inclusive contaminated area dug to 12 inches bgs.

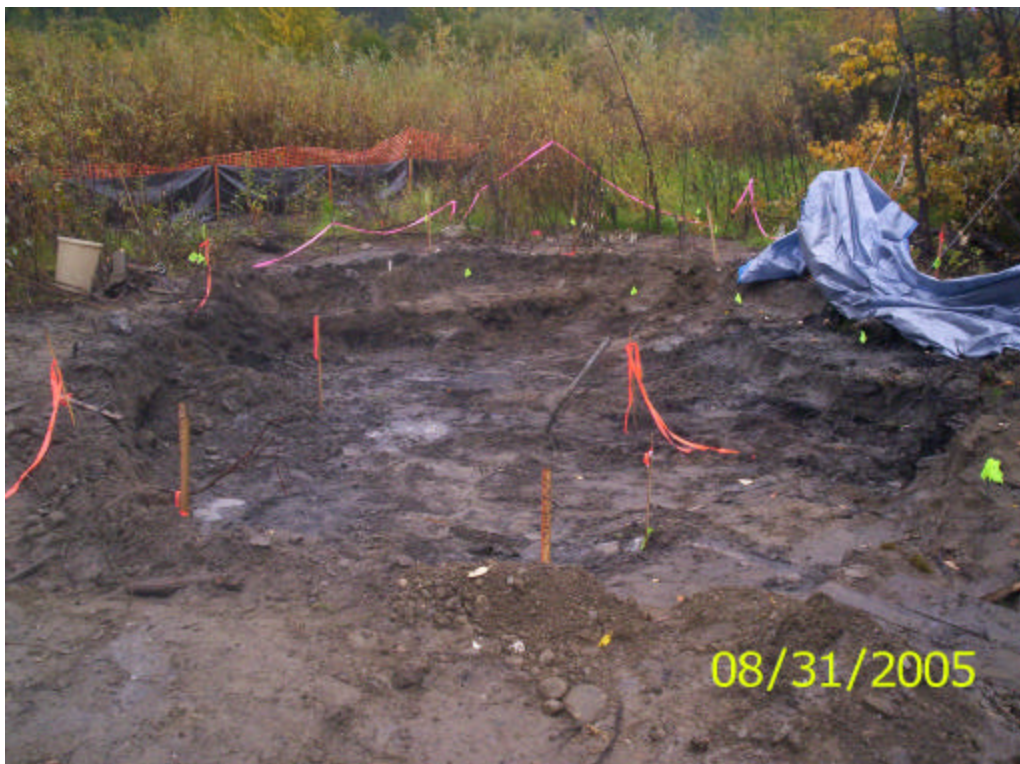
**Photo 4.** Inclusive contaminated area dug to 24 inches bgs.

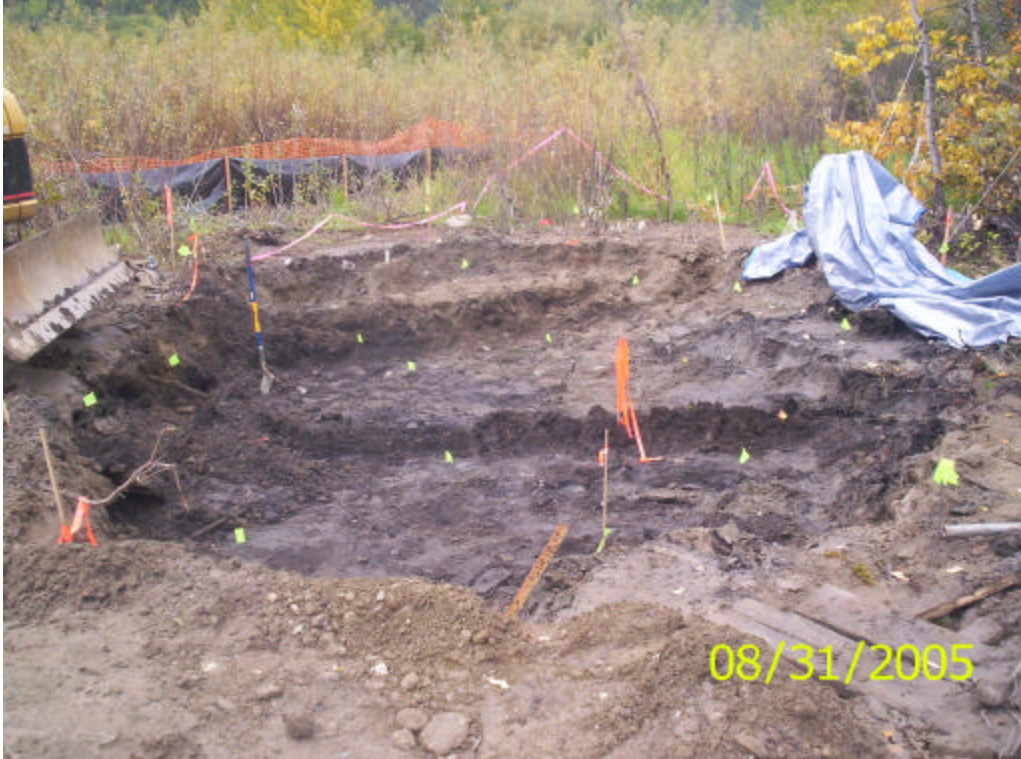
**Photo 5.** Inclusive contaminated area dug to 36 inches bgs.

Field screening determined that soils were negative (less than 1 ppm) for PCB at 36" bgs. Seven confirmation samples were run for the following reasons. Five samples were re-run from original soil after a drying period to insure water weight was not diluting the true PCB concentration. Samples were taken from the southern side at 36 inches where the surface had returned negative results to verify that the spill did not "pyramid" out at an angle (confirmation samples # 10, 14, and 18). Finally, a sample was collected at 48" bgs underneath sample #0831-13-36, where the concentration recorded the highest, to demonstrate that the PCB contamination did not penetrate deeper into the soil leaving behind a layer that was below cleanup levels, but be above cleanup levels a greater depth. All confirmation results came back negative for PCB revealing that the PCB concentration remaining in the ground is less than 1 ppm. Sampling #s 22 and 24 were the only points where digging was not ceased after a clean sample. Due to having adjacent contaminated samples on opposite sides, they were dug to 24" bgs and resampled. They then screened clean at 36" bgs consistent with adjacent sampling sites.

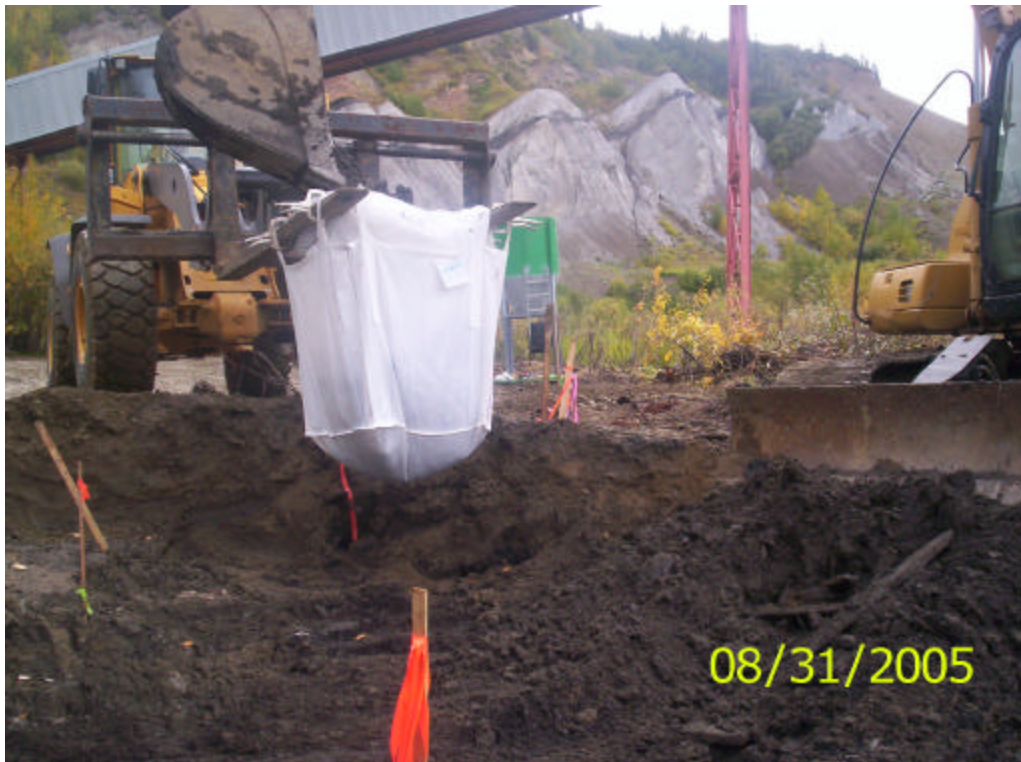
**Photo 6.** Loading supersacks with contaminated soil directly out of the ground. Notice conveyor structure in background. Bearing of picture is nearly due east.

Soil classified as “contaminated” was dug from the ground and placed directly into supersacks marked with contamination classification (1- 49 ppm/ Over 50 ppm) and sequential number. For example, the first sack of 1- 49 ppm PCB was labeled “#1, 1- 49” and the first sack of over 50 ppm PCB was labeled “#1, over 50”.

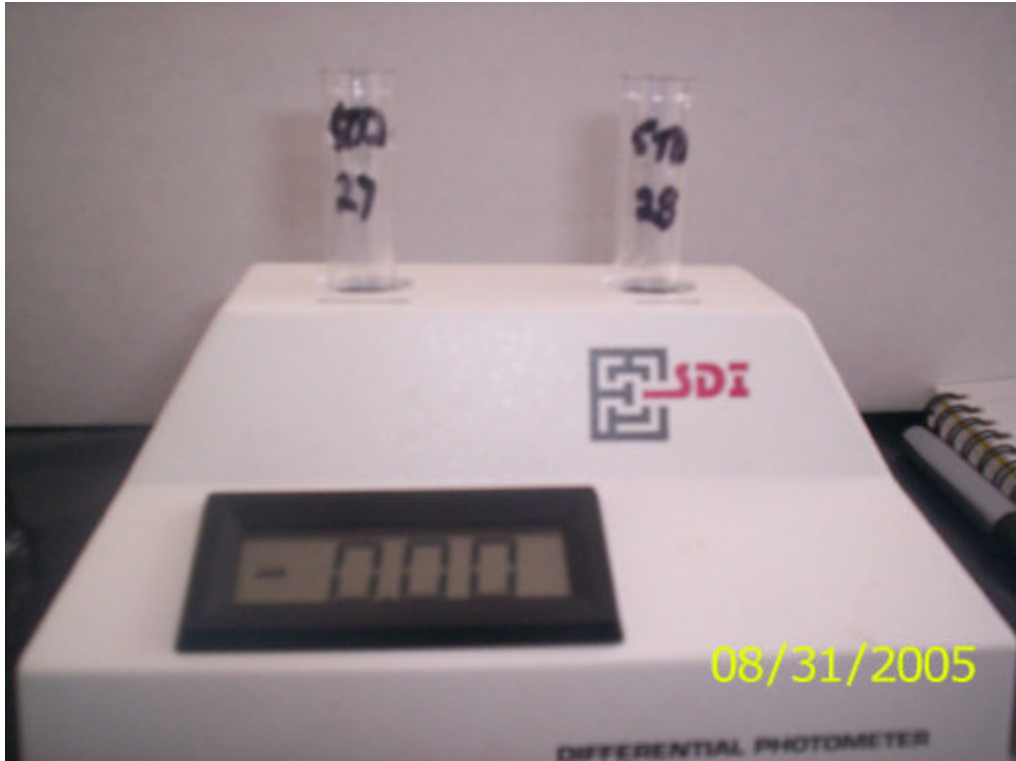
**Photo 7.** Differential spectrophotometer containing standards for calibration.

Field sampling involved collecting a sample, methanol extraction, serial dilutions, and placement into an antibody-coated test tube where it competes with conjugate and photo-active substrates for binding sites to produce a PCB concentration-specific color. This color is compared to a known standard of identical dilution and treatment with a differential photometer. The standards and customized dilution series were created by SDI for the client-specific action levels of one and 50 parts per million. The action level of 1 ppm for soil removal involved a single dilution, whereas the 50 ppm determination for disposal classification required three dilutions; 1ppm to 10 ppm to 50 ppm. If the photometer had a positive reading, it indicated that the sample had more color than the standard, and therefore possessed a lower PCB concentration. Conversely, if the value was zero or negative, the sample contains the same or more PCB than the standard. Therefore, if the sample was diluted three times, as stated above, and has the same or less color than the 1 ppm standard, it contains 50 ppm or greater PCB concentration.

The balance used to weigh out 10 grams of soil to start the screening analysis came with a 200 gram calibration weight and was checked and recalibrated, if necessary, before every run of samples. Two standards were prepared for every run of samples to compare to each other in the differential photometer to insure reproducibility and perform internal calibration within quality control limits of the photometer ( $\pm 0.03$ ). The standards were switched between the two wells in the photometer until stabilized at a reading closest to zero. Once this occurs, the standard in the right well is discarded and samples are evaluated in comparison to the standard in the left well. Specific results for this procedure are presented in Appendix B.

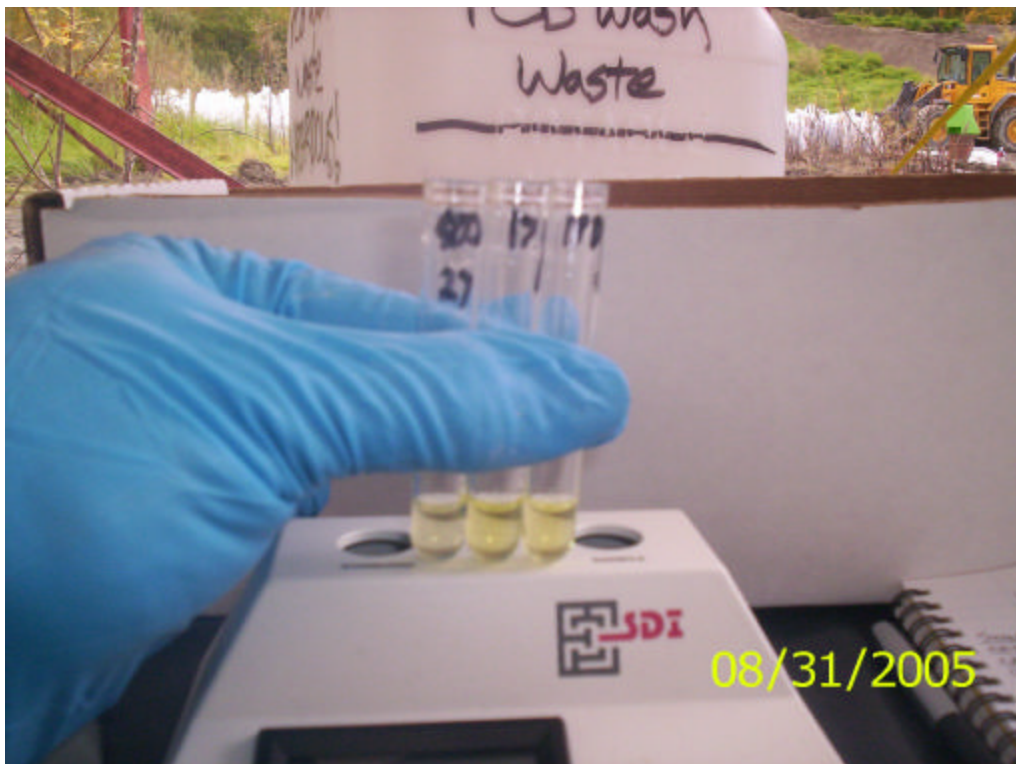
**Photo 8.** Example of color-dependent concentration. The duplicates “0831-17 (and 17D)-36” have similar color whereas the standard, “STD 27” at 1ppm, is lighter. This shows the duplicate pair to contain **less** PCB than the 1 ppm standard.

A new sample from point # 17 was collected directly into a plastic weigh boat provided by SDI. This was to insure that the different type of plastic bowls were not absorbing PCBs and lowering the effective concentration in the soil that is tested. The RPD between 17-36B (out of the weigh boat) and 17-36 was 28.5%, and the RPD with the 17D-36 (duplicate) was 38.3%.
