# SITE CHARACTERIZATION REPORT

## HEATING OIL SPILL AT THE TRAVELODGE 9200 GLACIER HIGHWAY JUNEAU, ALASKA

SEPTEMBER 1, 2010

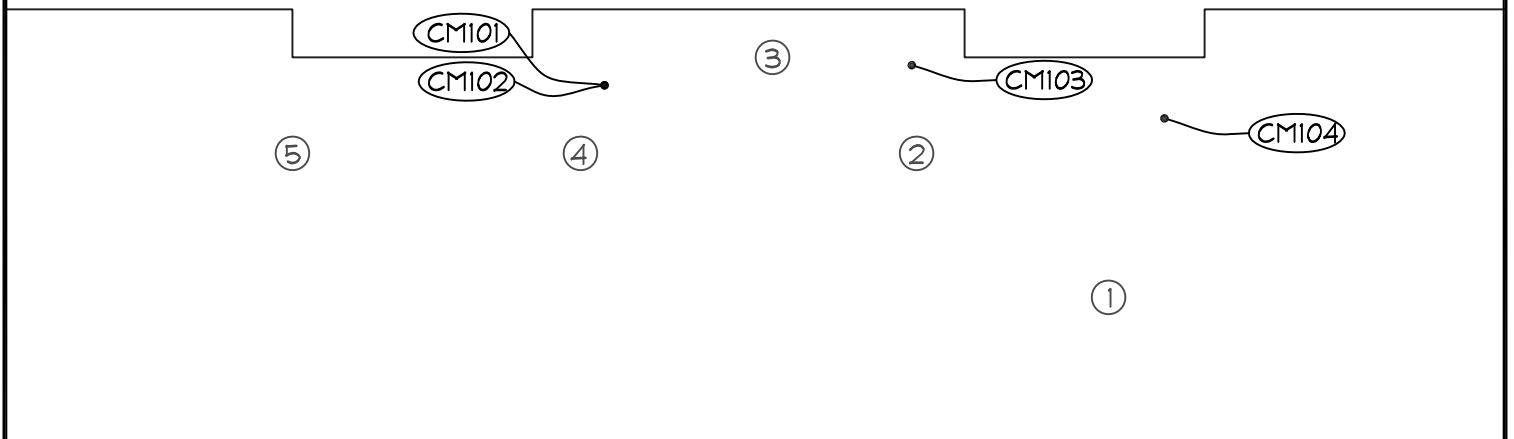
SCALE: 1" = 4'	FIGURE:
DESIGN: AD	3
DRAWN: CET	
PROJECT NO: 10-1084	
DWG: 101084A(03)	
DATE: 09/01/2010

EXTERIOR FOUNDATION WALL

FOUNDATION STEM WALL

The soil field screening and laboratory sample locations from each of the site features are shown in the figures in Appendix 1. Three soil samples were collected for laboratory analysis. These samples were sent to SGS Environmental Laboratories in Anchorage, Alaska. SGS analyzed all samples for DRO by AK102 and BTEX by 8260. Laboratory results are listed in the following table. Sample locations are shown in Figure 1.

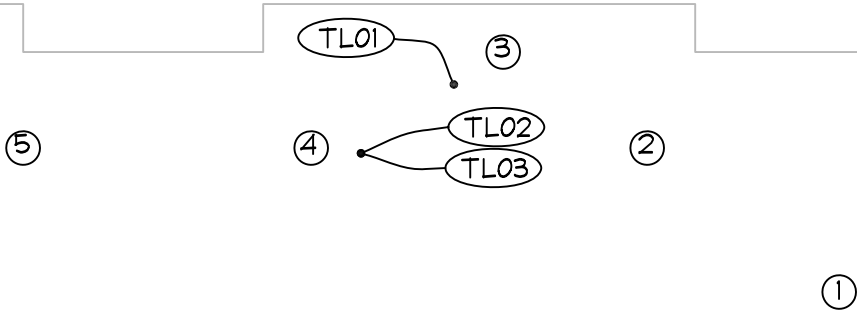
SCALE: 1" = 4'	FIGURE:
DESIGN: AD	4
DRAWN: CET	
PROJECT NO: 10-1084	
DWG: 101084A(04)	
DATE: 09/01/2010

2009 Sample Locations  
9200 Glacier Highway  
Juneau, Alaska

They collected six samples for field screening and collected two samples and one field duplicate from area that showed the highest field screening readings for laboratory analysis, per ADEC requirements. Sampling locations are shown in Figure 4. Site photos are shown in Appendix B.

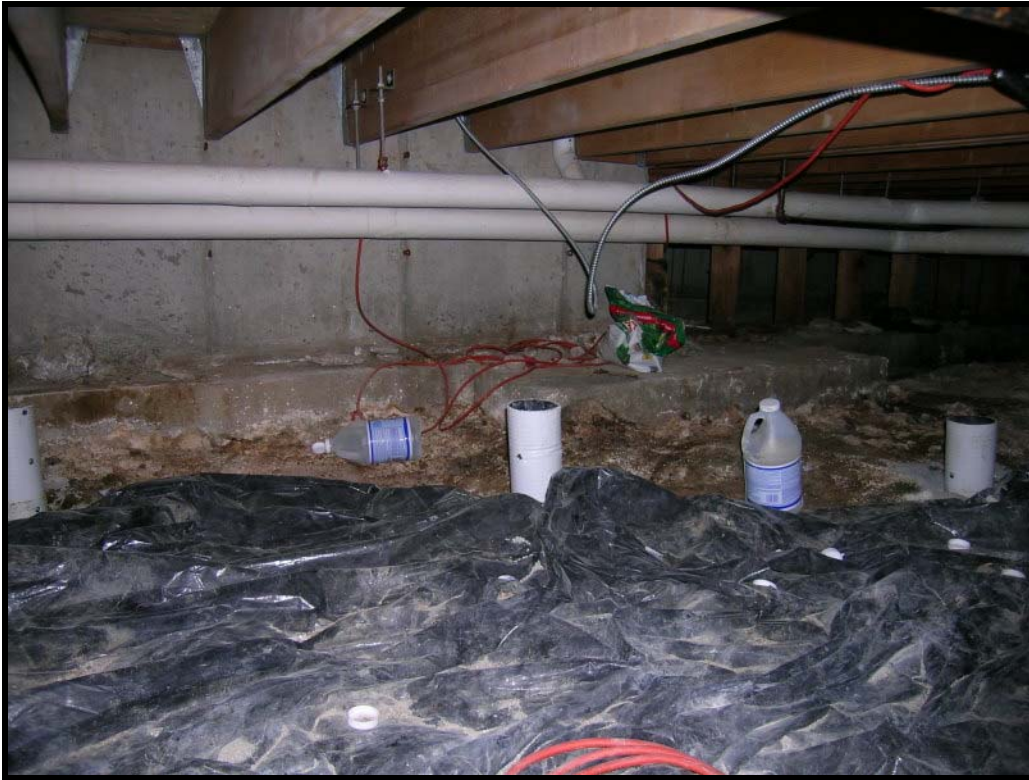
**Photo 1:** Nutrient Addition Ports

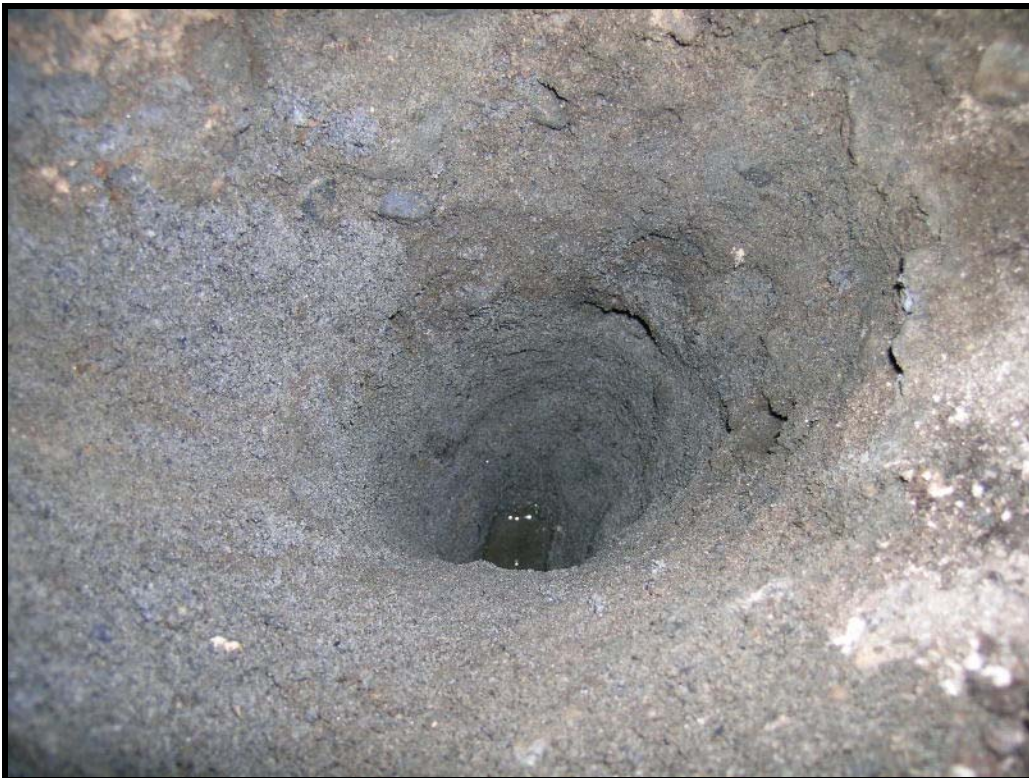
**Photo 2:** Sample Location for CM103
