SITE ASSESSMENT REPORT

James and Suzanne Mason 10481 Ann Coleman Road JUNEAU, ALASKA

NOVEMBER 2010

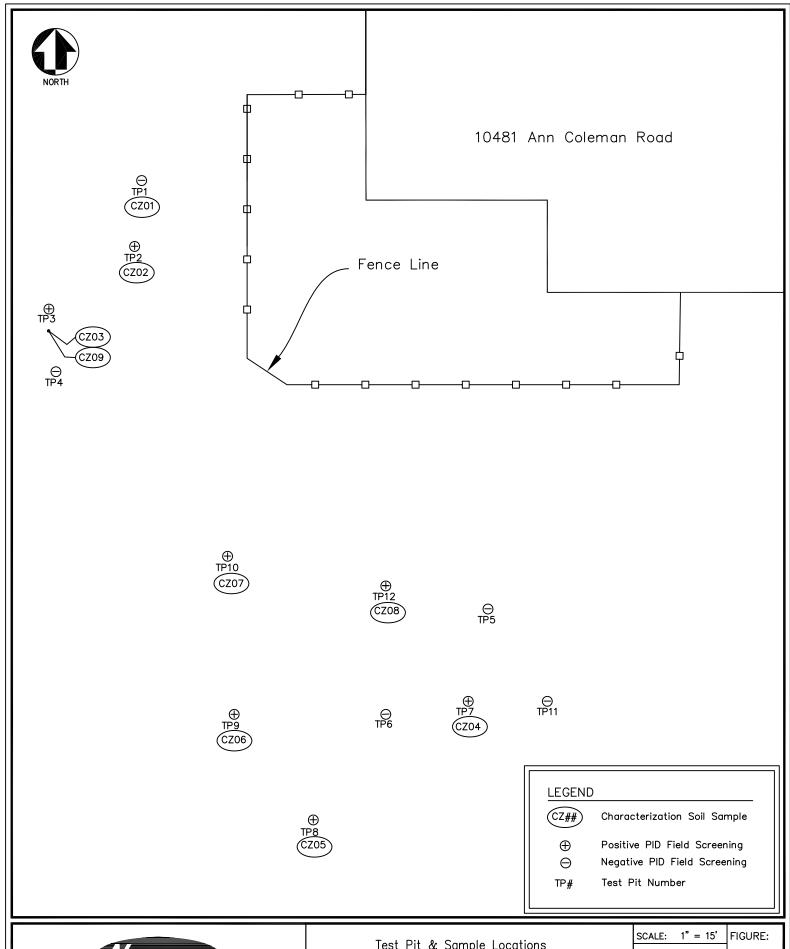
SCALE:	1" = 15'	FIGURE:
DESIGN:	AB	2
DRAWN:	BPC	_
PROJECT	NO: 10-	131
DWG:	101131a(02)
DATE:	10/29/201	0

The laboratory sample locations from the site are shown in the figures in Appendix A. Figure 1 is a general location map and Figure 2 shows the project area and sample locations in more detail.

Test Pit & Sample Locations 10481 Ann Coleman Road Juneau, Alaska

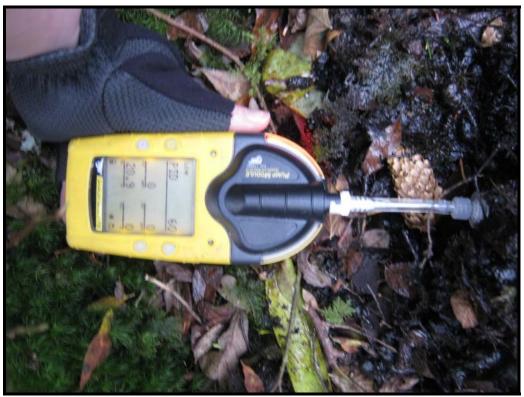
Photo 1: PID reading for TP10

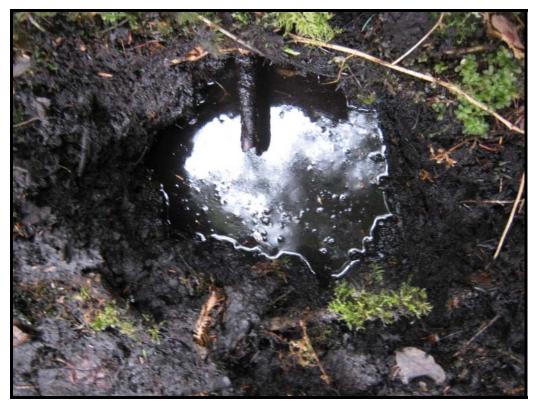
Groundwater was encountered about three to 48 inches below the ground surface. Topography at the Site was flat, forested with water-saturated, organic-rich soil and pools of standing water four square feet in surface area on average. Most of the contamination remains in this forested area, on the Mason property.

Photo 2: TP2 with groundwater at 4' below ground surface
