On October 29 and 30, 2012, Carson Dorn performed characterization sampling at 10481 Ann Coleman Road in Juneau, Alaska. The sampling followed excavation of approximately 90 CY of soil from the side yard of the residence, and of that total, about 34 yards was contaminated. The contaminated material was hauled to the Bicknell, Inc. treatment facility.

The excavation occurred at the site of a 2007 release of heating fuel from a leaking underground storage tank (UST). The tank was removed in 2007, but residual contamination remained at the site and in a wetland area on a neighbor's adjoining parcel (to the west).

**ENCLOSURE 2**  
**DIGITAL IMAGES**

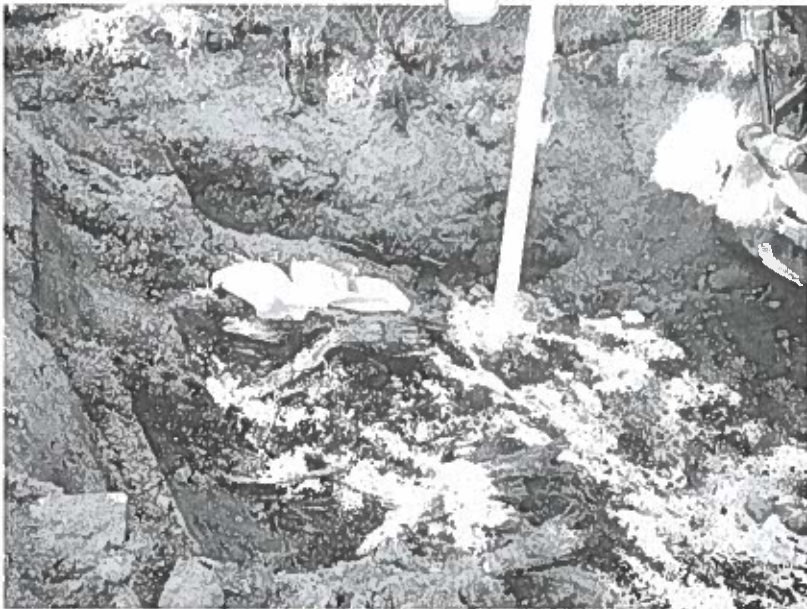
**Image 1**

- 2) The 2012 excavation of Hole#1 was constrained to the north by a fence along the property line, to the south by the foundation of the residence, and to the east by a concrete slab. The lab results show that some contamination may extend beneath the house and perhaps some under the slab. Only minor contamination exists at the north property line. Thus, the excavation of Hole #1 has eliminated the majority of contaminated soil that had remained in place since 2007. Fertilizer was spread on the floor of the excavation and a fertilizer injection stand pipe was installed when Hole #1 was backfilled.

**Hole #1, north wall. Fertilizer can be seen on floor of excavation. Fertilizer injection stand pipe is in place and ready for backfill.**

- 1) Hole #1: Fertilizer should be added on a quarterly basis to the three fertilizer injection standpipes. Another round of sampling should occur during September or October 2013 to evaluate the effectiveness of the treatment.
- 2) Hole #2: No further action is recommended.

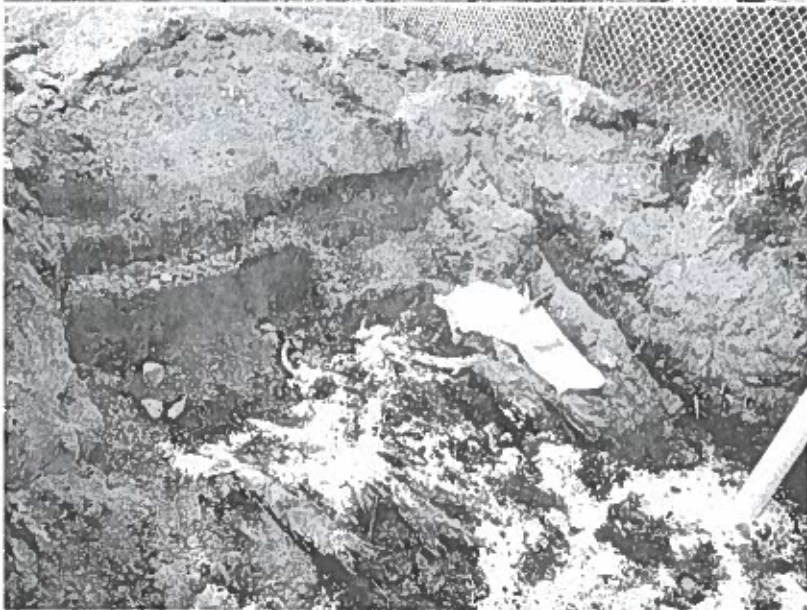
**Image 2**

**Hole #1, west wall. Fertilizer can be seen on floor of excavation. Fertilizer injection stand pipe is in place and ready for backfill.**

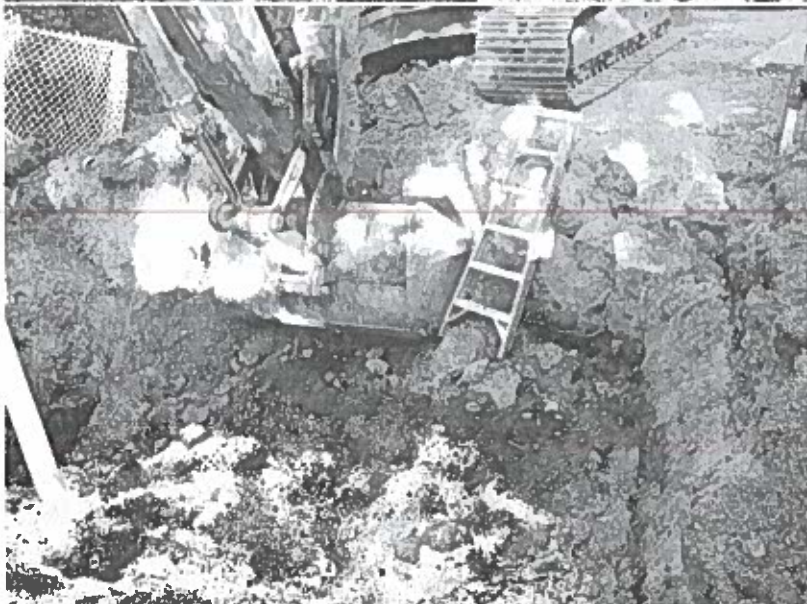
**Image 3**

**Hole #1, east wall. Fertilizer can be seen on floor of excavation. Fertilizer injection stand pipe is in place and ready for backfill.**

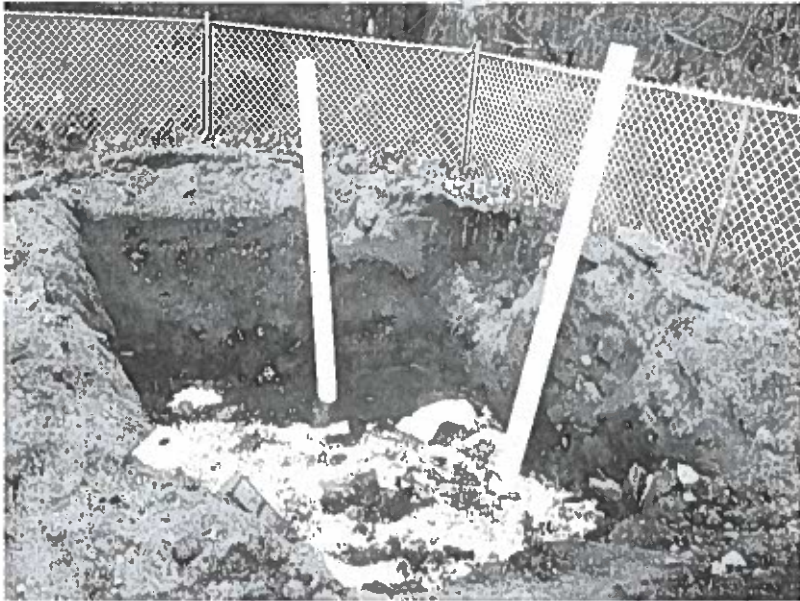
**Image 4**

- 3) The 2012 excavation and sampling of Hole #2 shows that no contamination remains in that area. Nonetheless, fertilizer was spread on the floor of the excavation and two fertilizer injection stand pipes were installed when Hole #2 was backfilled.

**Hole#2 north and west walls. Fertilizer has been spread on floor of excavation and fertilizer injection stand pipes are in position.**

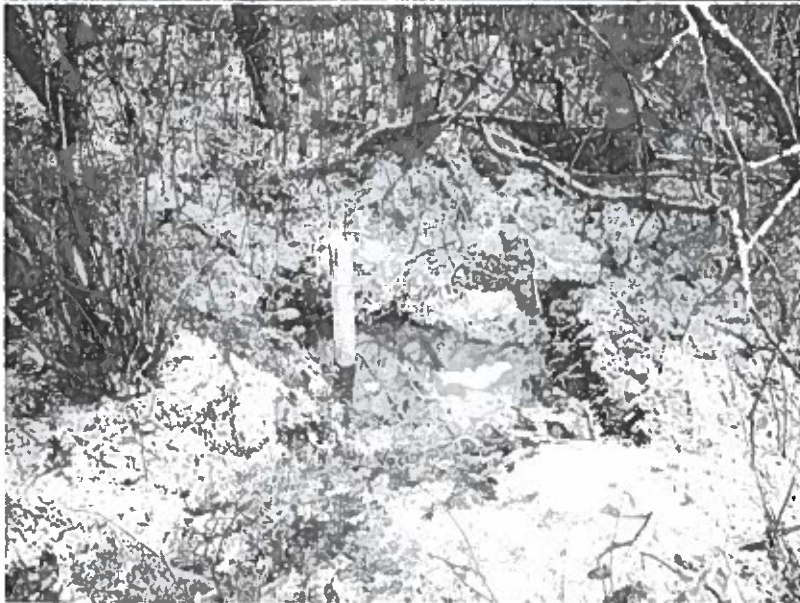
**Image 5**

- 4) The shallow 2012 excavations and sampling in the adjacent wooded area (Area 3N and Area 3S) shows that significant contamination still remains in that area, particularly in Area 3N. Fertilizer was spread on the floor of the excavations and fertilizer injection stand pipes were installed when those holes were backfilled.

- 5) Area 3N is situated at the low point of the wooded wetland area into which the 2007 spill migrated. Both Area 3 excavations had standing water in them (about 1.5' below surrounding grade) when sampling was accomplished.

**Area 3N. Fertilizer has been spread on floor of excavation and fertilizer injection stand pipe is in position. Note standing water in excavation. This is the low point in the surrounding wooded area.**

- 3) Area 3N and 3S: It appears that the remaining hydrocarbon contamination is bound in the organic soil in the adjoining forest wetlands. This situation is probably the best we could hope for since the contamination is held in an identifiable area and is probably not migrating further. In an effort to minimize impact to the forested area, we recommend constructing a collection basin at the low point of the impacted area and regularly maintaining the collected water with sorbent pads. Another round of sampling should occur during September or October 2013 to evaluate the progress of the treatment.

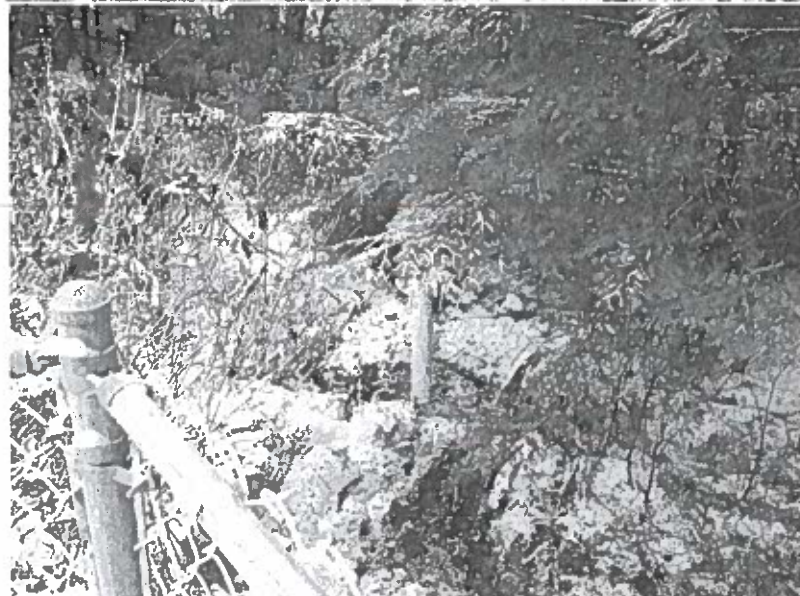
**Image 6**

**Area 3S. Fertilizer has been spread on floor of excavation and fertilizer injection stand pipe is in position. Some water is present in the excavation.**

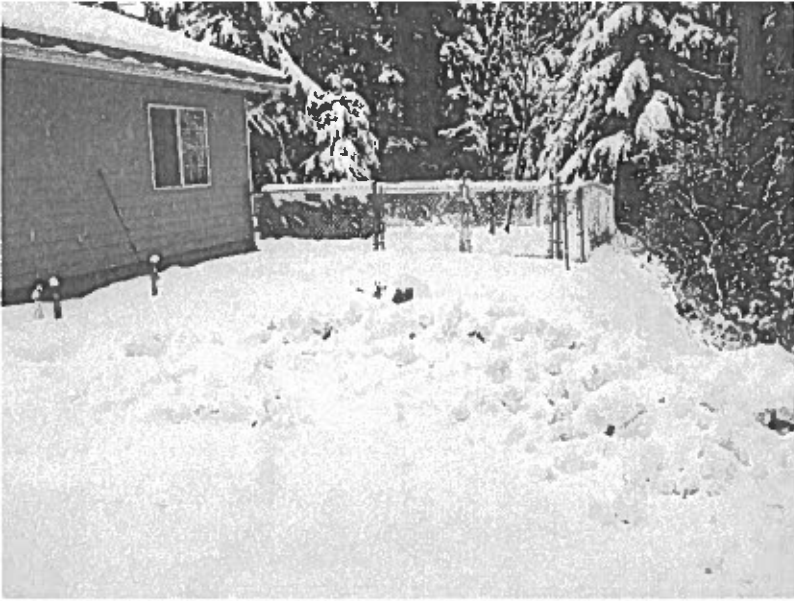
**Image 7**

**Mason residence, looking west along north wall. Holes #1 and #2 were both located in the foreground area adjacent to the house. Note drop off into forested area at right. Areas 3N and 3S are in the forested area beyond the fenced yard.**

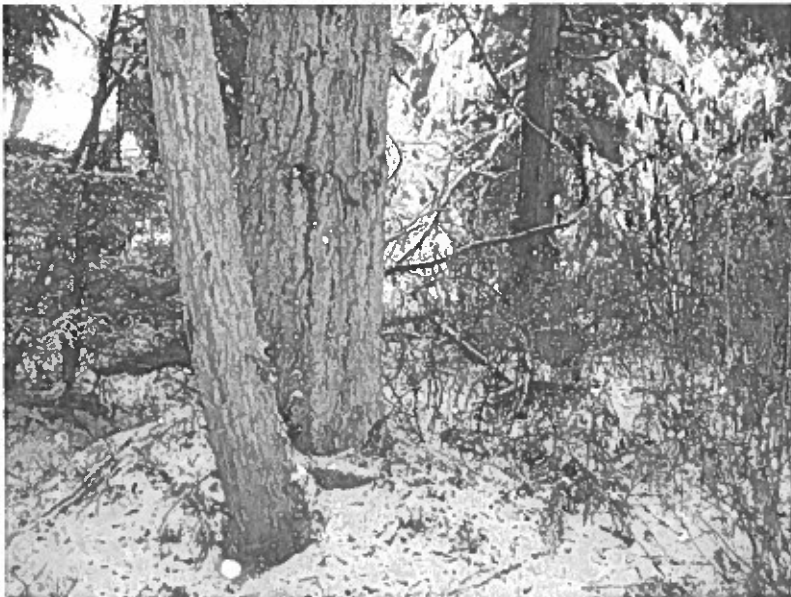
**Image 8**

**View from forested area looking south. Mason residence is visible in the distance at the left edge of the image. Areas 3N and 3S are just beyond the large tree in the center of the image.**

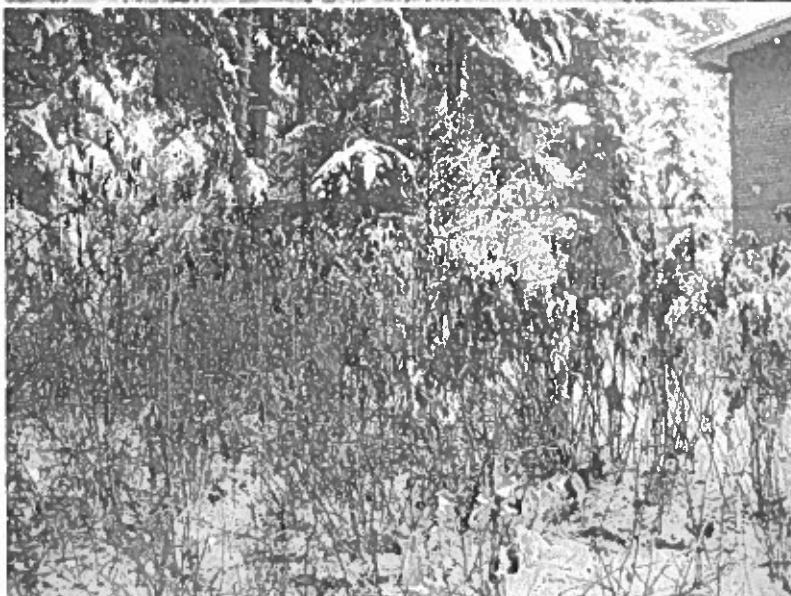
**Image 9**

- 6) The neighbor's home is built on a concrete slab on grade.

**Taken from the same position as Image 8 but looking to the west. The neighbor's house can just be seen at the right of the image. The house is built on a slab on grade, with no crawl space.**
