**RE: Addendum to the March 5, 2013 Site Characterization,
Remediation, and Closure Report
Former HIPAS Observatory, Fairbanks (Two Rivers), Alaska**

NORTECH is pleased to present University of California, Los Angeles (UCLA) with this Addendum to the March 5, 2013 Site Characterization, Remediation, and Closure Report (2013 Report) at the former High Power Aurora Stimulation (HIPAS) Observatory near Fairbanks, Alaska (the Site). This Addendum presents the results of the work outlined in the August 30, 2013 Proposed Work Plan and Cost Estimate letter (2013 WP) and the October 4, 2013 electronic mail conditional approval from the Alaska Department of Environmental Conservation (ADEC) for these activities expected to result in unrestricted land use for the former HIPAS site.

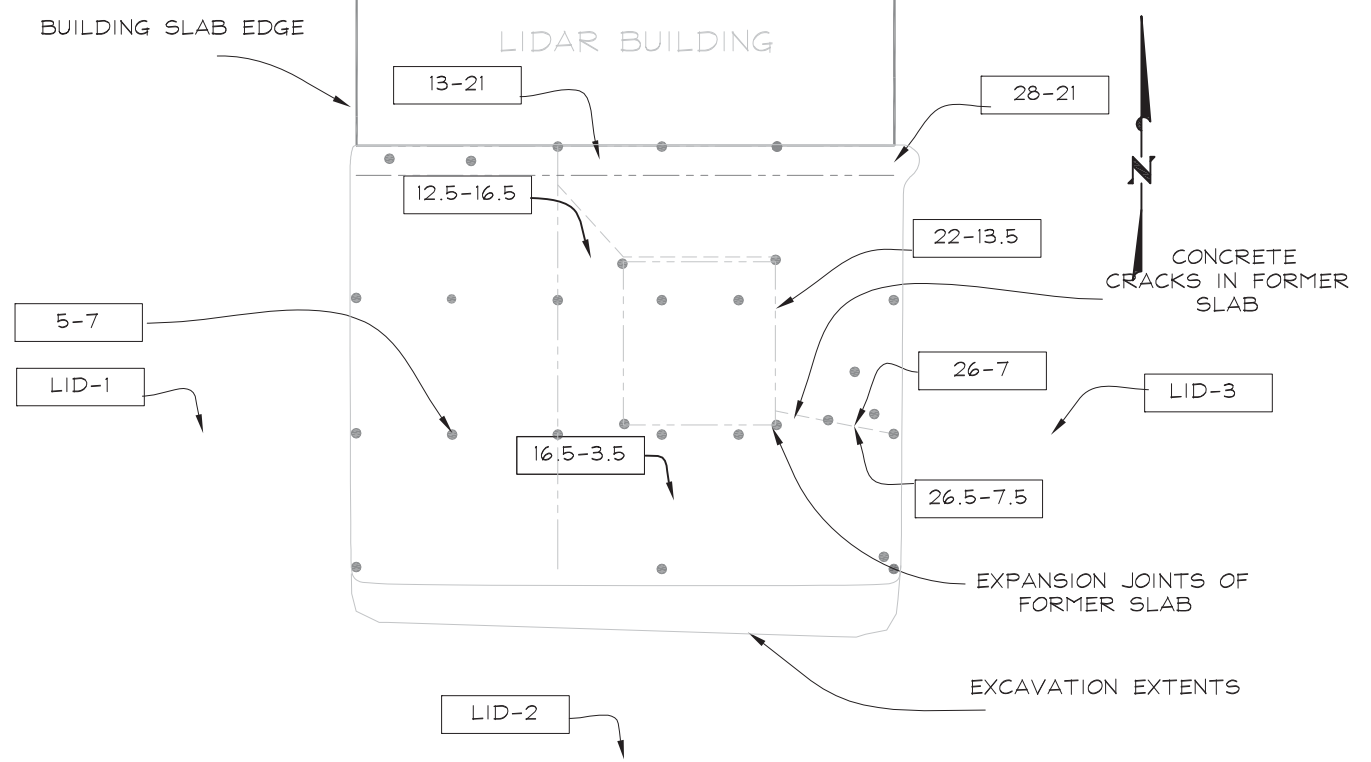
03a LIDAR Tower Closure - 2012

LIDAR Tower Laboratory Soil Sample Results Summary				
Sample ID	Date	Lab W.O.#	Field Screen	Mercury mg/kg
ADEC Cleanup Limit				
1.4				
Post-demolition Characterization Samples				
LID 01 ^{Dup10}	14-Dec-11	1119888	0.00	1.2
LID 02 ^{Dup10}	14-Dec-11	1119888	0.76	0.938
LID 03	14-Dec-11	1119888	1.33	7.13
LID 04	14-Dec-11	1119888	0.52	4.32
LID 05	14-Dec-11	1119888	0.00	0.882
Pre-excavation Characterization Samples				
26-7.5-6	23-Jul-12	1128246	1.30	4.28
26-7.5-12	23-Jul-12	1128246	0.00	0.606

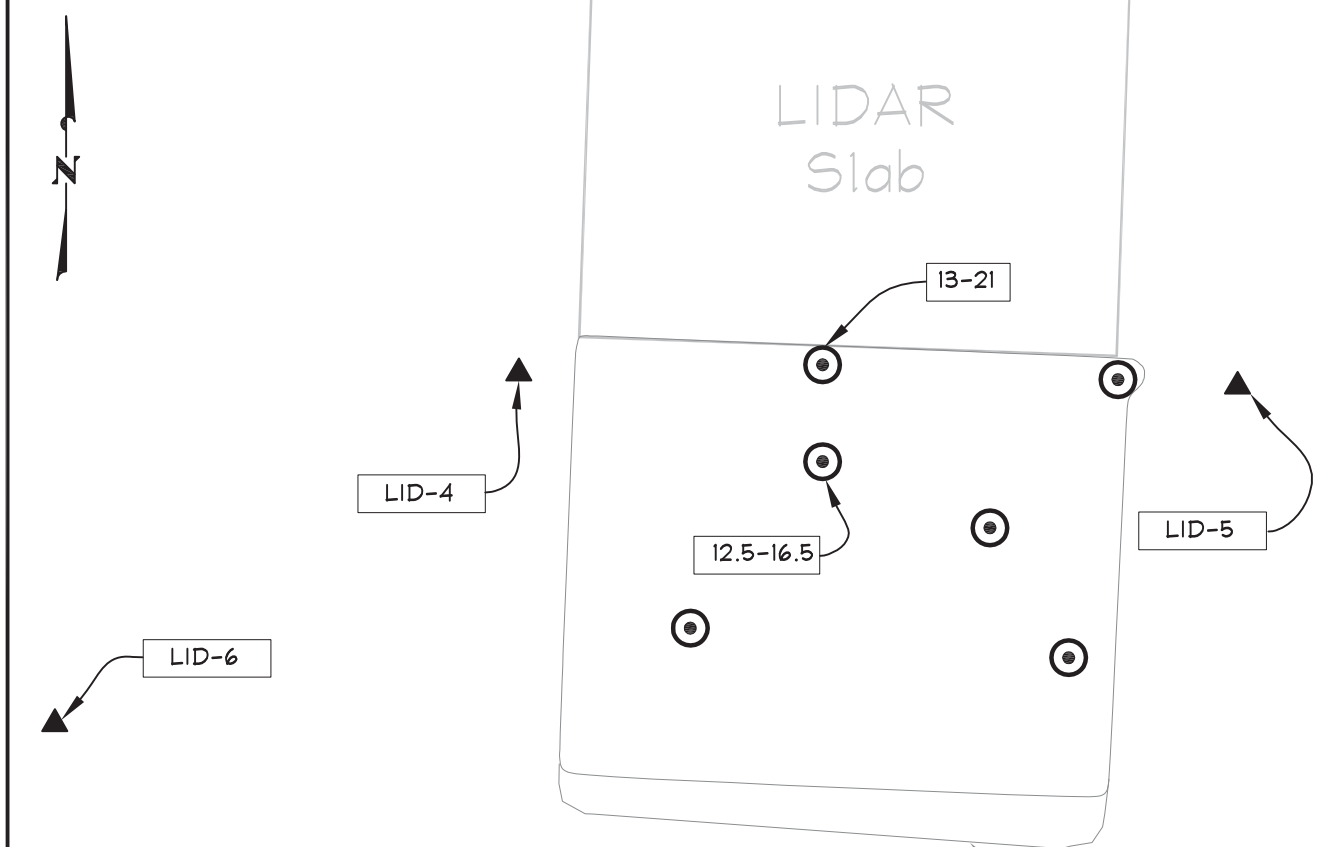
03b LIDAR Tower Additional Assessment - 2013

- Legend
- 2013 Soil Gas Field Screening Locations *All Closure Screening Zero
 - xx-xx 2013 Soil Gas Sample ID (Coordinates)
 - ▲ 2013 Hg Surface Sample Location and ID
 - LID-1
- Laboratory Results Summarized in Tables 3 and 4 of Attachment 2

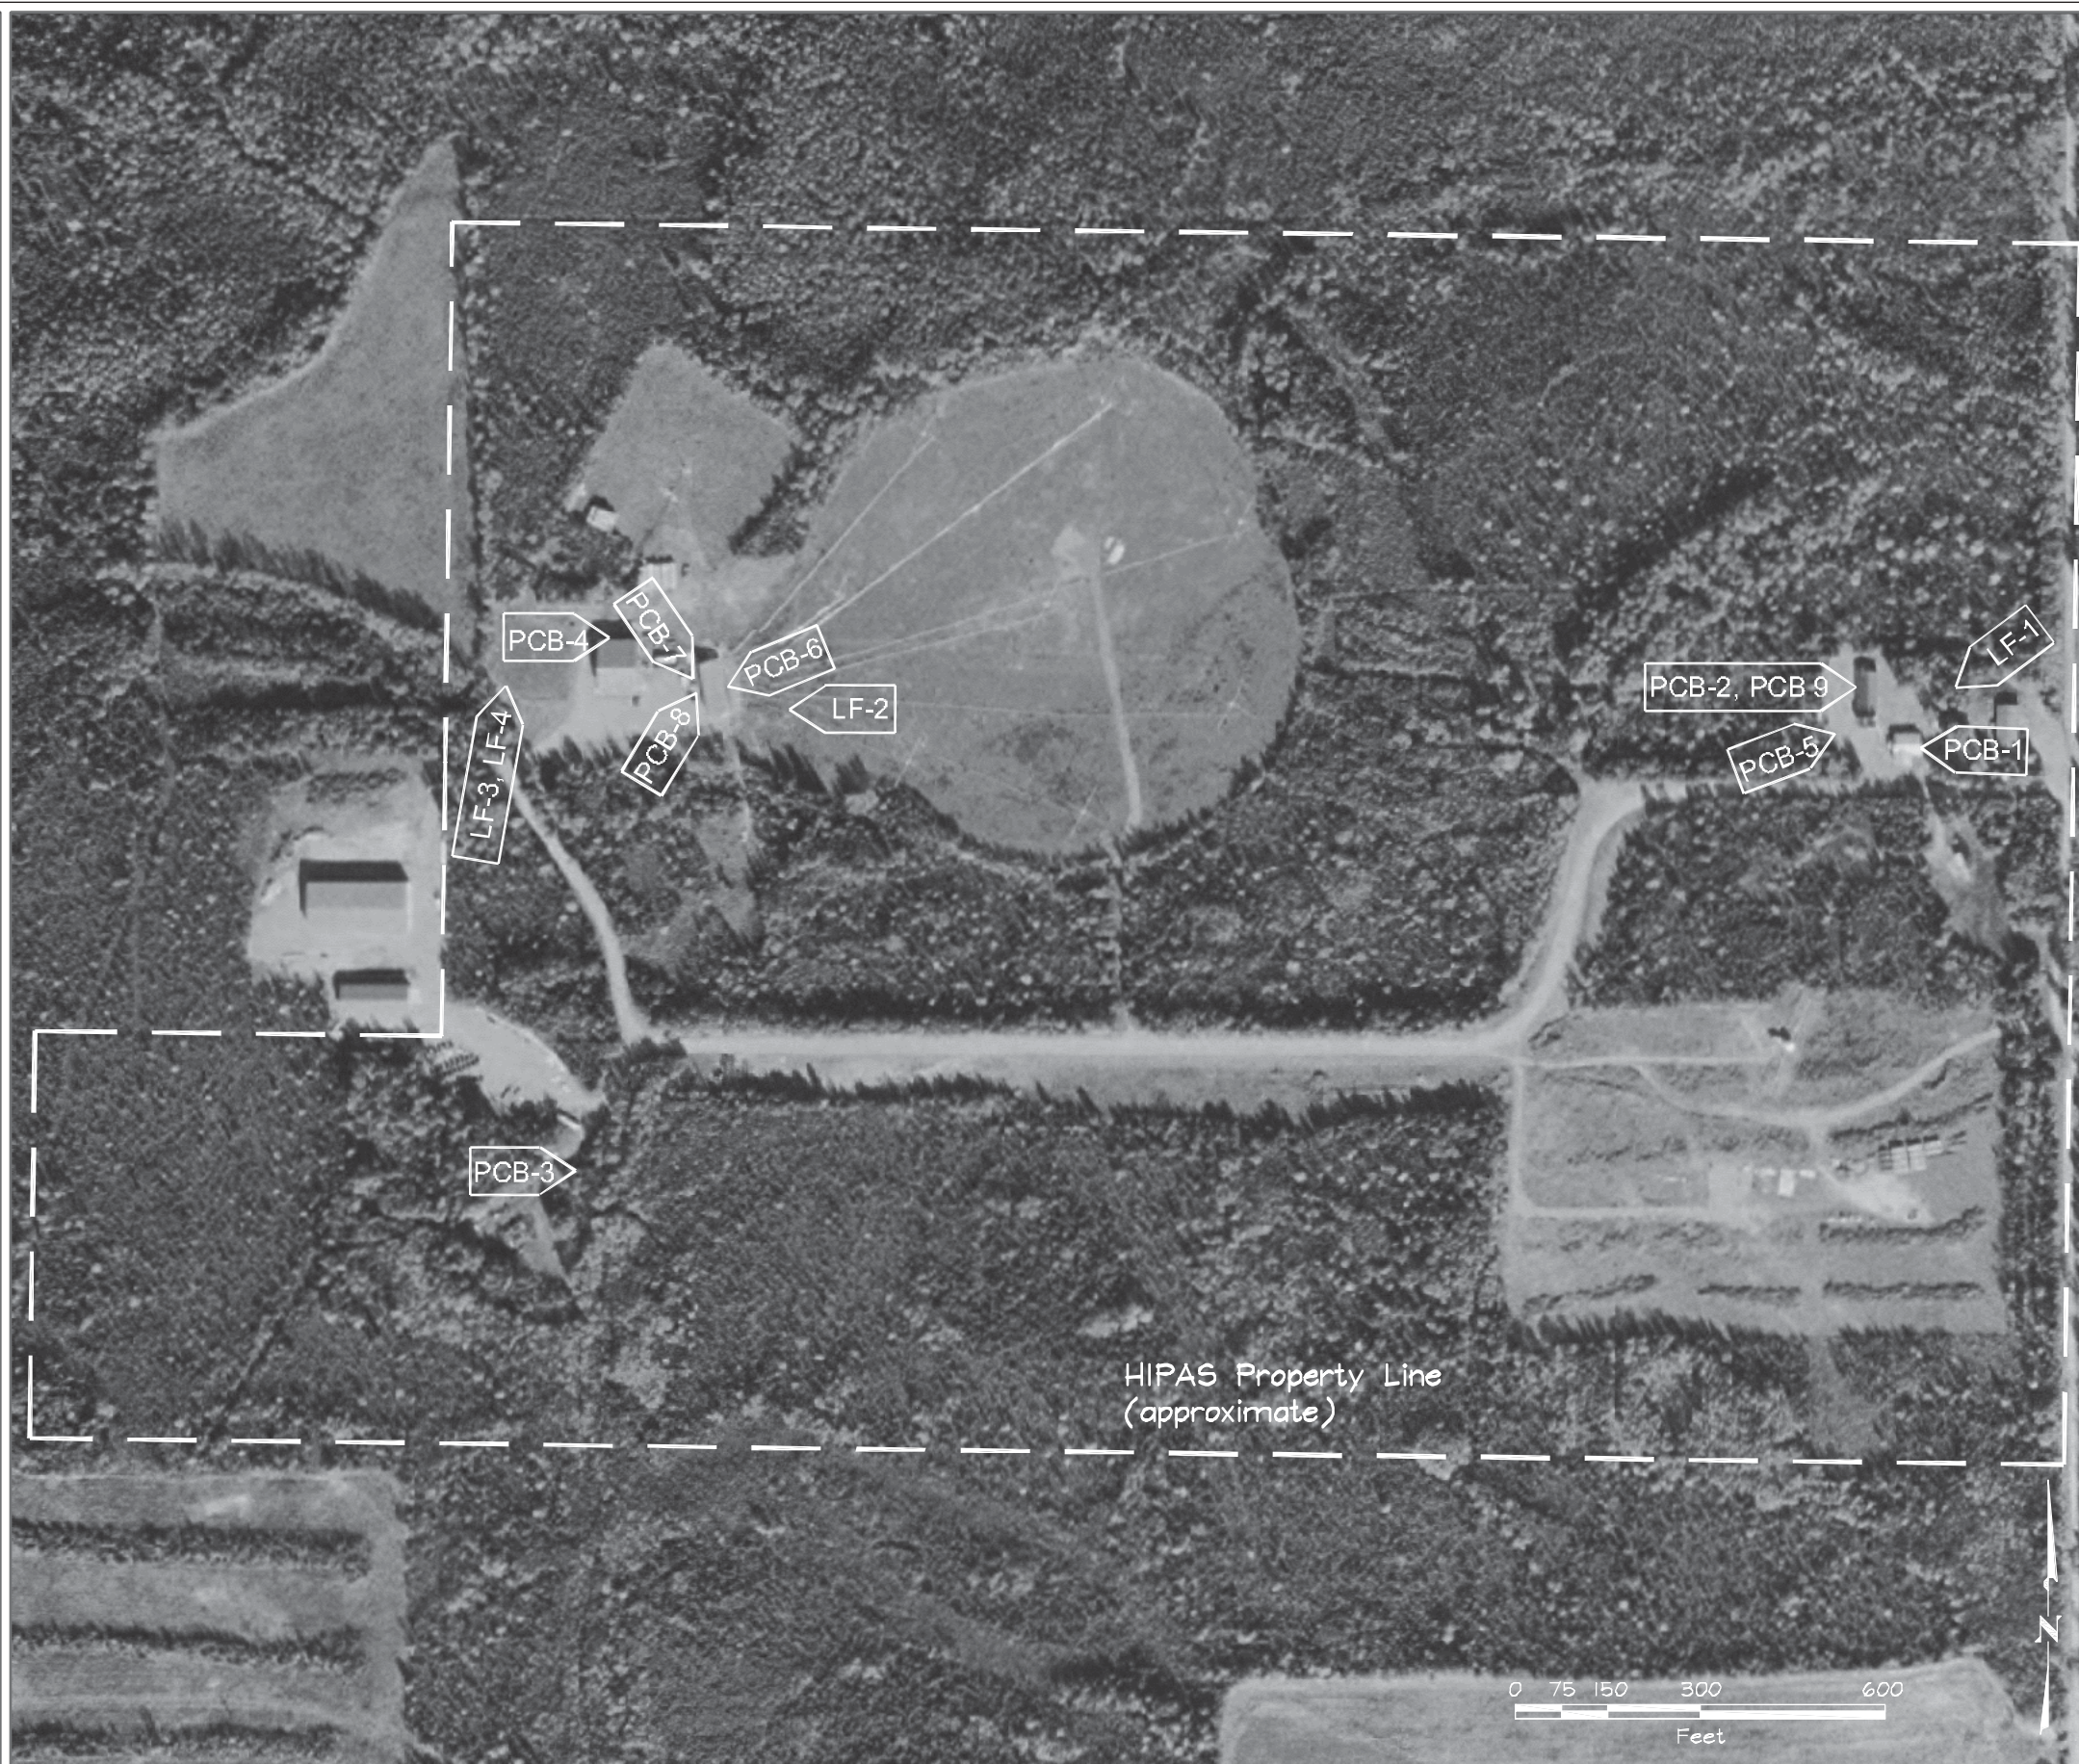
2013 Soil Absorption System and PCB Sampling Locations
 Former HIPAS Observatory Decommissioning
 Fairbanks (Two Rivers), Alaska

2013 Leachfield Sample Locations

- LF-1 → Bunkhouse/LIDAR Leachfield
- LF-2 → Transmitter Building Leachfield
- LF-3/4 → Generator Building Leachfield

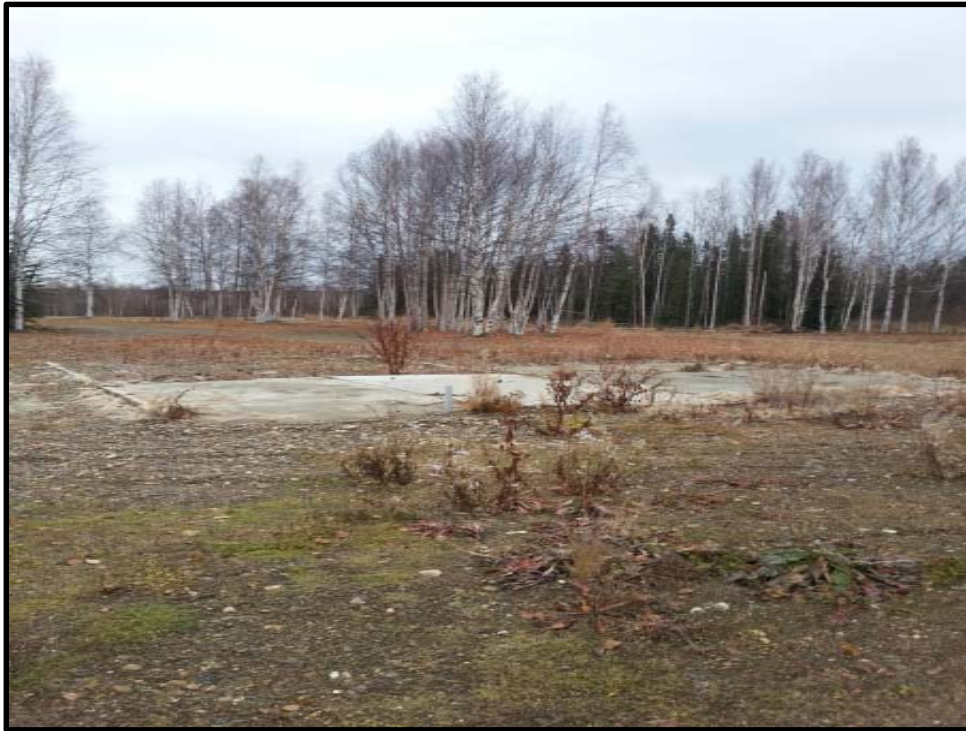
Photo 1: LIDAR Garage slab, photo taken facing southeast. Collected composite samples for PCBs near the former backdoor (typical of other suspect area samples at this location)

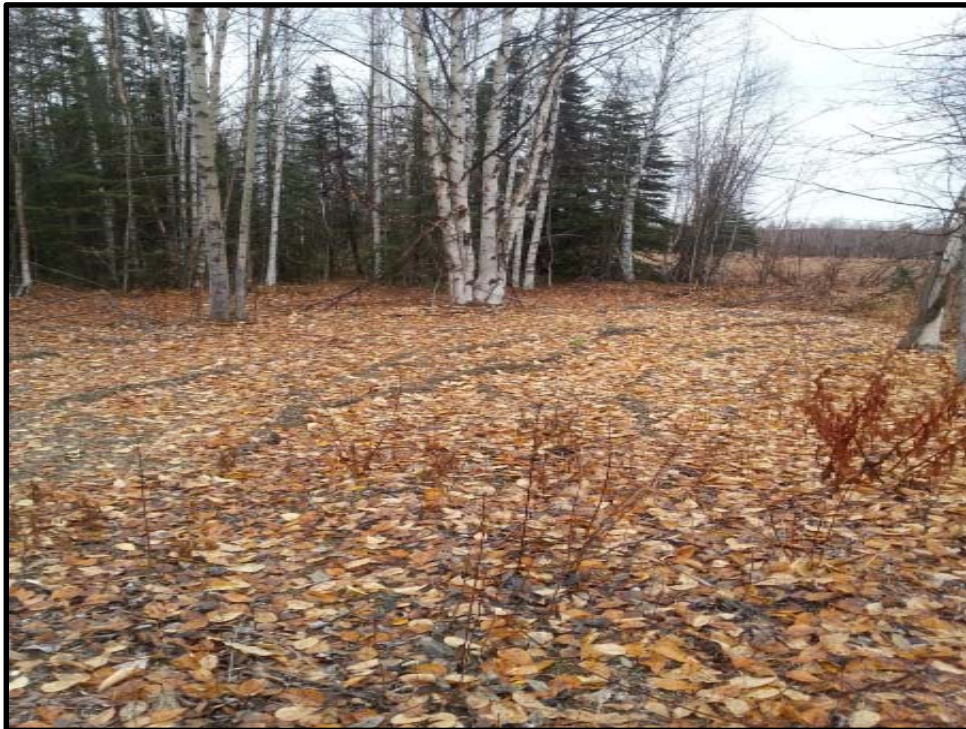
Photo 2: Backfilled location of former septic tank serving Bunkhouse/LIDAR Building near location of abandoned soil absorption system

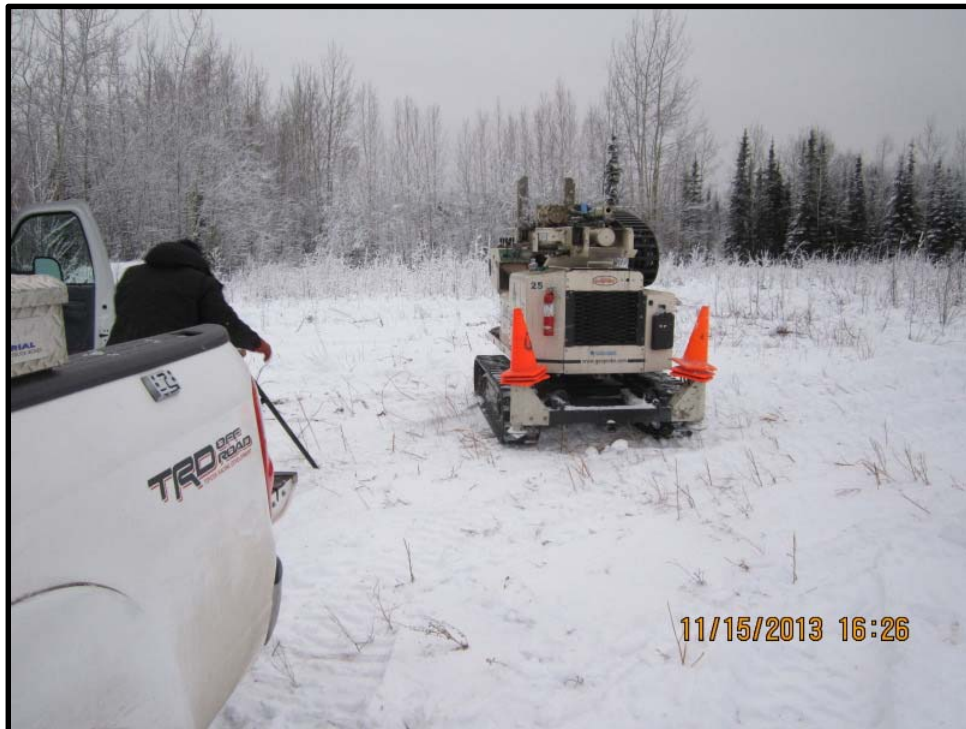
Photo 3: Preparing for advancement of soil boring at the soil absorption system for the Generator Building, located west of the remaining Generator Building foundation.

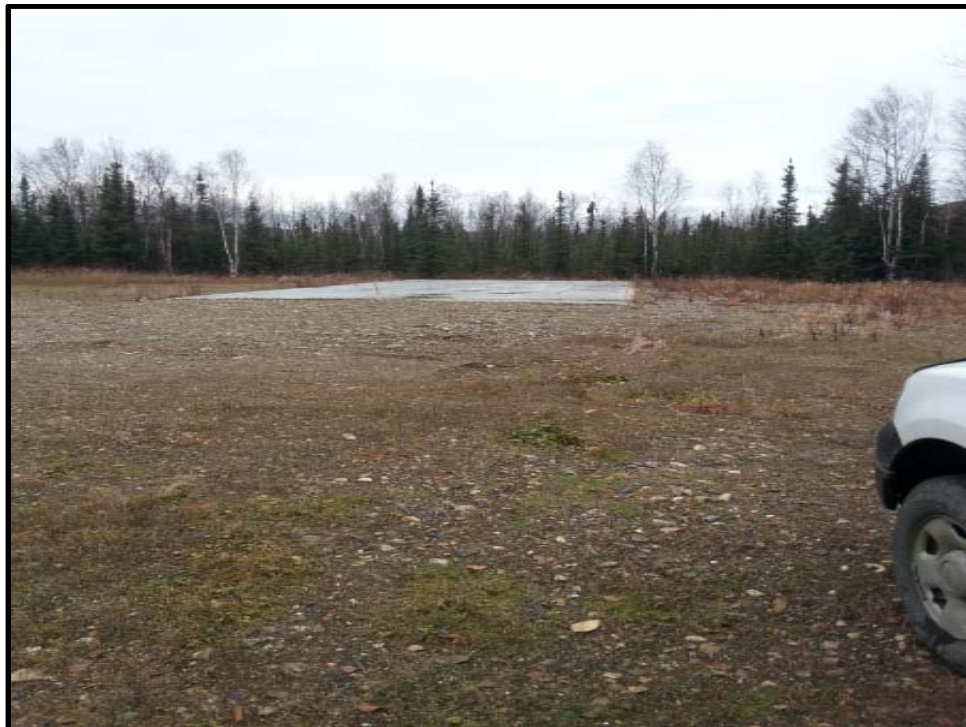
Photo 4: Former LIDAR Tower excavation area (no weeds present) on the south side of the remaining LIDAR Building slab. Additional perimeter mercury samples collected from perimeter and soil gas samples from within the former LIDAR Tower footprint

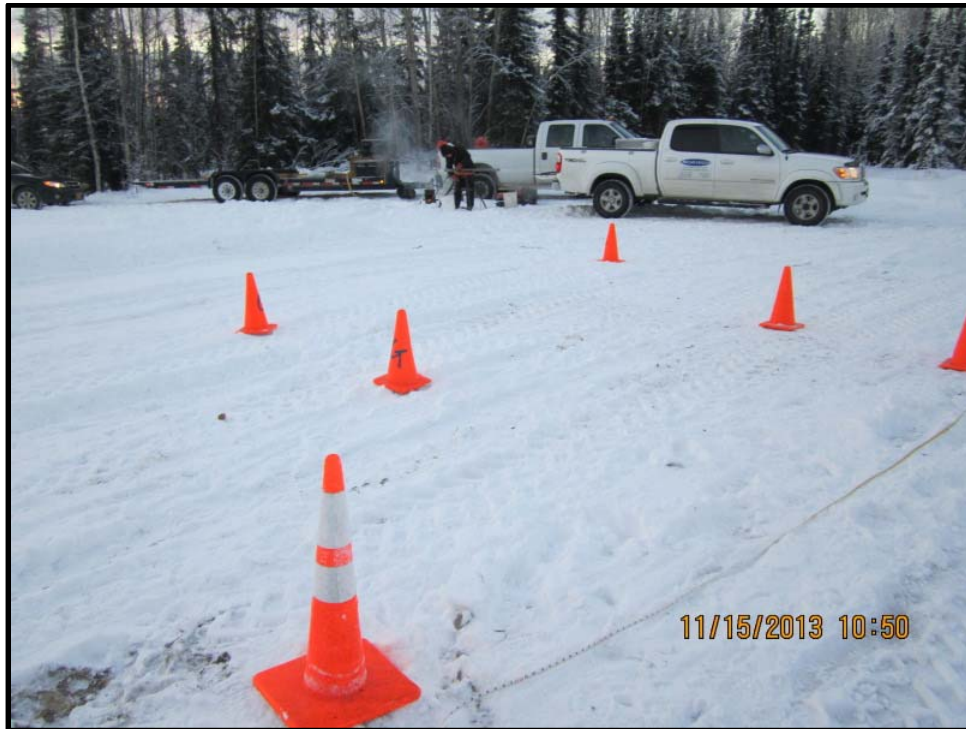
Photo 5: Looking southwest across former LIDAR Tower footprint with cones marking locations for installation of soil gas sampling ports with Geotek staff at decon station in background.

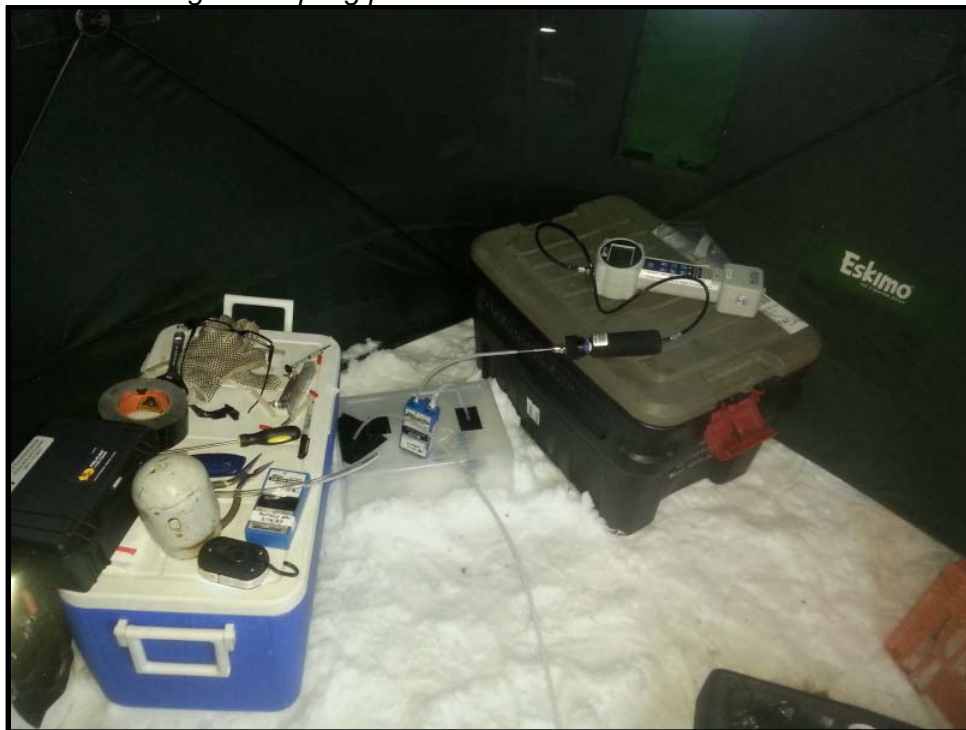
Photo 6: Soil gas sampling apparatus in use inside a heated portable ice fishing tent during the helium leak-test on the sampling train prior to sampling.
