SITE ASSESSMENT

JACK'S CHEVRON SERVICE DELTA JUNCTION, ALASKA

JACK ADAMS, OWNER DELTA JUNCTION, ALASKA

SEPTEMBER, 1995

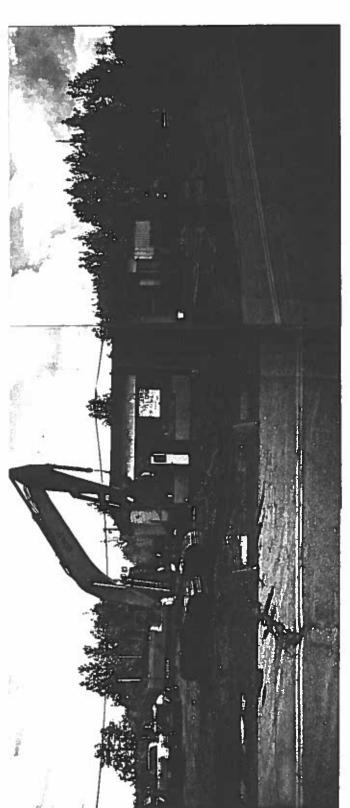
Photo #2: (Left) Fuel lines once serving the removed dispensers are photographed here alongside an access road that runs parallel to the Richardson Highway.

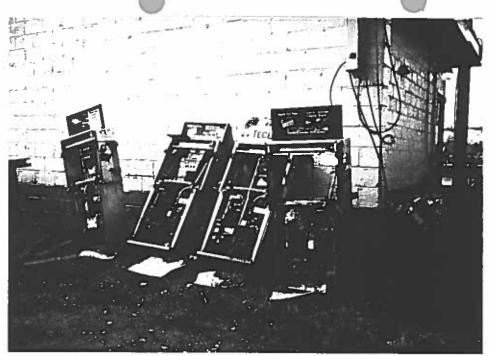
Photo #3: Four (4) dispensers, removed from the locations pictured in Photo #2, have been temporarily placed on the east side of the Chevron building.

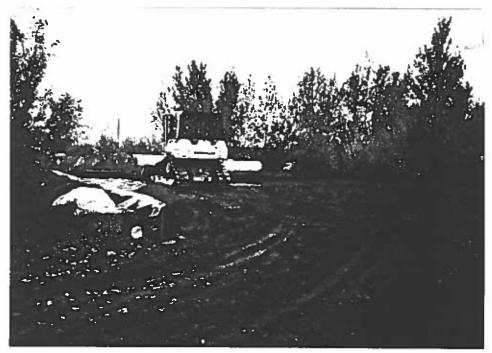
Photo #4: A bulldozer constructs a ramp of clean soils (removed during excavation of the new replacement tanks) over the prepared contaminated soil containment area located on the east side of Jack's Chevron. The ramp will be used as both an entrance and a buffer to protect the liner from the movement of large machinery needed to access the area.

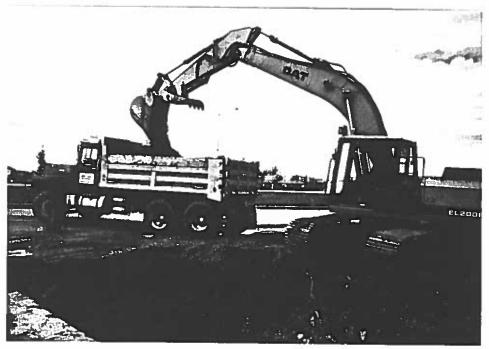
Photo #5: A large track backhoe loads a dump truck full of contaminated soils removed from the dispenser area on the west side of Jack's Chevron.

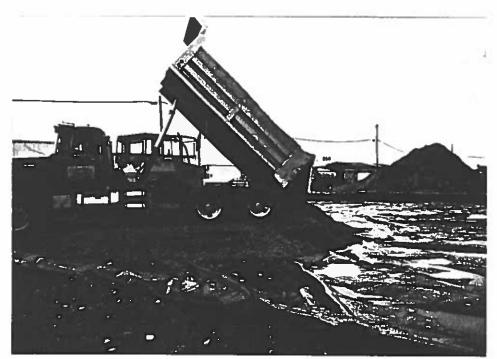
Photo #6: The dump truck deposits a load of contaminated soil onto the prepared liner at the soil containment area. By working its way backwards, the dump truck creates a protective surface on which it can drive to avoid damaging the liner.

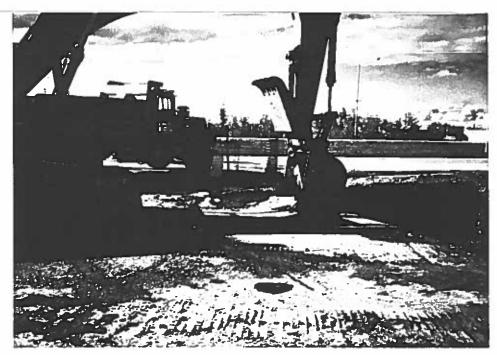
Photo #7: The large track backhoe is used to remove part of the concrete pad at the dispenser area.

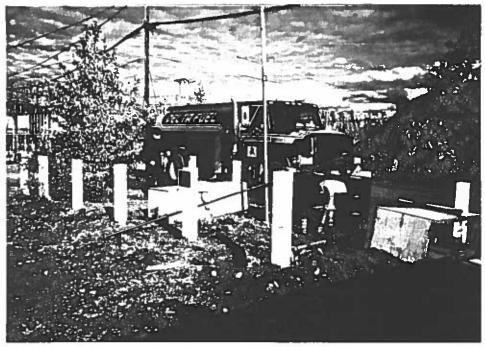
Photo #8: Delta Fuel pumps any remaining liquid product out of the three (3) USTs which will soon be removed.

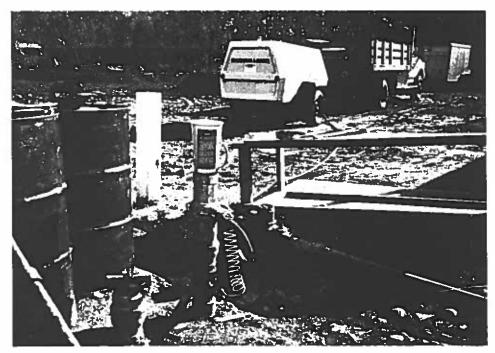
Photo #9: The tanks are then purged with air in preparation for their removal.

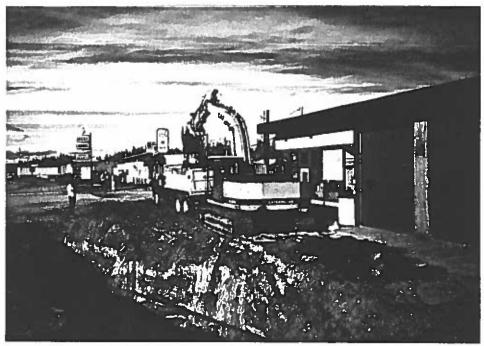
Photo #10: Excavation of the dispenser area continues.

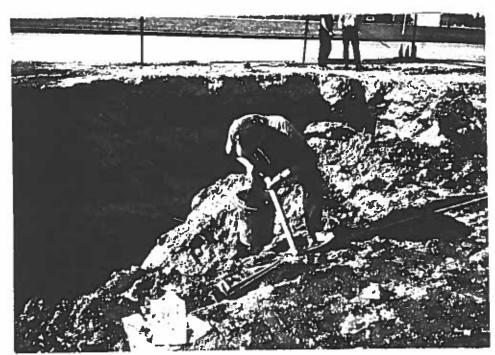
Photo #11: A Copper Valley Enterprises crewman drains remaining fuel into a five-gallon bucket from lines removed at the dispenser area.

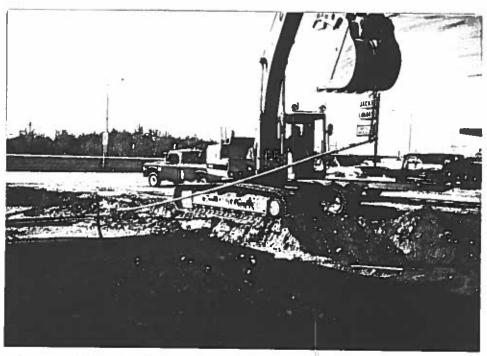
Photo #14: The large track backhoe removes a long length of fuel line between the joints shown above and the buried USTs.

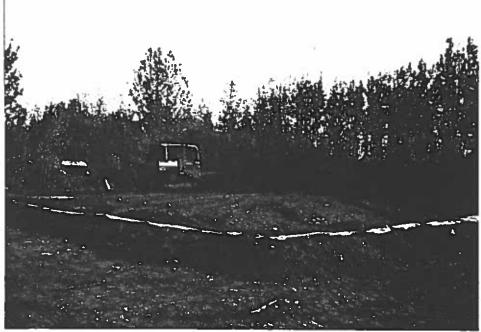
Photo #15: Approximately 800 cubic yards of contaminated dispenser area soils have been spread here about two feet high within the soil containment cell. The cell is surrounded by a straw berm covered by a liner which is anchored in place by clean soils that have been packed along the sides.

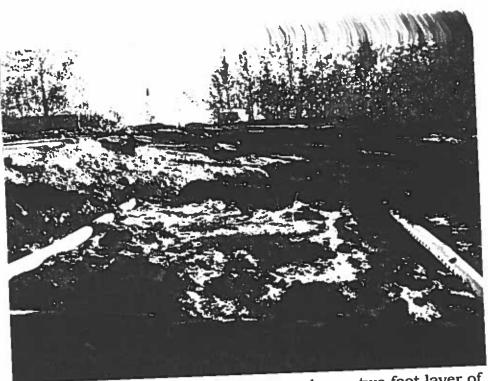
Photo #16: Fertilizer has been spread on a two foot layer of contaminated dispenser area soils where perforated vent pipes have been also placed. Additional contaminated soils are then spread above the pipes.

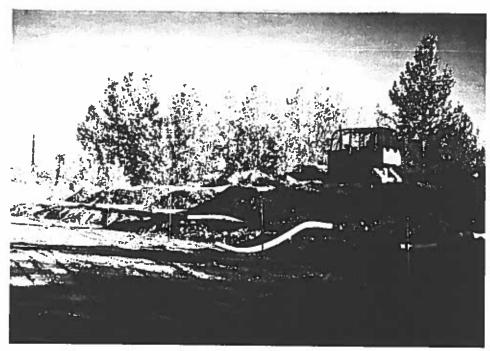
Photo #17: Dispenser area soils continue to be stockpiled and spread at the soil containment area.

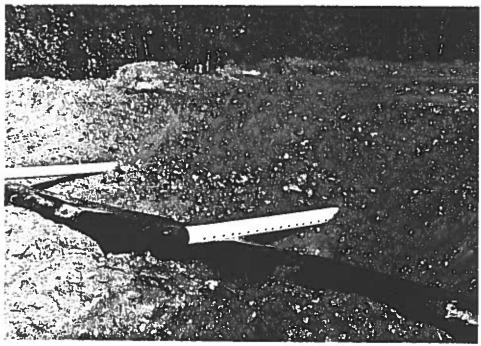
Photo #18: A closeup of the containment area perimeter shows the lined straw bale berm and the perforated vent pipes jutting out from contaminated dispenser area soils.

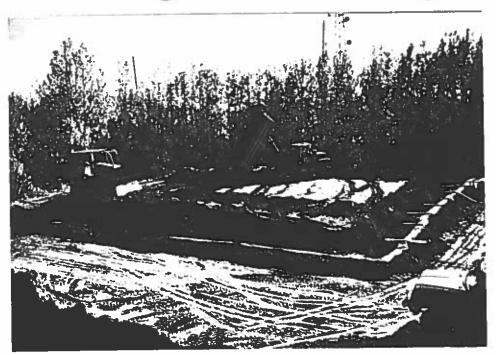
Photo #19: The last of the dispenser area soils, totaling approximately 2000 cubic yards, are spread out at the soil containment cell.

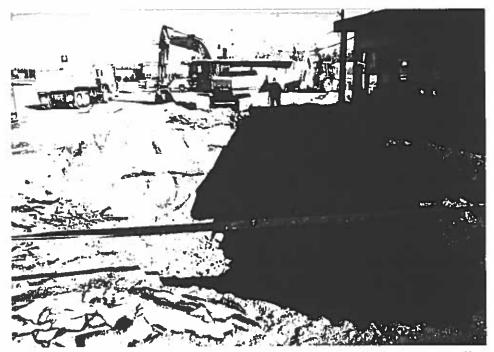
Photo #20: The dispenser area's steep-walled, potentially hazardous excavation has been cordoned off to restrict access. Further excavation of remaining, contaminated soils could not be carried out due to the close proximity of both Jack's Chevron and the access road to the area.

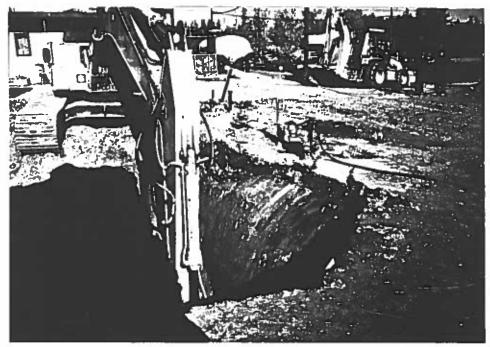
Photo #21: Excavation of the UST area on the north side of the building commences at the 12,000 gallon capacity, dual-chambered gasoline UST.

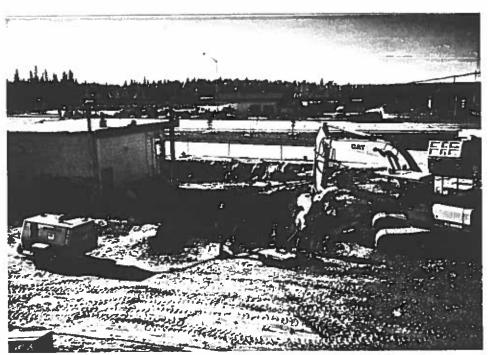
Photo #22: Excavation of a smaller 2000 gallon capacity diesel UST is then carried out.

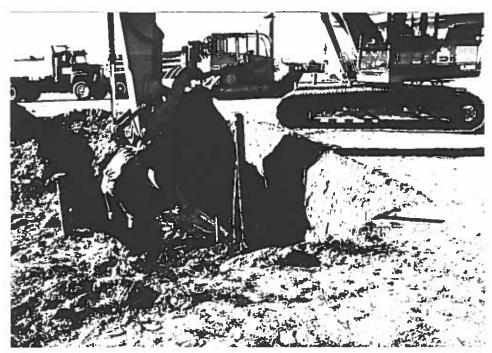
Photo #23: A contracting crewman shovels soil off the top of one (1) of two (2) diesel USTs while the large track backhoe excavates around the tank.

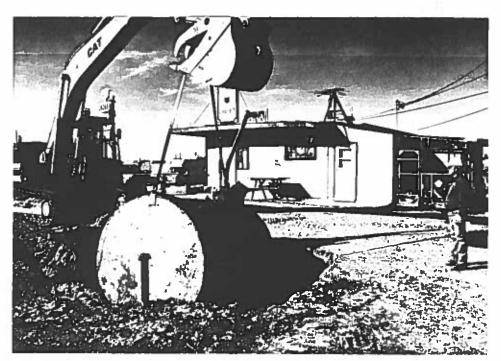
Photo #24: A diesel UST is removed from the excavation. Jack's Liquor is located in the background.

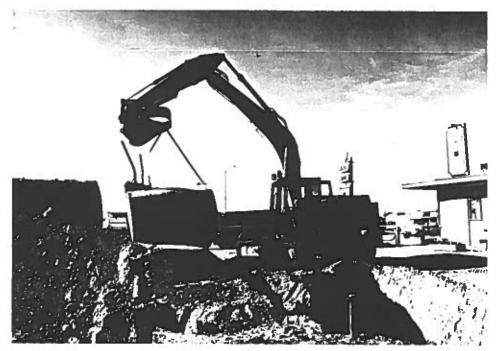
Photo #25: Same as Photo #24.

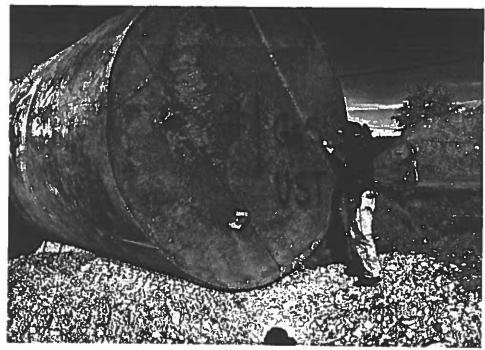
Photo #26: John Janssen marks the 12,000 gallon tank as UST #1, which is also identified as having contained gasoline.

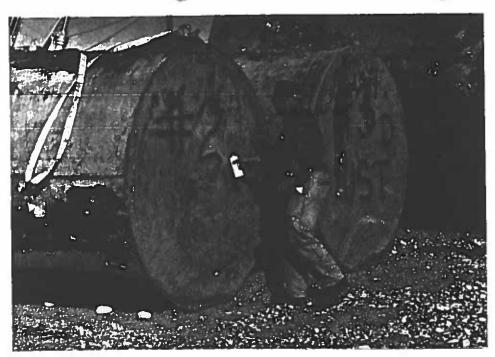
Photo #27: John Janssen continues to mark the other two (2) removed tanks as UST #2 and UST #3, adding a "D" to identify their contents as that of diesel.

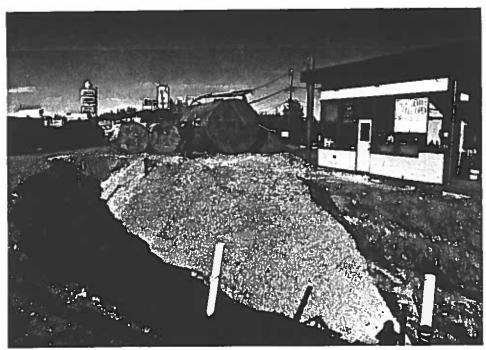
Photo #28: The marked tanks sit near the edge of the dispenser area excavation which has been partially filled with 3/4 minus aggregate.

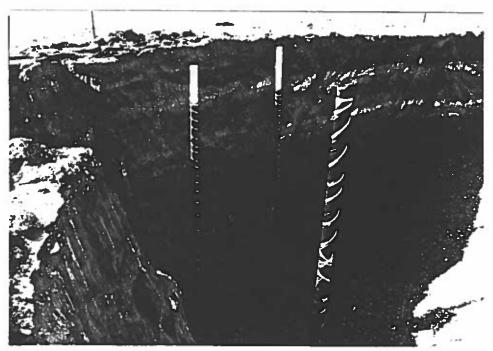
Photo #29: Wrapped air vent pipes which will serve to enhance aeration to remaining contaminated soils have been installed within the dispenser area excavation.

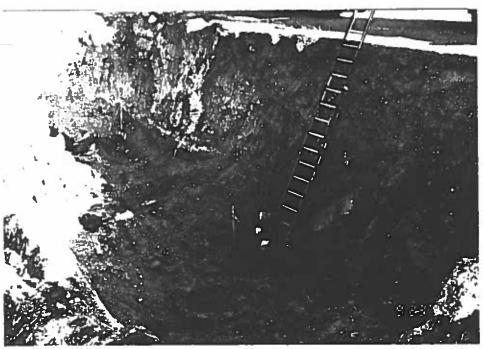
Photo #31: John Janssen collects secondary (baggie-type) field screening samples at locations in the UST excavation. Approximately 700 cubic yards of contaminated soils were removed here and were taken to the soil containment cell where they were spread above the dispenser area soils for a total of roughly 2700 cubic yards of removed soil.

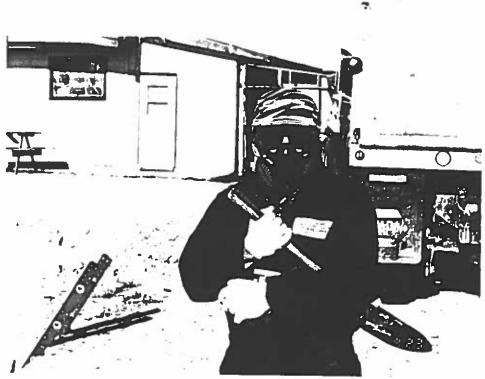
Photo #34: John Janssen dons a vapor mask prior to climbing down into the excavation to collect final laboratory samples.

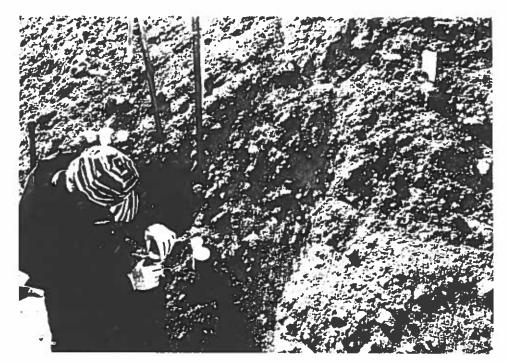
Photo #36: Due to safety hazards posed by the steep-walled dispenser area excavation, samples (duplicate) are collected from contaminated soils that have been removed from the dispenser area and stockpiled at the soil containment cell.

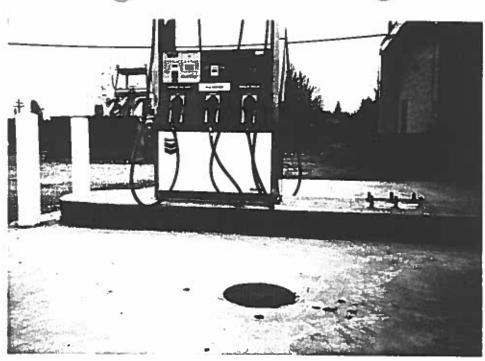
Photo #37: Weeks after the USTs were removed, John Janssen returned to Jack's Chevron to photograph the completed air vent system and new dispensers.

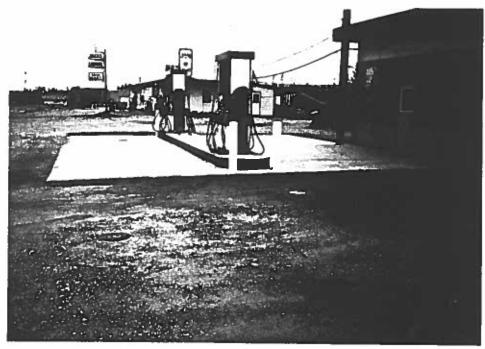
Photo #38: Manholes both in and beyond the concrete pad indicate air vent pipe locations.
