**SUSTAINABLE ENVIRONMENT, ENERGY,
HEALTH & SAFETY PROFESSIONAL SERVICES**

**RE: Indoor Air Screening and Sub-Slab Soil Assessment
157 Old Steese Highway, Fairbanks, Alaska [ADEC File No. 102.23.015]**

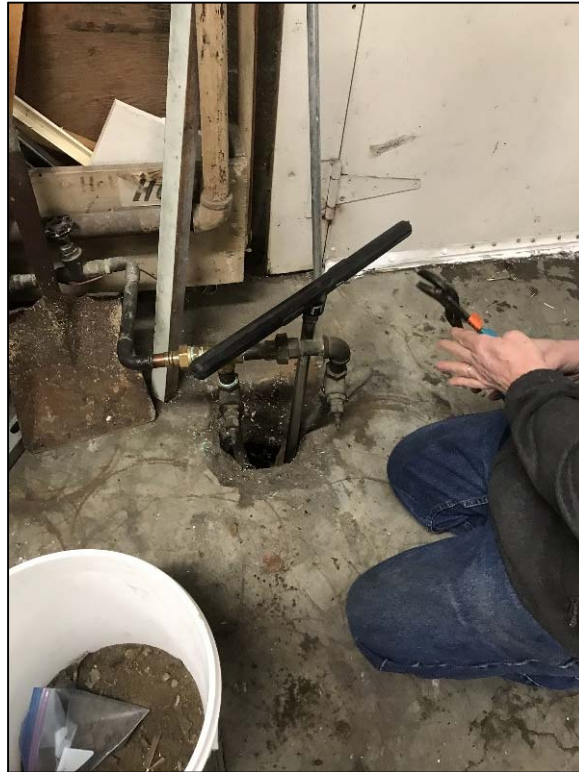
Photo 1: Hole in the concrete slab that was reportedly used for fluid disposal. Pipes coming from the hole appear to be the connection to the public water utility and the “T” handle is the hand auger that was used to collect soil samples for field screening and laboratory testing from below the concrete slab. Recovered soil is visible in the bucket.

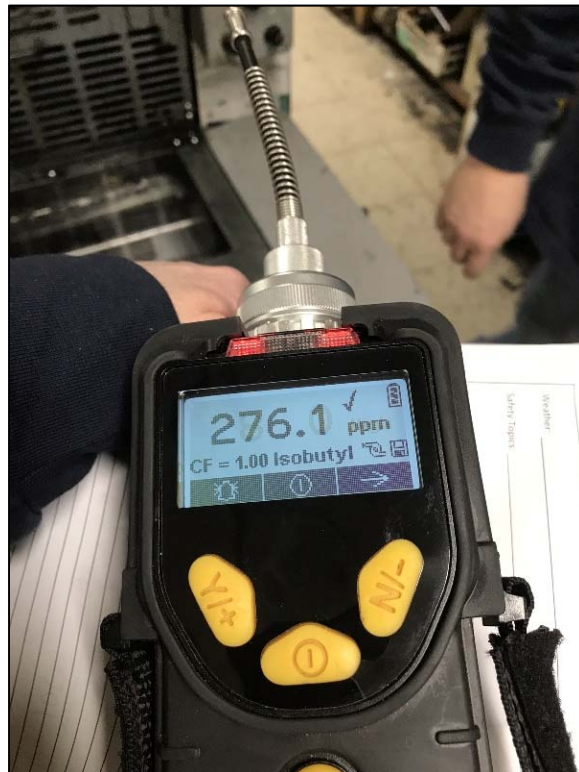
Photo 2: Typical indoor air reading near a printing unit during indoor air quality assessment.

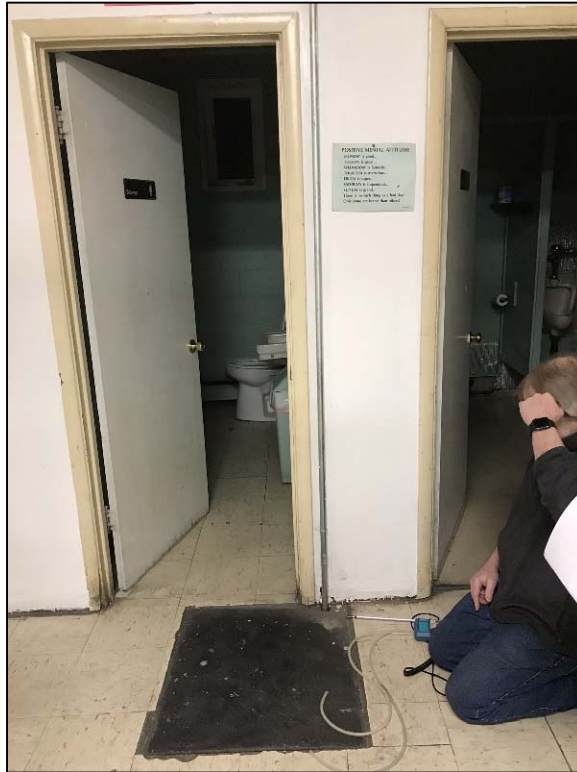
Differential pressure was also evaluated between the area beneath the slab and occupied spaces at two locations along the utility chase. The readings were 0.001 inches of water with pressure greater beneath the concrete slab. This means that air is moving from within the utility chase to the occupied space and provided a rationale for the lower VOC readings in the utility chases. This pressure differential minimizes the potential for the solvent vapors present on the first floor of the facility to migrate below the slab.

Photo 3: Measuring different pressure between occupied space and utilidor. Basement boiler room is present beneath the bathroom at back of photo.
