Whitestone Camp Bioremediation Cell Soil Sampling Report

Client: Sealaska

Date: May 14th, 2016

Project: Whitestone Camp
Bioremediation Cell Soil Sampling

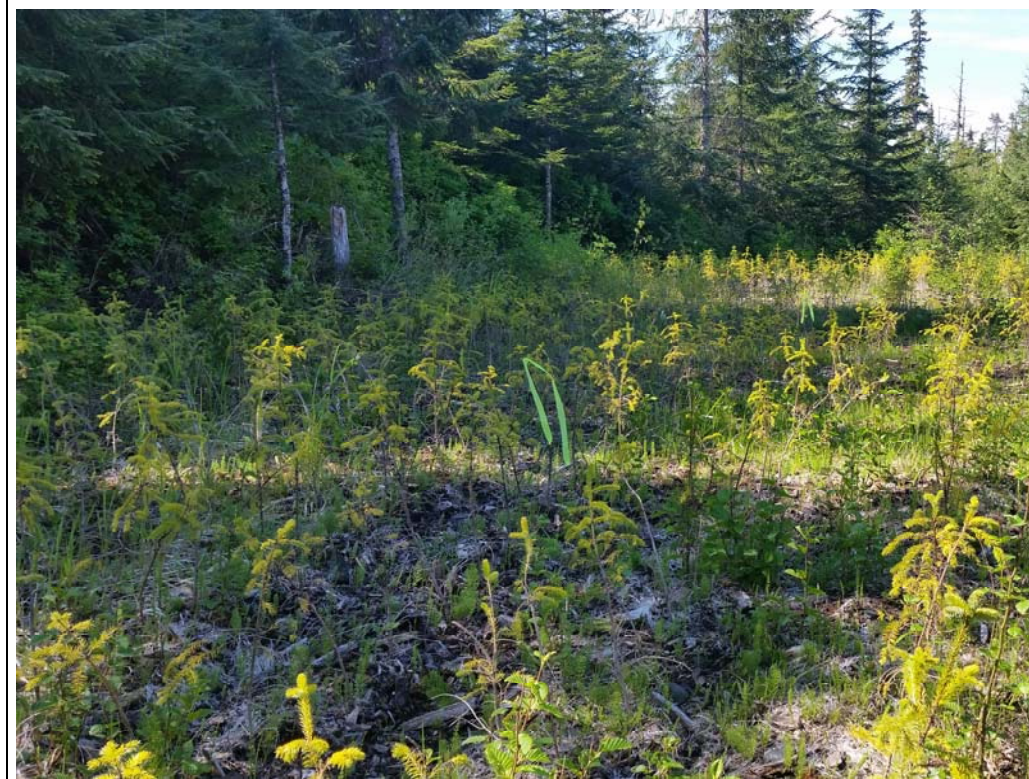
Photograph No. 1

Prior to beginning soil sampling of site field technician performed a visual observation of the existing bioremediation cell. During the visual inspection it was noted that the existing cell was approximately 90' long by 20' wide and approximately 18" deep. The existing surface of the bioremediation cell did not have an impermeable line covering it, however the R&M inspector did notice that the impermeable liner below the cell did appear to be intact. In general the

material in the cell consisted primarily of woody waste products (chipped up bark and small fragments of wood) consist with what would be encountered on the ground surface of a log sorting yard. Finally based on our field observations it there appeared to be a low spot in the middle of the cell where all the surface water would collect

Description:
Over all photo

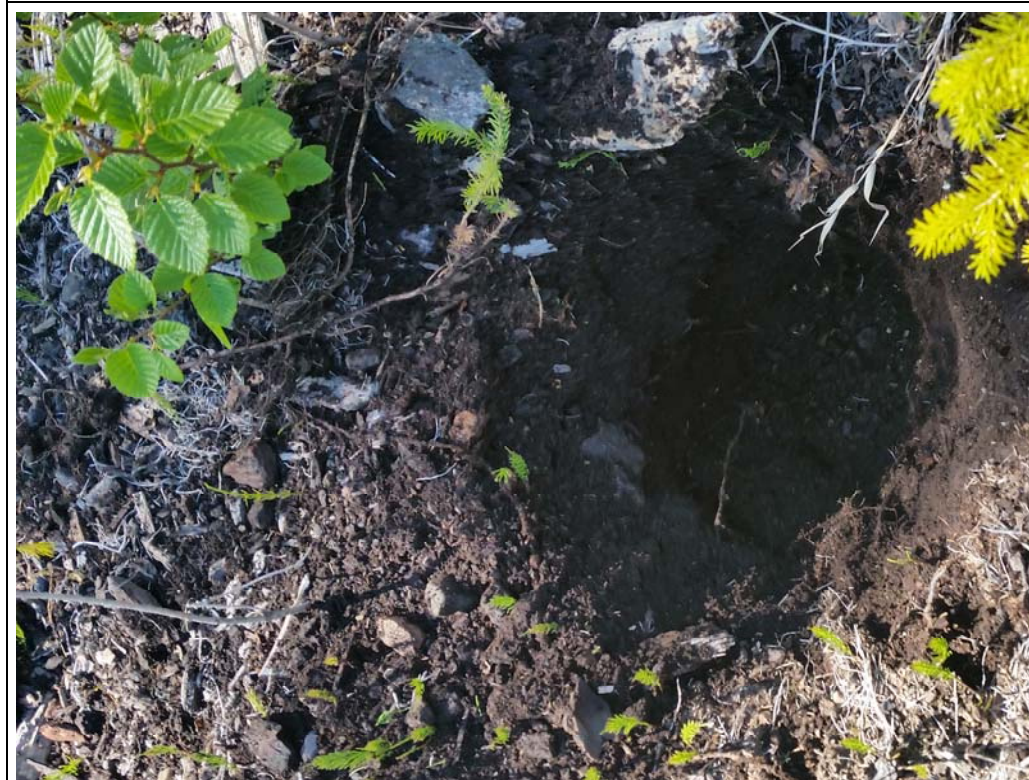
Photograph No. 2

Description:
Test Hole #1

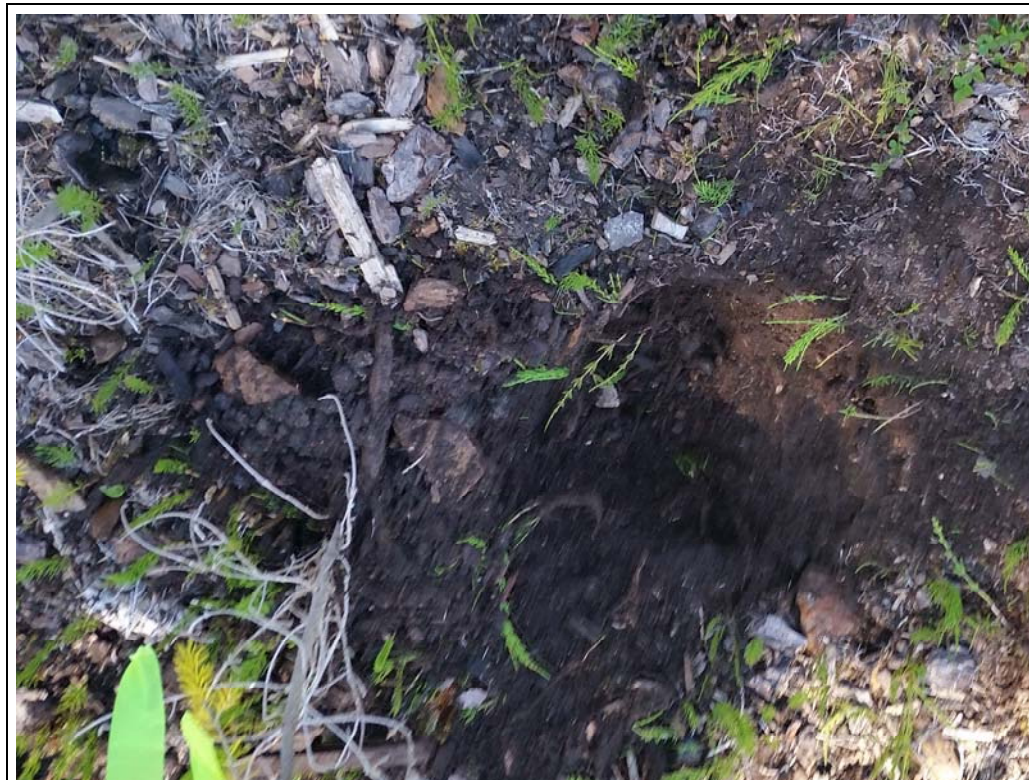
Photograph No. 3

Description:
Test Hole #2

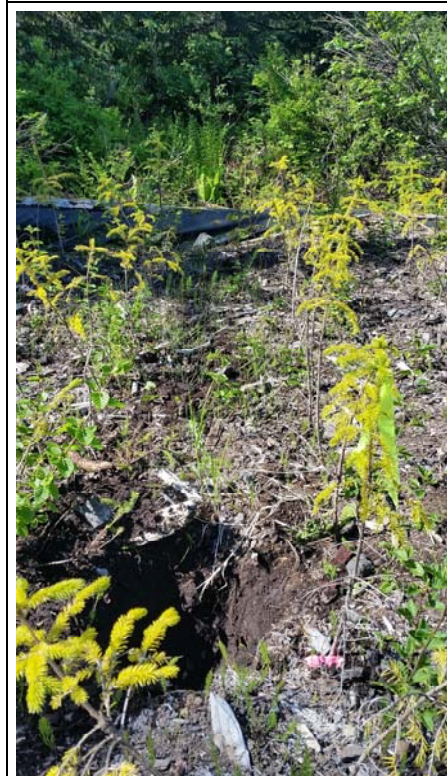
Photograph No. 4

Description:
Test Hole #3

Based on our review of the attached soil analysis report it appears that a large amount of the contaminated soil has been successfully remediated to contamination levels below the ACEC accepted limit of 200 mg/kg. However in the area where test hole 3 was located the contamination levels were still higher than the accepted limits. Therefore it is our recommendation some additional bioremediation be performed on the material. This can be accomplished by tilling, turning, and mixing nitrogen and phosphorus rich fertilize into the existing material in the bioremediation cell. Base off an assumed average hydrocarbon concentration of 130 mg/kg, an approximate unit weight of the existing soil of approximately 120 lb/cy, the addition of (3) 90 lb bags of nitrogen rich fertilizer thoroughly mixed into the existing soils will be sufficient to achieve the recommended 100carbon:100nitrogen:1 phosphorus ration in the existing soil. Once the fertilizer it mixed into the contaminated soil and the material is evenly spread along the bottom liner, this pipe should then be covered with a minimum 4mil impervious membrane to ensure no runoff water is allowed to mix in the with the contaminated soil.
