SSD/SVE SYSTEM OM&M AND VAPOR INTRUSION ASSESSMENT REPORT

**314 WENDELL AVENUE SITE
FAIRBANKS, AK
NTP 18-4002-11-036**

FINAL
January 2013

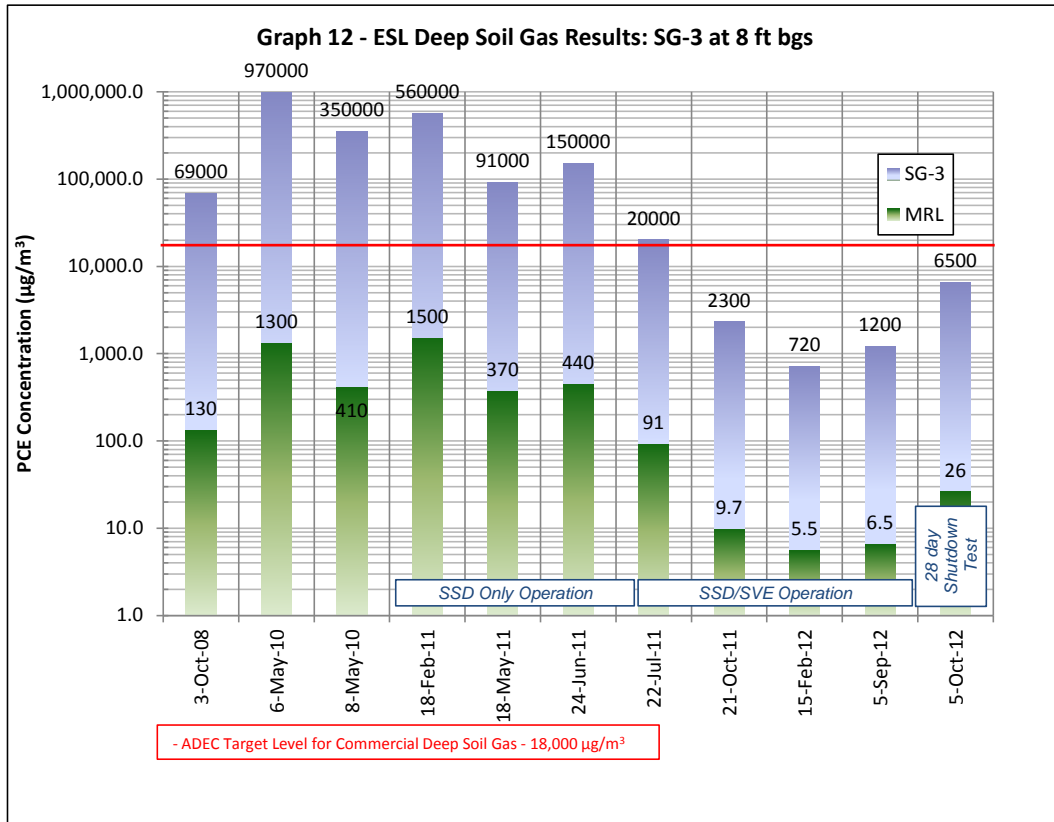
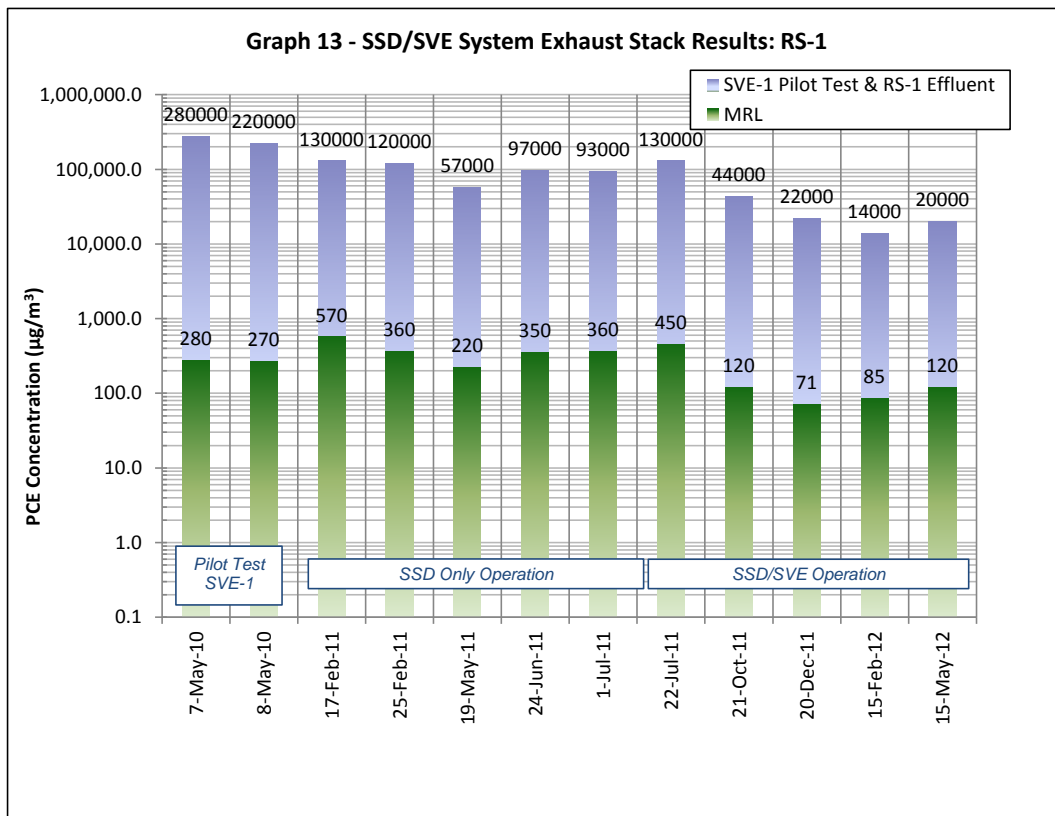
**Graphs 12 and 13 : SSD/SVE System OM&M Results
Deep Soil Gas and SSD/SVE System Exhaust Stack**

Cumulative VI assessment sampling results for the ESL Building from before SSD/SVE system installation, during system operation, and at the end of the 2012 shutdown test are displayed in a series of graphs to highlight the changes in site conditions. Graphs 8 and 9 present the analytical results for the indoor air and sub-slab soil gas samples from the office area of the ESL Building. Graphs 10 and 11 present the analytical results for the indoor air and sub-slab soil gas samples from the main laundry room area of the ESL Building. Graph 12 presents vadose zone soil gas results from VMP location SG-3 at a depth of 8 feet bgs. Graph 13 presents SSD/SVE effluent results from the system exhaust stack.

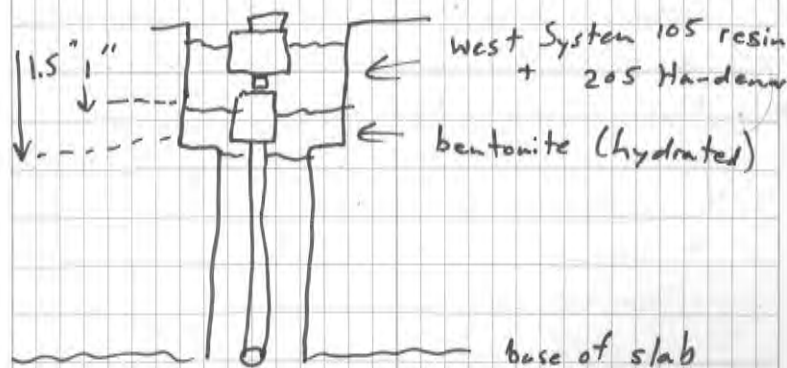
completed SS-4 and SS-5 according to following figure

- Epoxy in place at 13:30 - touch-up paint on floor around SS-5 (can of grey spray paint in back room)
- Placed cement cuttings + old probes in SAA 1400 offsite

Following recommendations made in the *Vapor Intrusion Report* (OASIS 2012a), sub-slab VMPs SS-4 and SS-5 were replaced to account for wear on the grout seal and probe threads. SS-5 was suspected of not penetrating the base of the slab. Upon replacement, it was found that SS-5 did penetrate the slab, but the probe was plugged. Both sub-slab soil gas points were reinstalled using an epoxy seal. Details of the reinstallation performed on March 12, 2012 are found in the field notes in Appendix C. Cement cuttings and old probes were placed in the Satellite Accumulation Area (SAA) at the SSD/SVE unit.

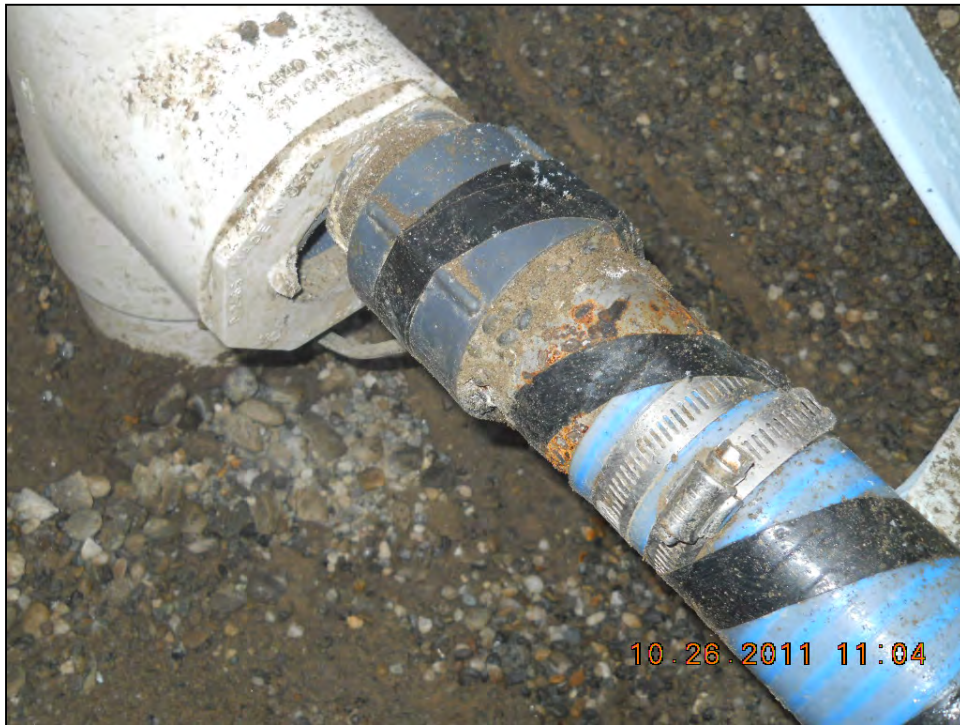
PHOTOGRAPH 1: SVE-4 CRACKED PIPE WHERE CONVEYANCE PIPING CONNECTS TO WELL CASING.

Non-routine maintenance included repair of broken piping at the SVE-4 wellhead on October 26, 2011. A problem with SVE-4 was suspected following an OM&M inspection at the end of the VI assessment sampling effort on October 21, 2011. A down-hole camera was used to identify cracked pipe where the conveyance piping connects to the well casing (Photograph 1, Appendix D). The soil around the wellhead was removed and new fittings were used to repair the well (Photograph 2). The frozen condition of the soil removed from around the wellhead prevented all the soil being returned to the hole. Approximately 20 gallons of surplus soil was placed just north of the propane tank for the ESL Building within the area of contamination (AOC).

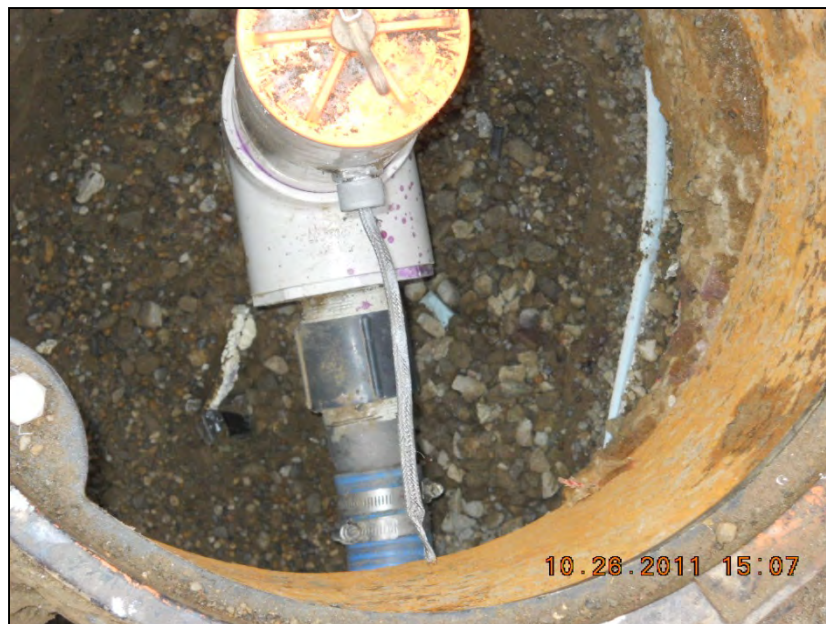
PHOTOGRAPH 2: SVE-4 WELL REPAIR WITH NEW FITTINGS.

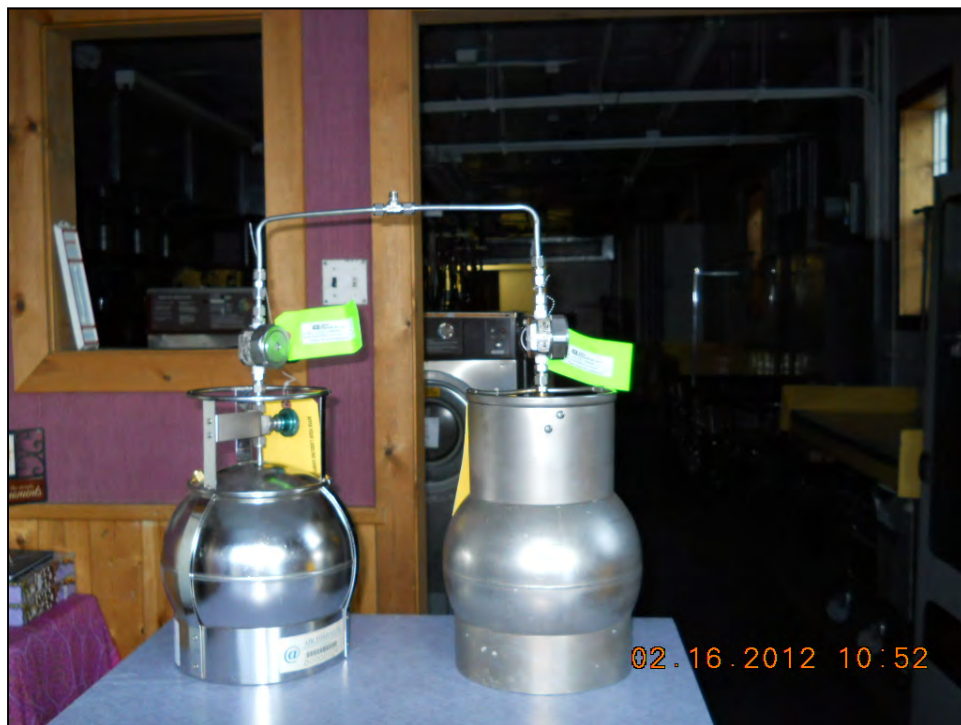
Quality assurance/quality control (QA/QC) air samples included field duplicates obtained at a rate of 10 percent for SIM-certified Summa™ canisters. A laboratory supplied stainless steel SIM-certified duplicate tee was utilized at locations where duplicate samples were obtained with SIM-certified Summa™ canisters. The duplicate tee was attached to the inlets of two flow controllers, and both samples were drawn in through a common inlet (Photograph 4).

PHOTOGRAPH 4: SUMMA™ CANISTERS CONNECTED WITH DUPLICATE SAMPLING TEE AT LOCATION IA-8 DURING FEBRUARY SAMPLING EVENT.

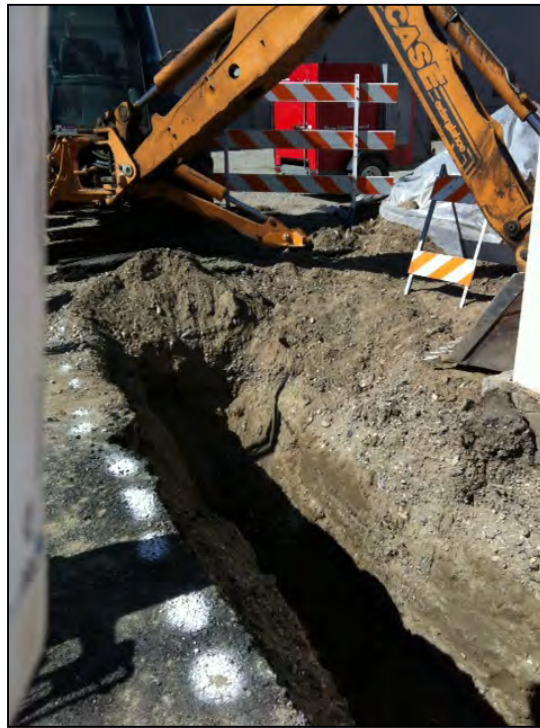
- OASIS-ERM was called out for waterline repairs occurring at the southwest corner of the ESL Building in May 2012. Andrew Weller of OASIS-ERM notified Fairbanks Pumping and Thawing at the site on May 7, 2012 to contact OASIS-ERM prior to performing any digging on the site. However, on an OM&M site visit on May 15, 2012, OASIS-ERM personnel observed excavation underway of a 10' x 10' x 4' area (Photograph 5 & 6). ADEC was notified of activities. Excavated soil remained on site and was used as backfill upon completion of excavation activities.

PHOTOGRAPH 5: EXCAVATION PROGRESS IN FRONT OF ESL BUILDING.

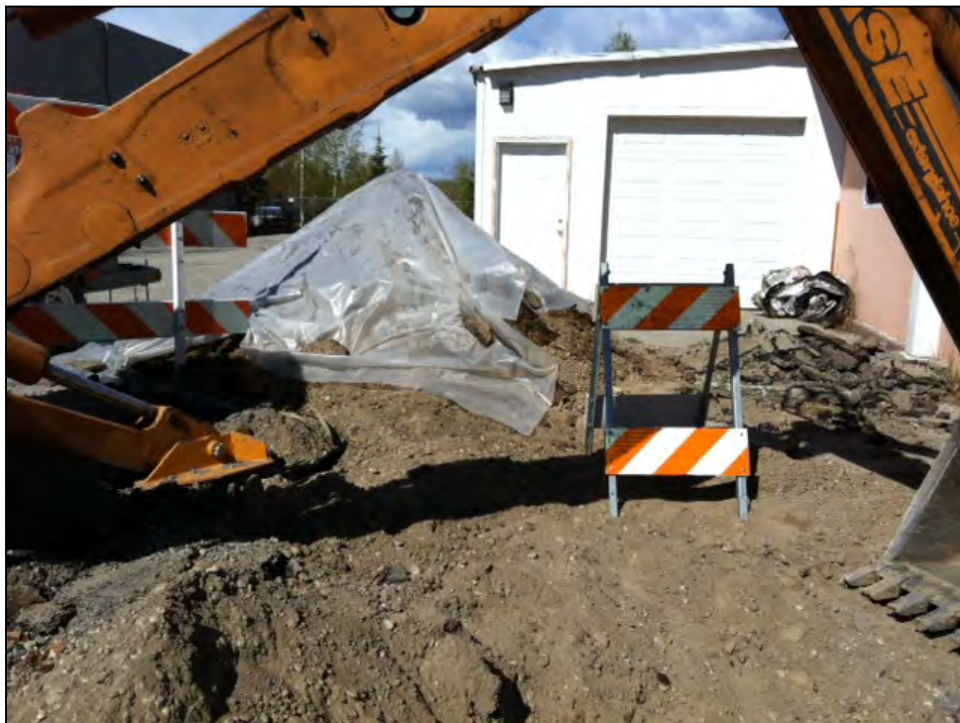
PHOTOGRAPH 6: SOIL REMOVED DURING EXCAVATION IN FRONT OF ESL BUILDING.

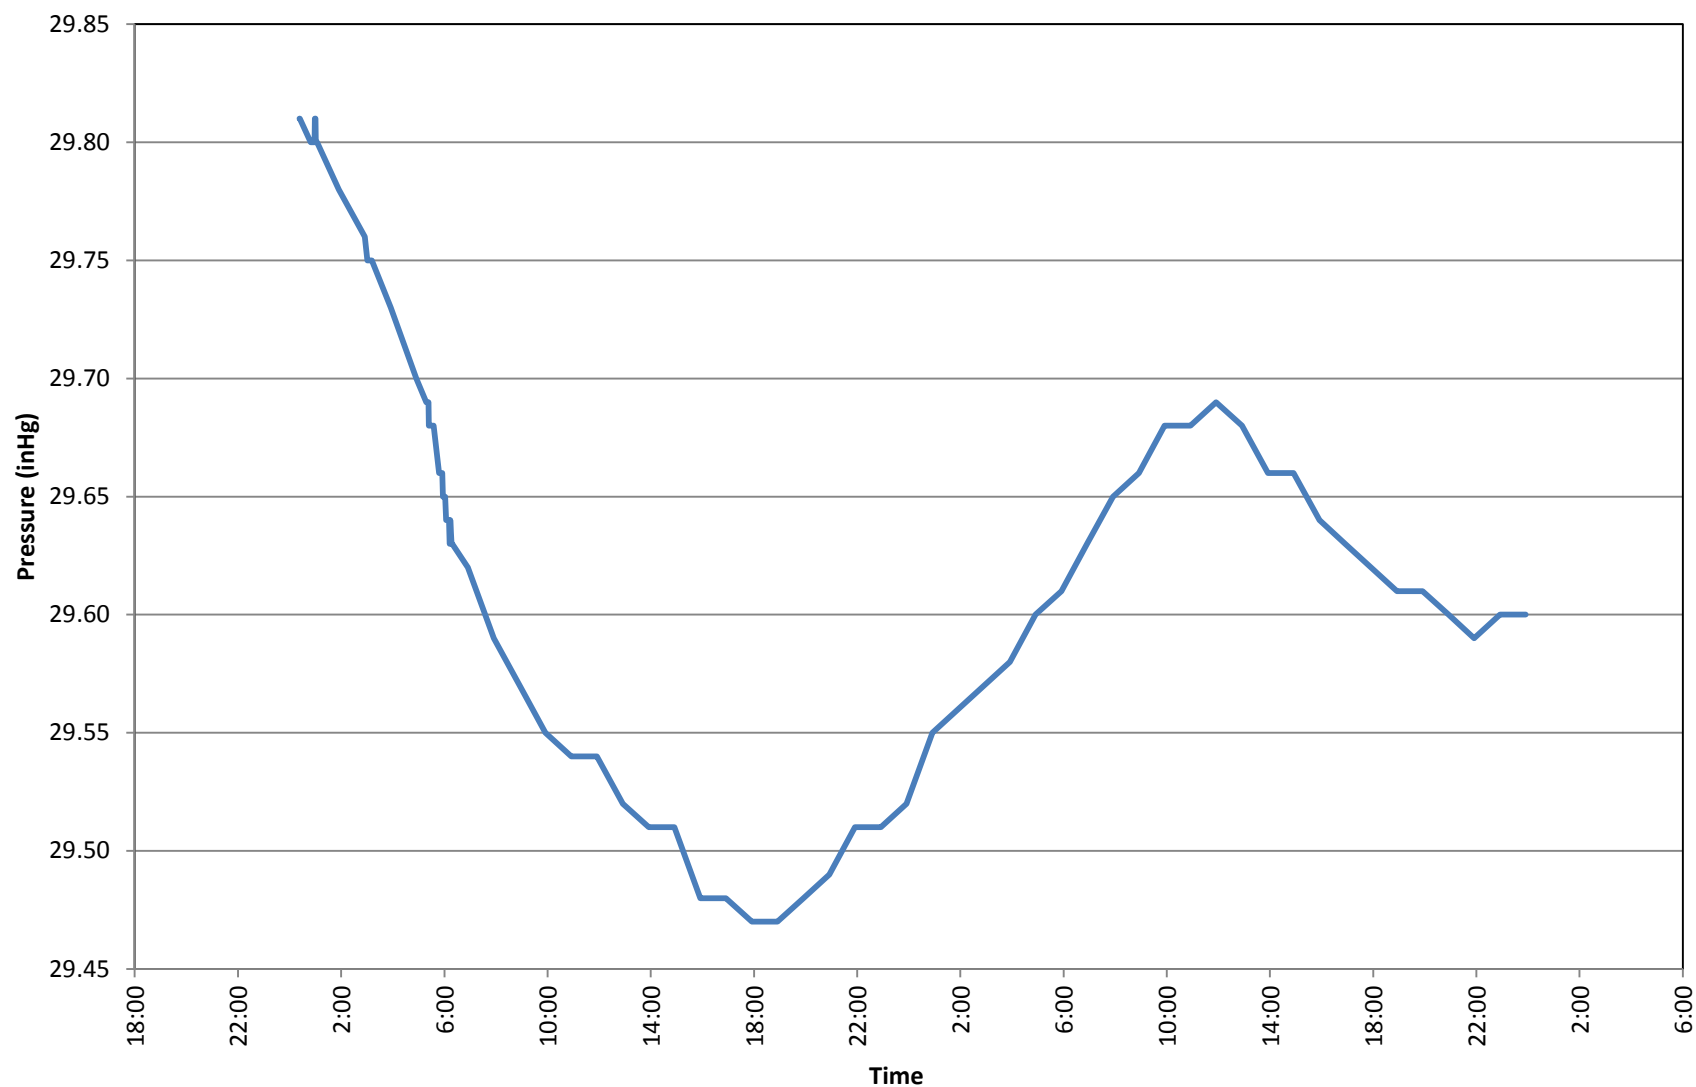
**Barometric Pressure Readings for Air Sampling
February 15, 2012- February 16, 2012**

Vapor intrusion assessment sampling was performed on four occasions under the SFY 2012 scope of work. Vapor intrusion assessment sampling for three of the events was performed with the SSD/SVE system operating, and one event was performed after a planned system shutdown. Vapor intrusion assessment samples were collected from the ESL Building during each of the four events. Vapor intrusion assessment samples were collected from 330 Wendell Avenue only during the September 2012 event. Table 4 presents a summary of VI assessment samples collected under the SFY 2012 scope of work, and Figure 3 presents the locations of each sample. All samples were collected in accordance with the methodology listed in the *Long-Term SSD/SVE System Operation, Maintenance, and Monitoring Work Plan* (OASIS 2011a). Vapor intrusion assessment sampling included the collection of indoor air, sub-slab soil gas, and soil gas samples. Figure 5 illustrates the sampling setup for soil gas collection and Photograph 3 shows soil gas sample collection at location SG-3. Barometric pressure was tracked during the sampling to assist in interpreting results.
