Final Report

Contract No. DAHA90-94-D-0005
Delivery Order No. 0501

Preliminary Assessment/Site Investigation at the Savoonga Federal Scout Armory Savoonga, Alaska

January 1998

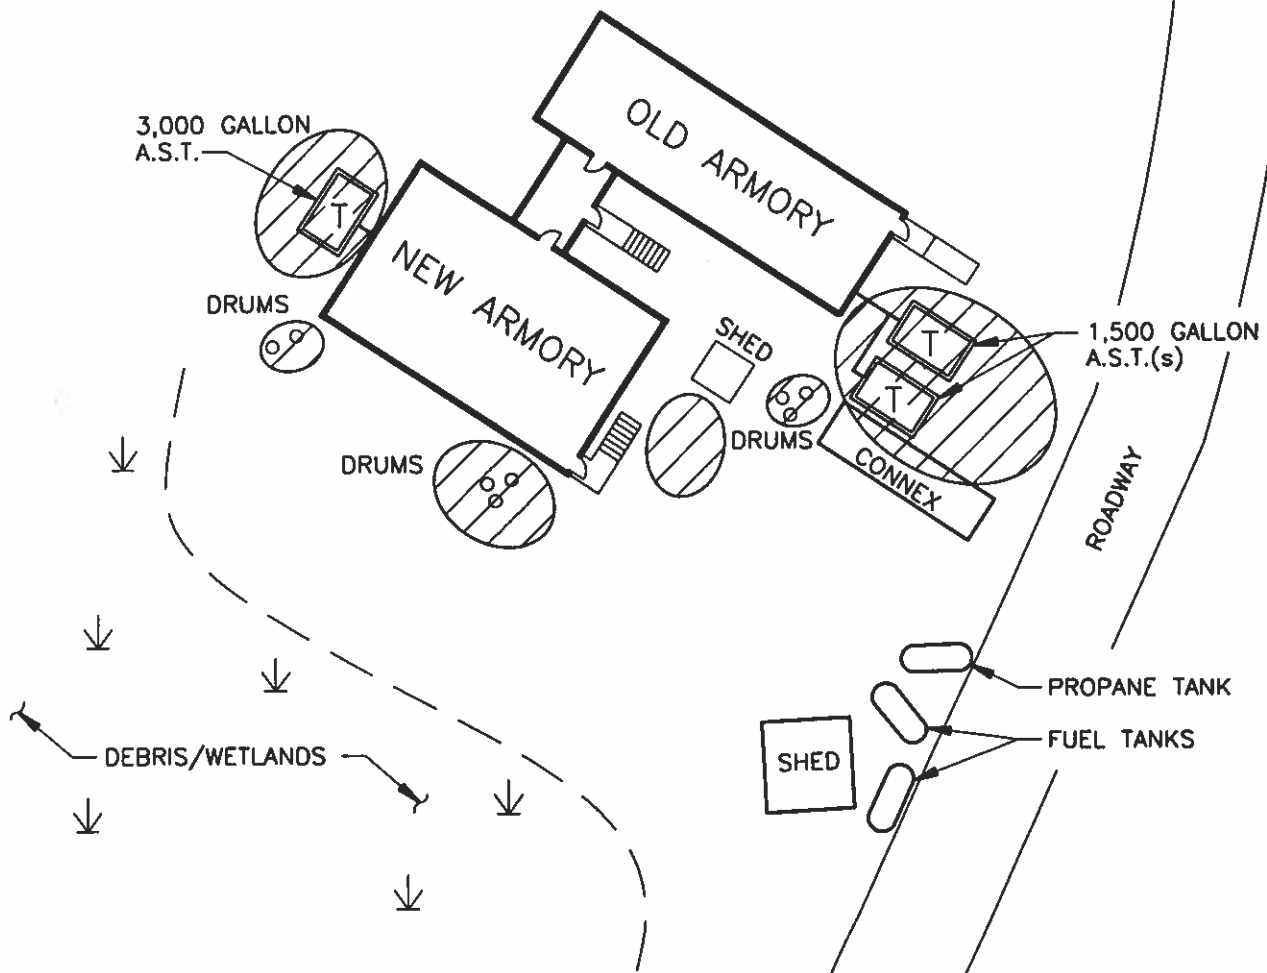
Aboveground Fuel Storage Tanks: The area surrounding the three existing aboveground fuel storage tanks and associated piping are areas of potential concern.

ABOVE GROUND STORAGE TANK (A.S.T.)

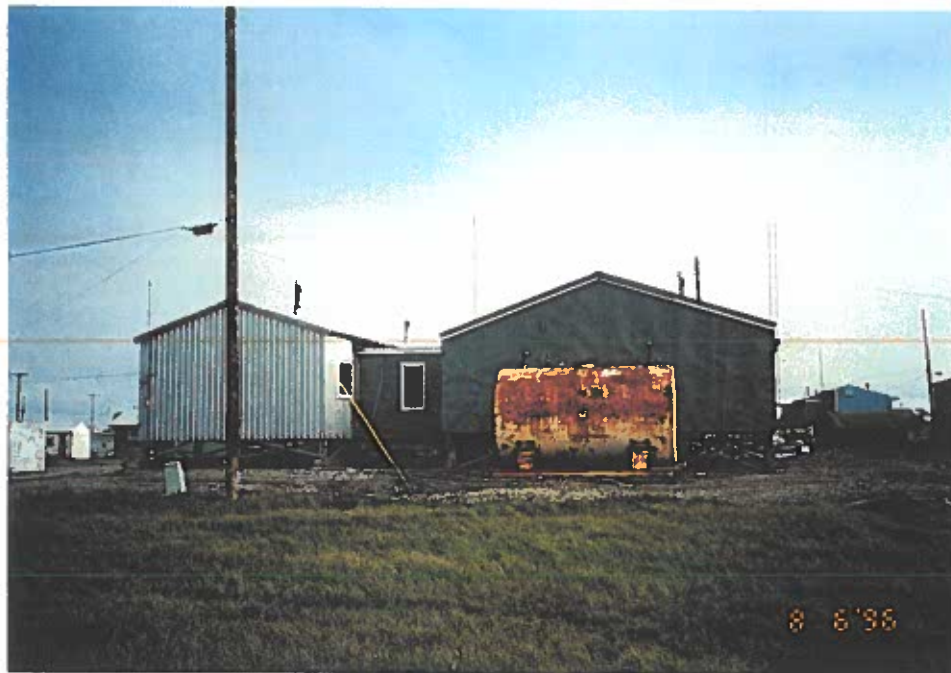
Photo No 4

Back of Armory. Looking Southeast at Heating Oil
AST.
