Re: Lot 6F, Block 2, Unalaska Airport Landfarm Sampling Report ADEC File No. 2542.38.010

Lot 6F, Block 2 Unalaska Airport Landfarm Sampling: Photo Log – November, 2017

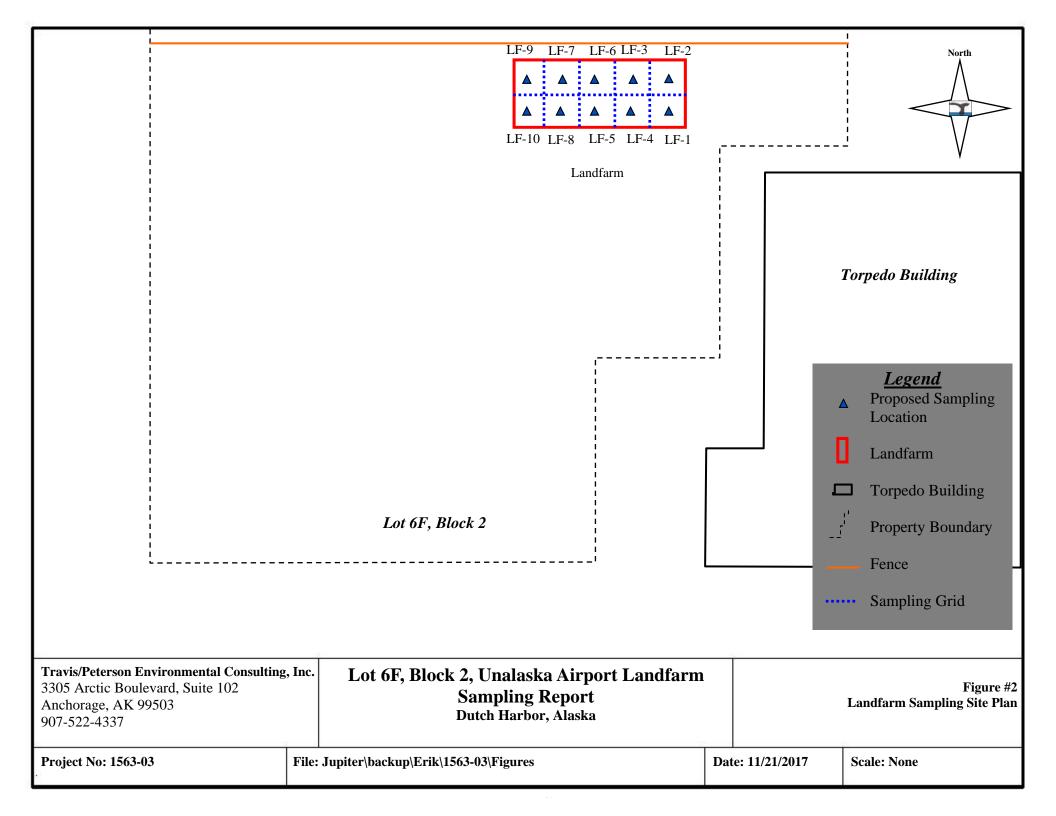
To confirm that DRO treatment objectives have been met, the landfarm was divided into a grid; field screening was conducted across the grid and discrete confirmation samples for laboratory analysis were collected from the areas with the highest field screening results. TPECI divided the 30 ft by 16.5 ft landfarm into 10 grid cells, each measuring approximately six feet by eight feet. One soil sample was collected for field screening from each of the grid cells. Soil samples were identified as LF-1 through LF-10 (Figure 2 enclosed).

The four grid cells with the highest field screening results were collected for laboratory analysis. All soil samples for field screening and laboratory analysis were collected at a depth of approximately six to eight inches below the soil surface.
