Subject: Costa Hill Repeater Closure Report**ENSR Project Number 00550-341**

ENSR Corporation (ENSR) is pleased to submit this report on behalf of Mr. Larry Bamberger, AT&T Environmental, Health, and Safety Operations Manager, in support of a Conditional Closure determination for the Costa Hill Repeater. The following report presents the results of site assessment and remediation work conducted by ENSR at the Costa Hill Repeater and summarizes all field activities performed at the site, including a review of sampling results, data quality, and site management recommendations. This report is being submitted as a supplement to the Conditional Closure Report submitted to the Alaska Department of Environmental Conservation (ADEC) in April 2007 (finalized August 2007).¹

The programmatic elements and risk evaluation for Costa Hill were derived from the April 2007 report.¹ Figures illustrating the site location, facility layout, sampling locations, and field and analytical results are provided in Attachment 1. Laboratory analytical results from 2003 to the 2007 are provided in tables in Attachment 2. Site photos for each field visit are provided in Attachment 3. These attachments provid

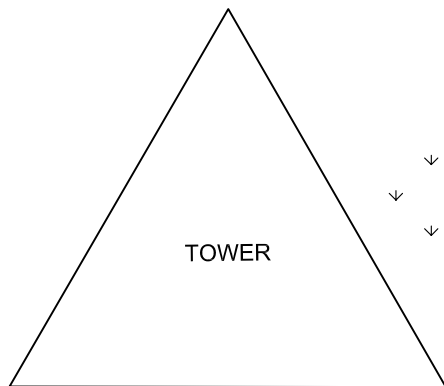
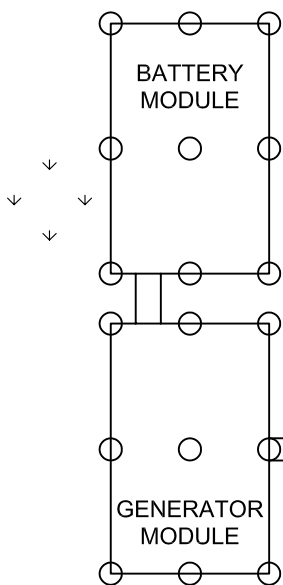
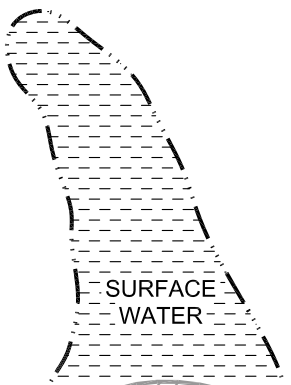
FIGURE 1
COSTA HILL REPEATER
FIELD SCREENING AND
ANALYTICAL RESULTS

APPROXIMATELY 16 CUBIC YARDS
OF PETROLEUM HYDROCARBON
CONTAMINATED MATERIAL REMAIN

COST05	26" bgs
DRO	1,200
RRO	1,430

APPROXIMATELY 12 CUBIC YARDS
OF PETROLEUM HYDROCARBON
CONTAMINATED MATERIAL WAS
REMOVED FROM THIS AREA TO
A DEPTH OF 2 FEET (PERMAFROST)

COST02	16" bgs
DRO	1,580
RRO	1,180

COST03	32" bgs
DRO	2,950
RRO	599

COST04	20" bgs
DRO	179
RRO	1,290

COST01	26" bgs
DRO	1,160
RRO	1,210

Soils identified as contaminated were removed from the AST area. Excavations under ASTs 2 and 3 were extended until they reached permafrost at approximately 30 inches bgs. These excavations were advanced to the maximum extent practical without compromising the structural integrity of the tank footings (see attached photographs). Approximately 6 cubic yards of contaminated material was removed in 2004, and an additional 8 cubic yards were removed in 2005. Approximately 10 cubic yards of D-1 and native tundra material were used to backfill the excavation beneath the AST area in 2005.

Analytical samples collected from excavations and potentially contaminated soils remaining in the AST area reported concentrations of DRO in all samples, ranging from 16.3 mg/kg (estimated) to 2,950 mg/kg. The highest remaining DRO concentration at the site (2,950 mg/kg) was located beneath AST 3 adjacent to the vertical support mount at 32 inches bgs. No further excavation was possible at this

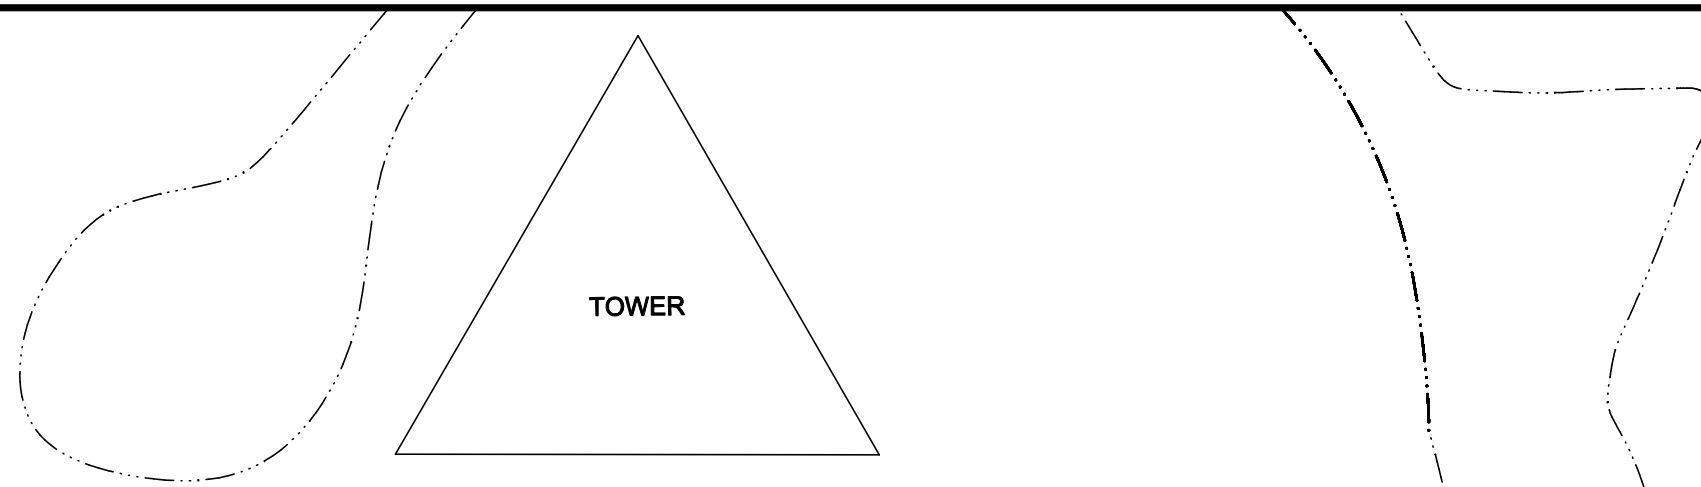
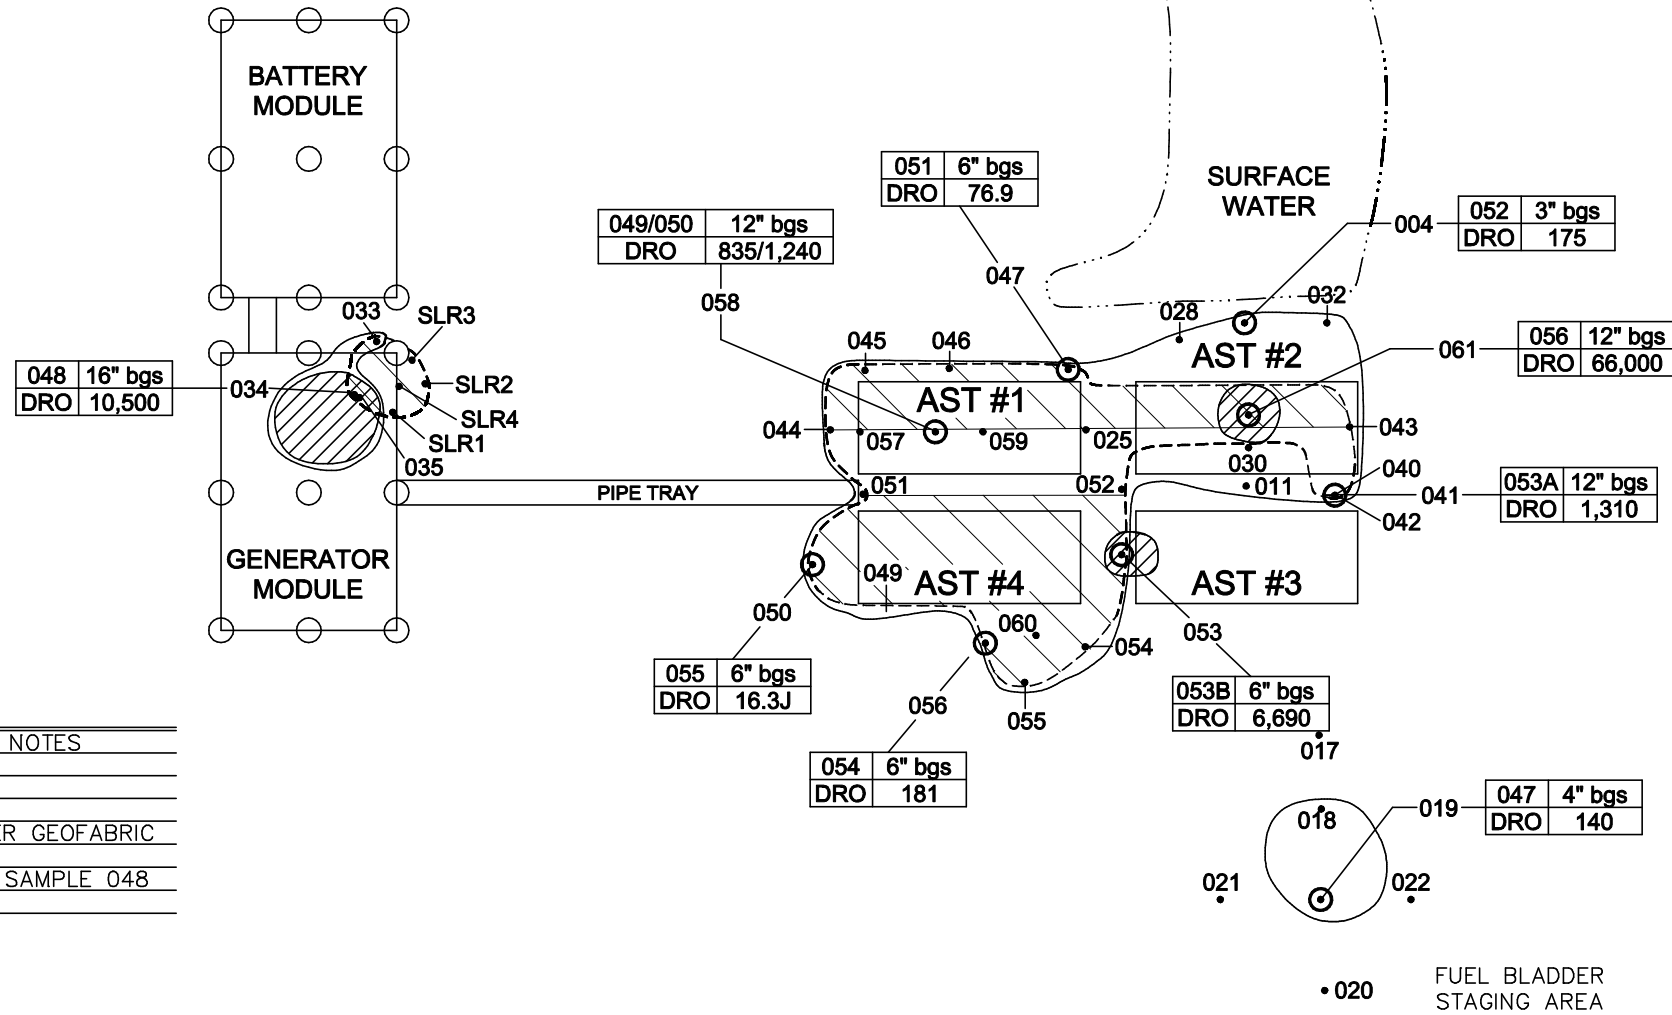
FIGURE 1
COSTA HILL REPEATER
FIELD AND ANALYTICAL RESULTS

PID RESULTS
GENERATOR MODULE AREA

Sample#	"bgs	HHS/PPM	NOTES
SLR1	6	0.5	
SLR2	6	2.0	
SLR3	6	0.8	
SLR4	15	1.5	UNDER GEOFABRIC
033	16	12.0	
034	16	156	LAB SAMPLE 048
035	6	113

PID RESULTS
AST AREA

Sample#	"bgs	HHS/PPM	NOTES
004	3	94.4	LAB SAMPLE 052
011	3	16.5	
025	6	17.1	
028	3	18.1	
030	6	25.0	
032	3	20.2	
040	6	16.2	
041	12	16.8	LAB SAMPLE 053A
042	15	34.4	
043	9	17.5	
044	6	13.2	
045	6	11.1	
046	6	13.7	
047	6	17.0	LAB SAMPLE 051
049	6	16.6	
050	6	10.2	LAB SAMPLE 055
051	6	12.5	
052	6	14.1	
053	6	37.0	LAB SAMPLE 053B
054	6	27.9	
055	6	15.3	
056	6	46.3	LAB SAMPLE 054
057	12	103	
058	12	106	LAB SAMPLE 049/050
059	12	30.3	
060	9	32.8	
061	12	1581	LAB SAMPLE 056

PID RESULTS
FUEL BLADDER STAGING AREA

Sample#	"bgs	HHS/PPM	NOTES
017	4	2.6	
018	4	31.2	
019	4	251	LAB SAMPLE 047
020	4	7.1	
021	4	2.9	
022	4	7.8

In 2004 excavations on the west half of the north side of the building were extended vertically and laterally until heated headspace (HHS)/PID results were below 10 parts per million (ppm) or to the extent practical without potentially compromising the integrity of the structure. Approximately 4 cubic yards of contaminated soil was removed from this area to a depth of approximately 16 inches bgs. An analytical sample collected from potentially contaminated soils remaining in place reported DRO concentrations of 813 mg/kg.

Field screening and analytical results indicate that little contaminated soil above the cleanup level remains under the generator module. PID samples ranged from 7.9 ppm to 87.2 ppm in the excavation beneath the generator module.

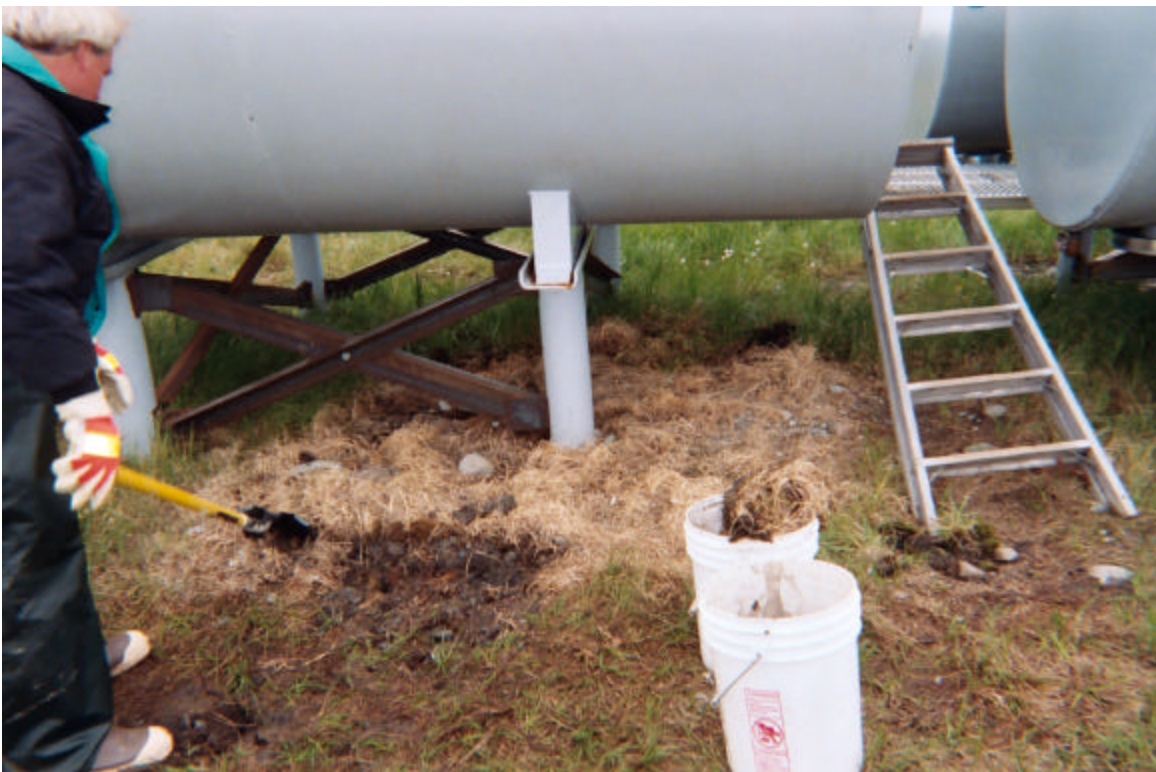
Stressed vegetation under Tank 4.

Field screening in the AST area indicated possible contamination under each of the four tanks. Contamination under the tanks is likely due to slow leakage over time and/or spillage at the tank fill valve during refueling. Very little contamination was encountered beneath ASTs 1 and 4. However, contamination was encountered beneath ASTs 2 and 3; and remedial excavations were conducted to the maximum extent practical.

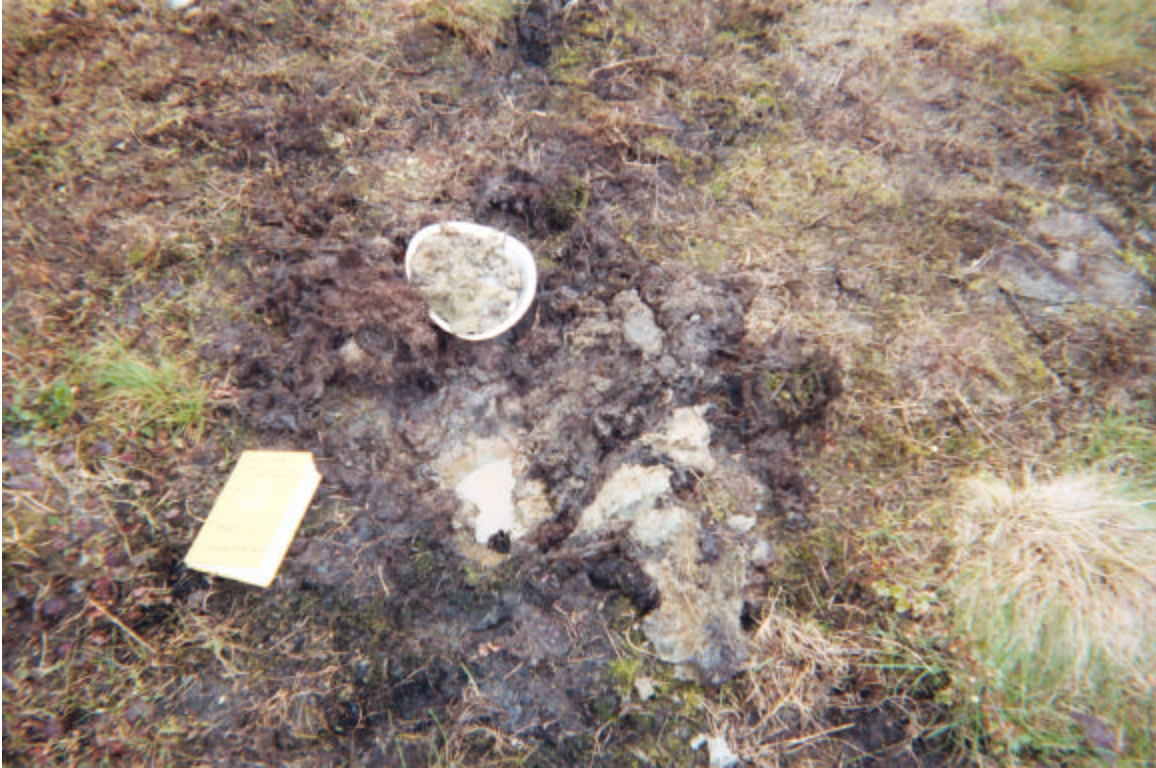
Analytical sample location 047 at fuel bladder staging area.

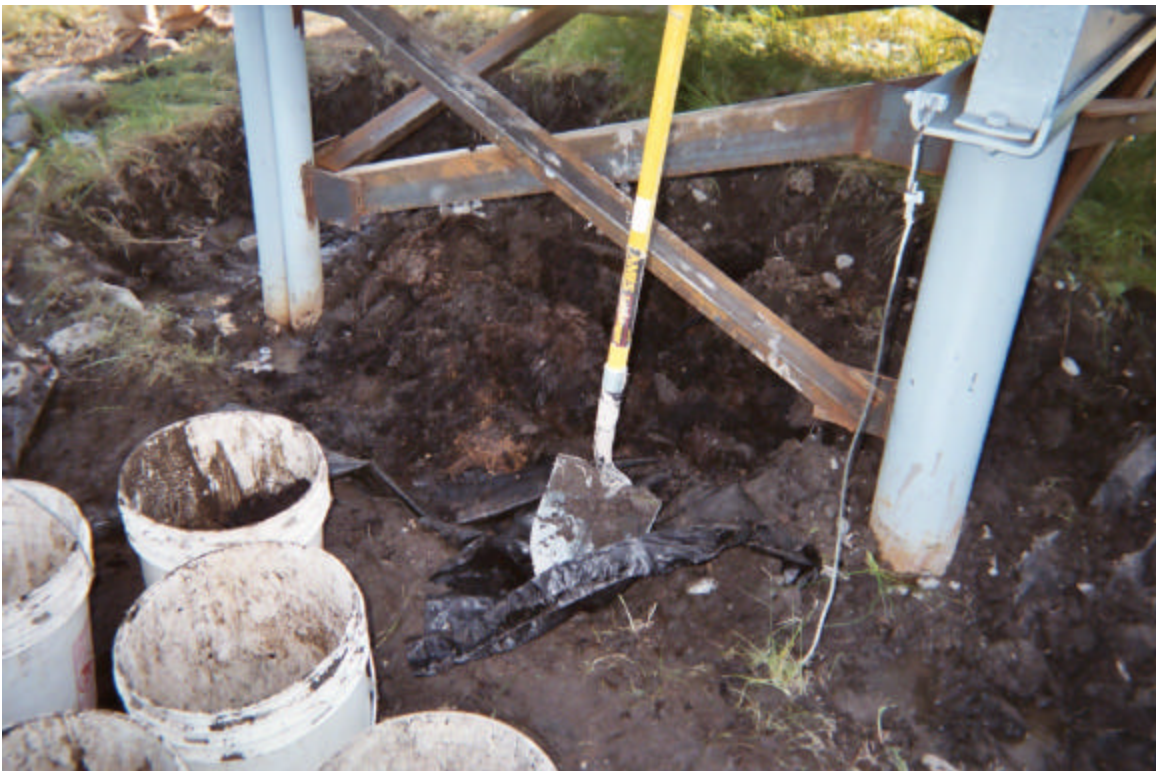
Excavation at Tank 2 center, note contaminated organic matter.

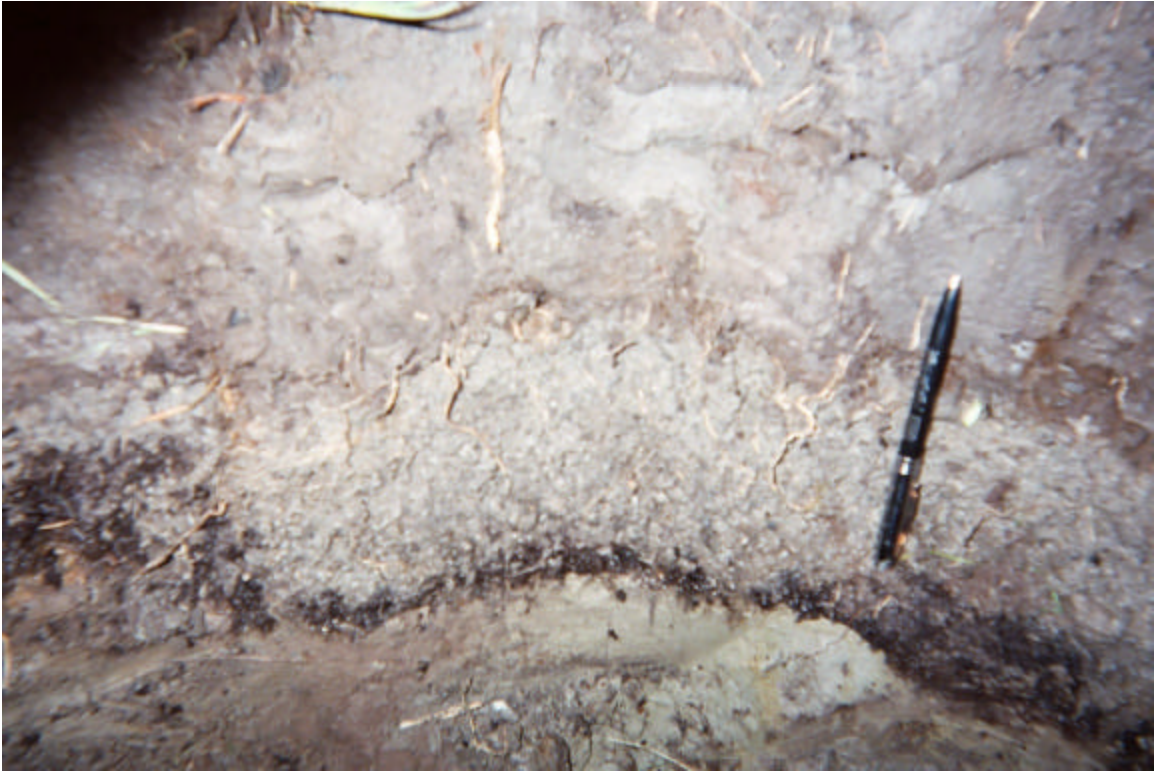
Soil horizons: Peat (high organic matter); presumably imported fill, thin dark organics; clay

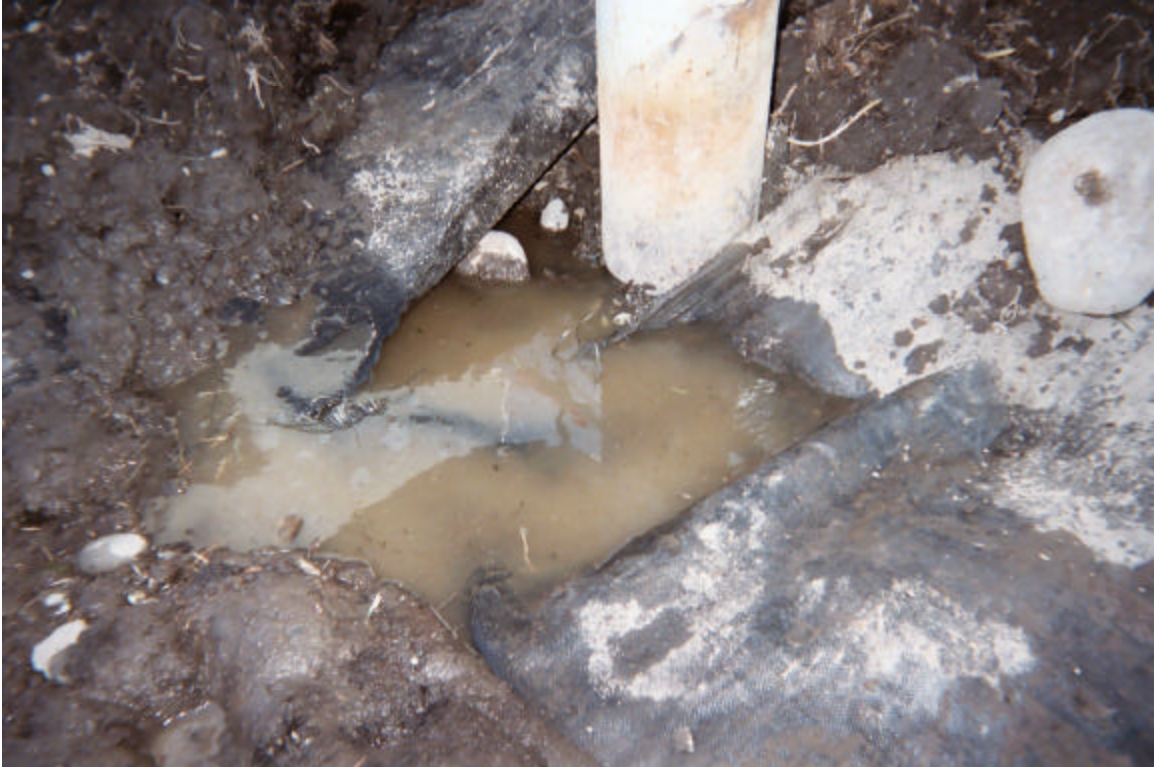
Sheen on water in excavation beneath Tank 1.

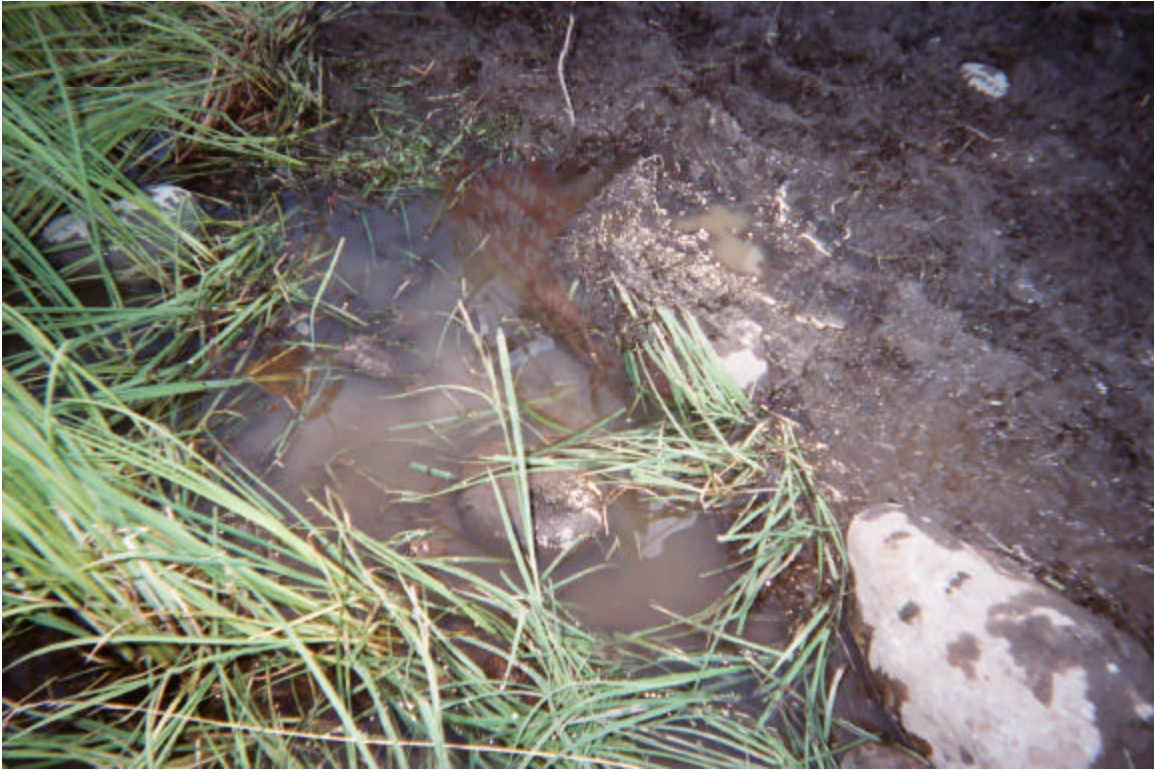
No sheen on surface water adjacent to Tanks.

A tundra pond was present approximately 4 feet to the north of the AST area. In 2004, samples were collected from the surface water and reported DRO concentrations of 0.485 mg/kg and 0.498 mg/kg. In 2005 surface water samples were collected again and the DRO results were all estimated concentrations ranging from 0.224 mg/kg to 0.265 mg/kg. This pond was subsequently de-watered and backfilled as described below.

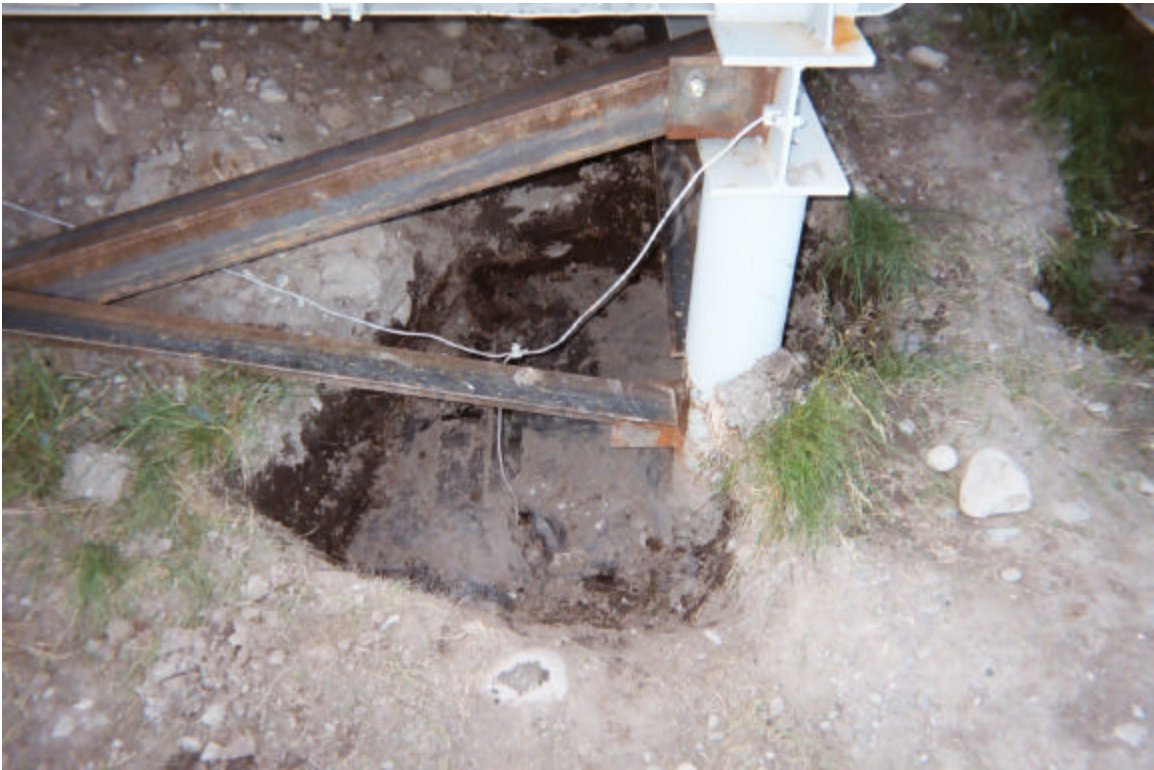
Final excavation at generator module.

Approximately 3 cubic yards of D-1 and native tundra material were used to backfill the excavation beneath the generator module in 2004

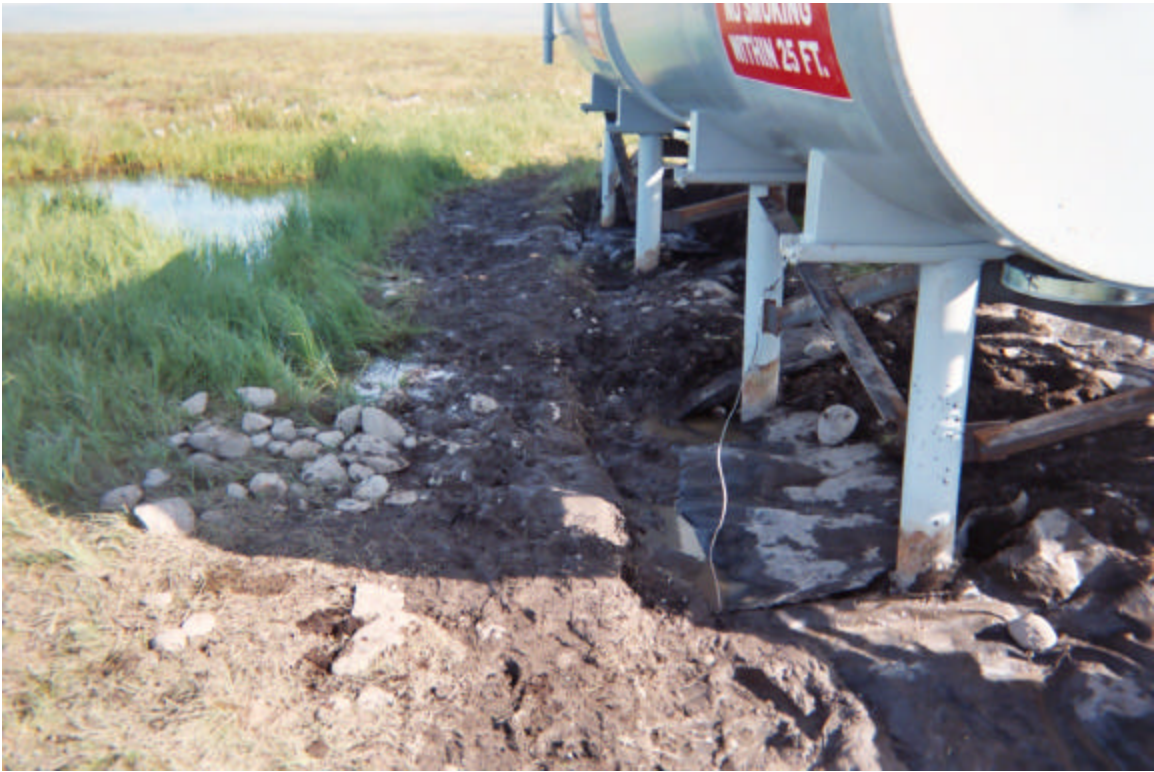
Excavation at Tank 1 and Tank 2; note distance to adjacent surface water.

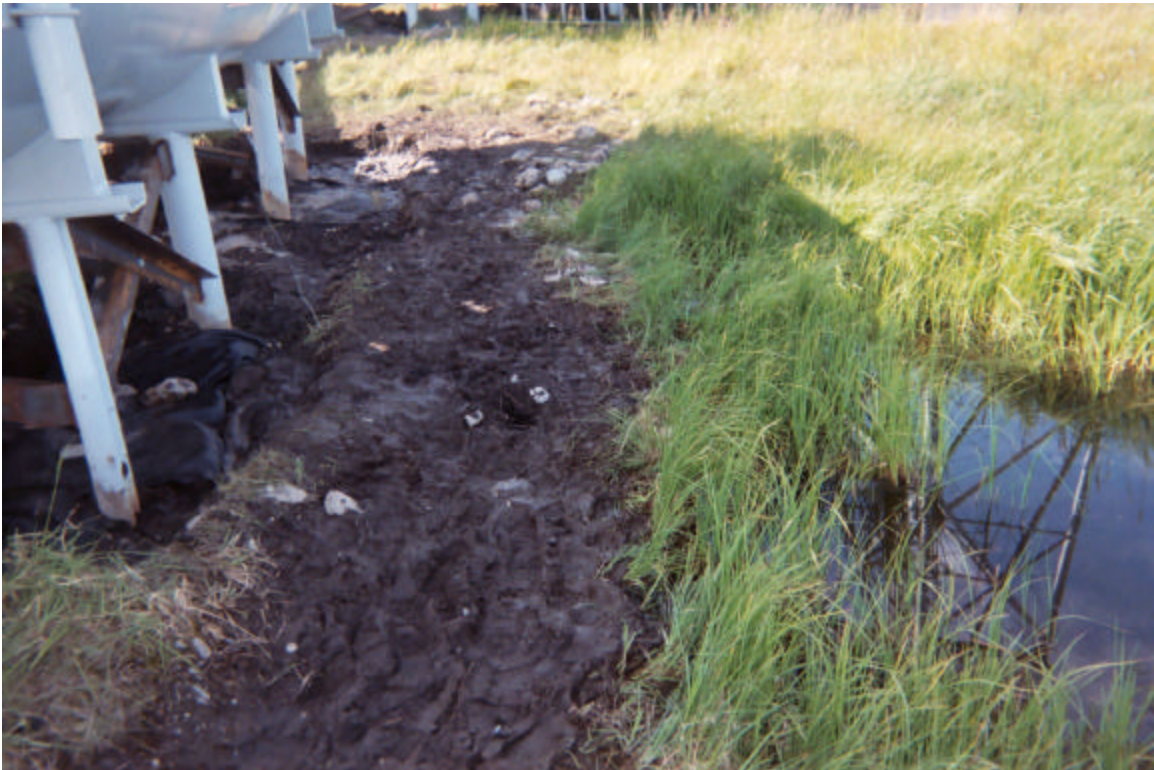
View between tank and water; looking west.

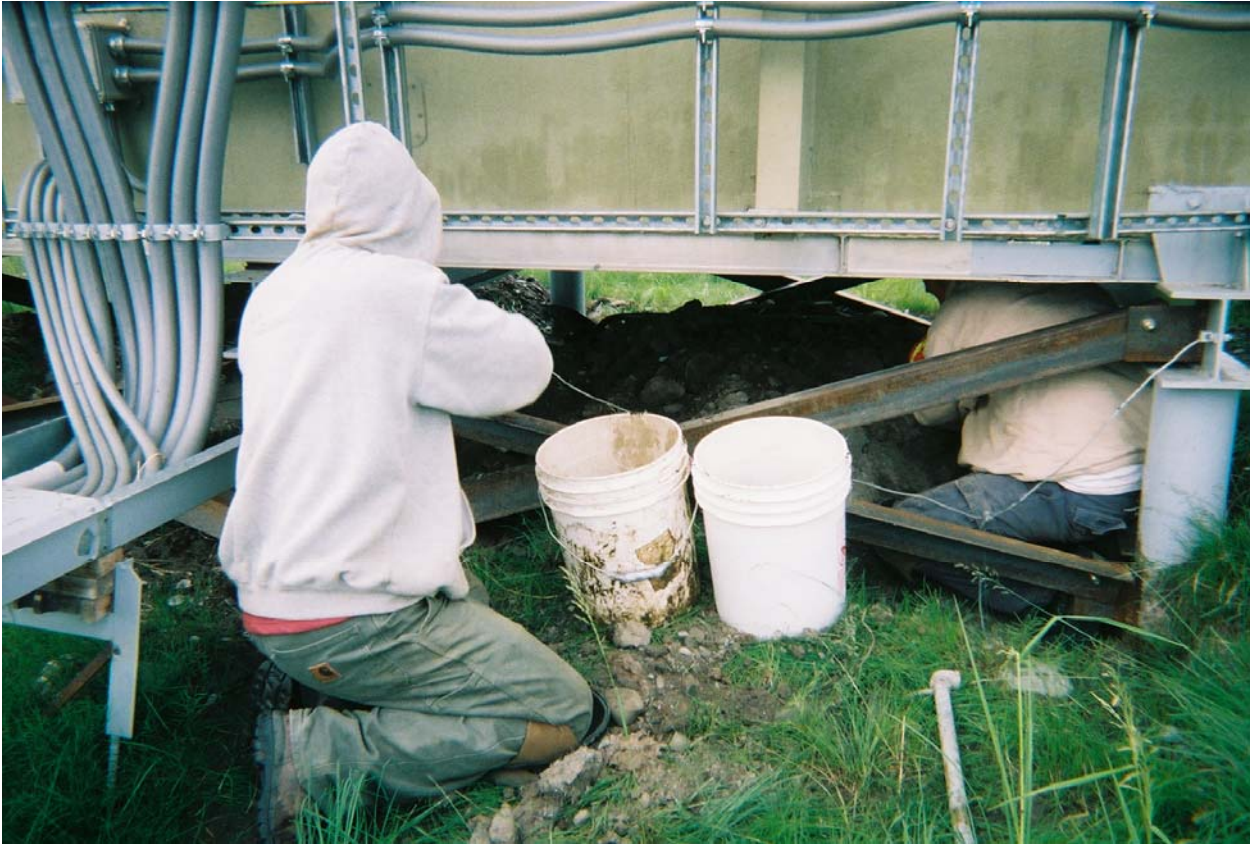
Generator module excavation in progress. Looking west.

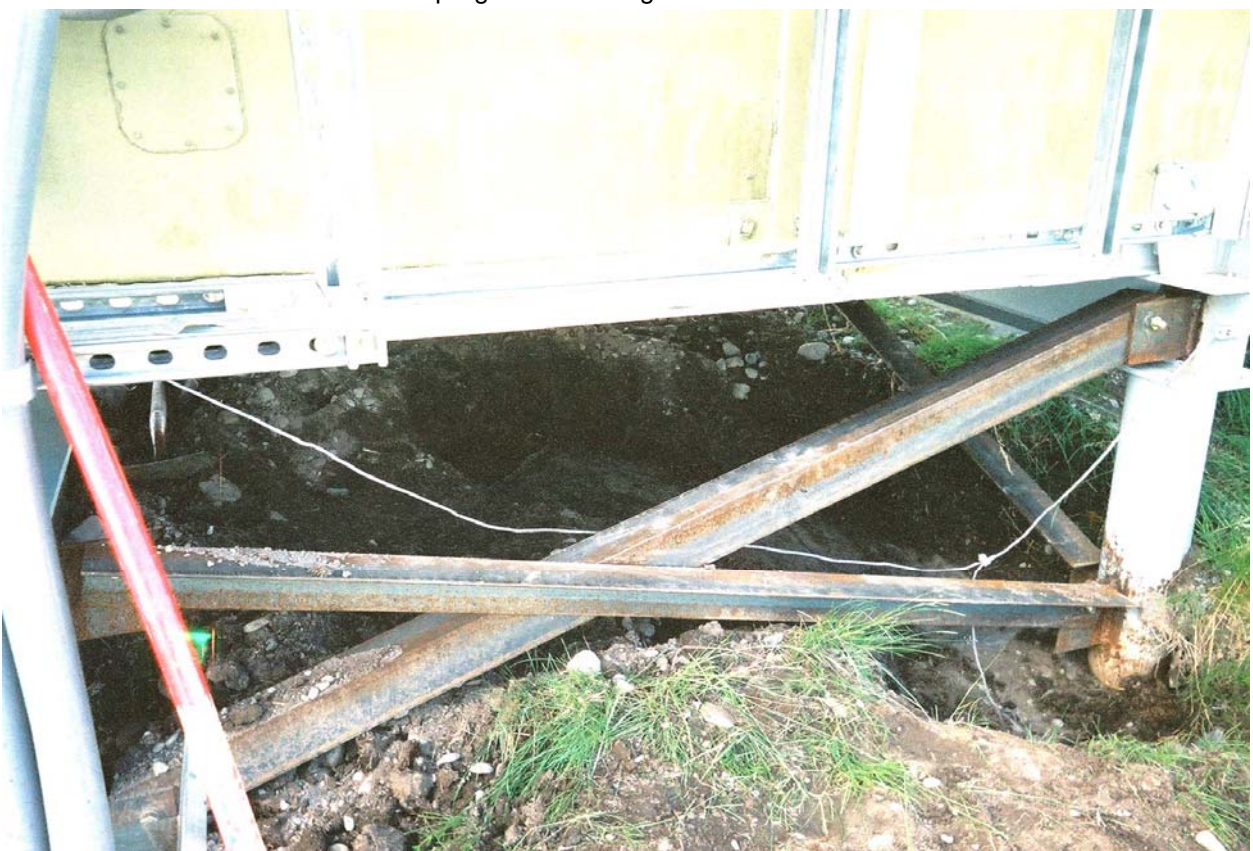
Completed excavation beneath generator module, note liner at base of excavation. Looking west.

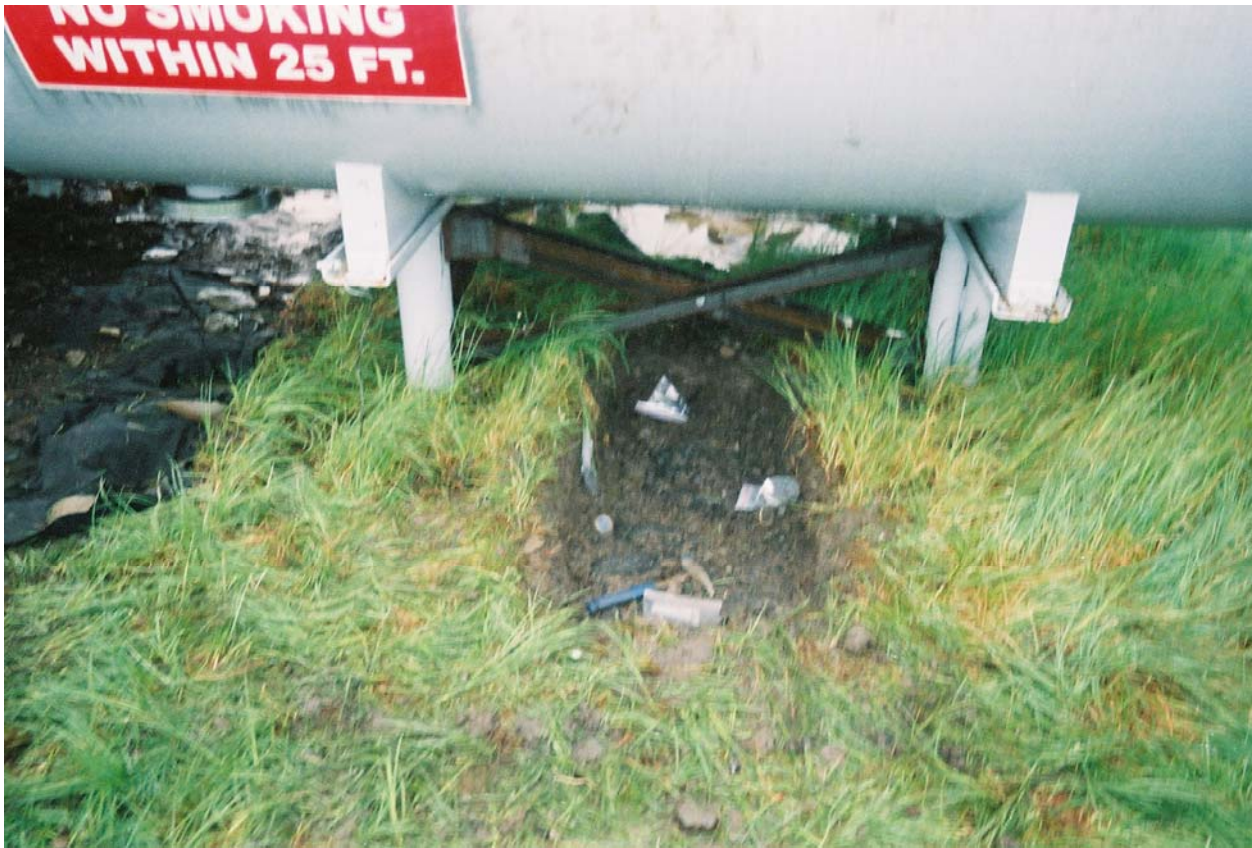
Early stages of excavation beneath AST 3. Looking north.

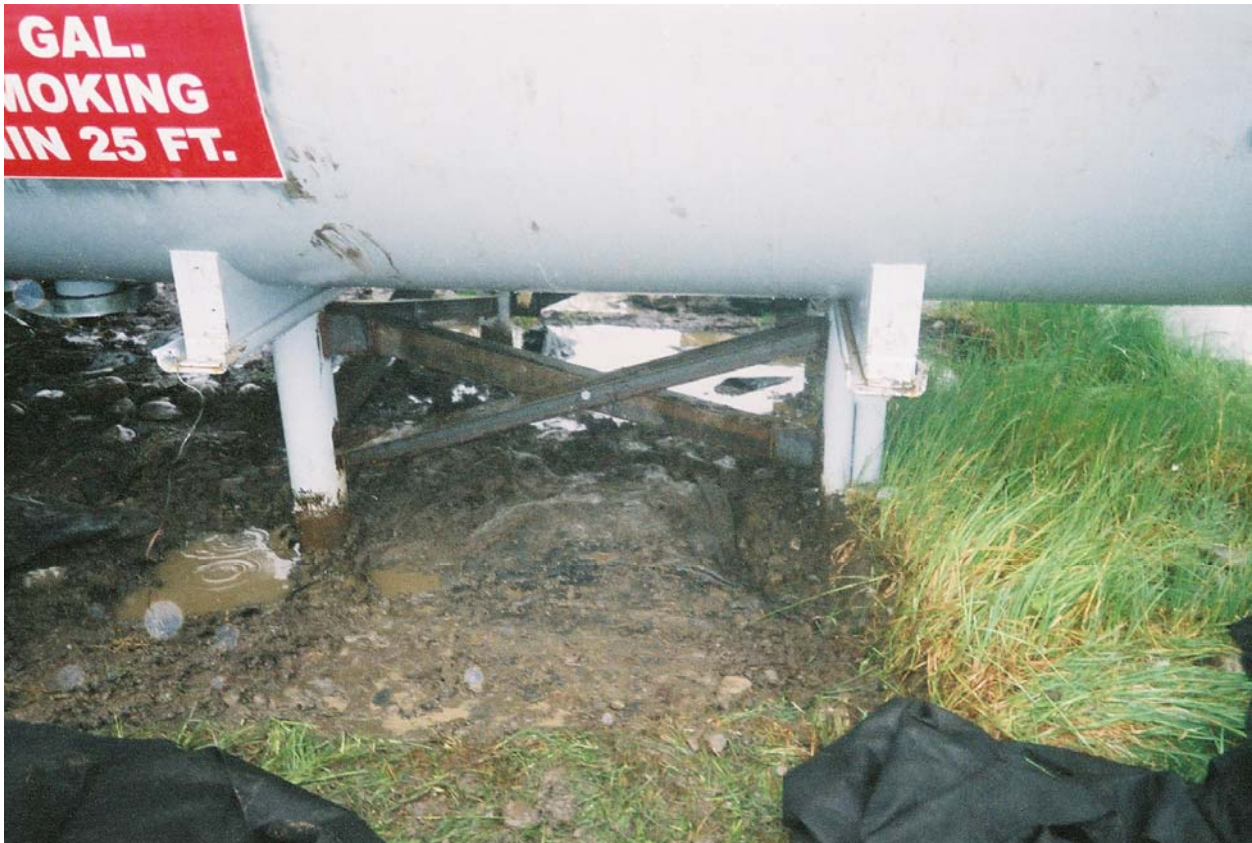
Finished excavation beneath AST 3, note liner at depth of excavation. Looking north.

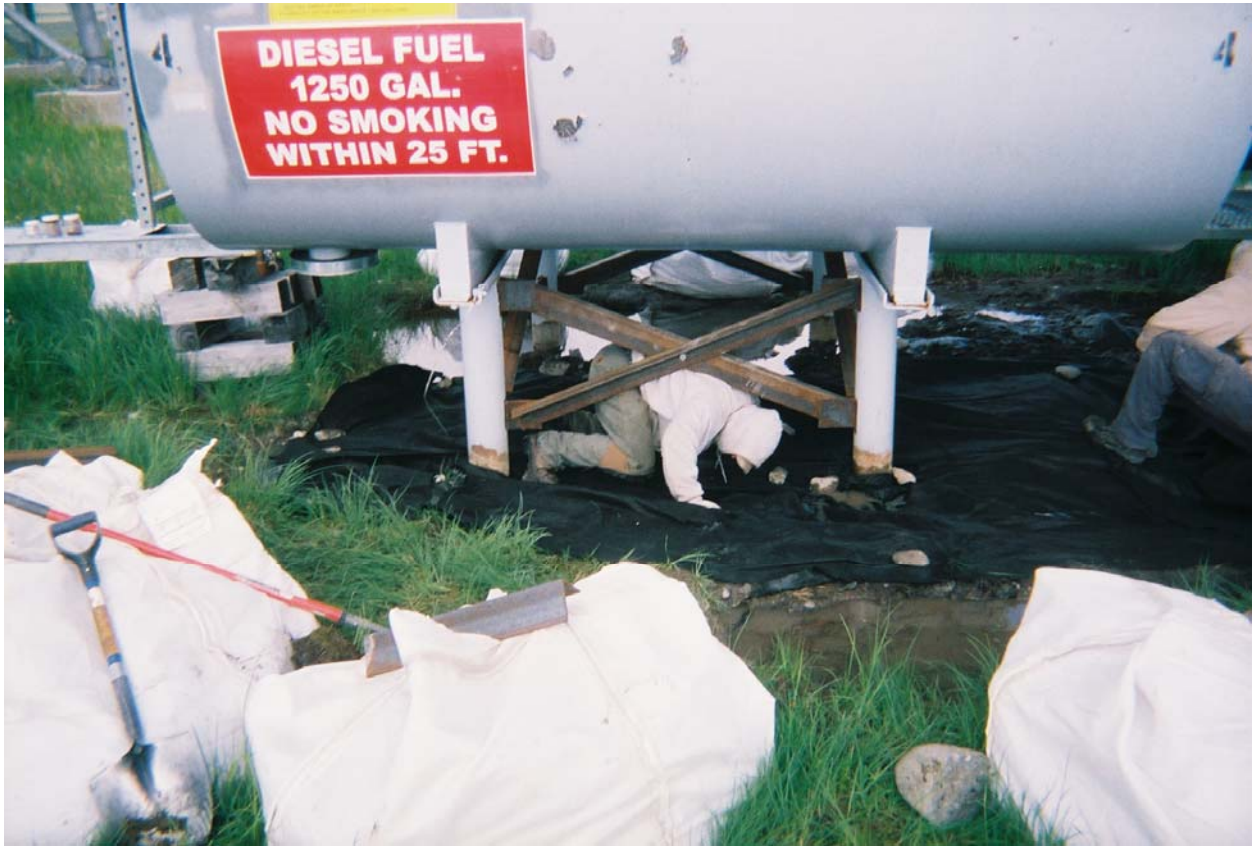
Installing geofabric liner beneath AST 4 and AST 1. Looking north.

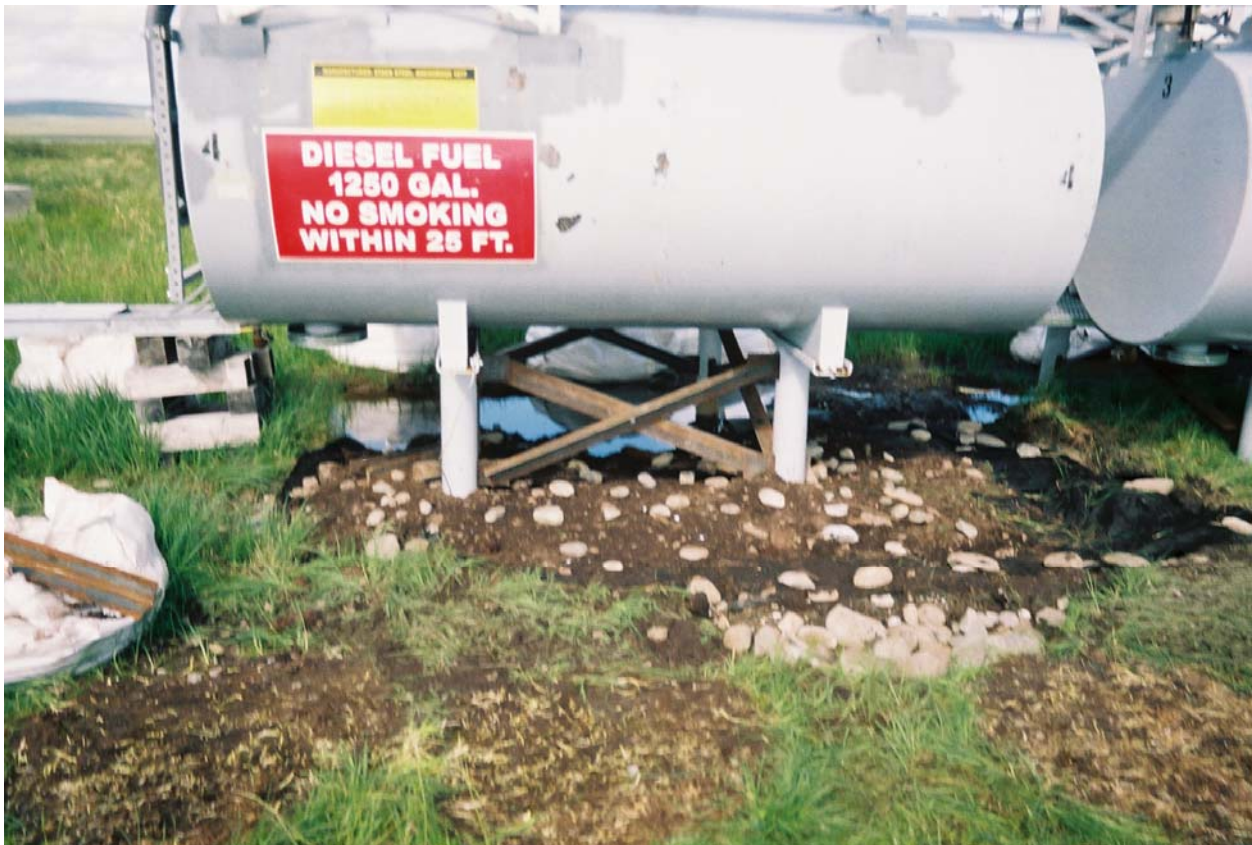
Initial layer of native fill material applied at AST 4. Looking north.

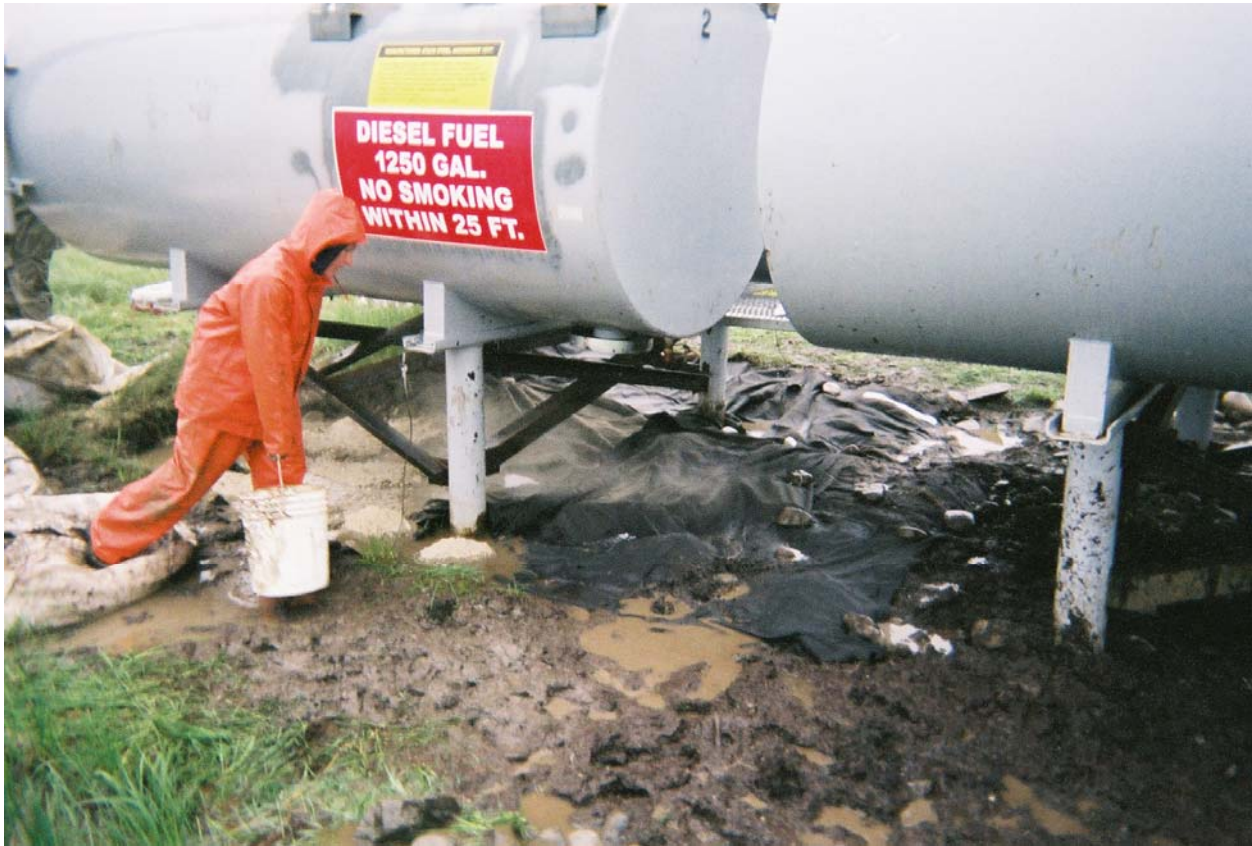
Geofabric liner beneath ASTs 2 and 3, ready for base layer of D-1 fill. Looking southeast.

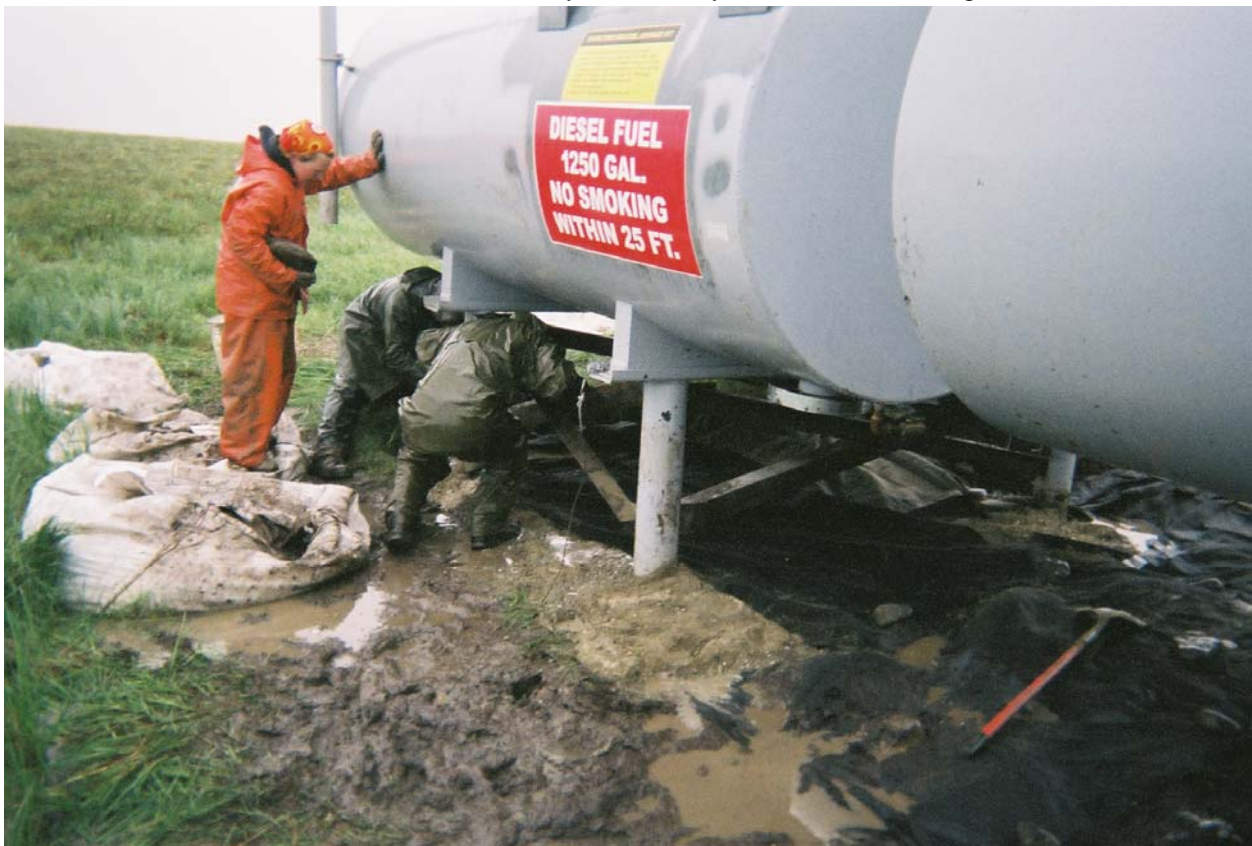
Applying geofabric liner on top of D-1 fill, preparing to complete backfill with native material. Looking southeast.

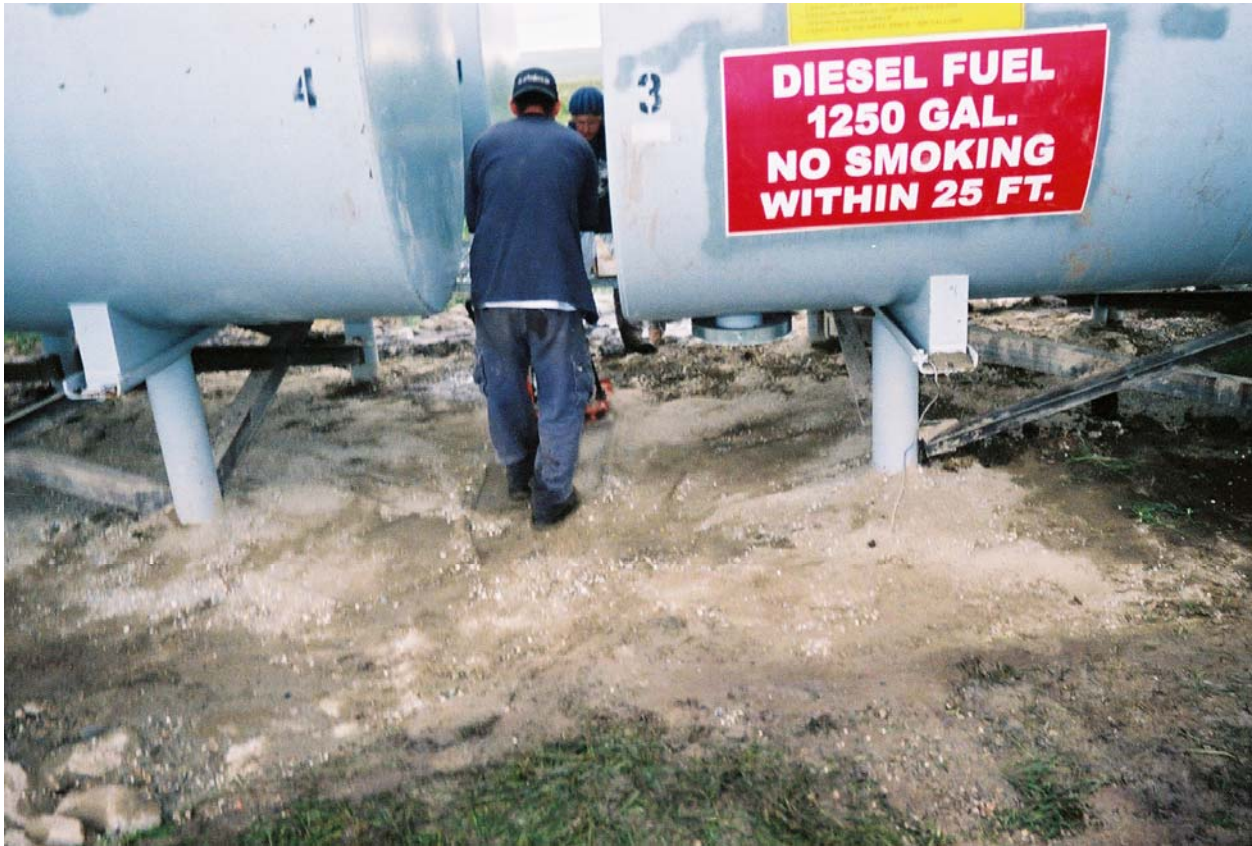
Compacting fill between AST's 3 and 4. Looking north.
