Subject: Costa Hill Repeater Closure Report**ENSR Project Number 00550-341**

ENSR Corporation (ENSR) is pleased to submit this report on behalf of Mr. Larry Bamberger, AT&T Environmental, Health, and Safety Operations Manager, in support of a Conditional Closure determination for the Costa Hill Repeater. The following report presents the results of site assessment and remediation work conducted by ENSR at the Costa Hill Repeater and summarizes all field activities performed at the site, including a review of sampling results, data quality, and site management recommendations. This report is being submitted as a supplement to the Conditional Closure Report submitted to the Alaska Department of Environmental Conservation (ADEC) in April 2007 (finalized August 2007).¹

The programmatic elements and risk evaluation for Costa Hill were derived from the April 2007 report.¹ Figures illustrating the site location, facility layout, sampling locations, and field and analytical results are provided in Attachment 1. Laboratory analytical results from 2003 to the 2007 are provided in tables in Attachment 2. Site photos for each field visit are provided in Attachment 3. These attachments provid

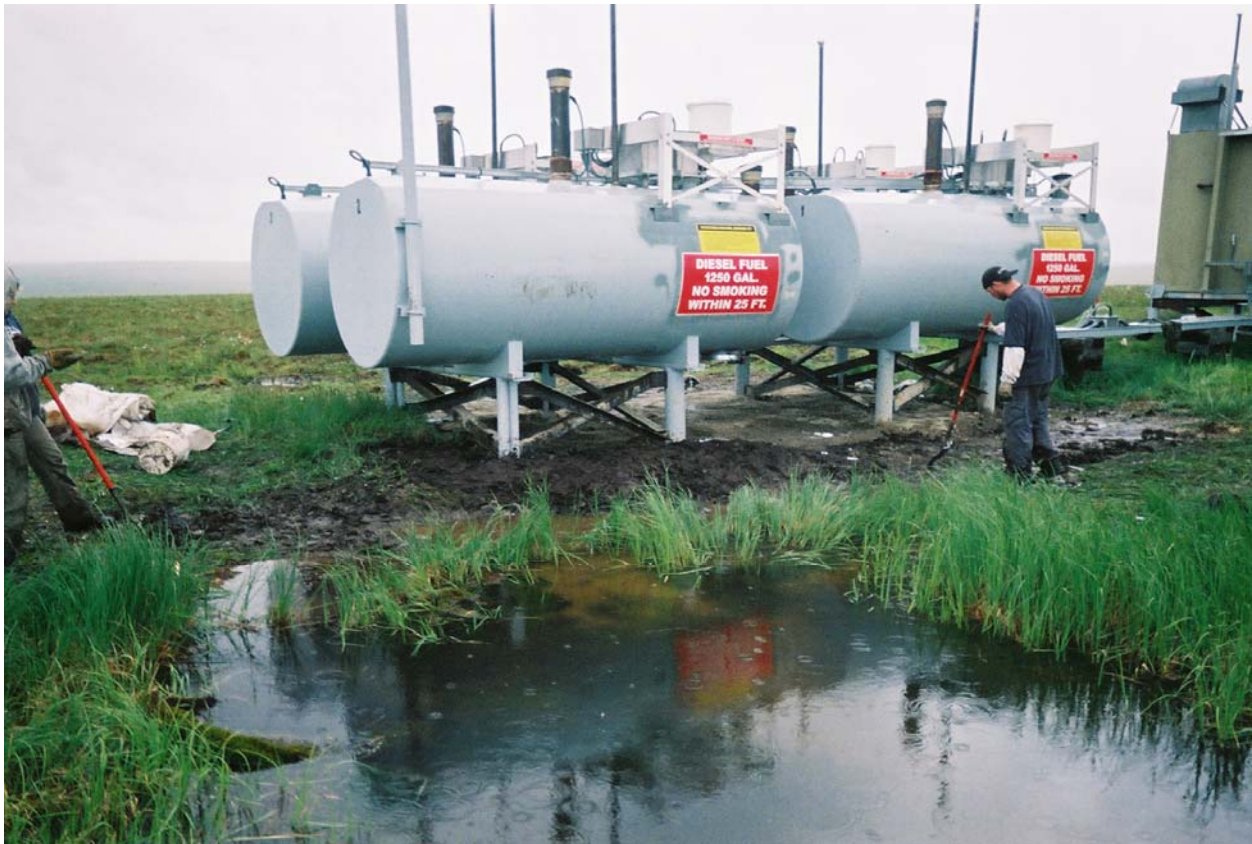
Completed backfill at ASTs with dike of native material between AST 1 and surface water. Looking southwest.

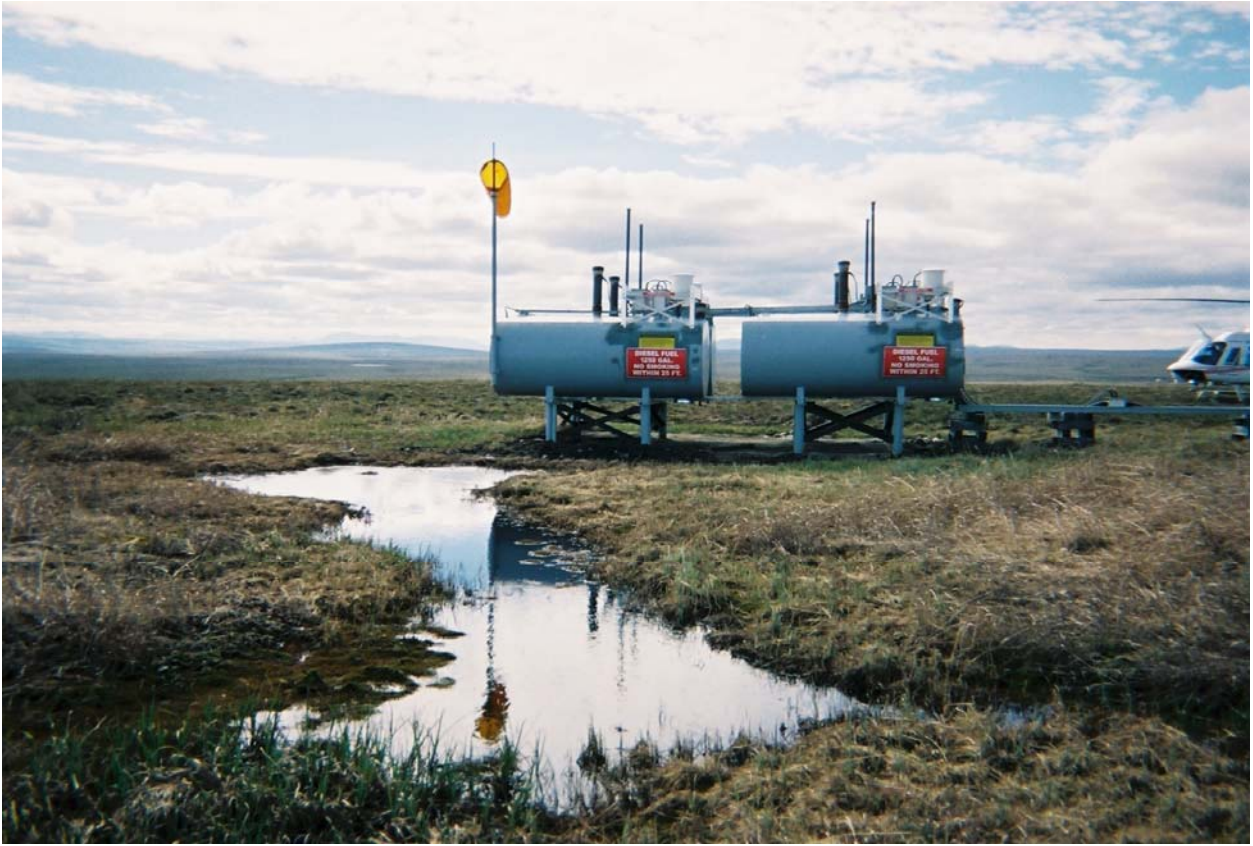
Surface Water pond on the north side of the tanks looking south.

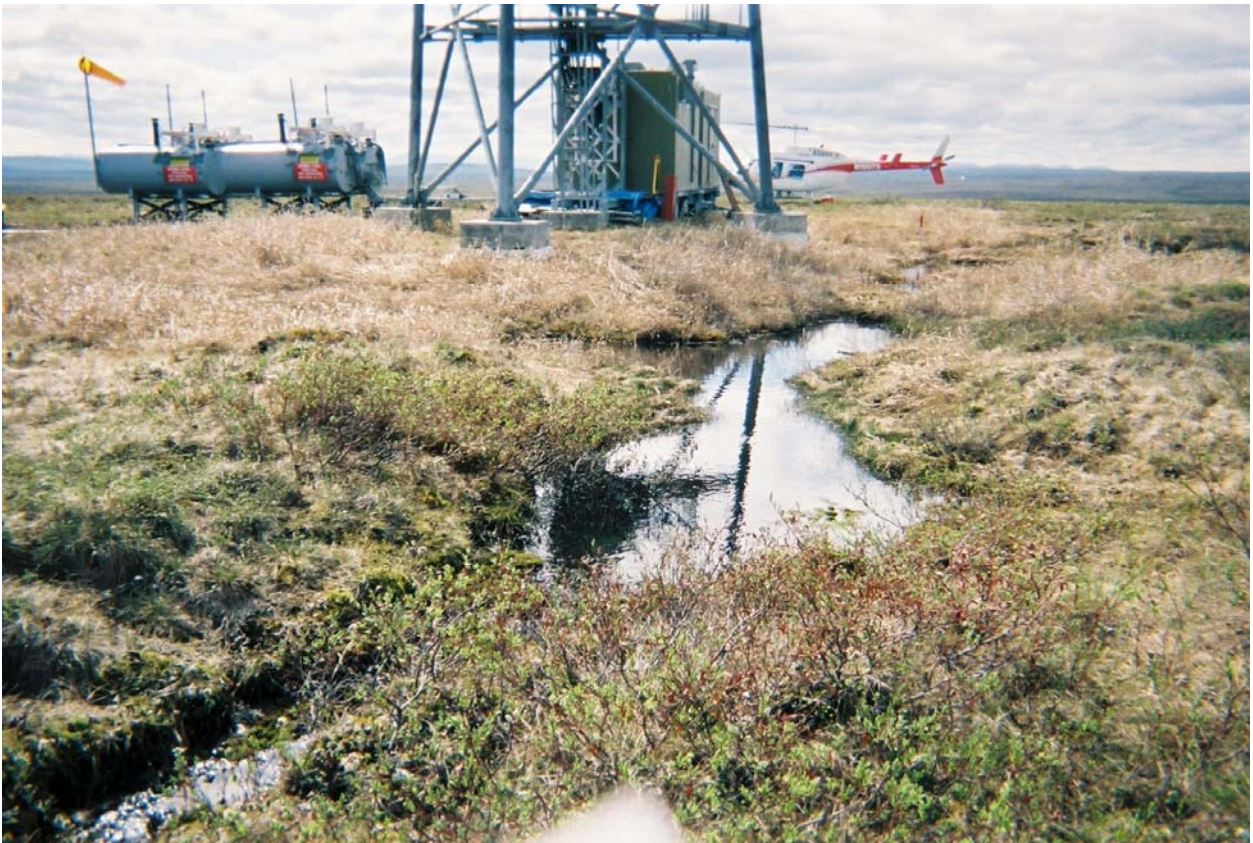
Surface Water pond north of the Communication Tower looking south.

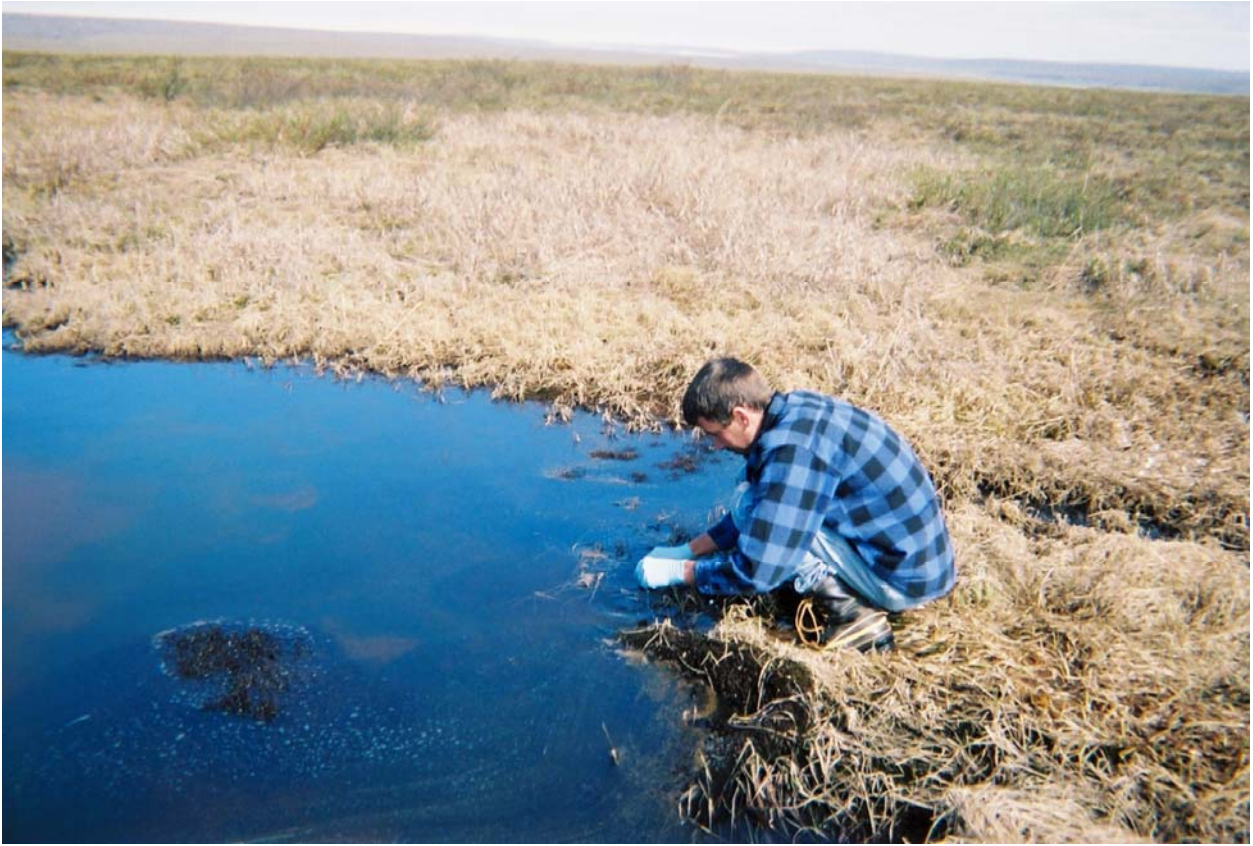
Sampling at SW01 looking north.

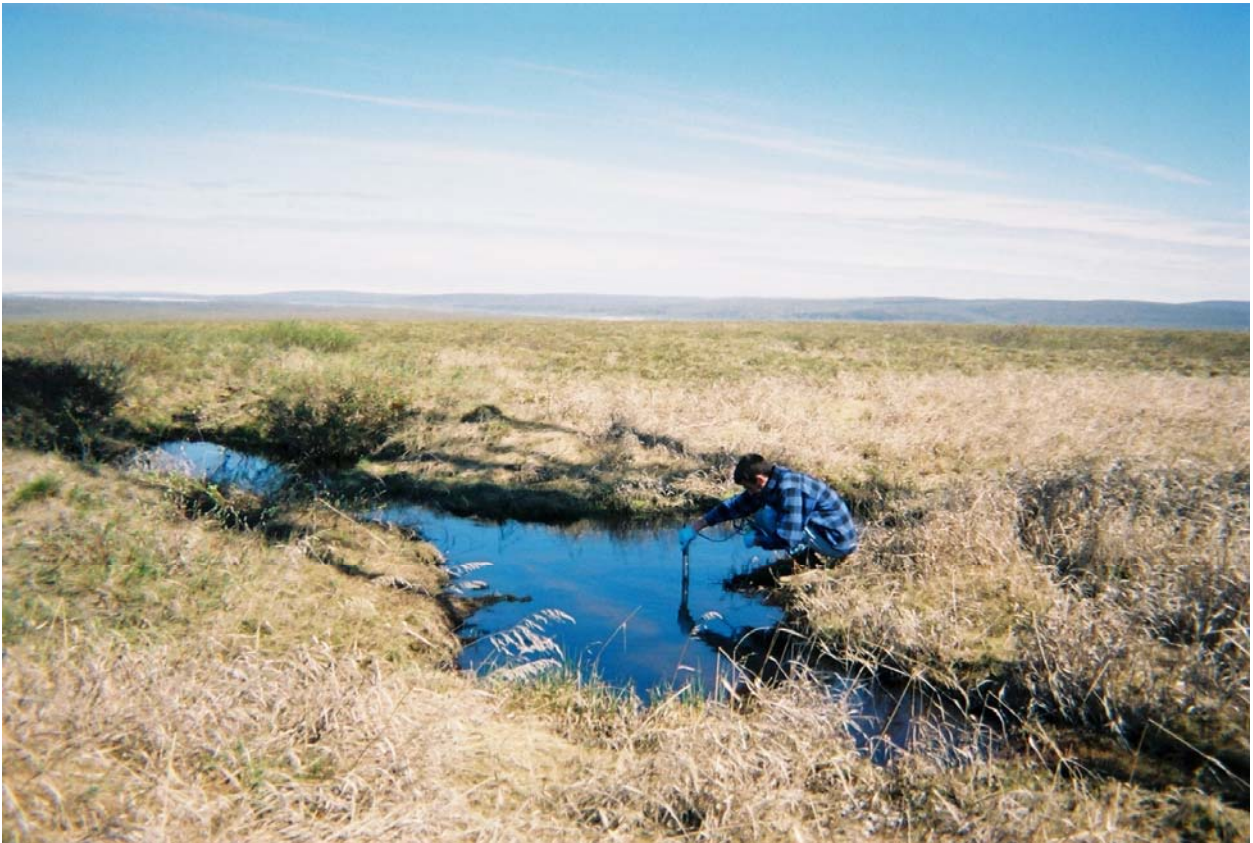
Collecting water quality measurements at SW03 looking north.

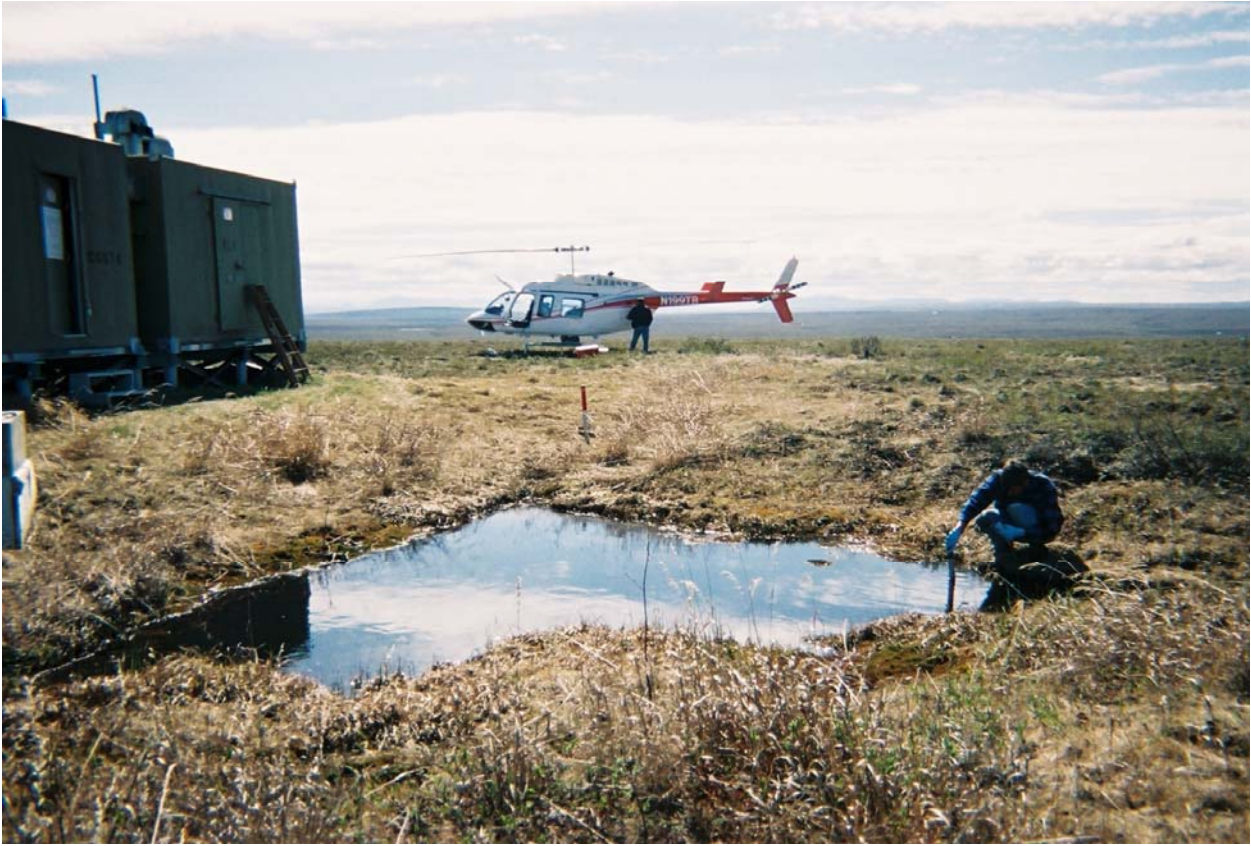
Collecting water quality measurements at SW05 looking south.

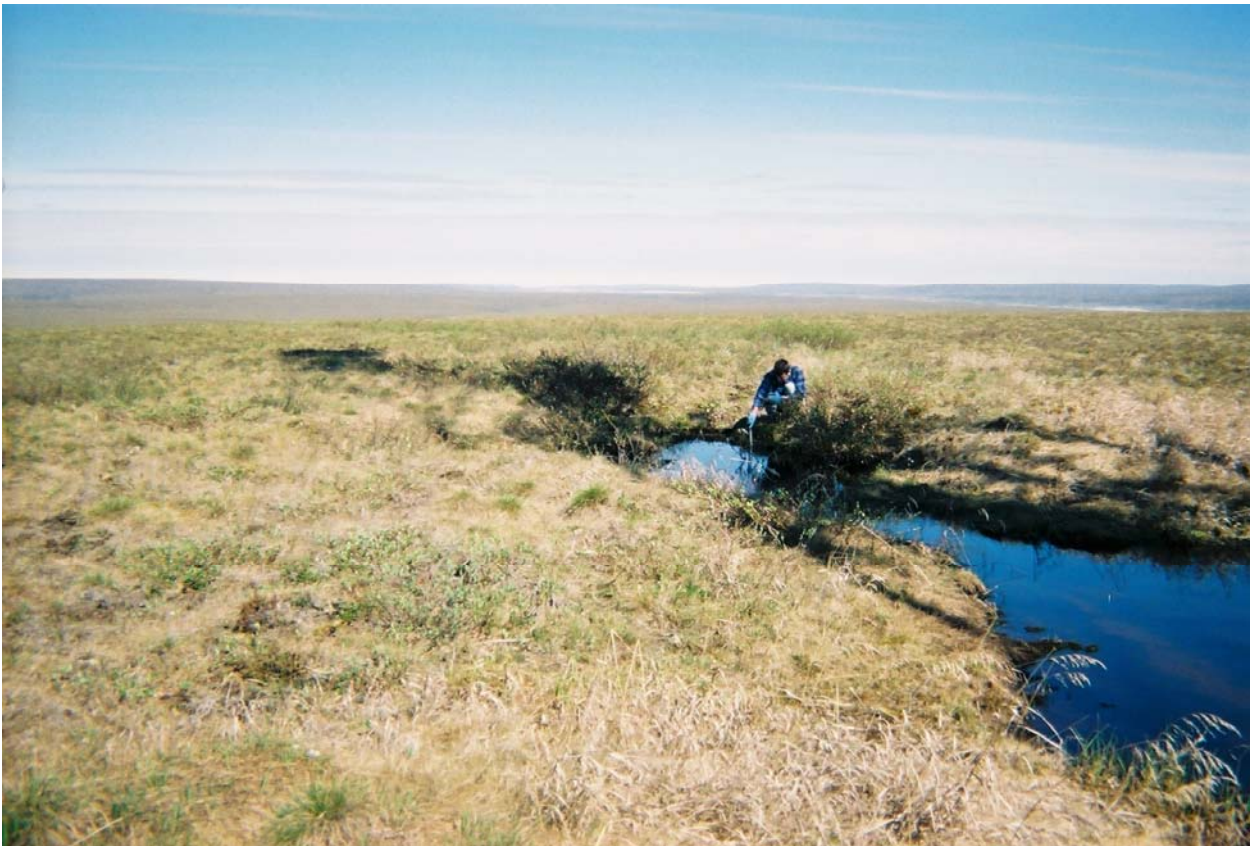
Collecting water quality measurements at SW04 looking north.

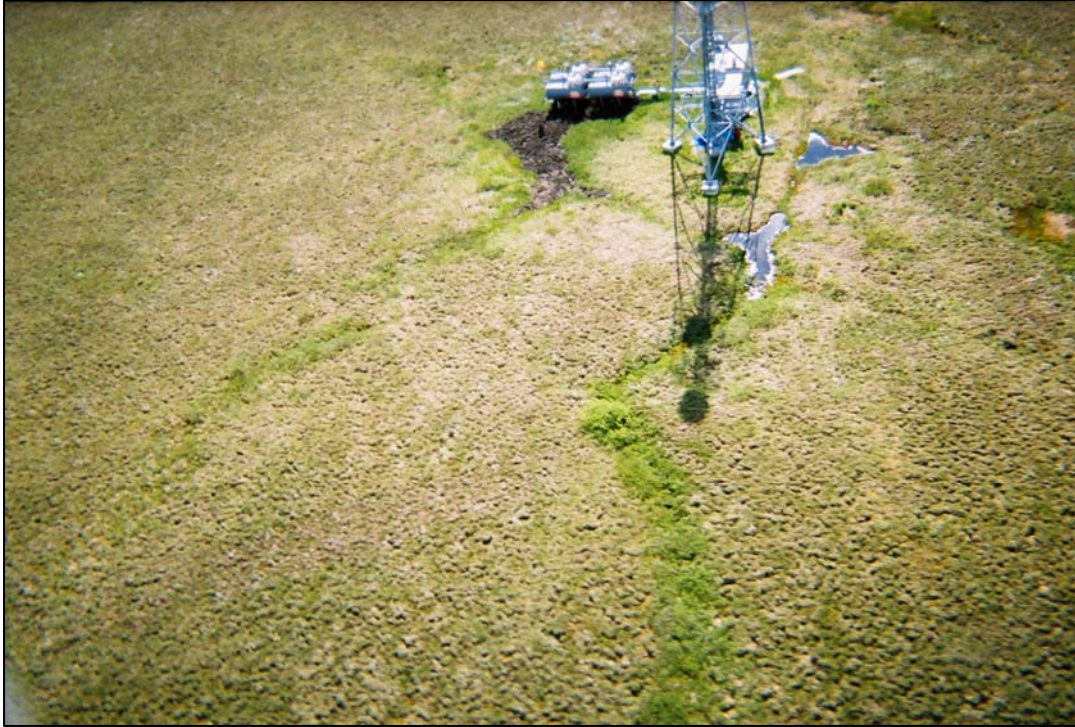
Costa Hill Repeater prior to dewatering activities looking south.

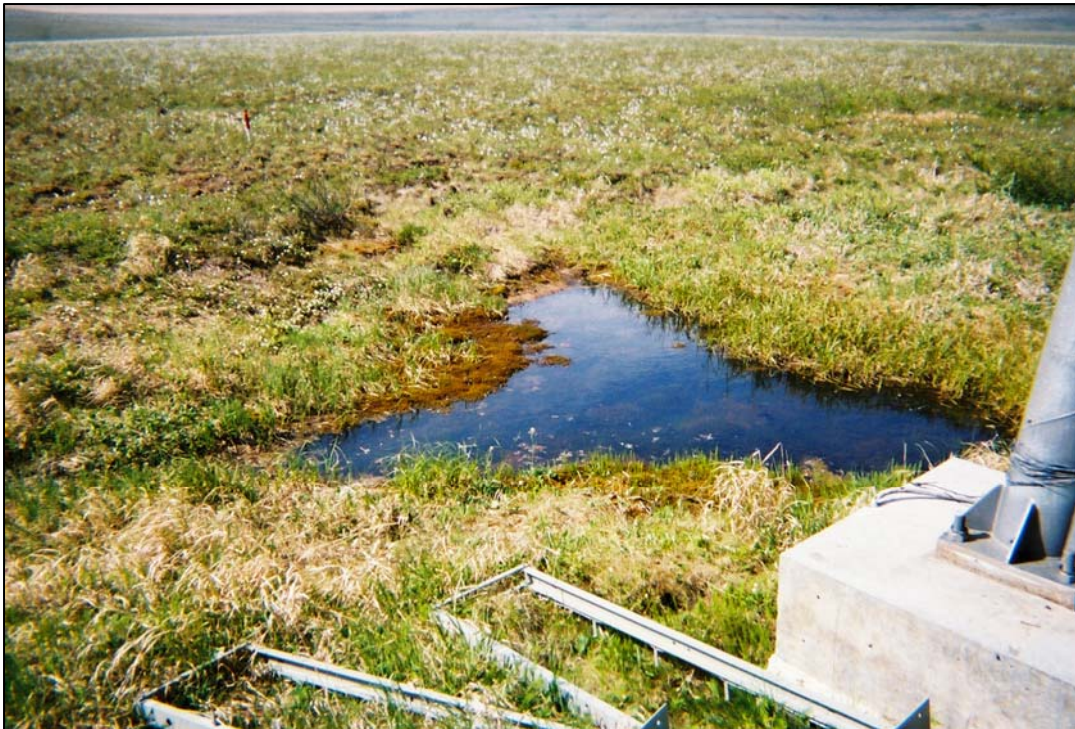
Tundra pond to the west of the tower leg prior to dewatering activities looking northwest.

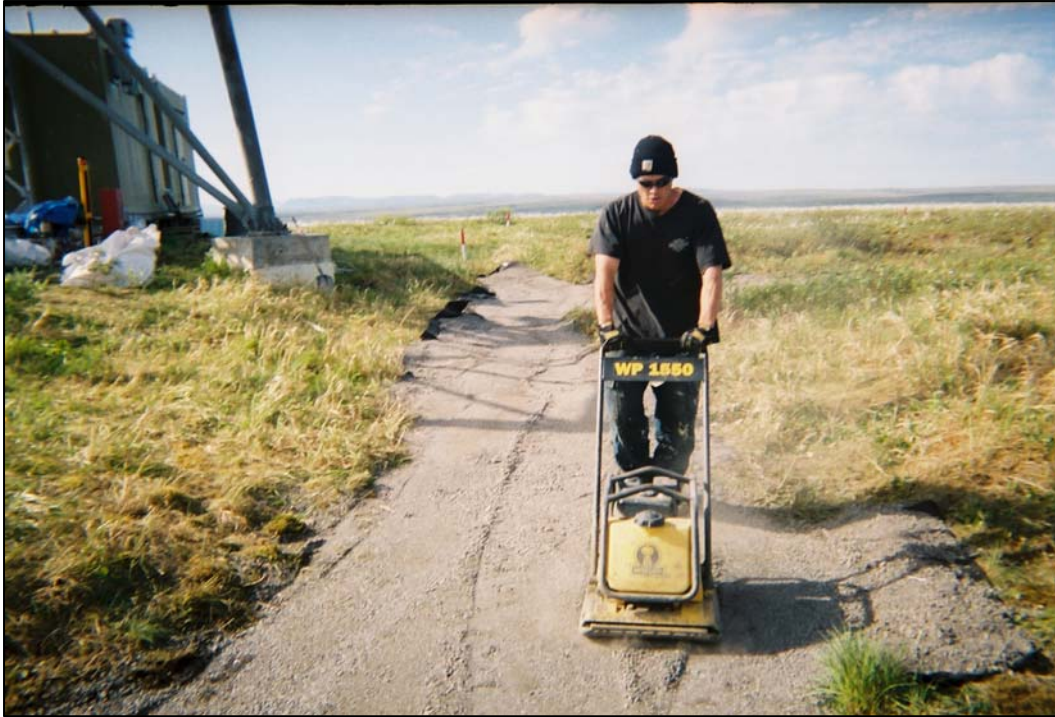
D-1 gravel in place and compacted in the area north west of the tower..

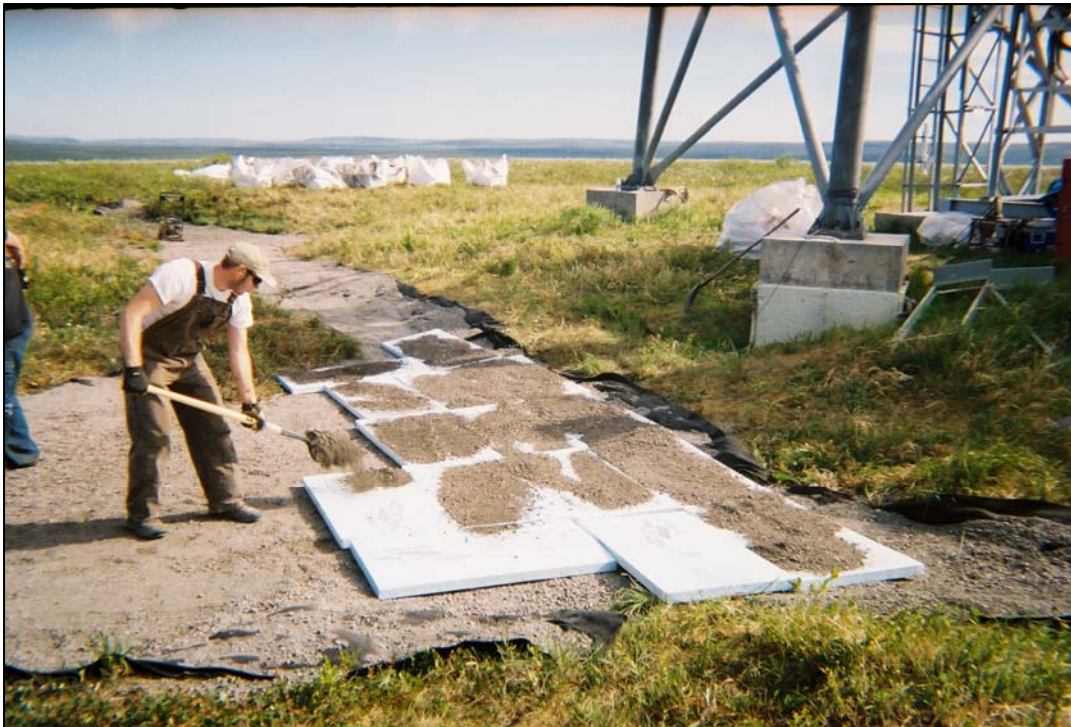
Polystyrene blue board insulation placed on top of the D-1 gravel to provide additional thermal insulation.

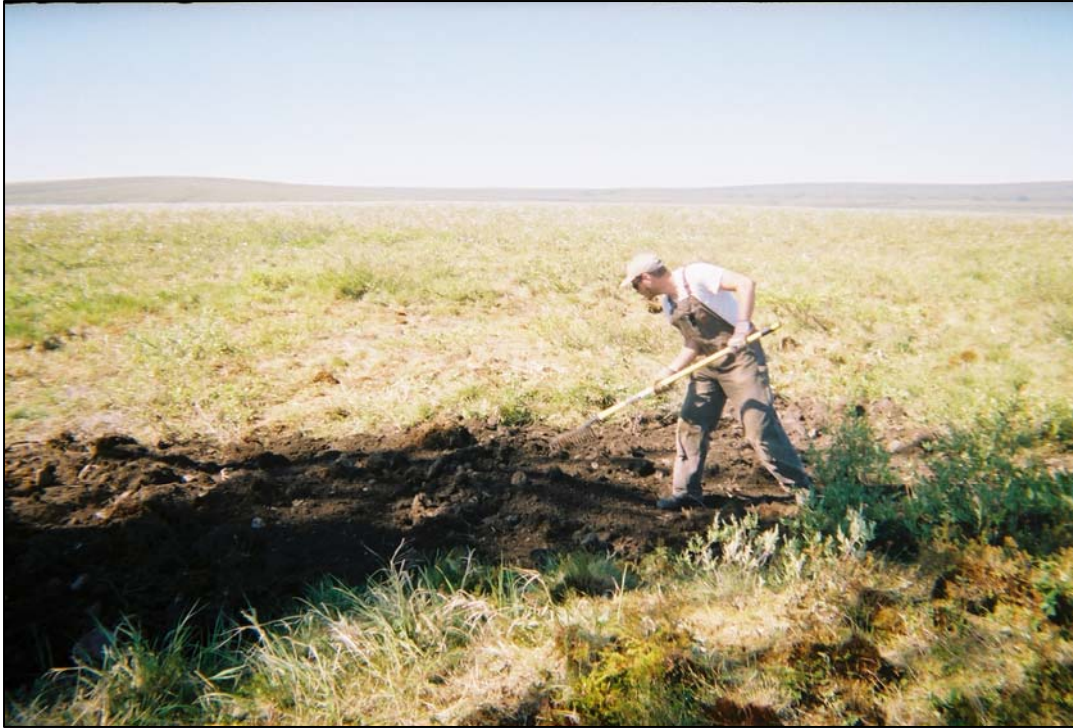
Spreading tundra material in the northern extent of the depression looking west.

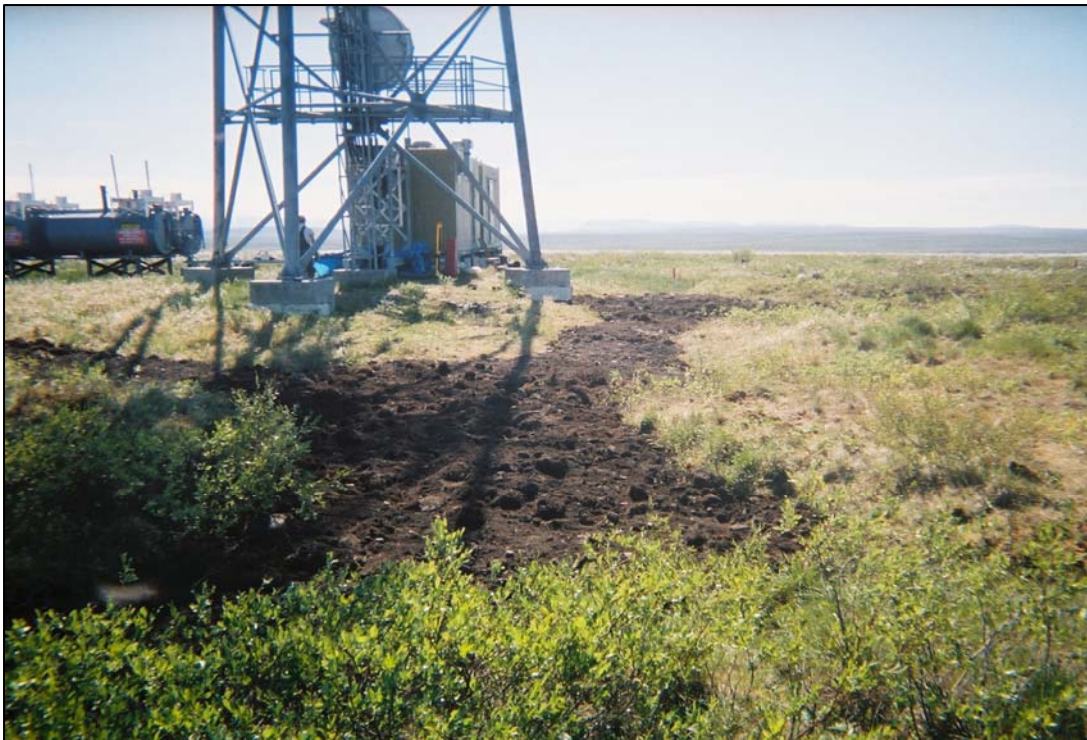
Tundra material backfill complete in the depression looking south.

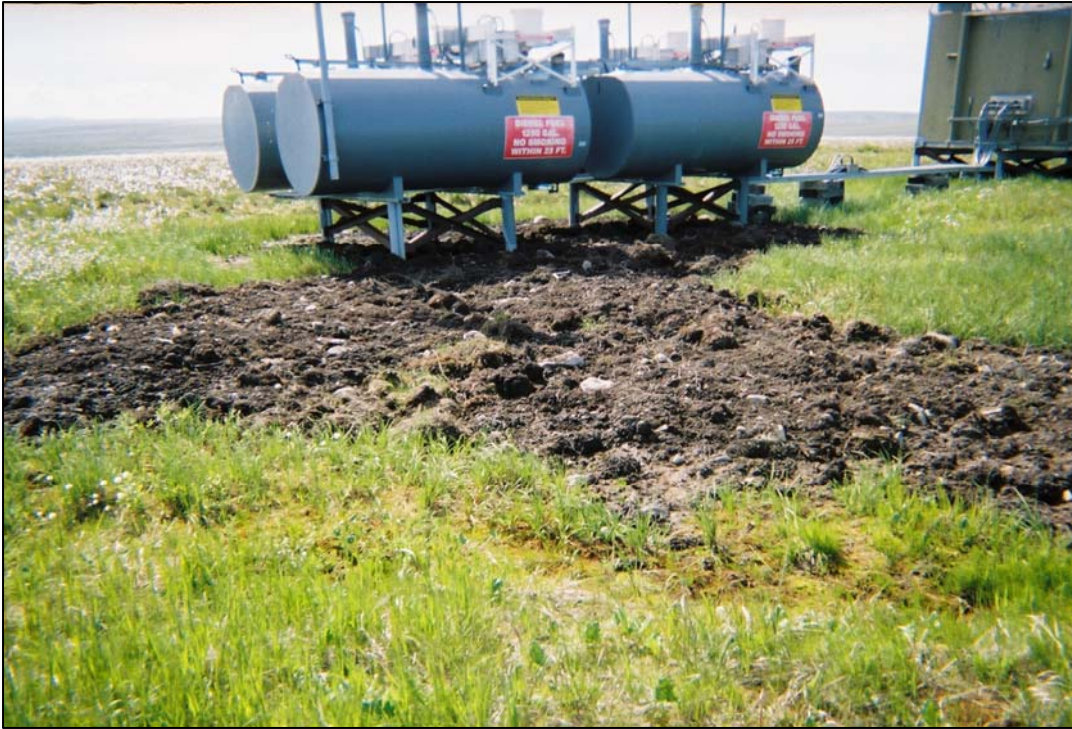
Tundra material fill from 2006 field season with re-vegetation in progress looking south.

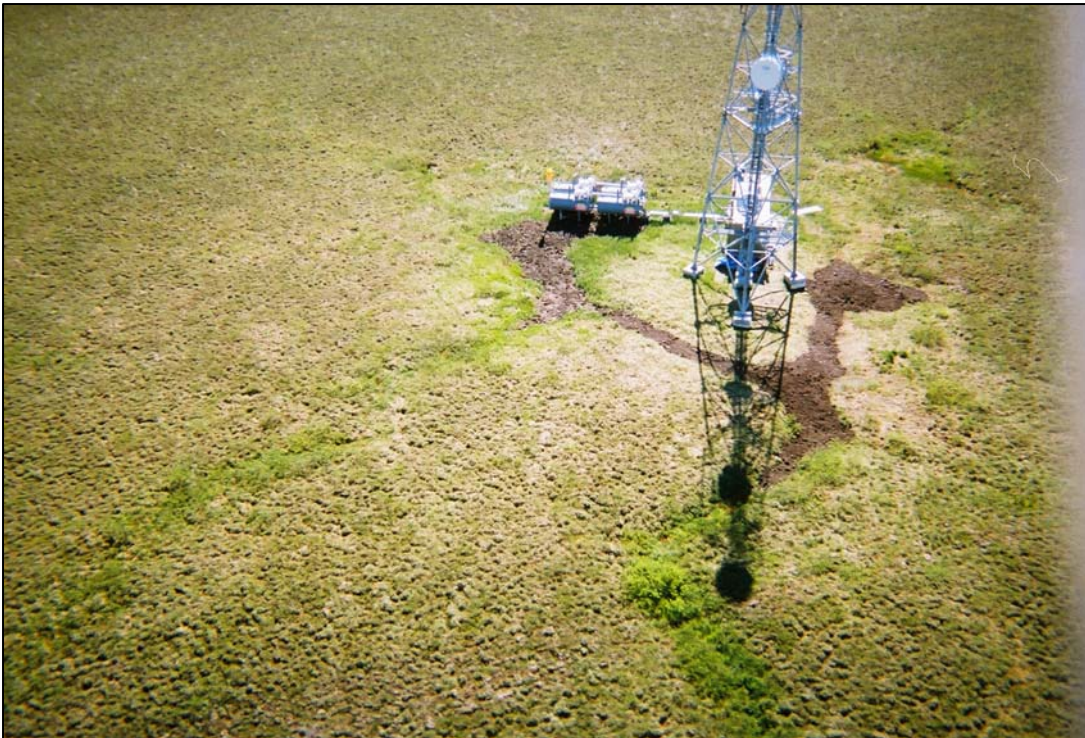
Aerial view of Costa Hill Repeater site after all dewatering and backfill activities complete.

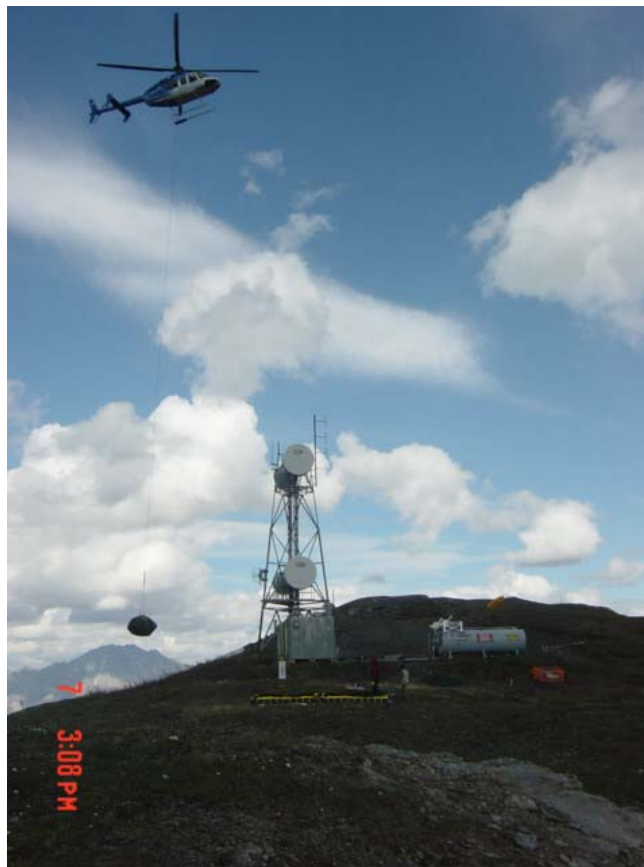
Fuel bladder sling load to portable secondary containment system on ground at repeater site.

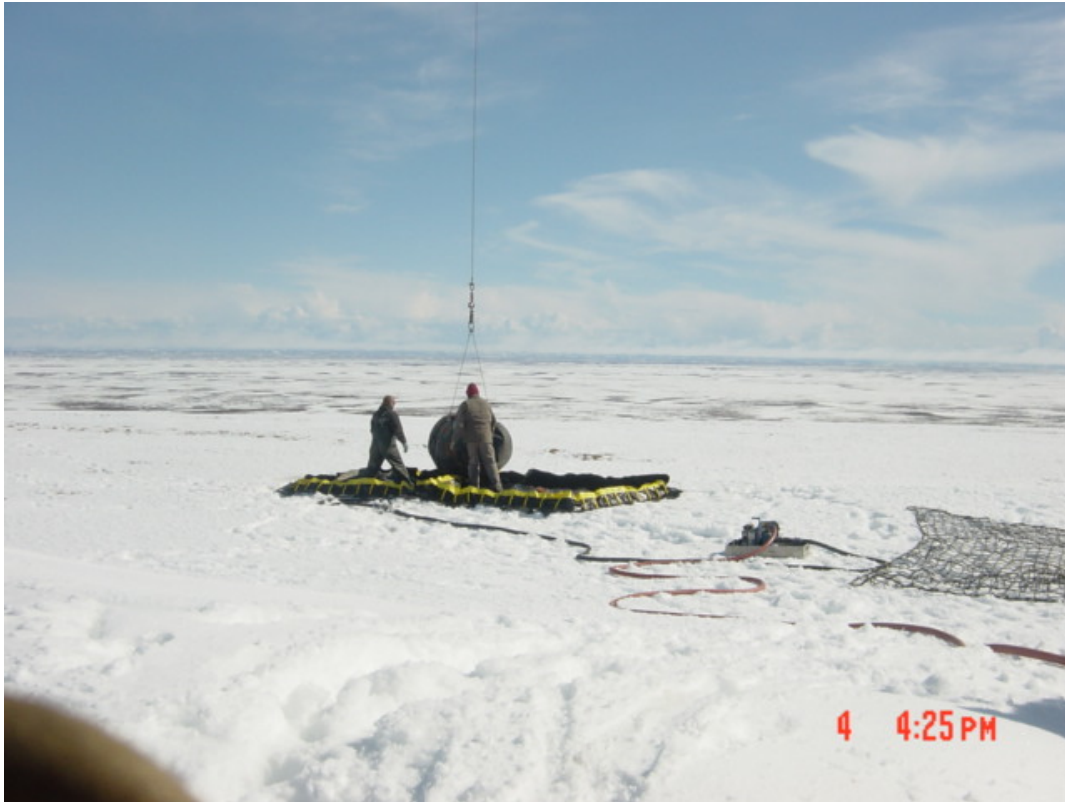
Landing fuel bladder within portable secondary containment system.

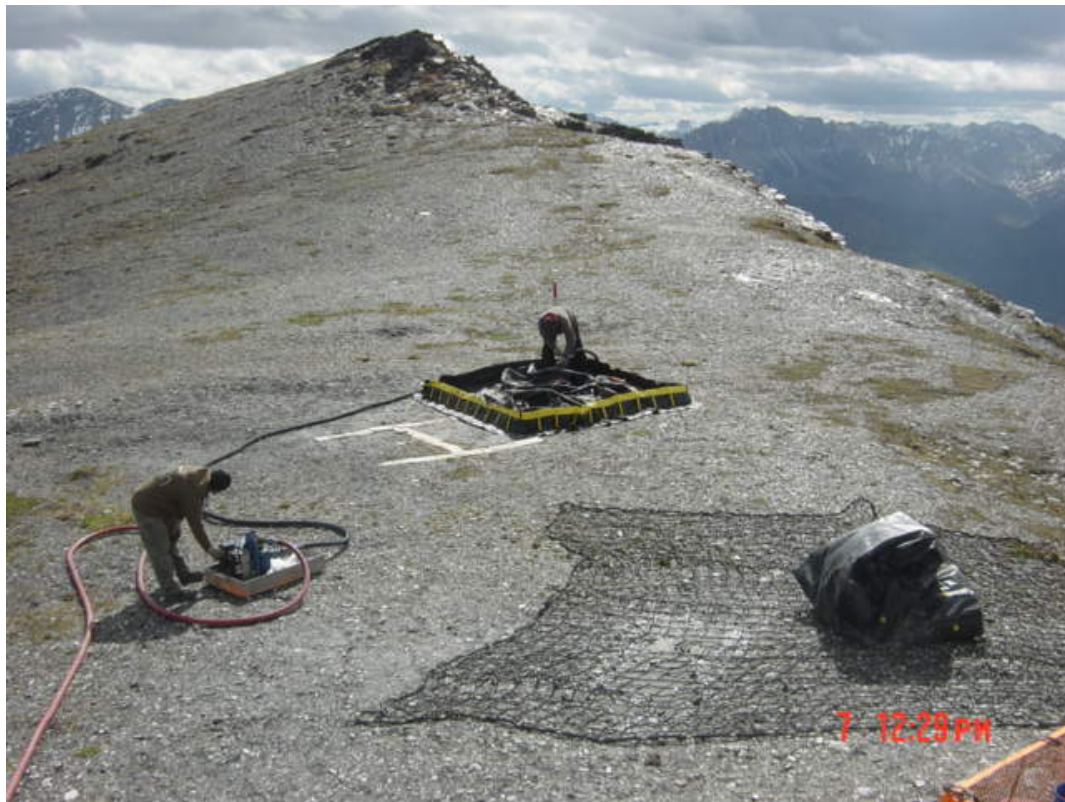
Pump fuel from bladder in secondary containment via modular portable pump with secondary containment.
