Corrective Plan of Action

Underground Storage Tank
Closure Assessment
Willow Creek Mine
Hatcher Pass Road
Palmer, Alaska

UNDERGROUND STORAGE TANK CLOSURE ASSESSMENT WILLOW CREEK MINE HATCHER PASS ROAD PALMER, ALASKA

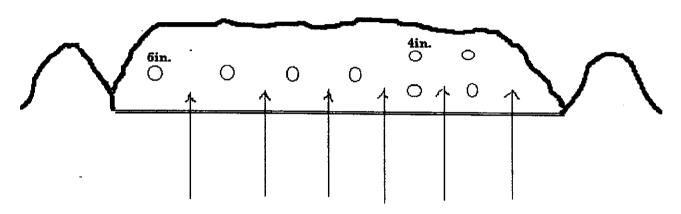
Containment area 50ft. x 60ft.

Soil Highth 5ft.

6in. and 4in. perforated pipe was used to ventalate soil

Two layers of reinforceed plastic was used to cover soil after ventilating soil sets on a 20-mil petroleum resistant liner

In 1998 Thor Gold placed perforated pipe threw out the soil to start Ventilating as shown in the sketch marked #1. The soil was then covered.

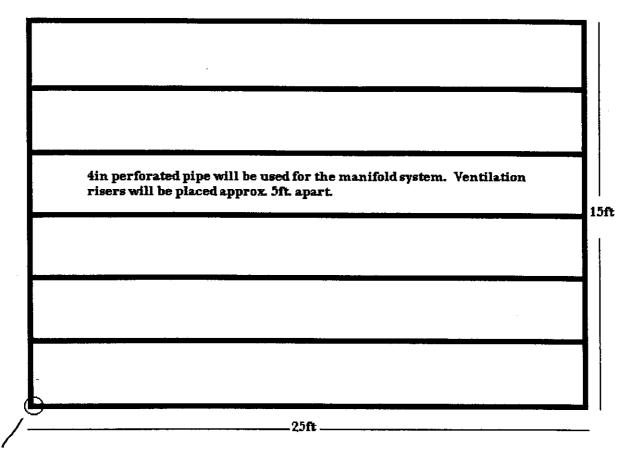
4in. perferited pipe will be added to allow for better ventilation.

Risers

In 1999 Thor Gold would like to add more perforated pipe to allow for more soil to be exposed to air movement. every four years after the placement of the vent pipe, samples will be taken and tested. Sampling of the soil will be repeated every four years until soil reaches DEC standards.
