FINAL REPORT

COMPLETION OF SOIL EXCAVATION AND TREATMENT AT CUBE COVE - ADMIRALTY ISLAND

Cube Cove

September 15, 2004

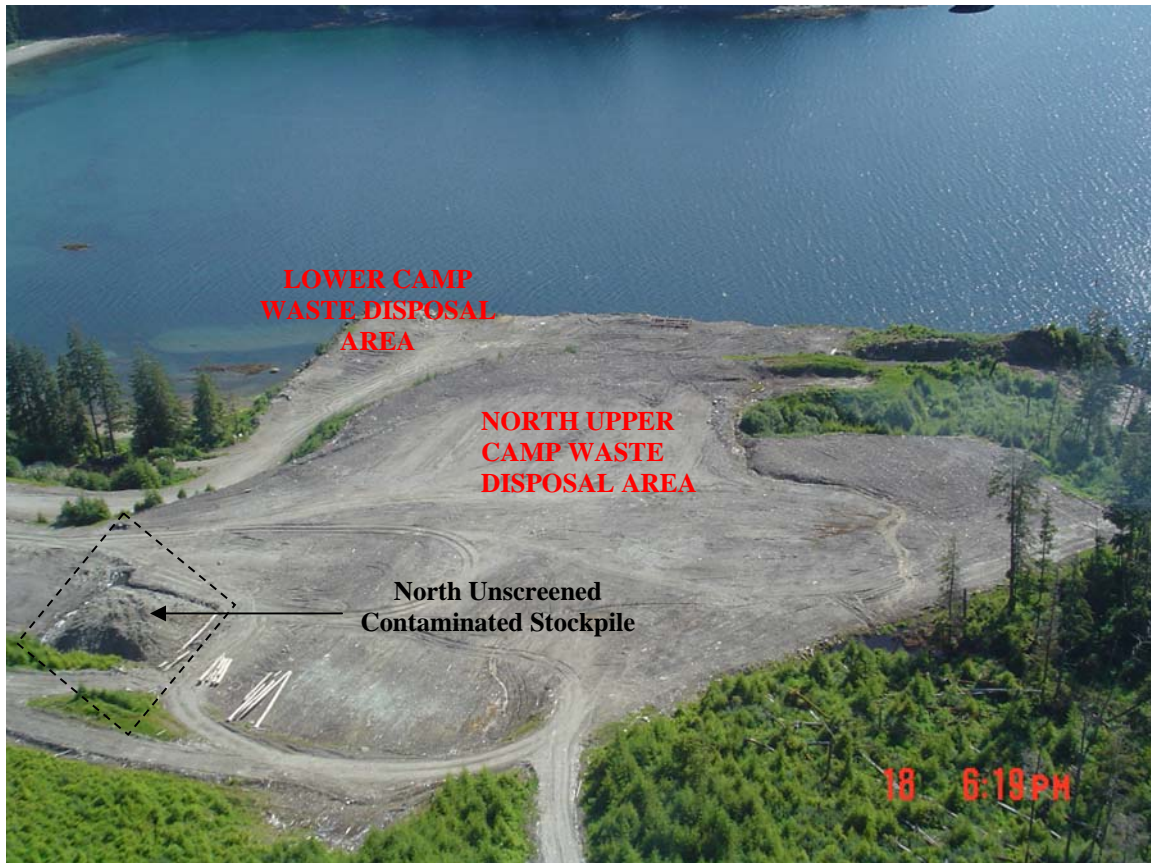
Photo 1. North Unscreened Contaminated Stockpile

The following photograph identifies the north unscreened contaminated stockpile:

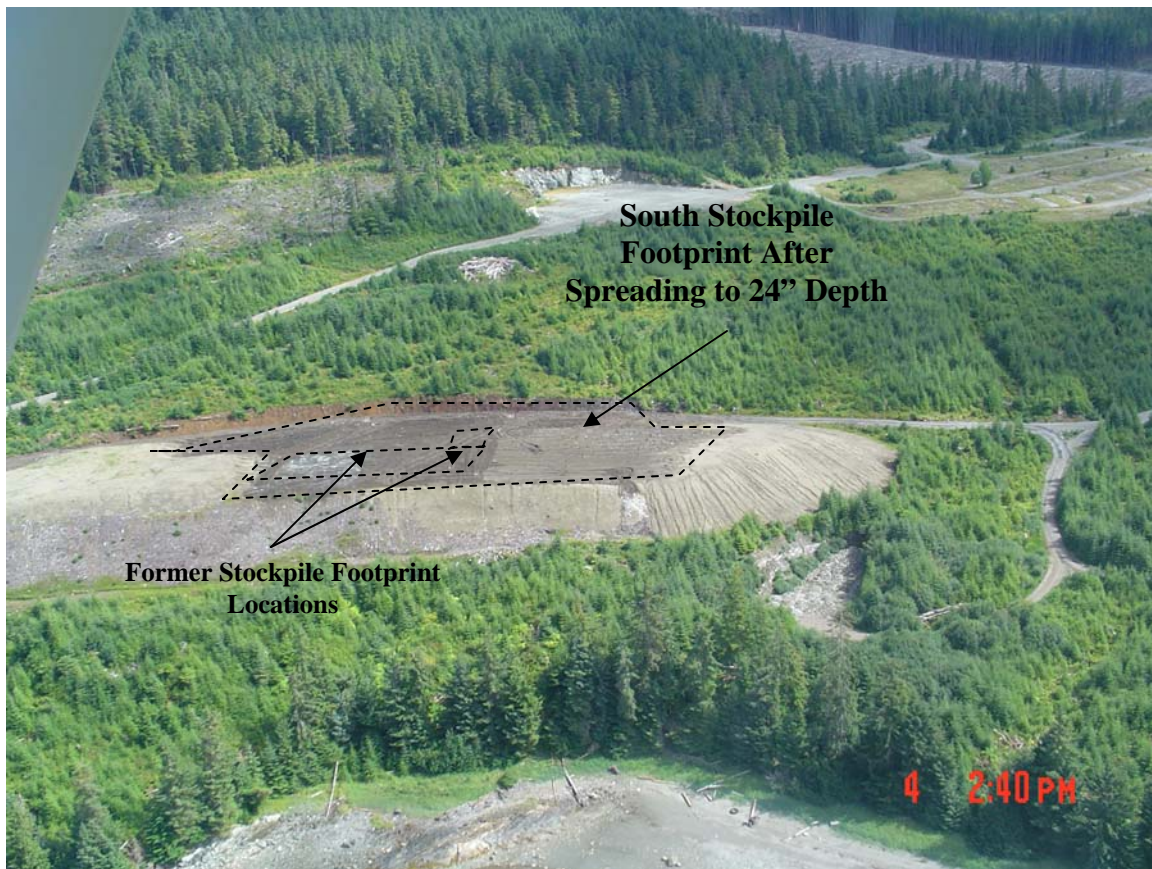
Photo 4. Configuration of South Stockpile Following Spreading.

In a similar manner the stockpiles in the south area were spread out to a depth of 24". The configuration of the south area after spreading is illustrated below:

After spreading the stockpile area was divided into 9 quadrants to facilitate further volume calculations, treatment and confirmation sampling.

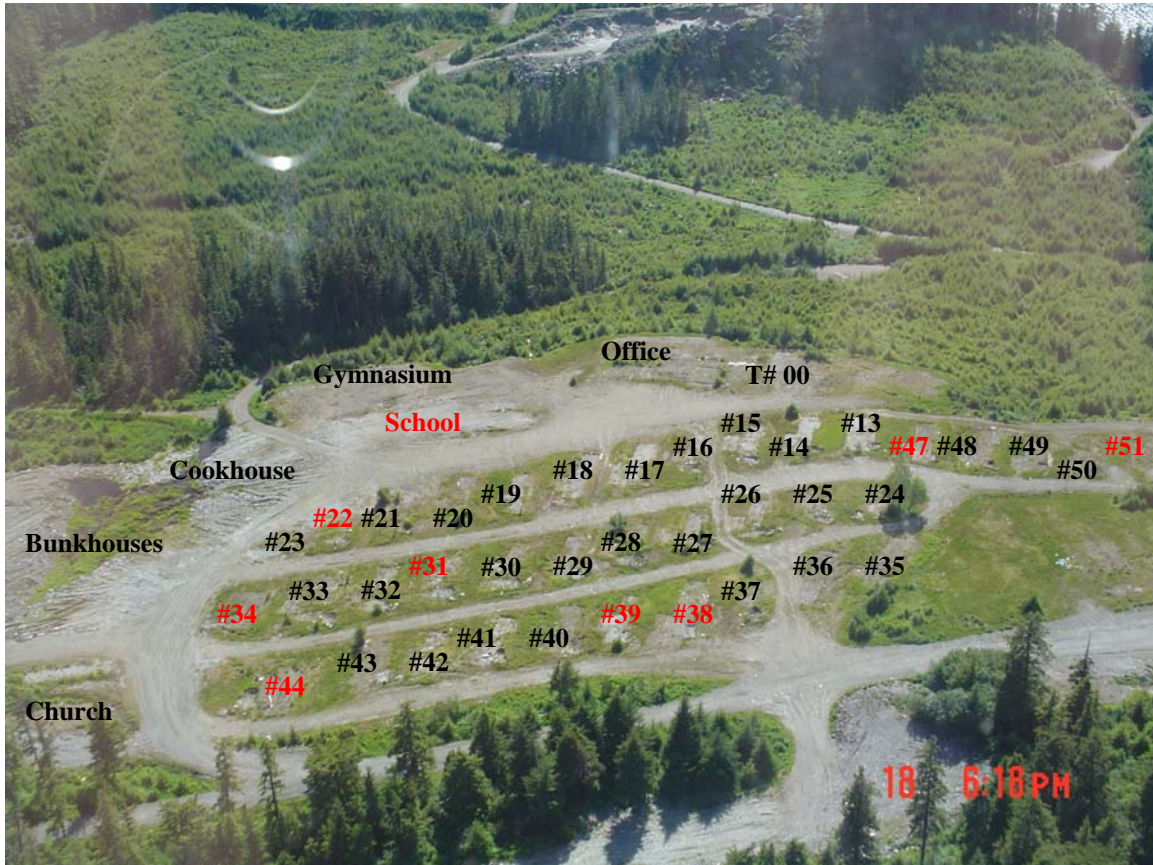
Photo #5. Residential Area Trailers and School Requiring Excavation

The Residential Area is illustrated in the following photograph. Although the structures have been removed, the locations can still be mapped and are noted on the photograph.

Each of the excavations (noted in red) are discussed below relative to additional excavation needed and confirmation samples collected. In general, the effort needed to achieve clean-up limits required that the previous excavations be widened by 1-2 feet and deepened by 1-2 feet.

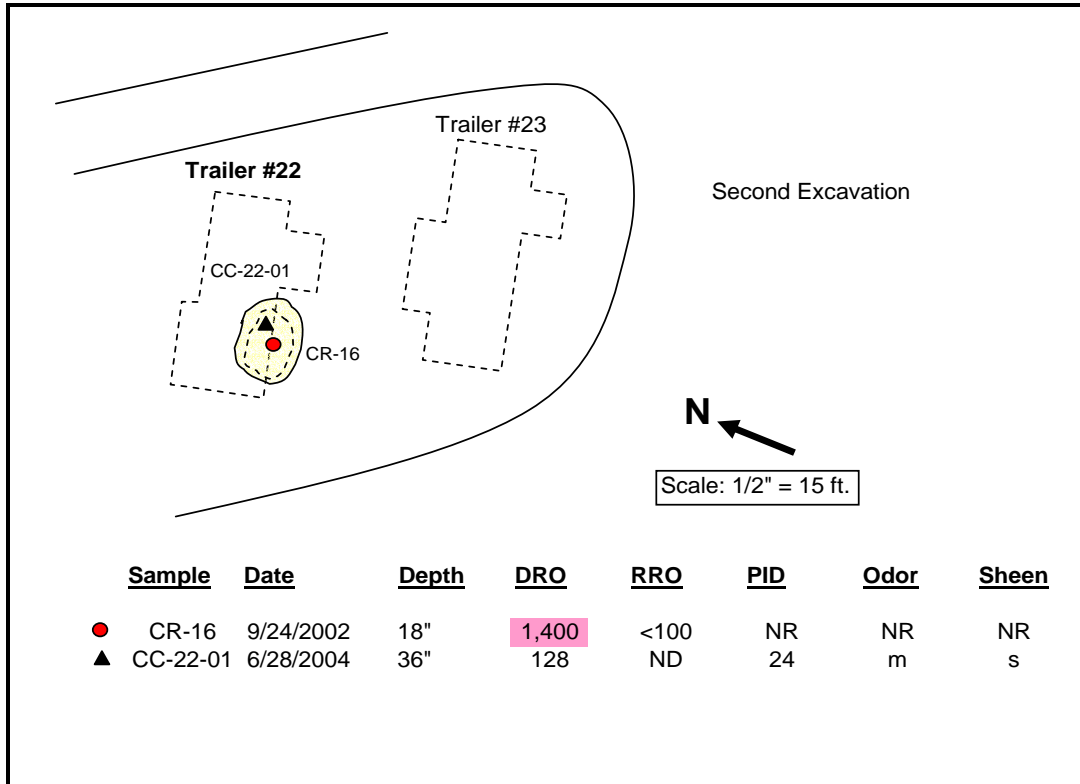
Figure 9. Trailer #22 Excavation and Confirmation Sampling

4.2 CY of contaminated soil was removed from Trailer #22 pad on 6/25/2004. The former excavation hole was widened and deepened. One confirmation sample (CC-22-01) was collected and analyzed. Results indicated that the site had achieved the Method 2 limit of 230 ppm DRO. No further action was performed.

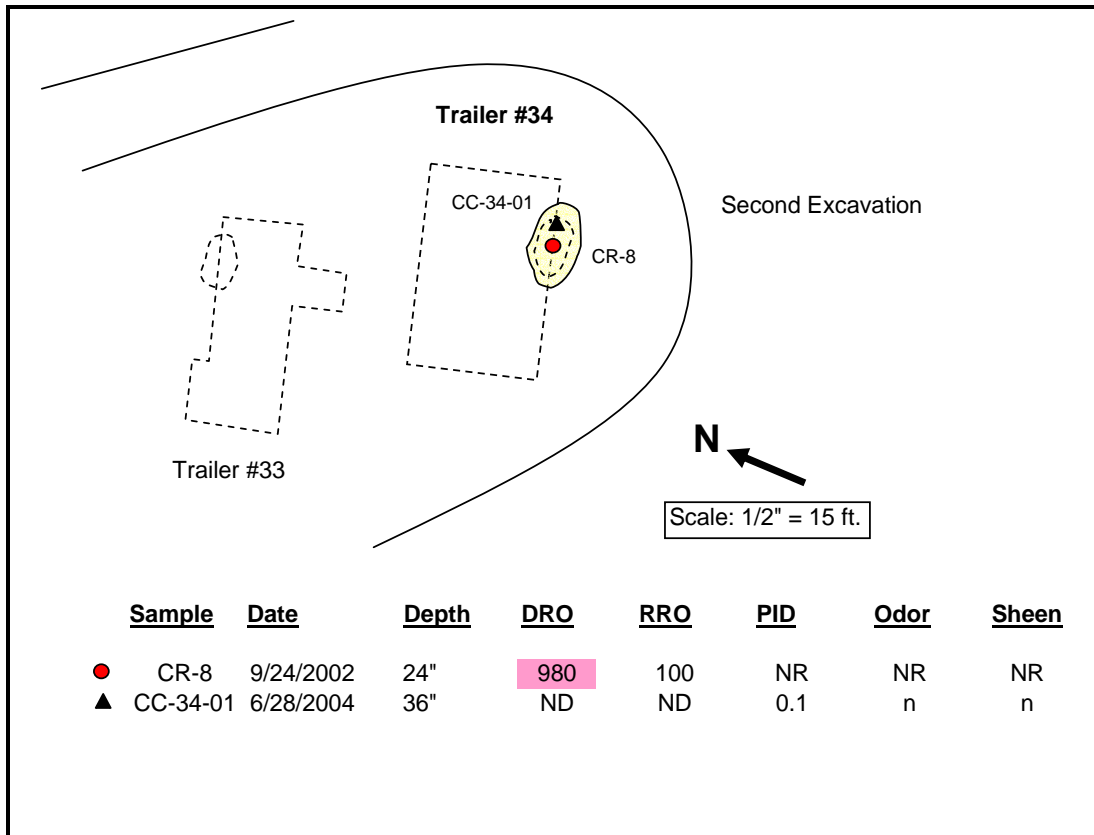
Figure 11. Trailer #34 Excavation and Confirmation Sampling

4.2 CY of contaminated soil was removed from Trailer #34 pad on 6/25/2004. The former excavation hole was widened and deepened. One confirmation sample (CC-34-01) was collected and analyzed. Results indicated that the site had achieved the Method 2 limit of 230 ppm DRO. No further action was performed.

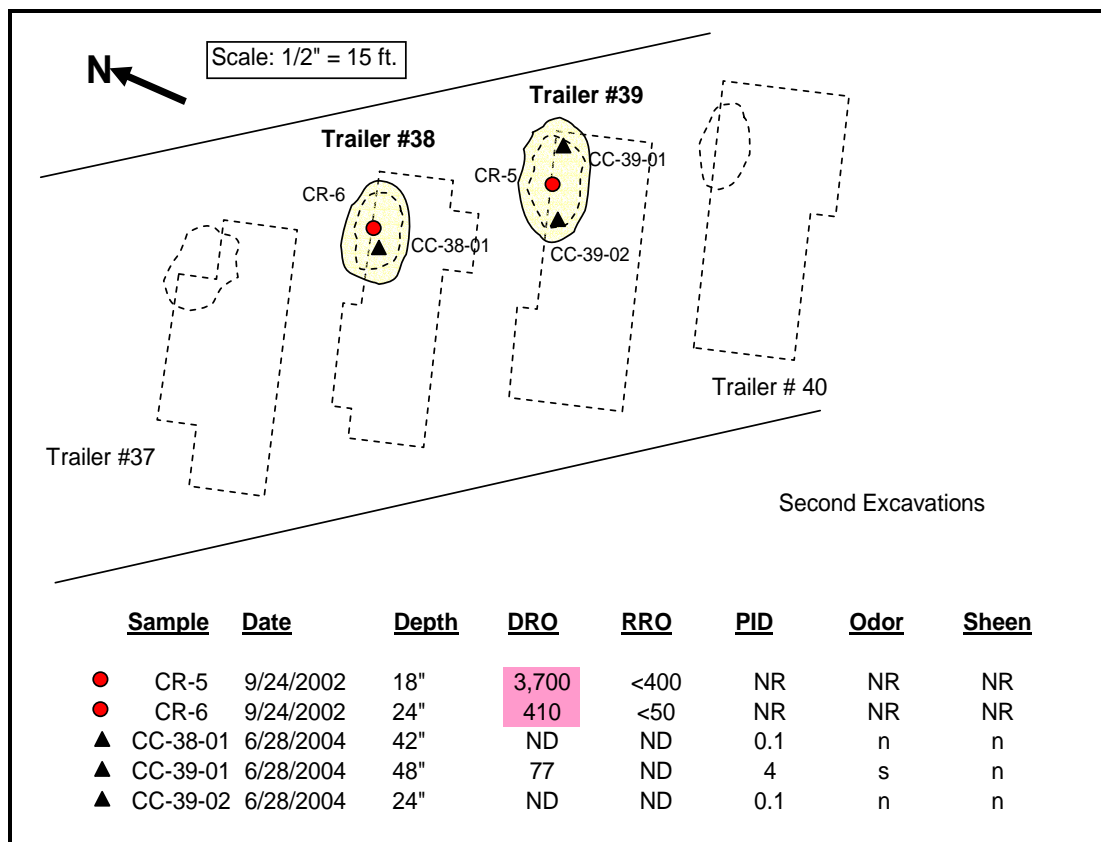
Figure 12. Trailers #38 & #39 Excavation and Confirmation Sampling

4.2 CY of contaminated soil was removed from Trailer #39 pad on 6/25/2004. The former excavation hole was widened and deepened. Two confirmation samples (CC-39-01 & CC-39-02) were collected and analyzed. Results indicated that the site had achieved the Method 2 limit of 230 ppm DRO. No further action was performed.

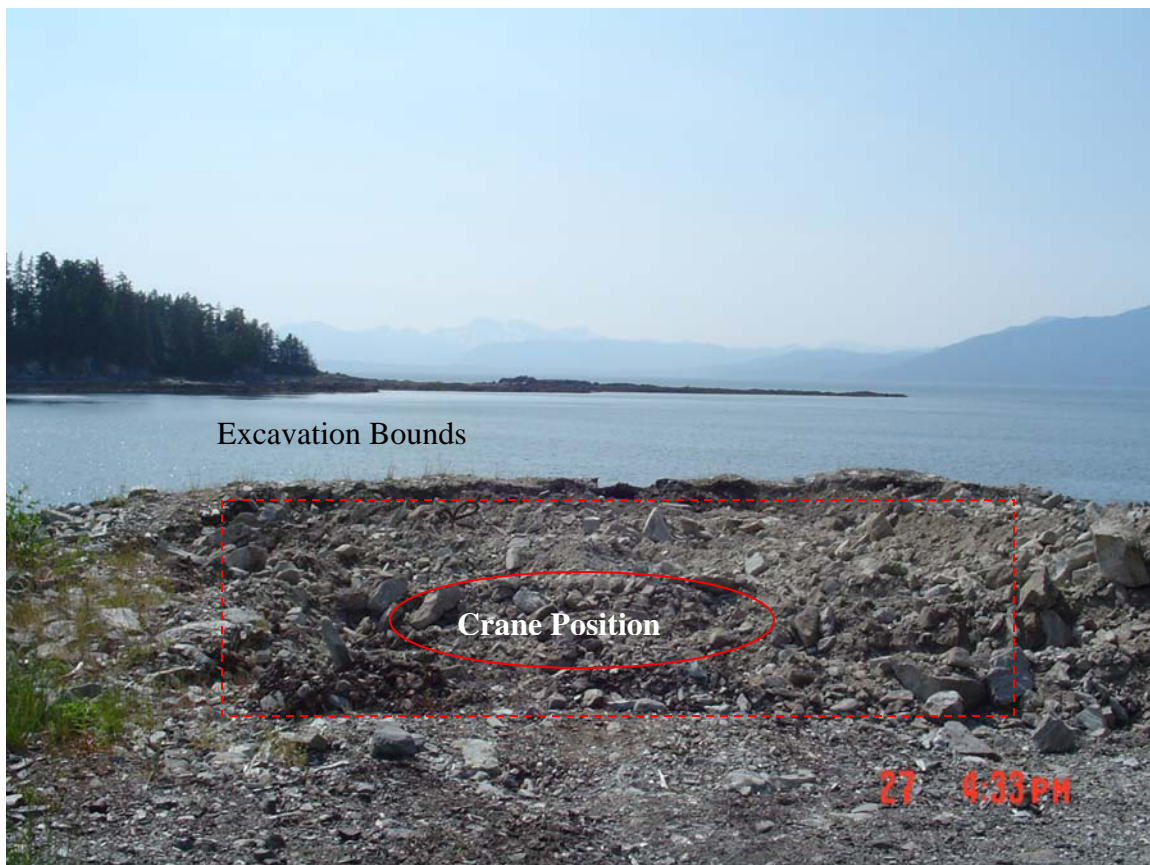
Photo 6. LTF Crane Pad Excavation

49.0 CY of contaminated soil was removed from the LTF Crane Pad on 6/25/2004. No previous excavation work in this area had been performed during the 1998 characterization effort and preliminary remediation work in 2001-2002. Based on historic aerial photographs, the crane pad was identified and excavations commenced at the crane upright and proceeded in an outward fashion. The soils immediately under the crane pad appeared darker at 60", but without significant field measurements indicators to suggest it represented contamination. The discoloring at depth is likely the high tide influence line. Five confirmation samples were collected all indicating that the contaminated soil in the area was effectively removed. No further action was taken at the site.

The following photograph depicts the former location of the LTF Crane.

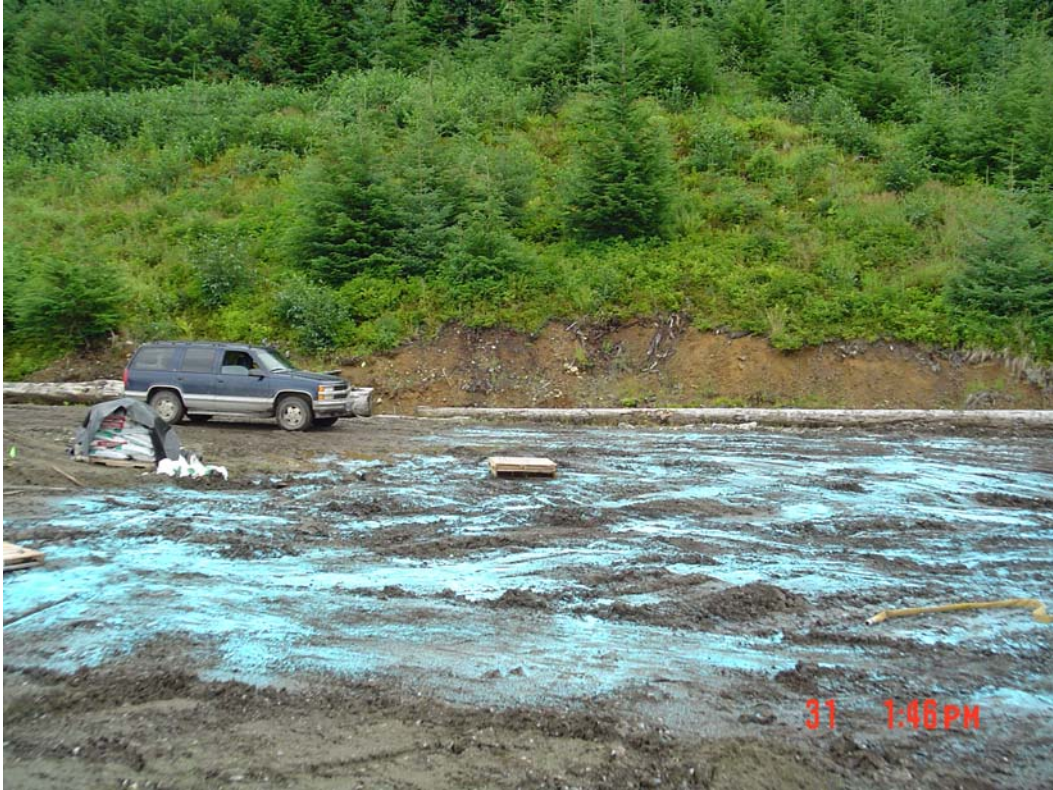
Photo 11. Hand Spread N- Nutrient Across a Typical Grid.

The following photographs illustrate the process used to apply nutrient and microbes to contaminated soil.

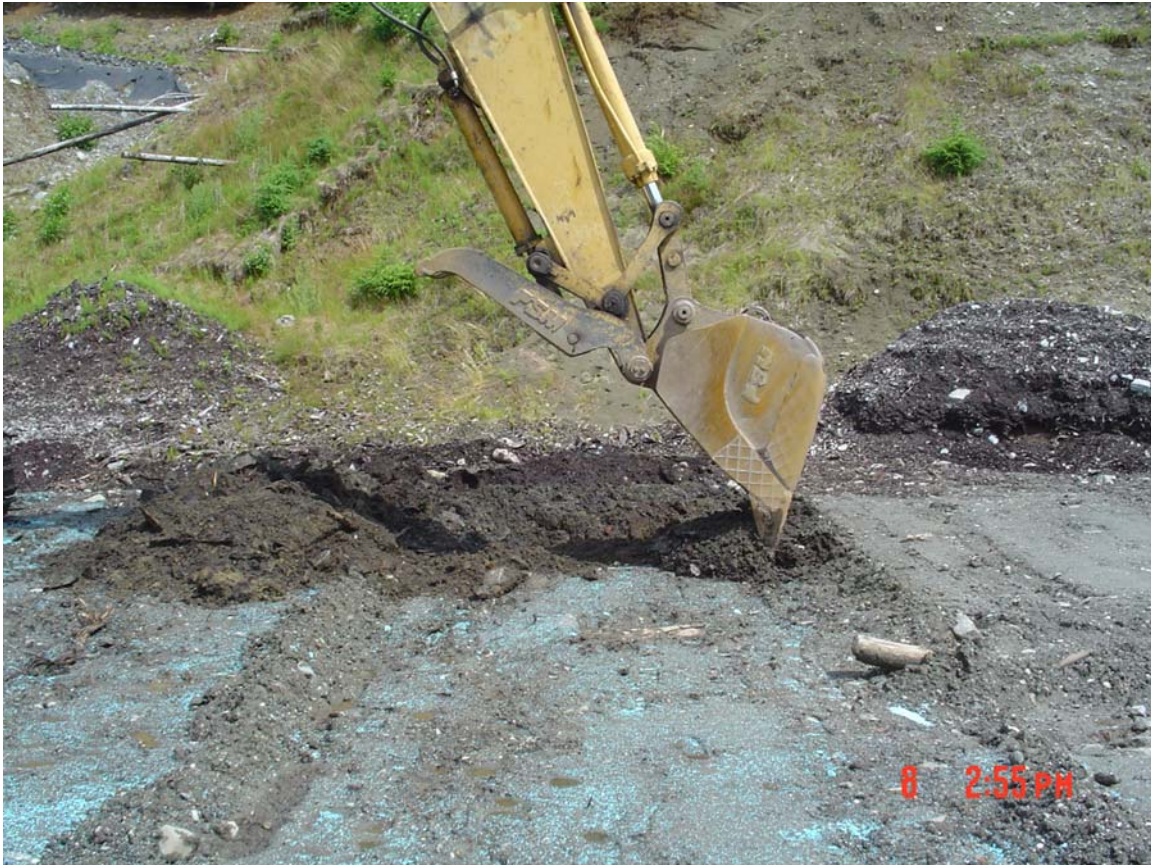
Photo 13. Mixing Soil Using an Excavator Bucket

Alternatively, a manufactured rake welded to the blade of a dozer was used to mix soils. The mechanical is rake is very effective o significant depth in mixing soils, but works best for screened materials. Mixing methods are noted in the following photos.

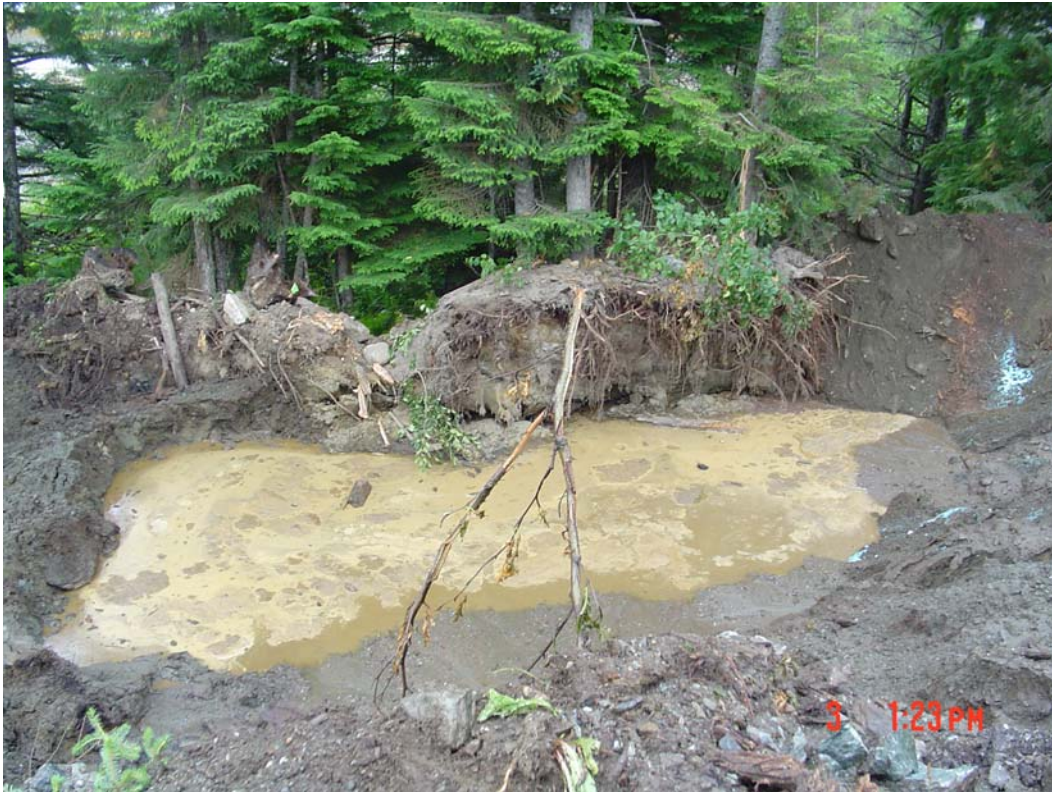
Photo 15. Microbes and Nutrient Added to Lower Fuel Depot.

The following photo illustrates the water table at the lower fuel depot after the application of 3,000 gallons of organisms.

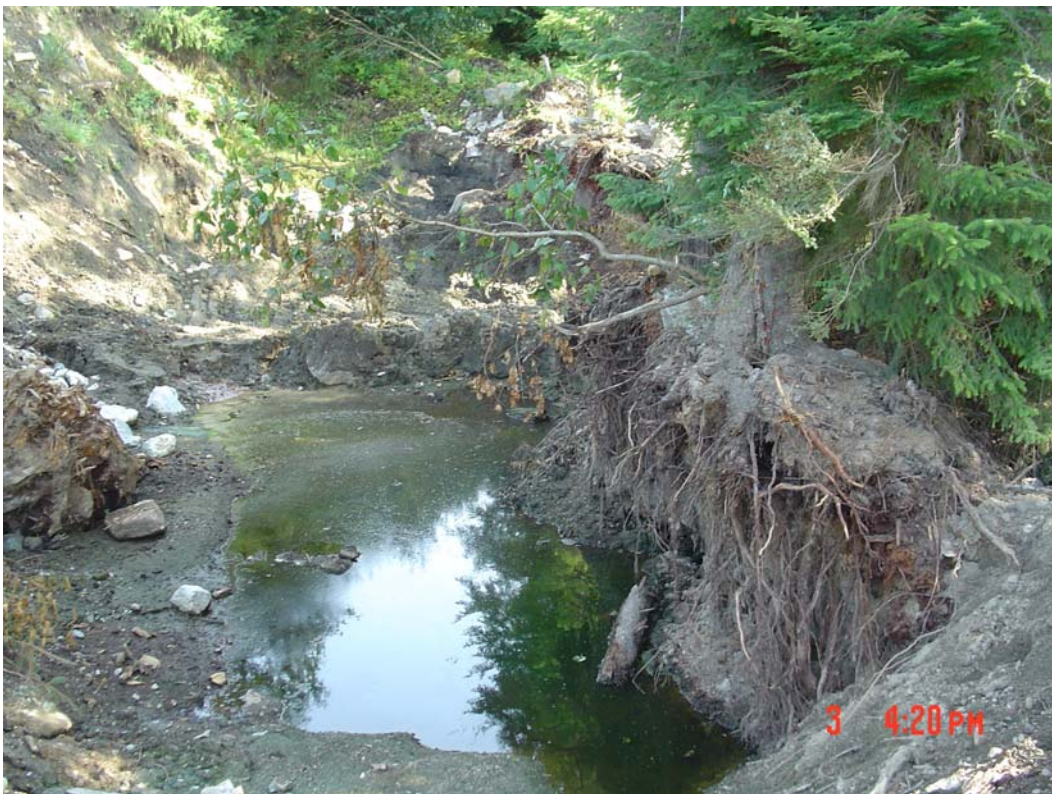
Photo 16. Fuel Depot Water Table 30 Days Post Treatment

30 days after in-situ treatment the depot was inspected. The water table was lower and non-soluble nutrient was observable on the ground surface. The ponded water was clear indicative of treatment.

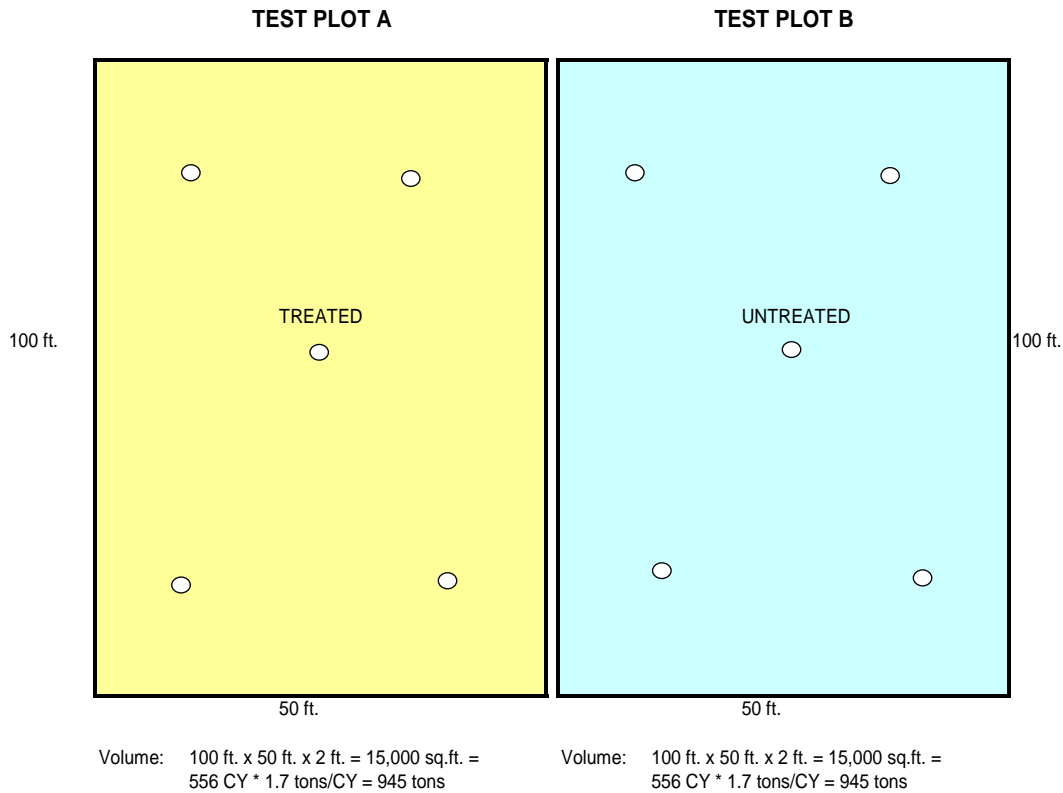
Figure 22. Layout and Volume of Test Plots

The test plot volumes are as large as most small bioremediation projects in Alaska.
