OCEAN CAPE RADIO RELAY STATION
ABOVEGROUND FUEL STORAGE TANK
AND
SEAPLANE RAMP
REMOVAL ACTION COMPLETION REPORT
FOR
FIELD SEASON 2009

Prepared for the
Yakutat Tlingit Tribe

Prepared by
RIDOLFI Inc.

December 2009

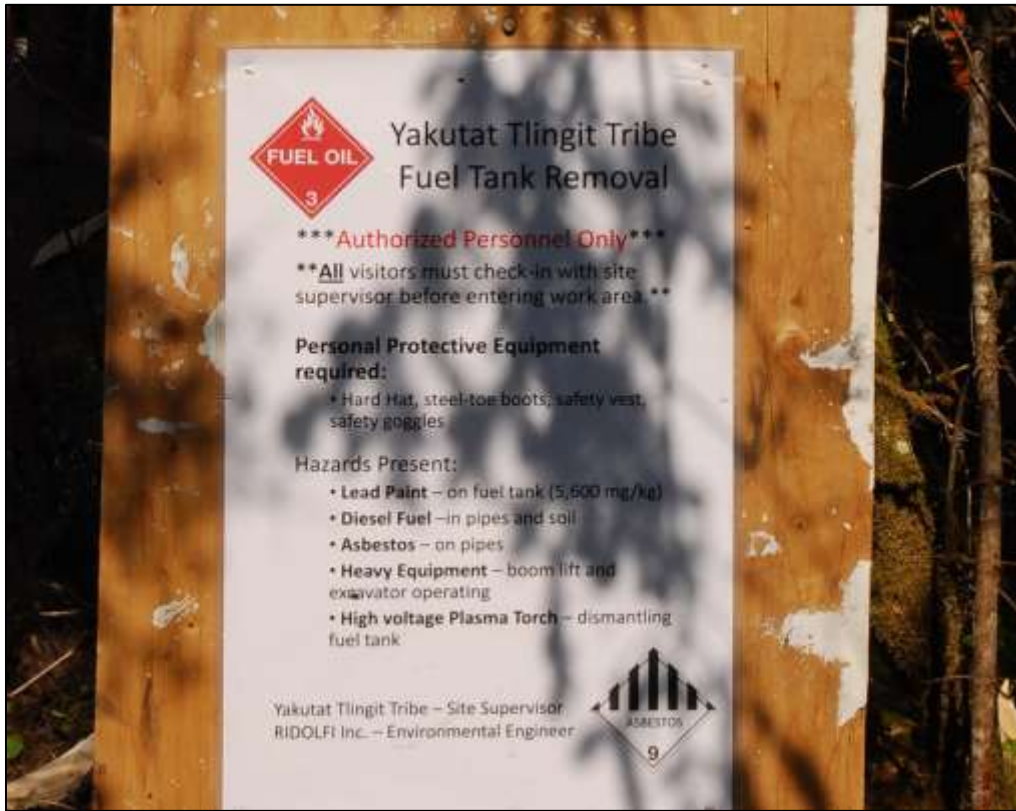
Photograph 1. Warning Sign: Fuel Tank Removal and Asbestos Work

Following completion of the site preparation work, the regulated area was established. The regulated area was clearly marked by red “asbestos warning” tape and multiple signs, and entry to the regulated area was limited to six workers at a time. The field supervisor supplied half-face respirators to all persons who entered the regulated area and informed others onsite of the nature of the work, regulated area requirements, and measures taken to protect employees. Smoking, chewing, eating, or applying make-up are prohibited in the regulated area. Health and safety meetings were conducted prior to entering the regulated zone to reinforce proper work habits. YTT workers were extremely cognizant and exercised proper health and safety protocol.

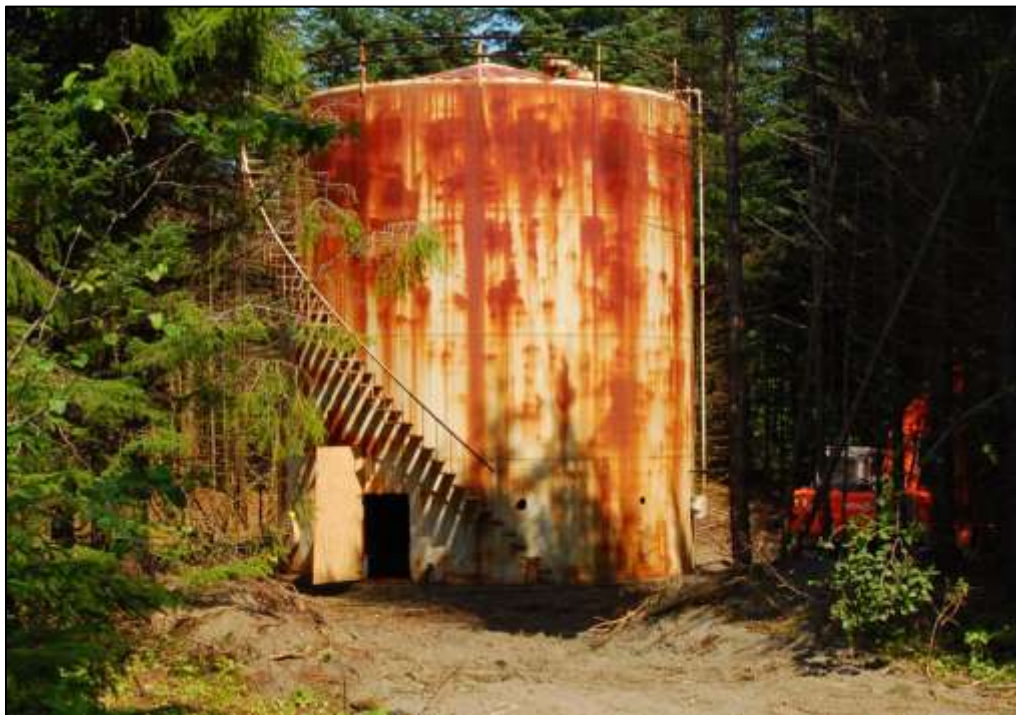
Photograph 2. 130,000-Gallon Fuel Tank with Access Door

The AST, which was emptied and cleaned in 2008, was used as a storage and staging area (Photograph 2). An entryway was cut into the tank and plywood installed to cover the entryway. Supplies and equipment, including the high-efficiency particulate air (HEPA) vacuum, water, personal protective equipment (PPE), tyvek suits, 6-mil plastic sheeting, respirator cartridges, 6-mil bags, and glovebags were staged inside the AST for easy access. The tank entryway was securely closed every night to prevent entrance by humans or animals.

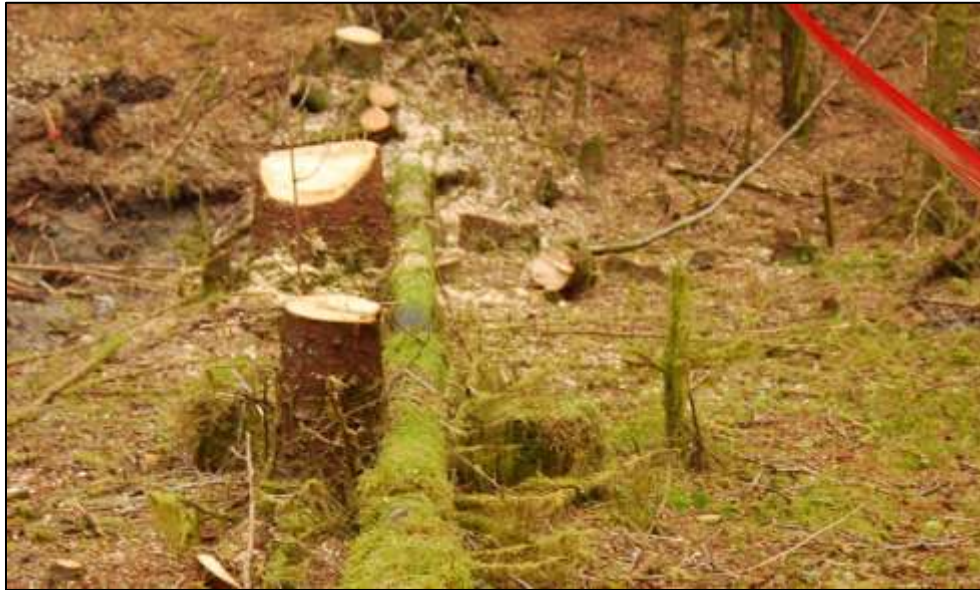
Photograph 3. Site clearing in preparation for abatement.

Once the regulated area was established, additional clearing was conducted adjacent to the pipes (Photograph 3). The remaining soil covering the pipe was then removed using hand tools to expose the pipe without disturbing the asbestos wrap and fibers (Photograph 4). Once the pipe was exposed, the abatement work began.

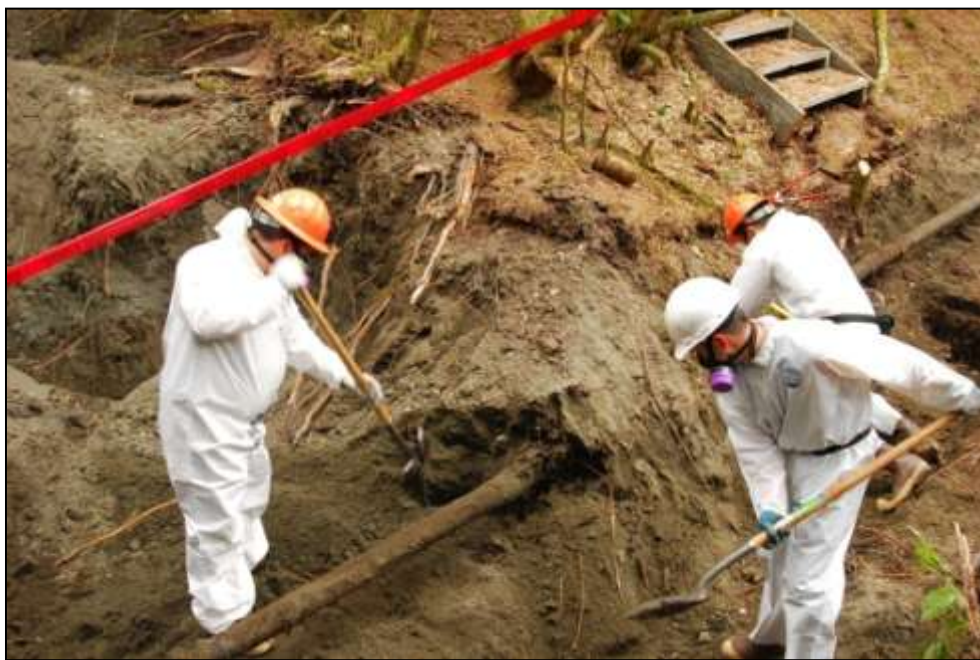
Photograph 4. Uncovering the pipe from beneath the berm using hand tools.

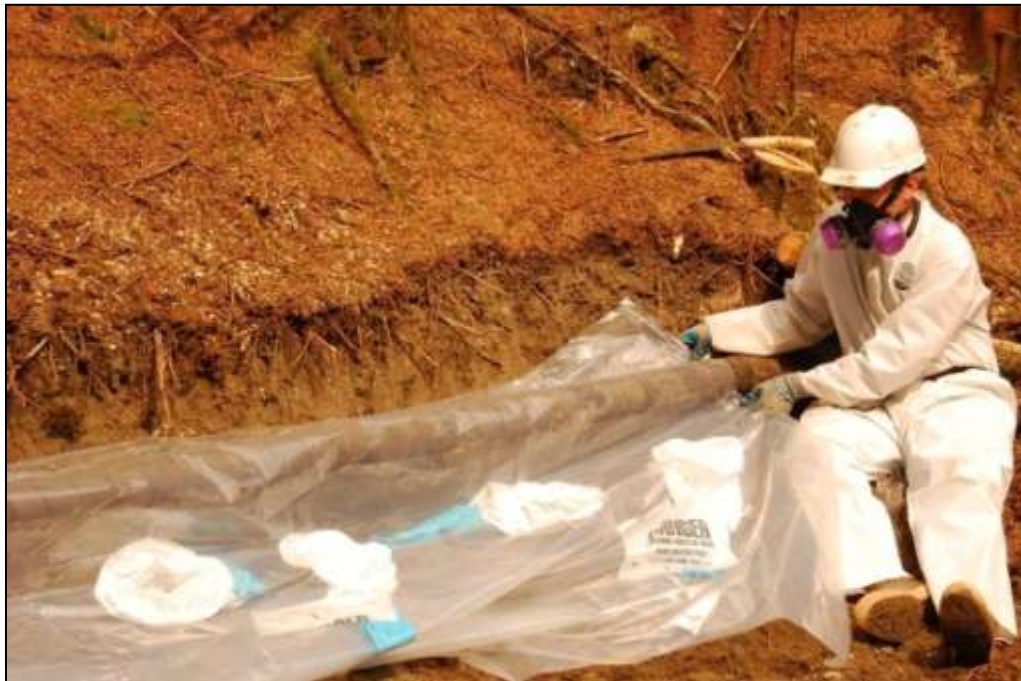
Photograph 5. Wrapping the pipe with the glovebag.

Abatement of the pipe insulation was conducted using commercially available glovebags of 6-mil clear polyethylene (Photograph 5) appropriately sized for the project. The outer diameter of pipe insulation to be removed did not exceed one half the bag's working length or height above the attached glovebag in accordance with regulations. All necessary tools and materials were brought into the work area before the glovebag procedure began.

The asbestos wrap was saturated with water amended with surfactant before attaching the glovebags. The contents of a smoke tube and abatement tools were placed inside the glovebag prior to being sealed. The glovebags were installed in two continuous sections between two tree stumps that blocked a possible continuous installation (Photograph 5). The glovebags were attached securely around the insulation in a manner to prevent air transfer (Photograph 6). The integrity of the glovebag seal was smoke tested before disturbing the ACM. The bag was squeezed gently to check for leakage points, which were then taped airtight.

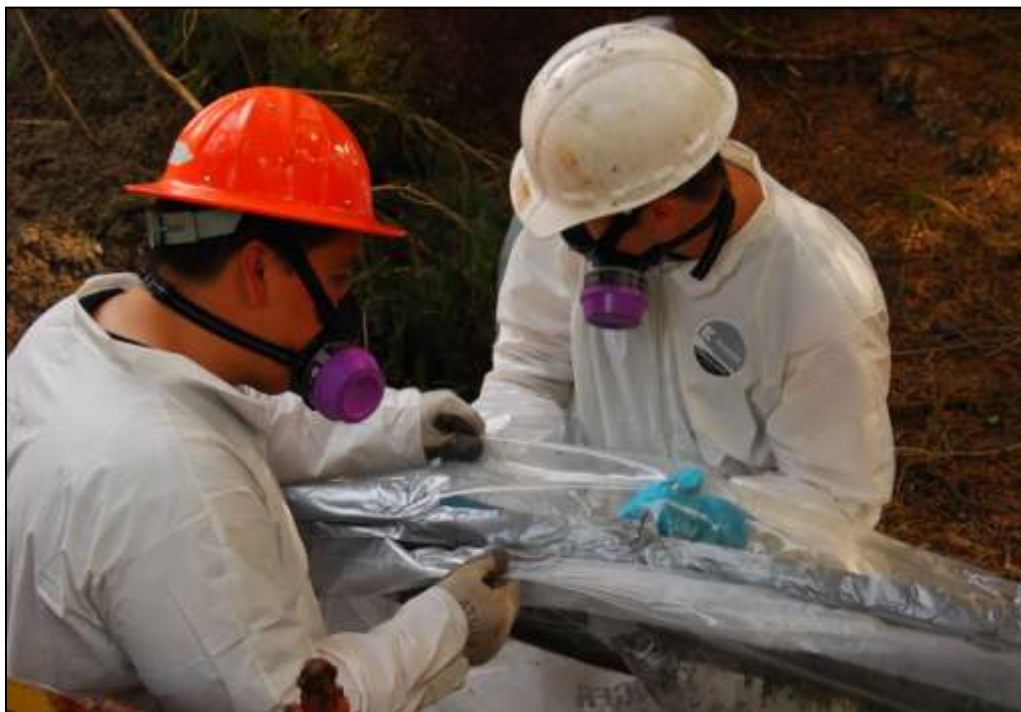
Photograph 6. Sealing the top of the glovebag.

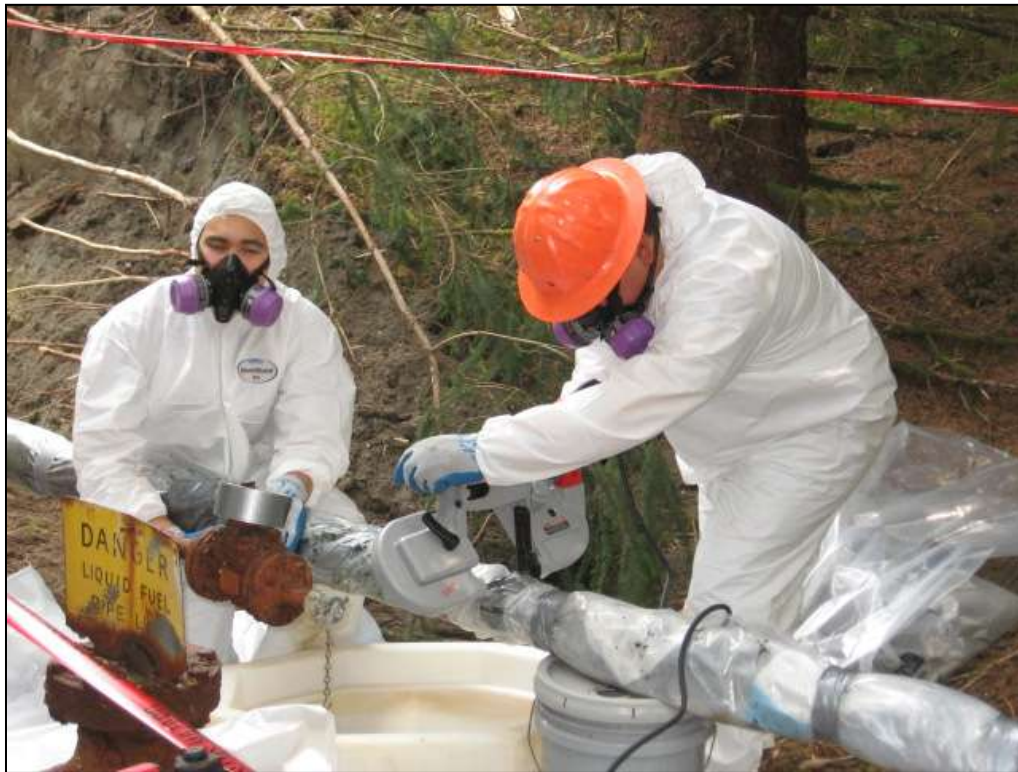
Photograph 7. Cutting pipe into sections with plastic containment below the pipe.

Residual fluids in the piping could not be accessed from either inside the tank or from the fuel pump house because the valves were rusted shut. Therefore, containment was set up under the pipe to catch any fuel in the pipe, and plastic was placed beneath that to provide further spill prevention and protection. The pipes were then cut into 8-foot sections. A worker began cutting the first section of pipe at the low-point in the line where the diesel would accumulate.

Immediately after cutting the pipe, diesel fuel started to flow into the containment. Cutting the pipe was stopped to control the flow rate into the containment. A total of 55 gallons of fuel was pumped into three 30-gallon drums. The drums were not filled more than three-quarters full for safe handling. Diesel vapors were monitored with the FirstCheck+1000 multigas photoionization detector (PID). The atmosphere's combustibility was monitored with the goal of maintaining a vapor level less than 10 percent of the Lower Explosive Limit (LEL). The generally accepted LEL for diesel fuel is 0.6 percent or 6,000 parts per million (ppm); therefore, a vapor level of less than 600 ppm is required to mitigate potential combustibility. Readings were taken throughout the site, and Table 2 summarizes the monitoring results.

Once all of the diesel was removed from the pipe, the pipe cutting continued. As the crew cut sections of pipe, they captured residual diesel fuel by placing the containment system under the pipe area to be cut and under the exposed end. The system included a bucket at each pipe end and 6-mil plastic sheeting placed on the ground as a secondary protective barrier (Photograph 7). Once a section of pipe was cut, it was removed to the waste handling area. The piping was cut into a total of 14 sections.

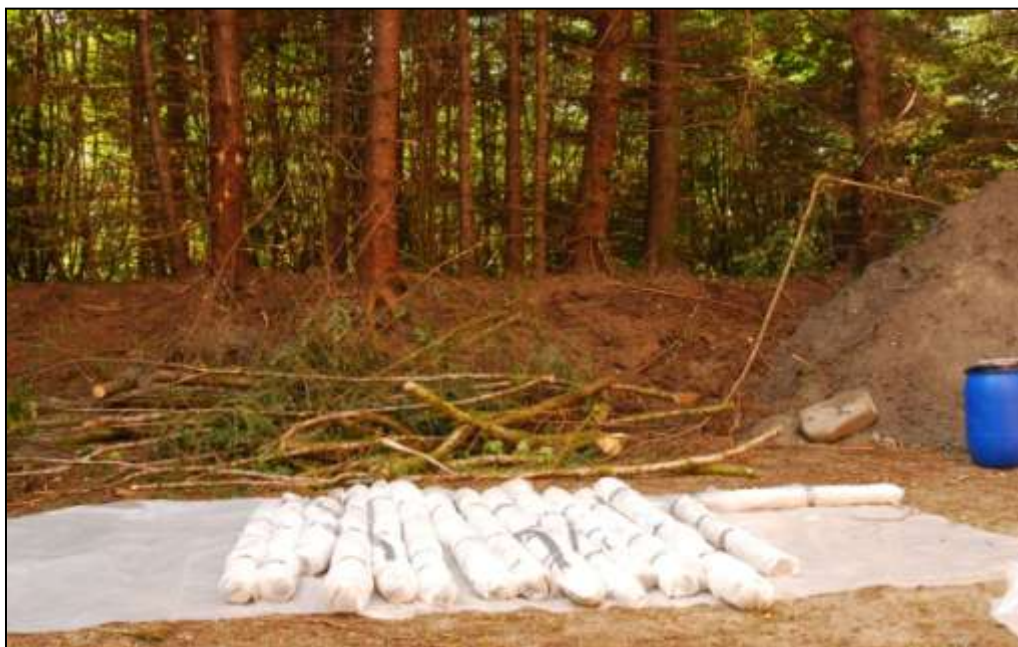
Photograph 8. Fourteen (14) sections of wrapped pipes ready for disposal.

The waste handling area was setup along the south edge of the regulated area. The ground was covered with an impermeable drop cloth that covered the designated area. In the waste handling area, the pipe sections were wrapped in 6-mil plastic sheeting. The plastic sheets were cut one foot wider than the pipes on both sides and the excess was folded inward to ensure the pipes

were fully sealed. The pipes were placed on plastic in the regulated zone and were rolled out of the regulated area. An asbestos warning label, with the project name and location, was placed inside the outermost layer of plastic within each package.

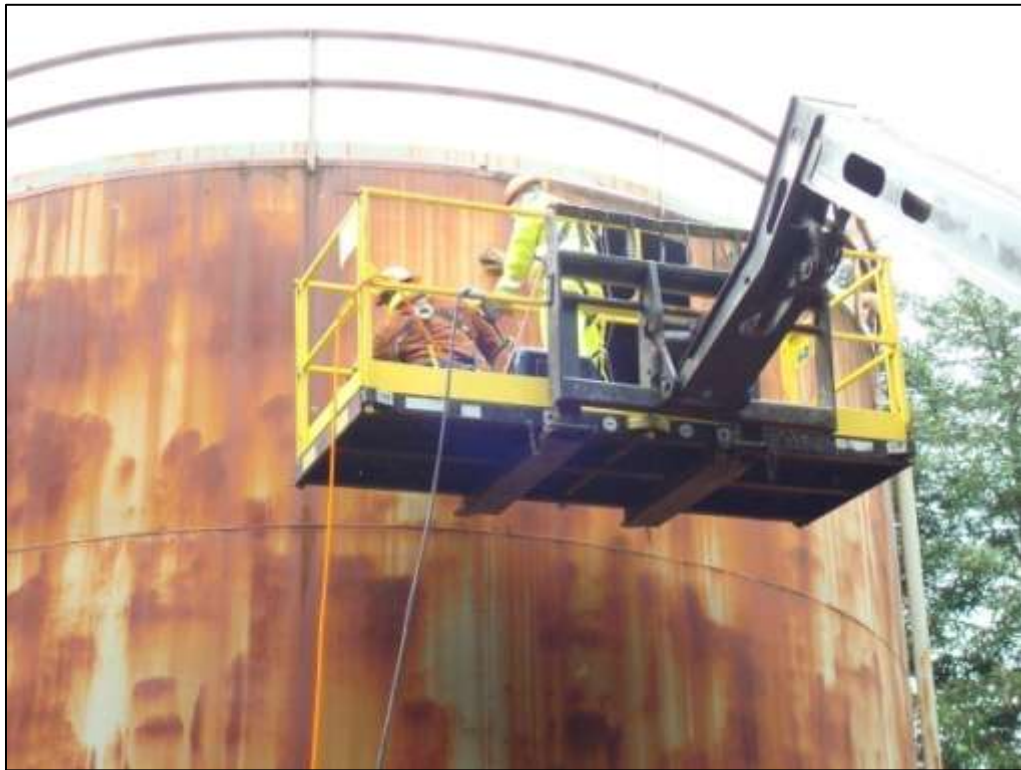
Photograph 9. Starting the task of dismantling the 130,000-gallon AST.

Once the asbestos abatement and pipe dismantling activities were complete, the AST was dismantled (Photographs 9 and 10). The AST atmosphere was monitored to ensure that combustible vapors were not present within the explosive range prior to flame cutting.

To dismantle the AST, the top portion was cut and removed using a Thermal Dynamics Plasma cutter. The tank sides were then cut into panels for safe handling and efficient transport. As the panels were cut, each was lowered, by gravity, into the interior of the tank (Photograph 11). Once dismantling was complete the panels were removed from the site (Photograph 12).

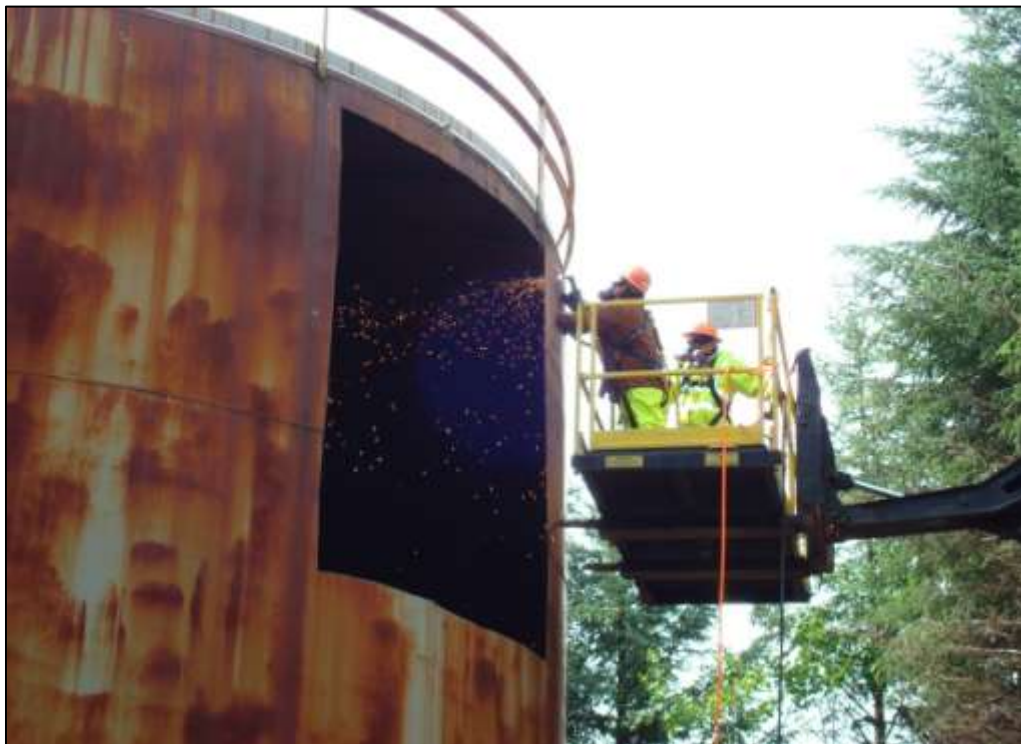
Photograph 10. Dismantling the 130,000-gallon AST.

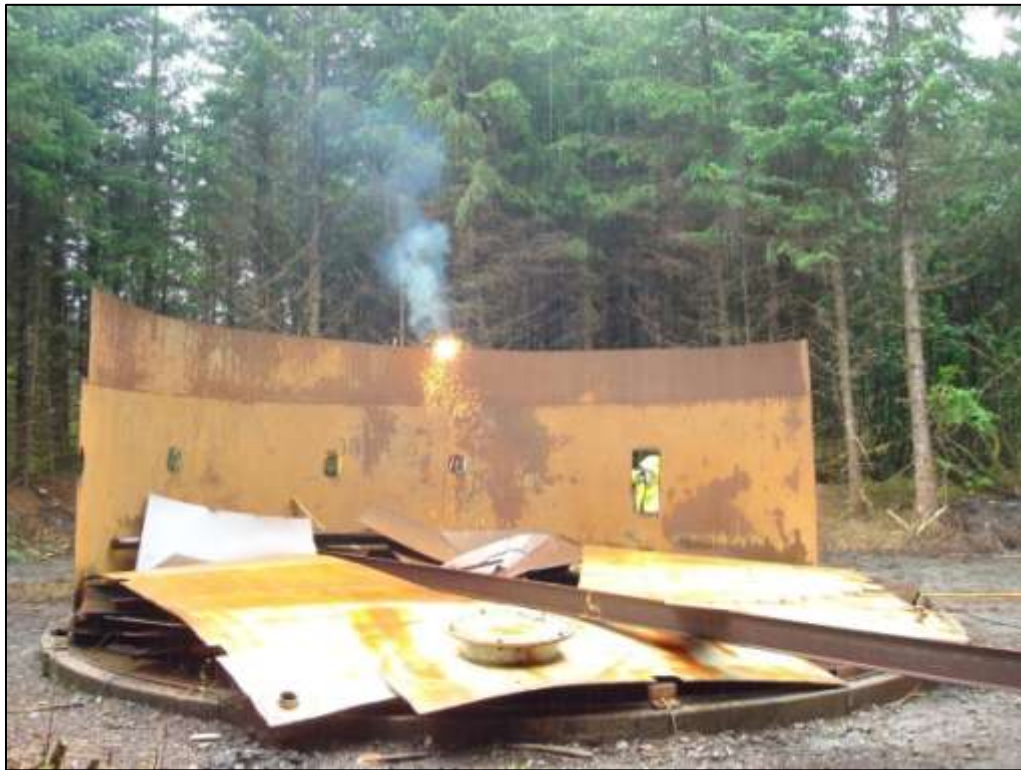
Photograph 11. Dismantling the lower section of the AST.

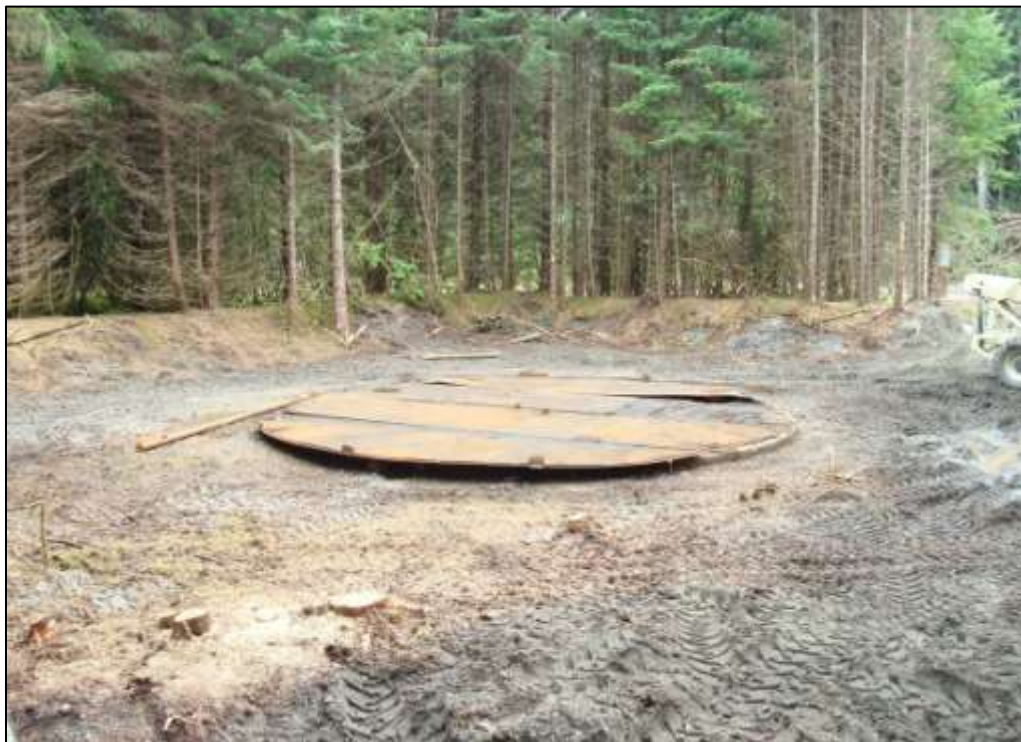
Photograph 12. Site after completion of AST removal.

The AST removal took three weeks. The steel was given to the Yakutat community for reuse. The AST concrete foundation is a circular concrete footing filled with sand that was stained with a distinct petroleum odor. The material should be sampled prior to removal.

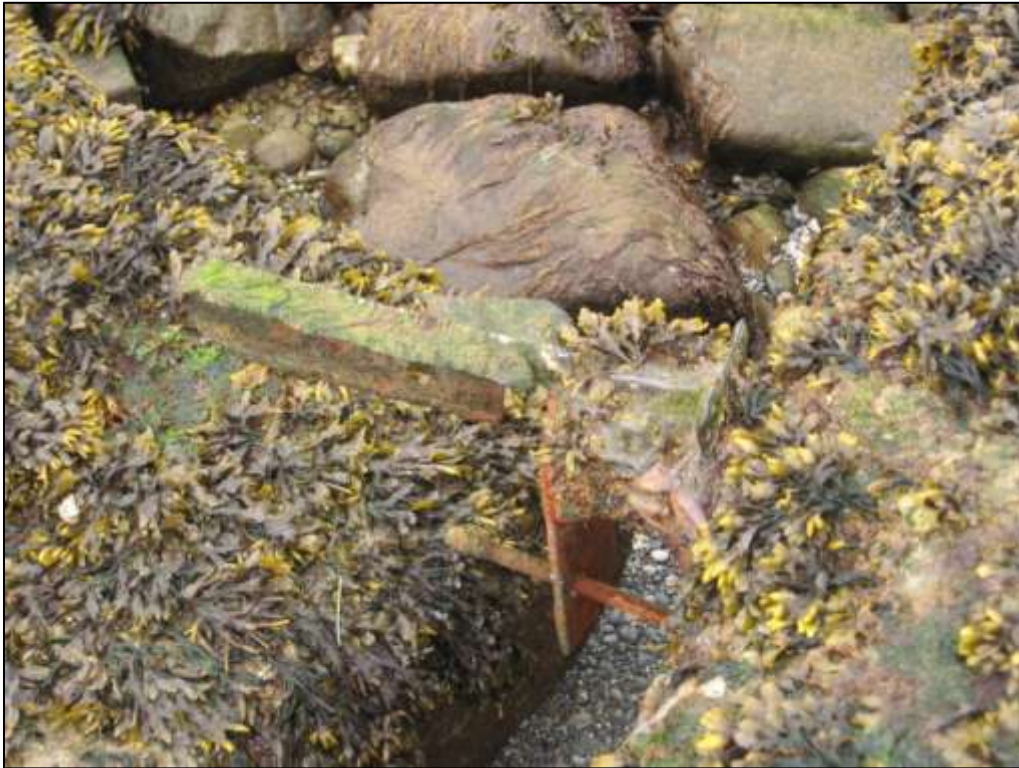
Photograph 13. Example of metal removed at the Seaplane Ramp.

The protruding and exposed rebar throughout the area was removed. Work took place over a week and was conducted during low tides to allow the best access to the entire seaplane ramp. Metal debris, dislocated steel rail, and other protruding debris were cut with a Thermal Dynamic Plasma cutter, flush to the concrete to eliminate these hazards on and near the seaplane ramp at the Seaplane Base. The 2,000 pounds of metal debris was disposed of in the Yakutat Landfill.

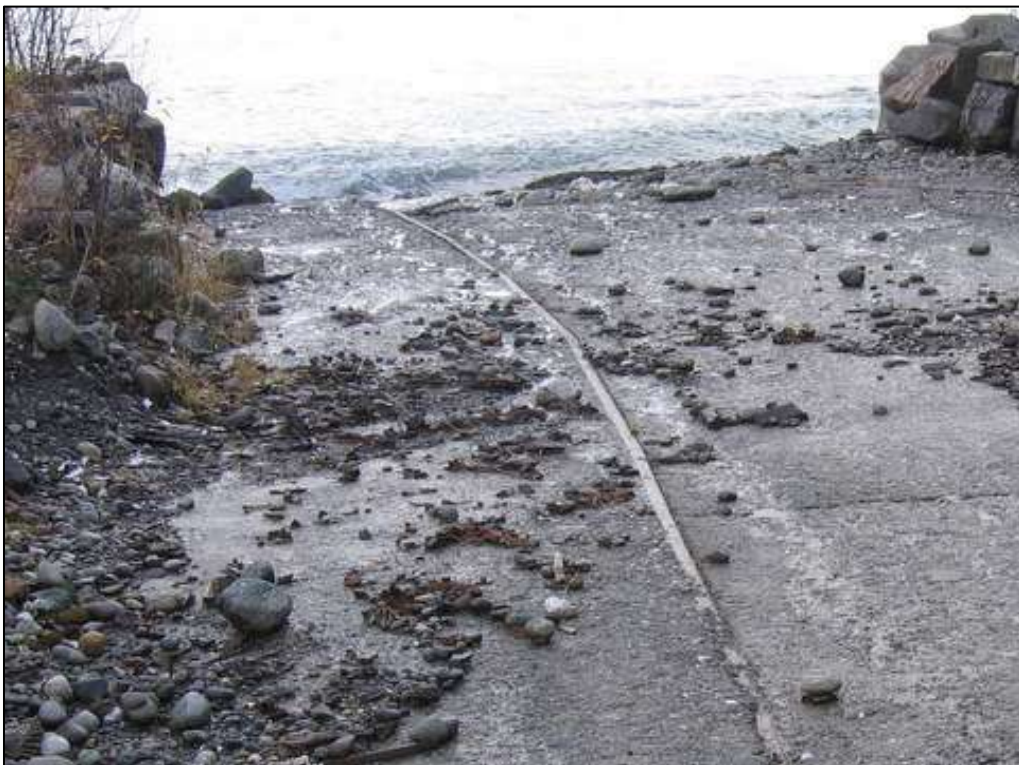
Photograph 14. Rails remaining at the Seaplane Ramp.

Approximately 2,000 pounds of metal debris was removed from the Seaplane Ramp. Most of the material was from the rails.
