NATIVE AMERICAN LANDS ENVIRONMENTAL
MITIGATION PROGRAM (NALEMP) 2012

OCEAN CAPE RADIO RELAY STATION
PETROLEUM-CONTAMINATED SOIL
INTERIM REMOVAL ACTION REPORT

for
Field Season 2013

YAKUTAT TLINGIT TRIBE

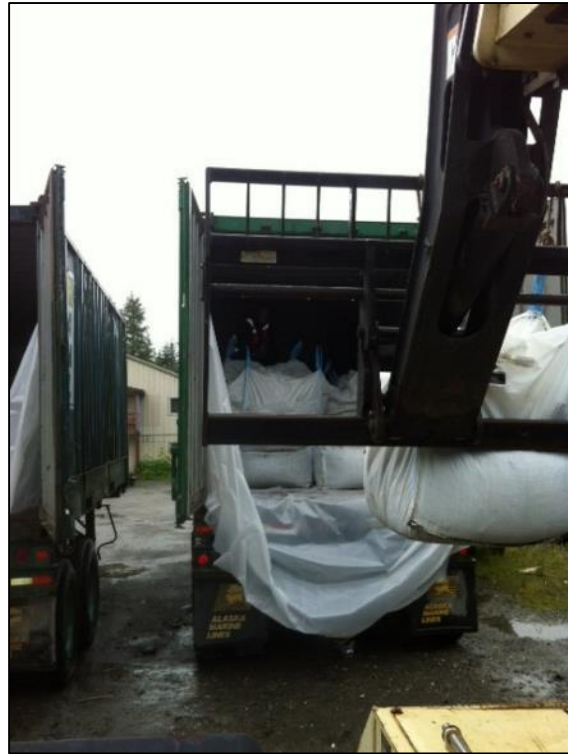
Photograph 1. Loading PCS filled Super Sacks® in shipping container.

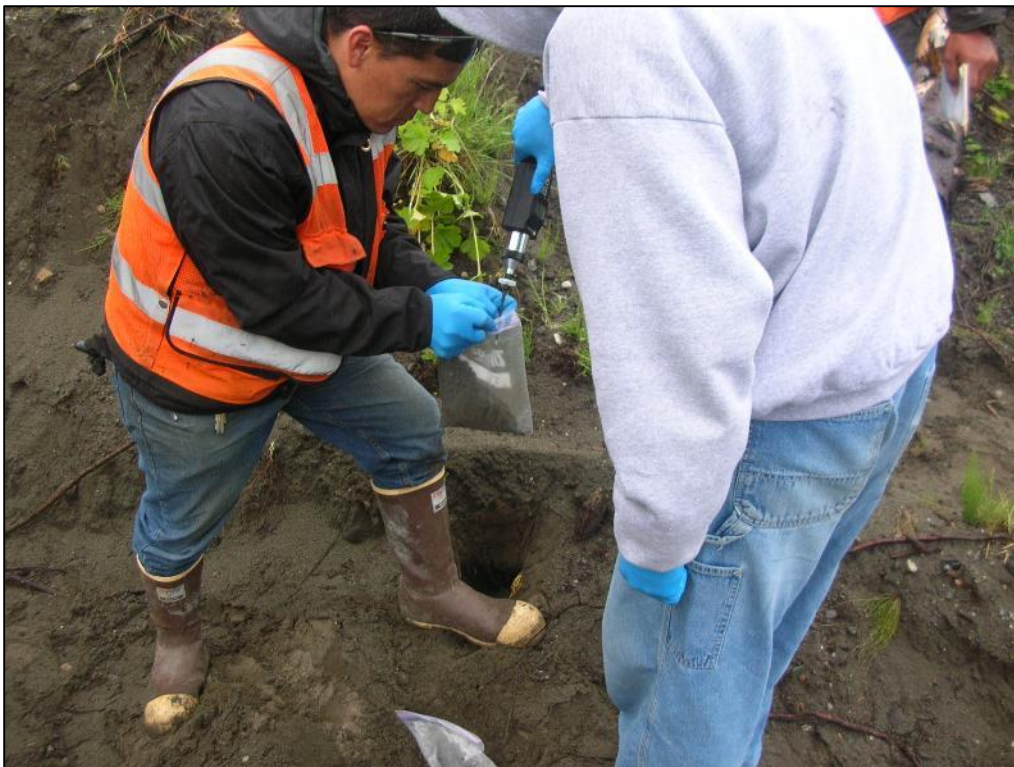
Photograph 2. Crew conducting field screening using PID.

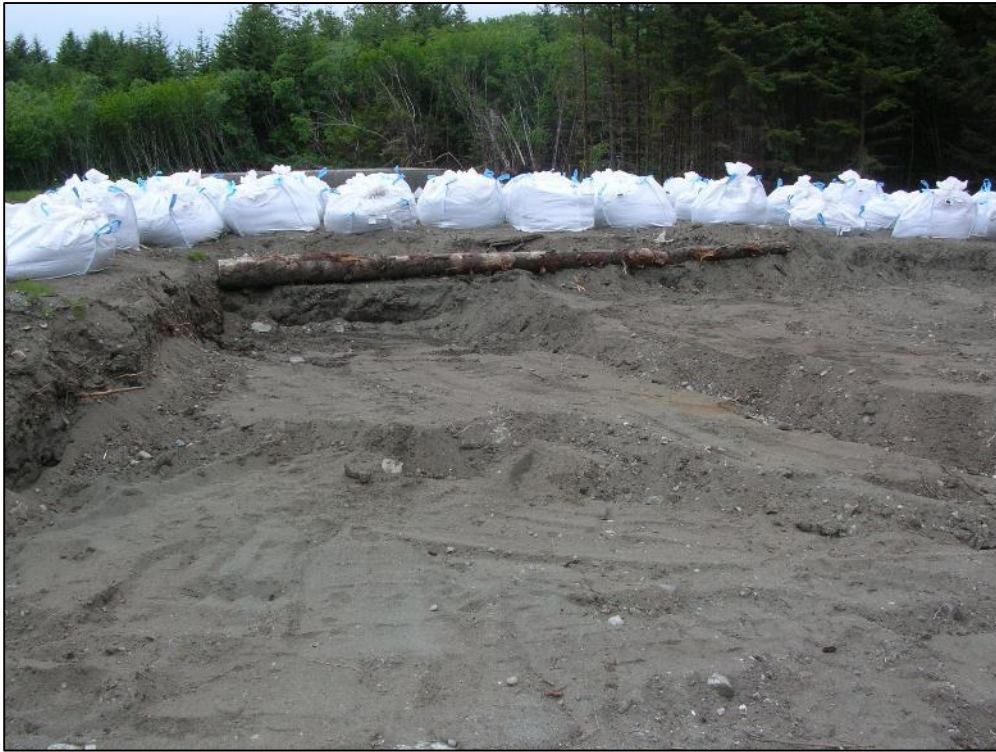
Photograph 3. Former Diesel AST Area excavation. Looking northwest.

Removal of PCS at the Former Diesel AST Area began on May 30, 2013 and continued until June 12, 2013. A total of approximately 68 cubic yards (CY) of PCS were removed from the Former Diesel AST Area excavation.

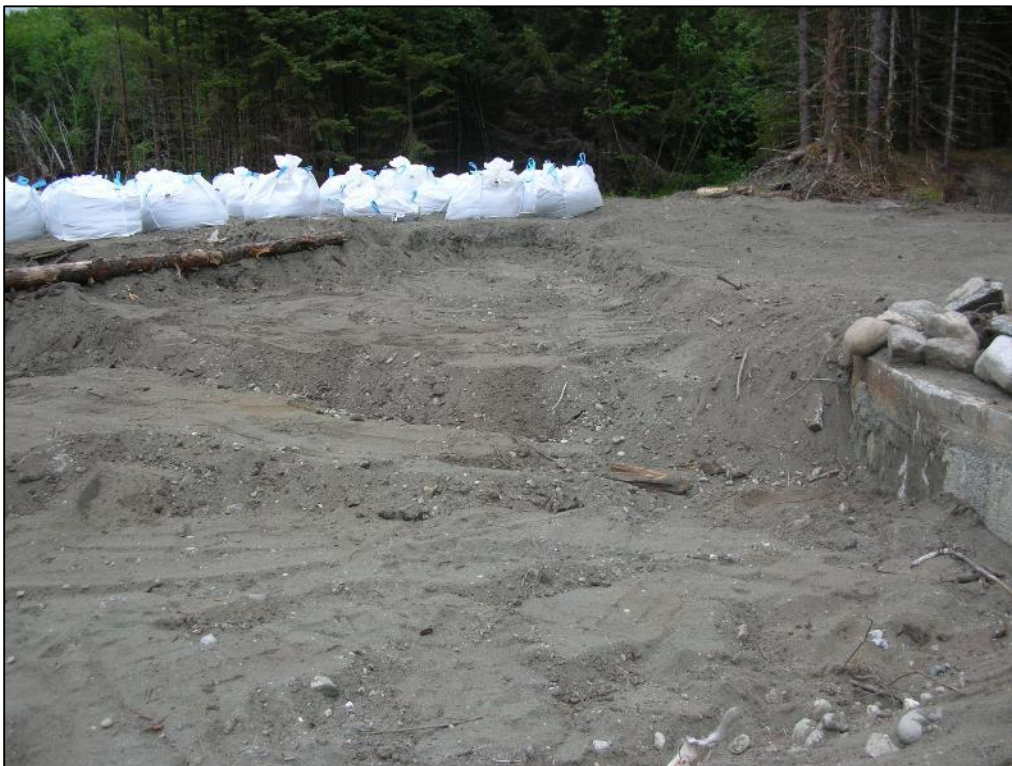
Photograph 4. Former Diesel AST Area excavation. Looking northeast.

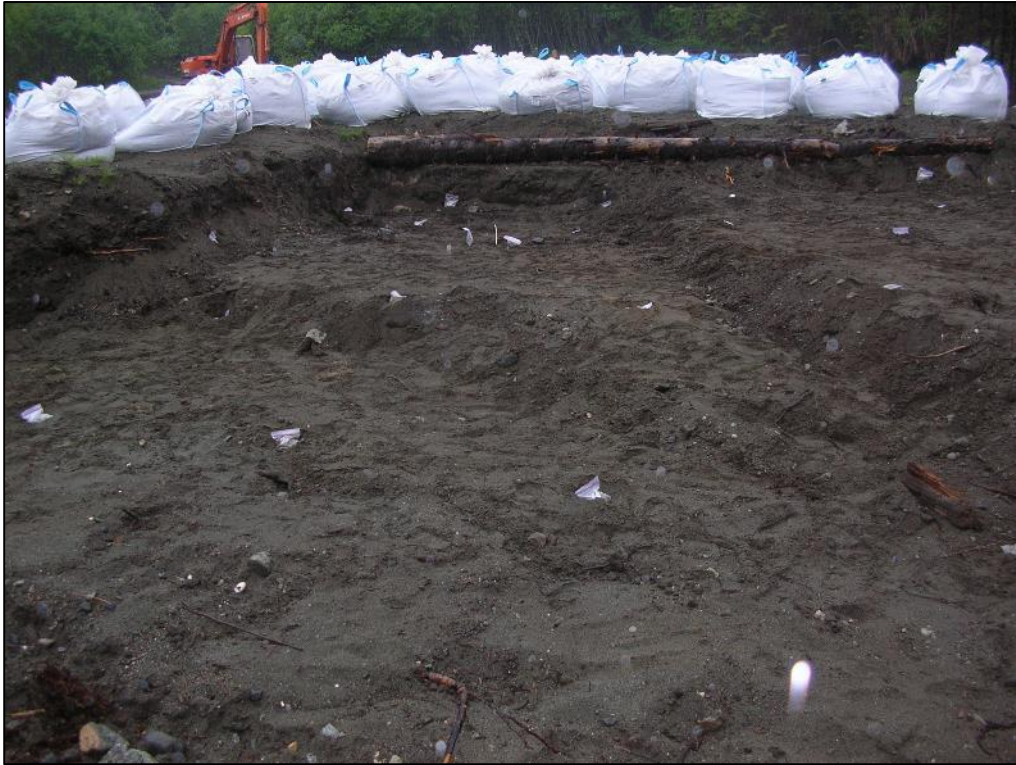
Photograph 5. Former Diesel AST Area showing screening samples and PCS filled Super Sacks®.

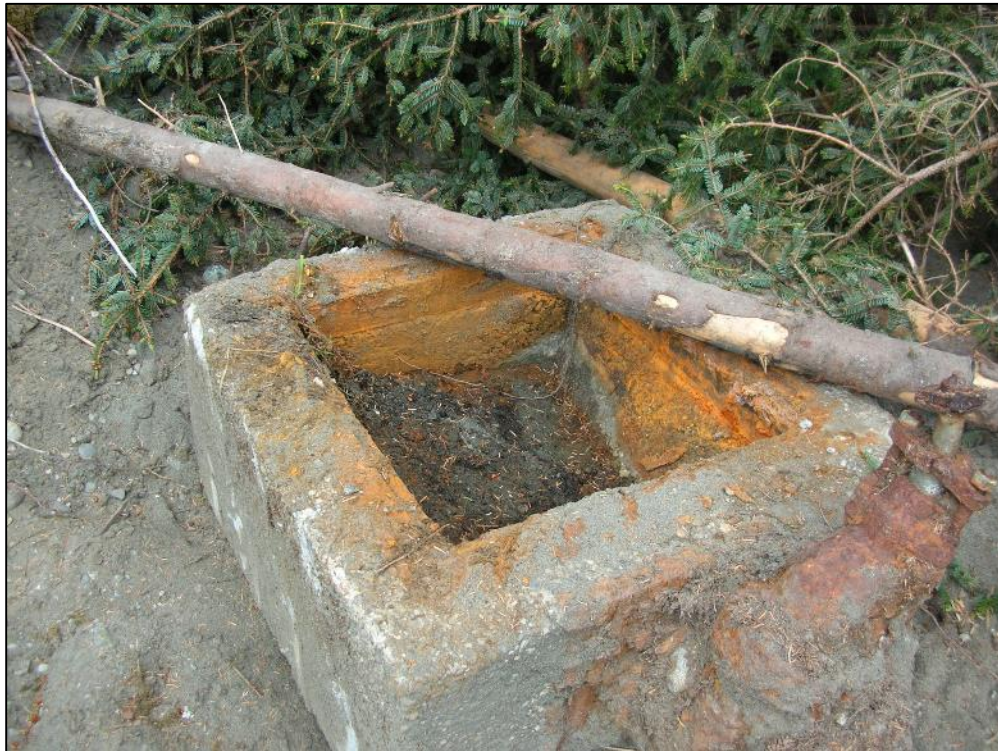
Photograph 6. Drain Area concrete catch basin after removal.

Removal of PCS at the Drain Area took place June 13 and 14, 2013. A total of approximately 3 CY of PCS were removed from the Drain Area excavation.

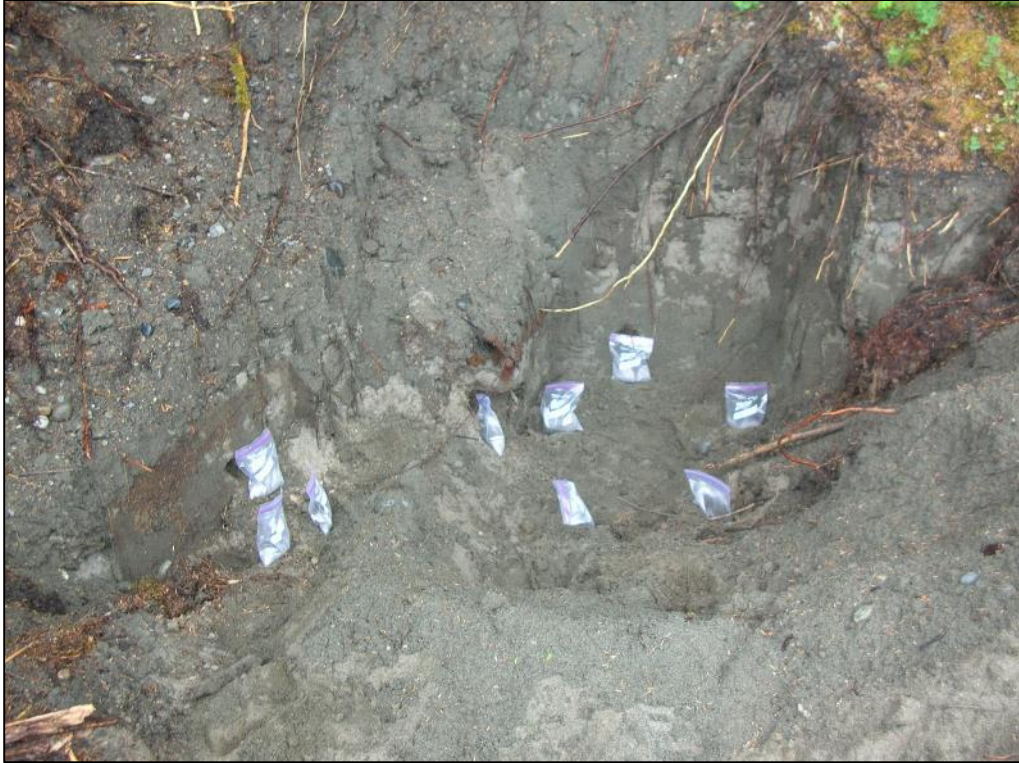
Photograph 7. Drain Area excavation showing screening samples.

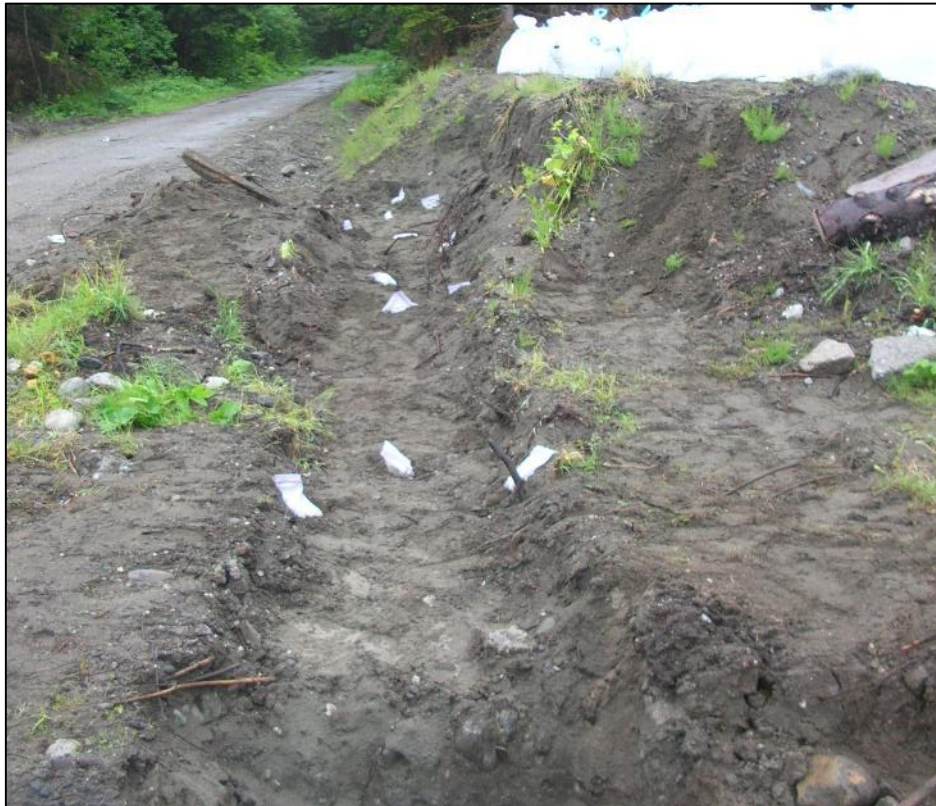
Photograph 8. Former Diesel AST Area showing screening samples in trench area.

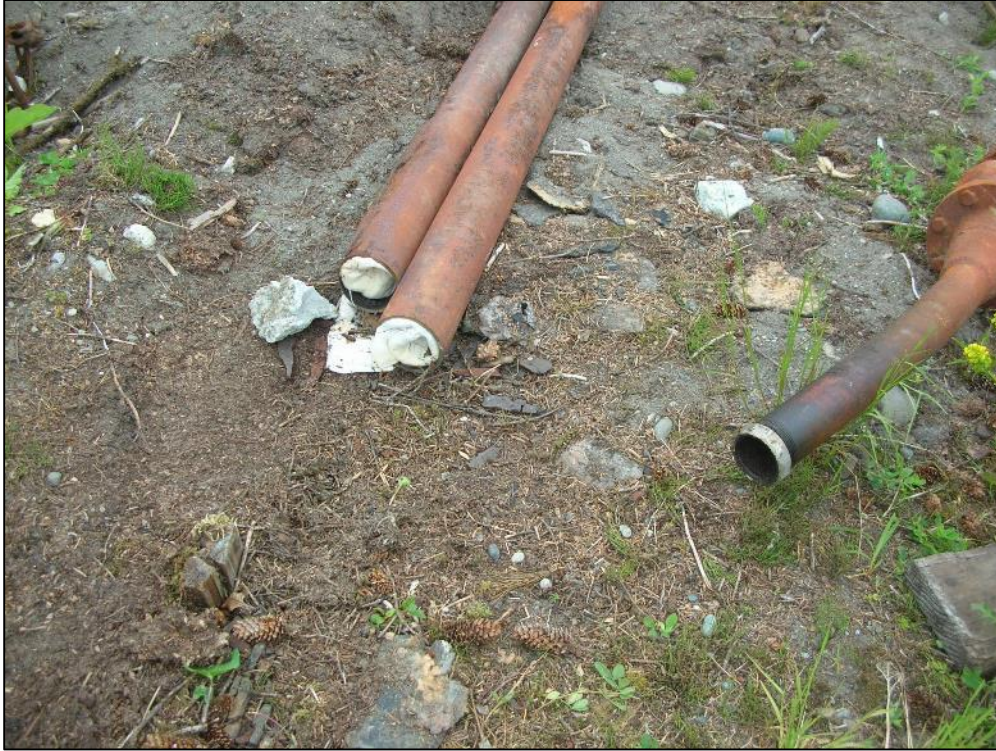
Photograph 9. Removed piping from the Former Fuel Pumphouse Area.

Removal of PCS at the Former Fuel Pumphouse Area began on June 17, 2013 and continued until June 21, 2014. A total of approximately 43 CY of PCS were removed from the Former Fuel Pumphouse Area excavation.
