October 25, 2019

Re: Summary of Permafrost Conditions Near Pump Station PS05 and the Yukon Response Base

Summary of Permafrost Conditions Near Pump Station PS05 and the
Yukon Response Base

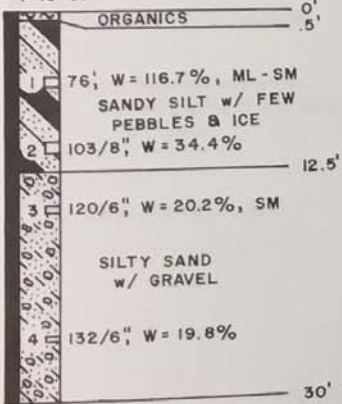
T.H. 4-75 (TAPS)
4-16-69

T.H. 4-75
Pump Station 5
drill depth 30'

Each of the boreholes show frozen conditions and ice lenses to the borehole total depths which ranged from 20.5 feet below ground surface (bgs) at TH-4-76, to 30 feet bgs at TH-4-75. In addition, the presence of ice lenses in each of these boreholes indicate permafrost since segregated ice accumulations are not associated with seasonally-frozen soil. Groundwater was not encountered in any of these three boreholes.

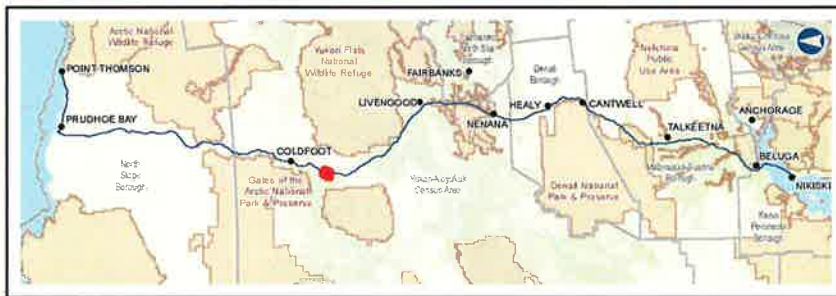
AKLNG DRAFT EIS CONTAMINATED SITES, PERMAFROST, AND SOIL SUMMARIES PS05

TABLE 1							
Potential Permafrost Stability Disruption within the Alaska LNG Project Area							
Facility Name ^a	MP (To)	MP (From)	Length (mi)	% Permafrost Crossed ^b	Permafrost Mileage	Thaw Stability	Construction Spread-Season
						(Thaw Unstable/ Thaw Stable) ^b	
LIQUEFACTION FACILITY							
Mainline	271.75	272.1	0.35	0.7	0.24	TU	Summer
Mainline	272.1	272.31	0.22	0.05	0.01	TU	Summer
Mainline	272.31	272.46	0.14	0	0	NA	Summer
Mainline	272.46	272.55	0.09	0.25	0.02	TU	Summer
Mainline	272.55	272.56	0.02	0.7	0.01	TU	Summer
Mainline	272.56	274.65	2.08	1	2.08	TU	Summer
Mainline	274.65	274.67	0.03	0.75	0.02	TU	Summer
Mainline	274.67	274.68	0	0.7	0	TU	Summer
Mainline	274.68	274.7	0.02	0.15	0	TU	Summer
Mainline	274.7	274.86	0.16	0.7	0.11	TU	Summer
Mainline	274.86	281.3	6.44	1	6.44	TU	Summer
Mainline	281.3	281.36	0.05	0	0	NA	Summer
Mainline	281.36	281.44	0.08	0.3	0.03	TU	Summer
Mainline	281.44	282.49	1.05	1	1.05	TU	Summer

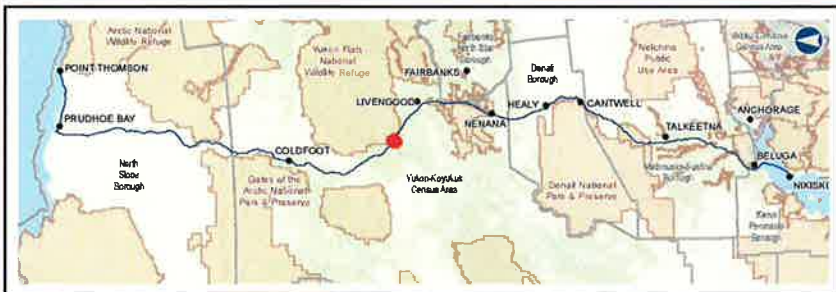
AKLNG DRAFT EIS CONTAMINATED SITES, PERMAFROST, AND SOIL SUMMARIES YRB

TABLE 1							
Potential Permafrost Stability Disruption within the Alaska LNG Project Area							
Facility Name ^a	MP (To)	MP (From)	Length (mi)	% Permafrost Crossed ^b	Permafrost Mileage	Thaw Stability	Construction Spread-Season
						(Thaw Unstable/ Thaw Stable) ^b	
LIQUEFACTION FACILITY							
Mainline	352.54	352.56	0.02	0.9	0.02	TU	Winter
Mainline	352.56	352.57	0.01	1	0.01	TU	Winter
Mainline	352.57	352.59	0.02	0.75	0.01	TU	Winter
Mainline	352.59	352.89	0.3	1	0.3	TU	Winter
Mainline	352.89	353.29	0.4	0.7	0.28	TU	Winter
Mainline	353.29	353.87	0.58	1	0.58	TU	Winter
Mainline	353.87	353.92	0.04	0.75	0.03	TU	Winter
Mainline	353.92	354.23	0.31	1	0.31	TU	Winter
Mainline	354.23	354.24	0.01	0.85	0.01	TU	Winter
Mainline	354.24	354.46	0.22	0.75	0.17	TU	Winter
Mainline	354.46	354.81	0.35	1	0.35	TU	Winter
Mainline	354.81	354.83	0.02	0.75	0.01	TU	Winter
Mainline	354.83	354.89	0.06	0.7	0.04	TU	Winter
Mainline	354.89	354.91	0.02	0.75	0.02	TU	Winter

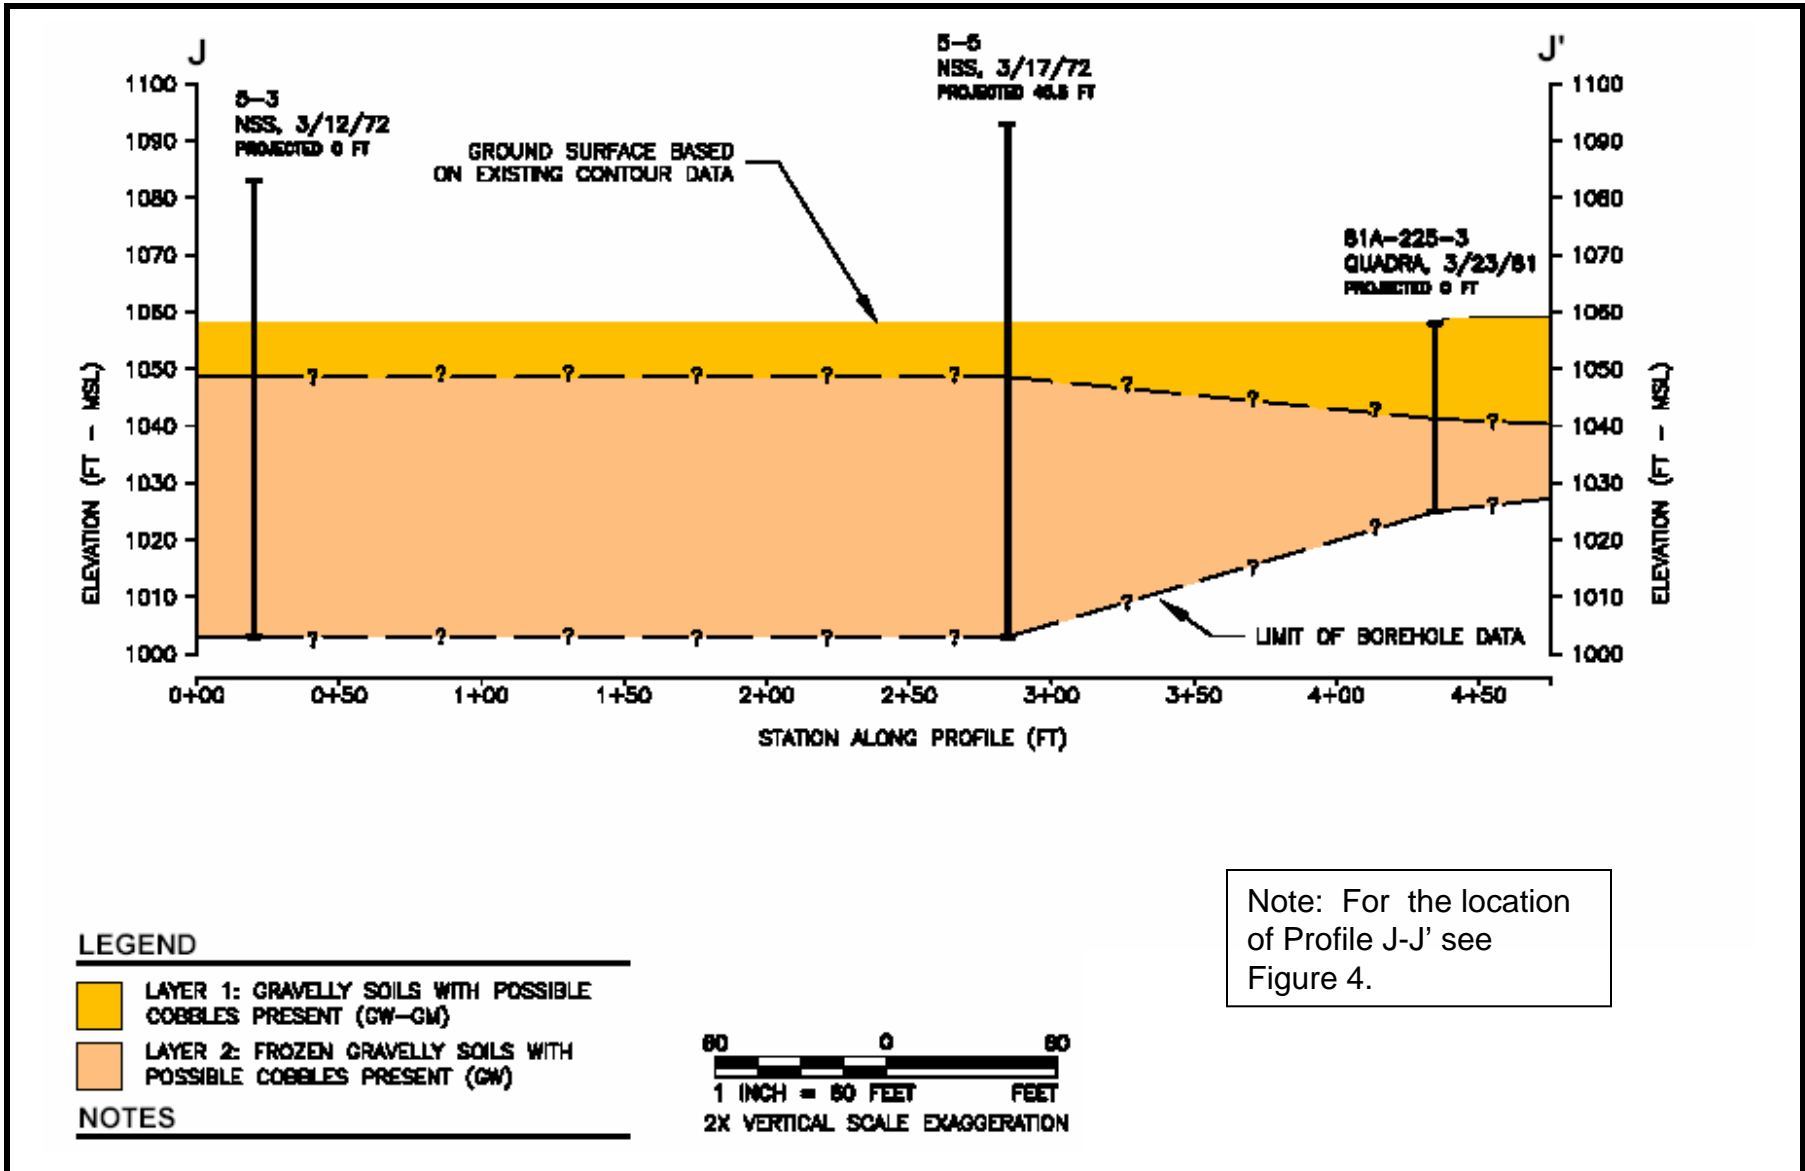
Figure 5

Profile J-J'

Borehole data were compiled into facility maps (Figures 3 and 4) and cross sections (Figures 4 through 7) and are provided as Appendix F. Facility cross sections show frozen soil was encountered across the facility up to 70 feet beneath the placed-fill surface layer. Frozen soil was present to the full depth of each boring (Appendix F). Groundwater was not noted on any of the ten borehole logs for boreholes drilled at the PS05 facility. The active, seasonal thaw, layer was estimated to extend to 8 feet bgs. Below the active layer, the permafrost was estimated to extend to greater than 100 feet bgs (Golder, 2004a).

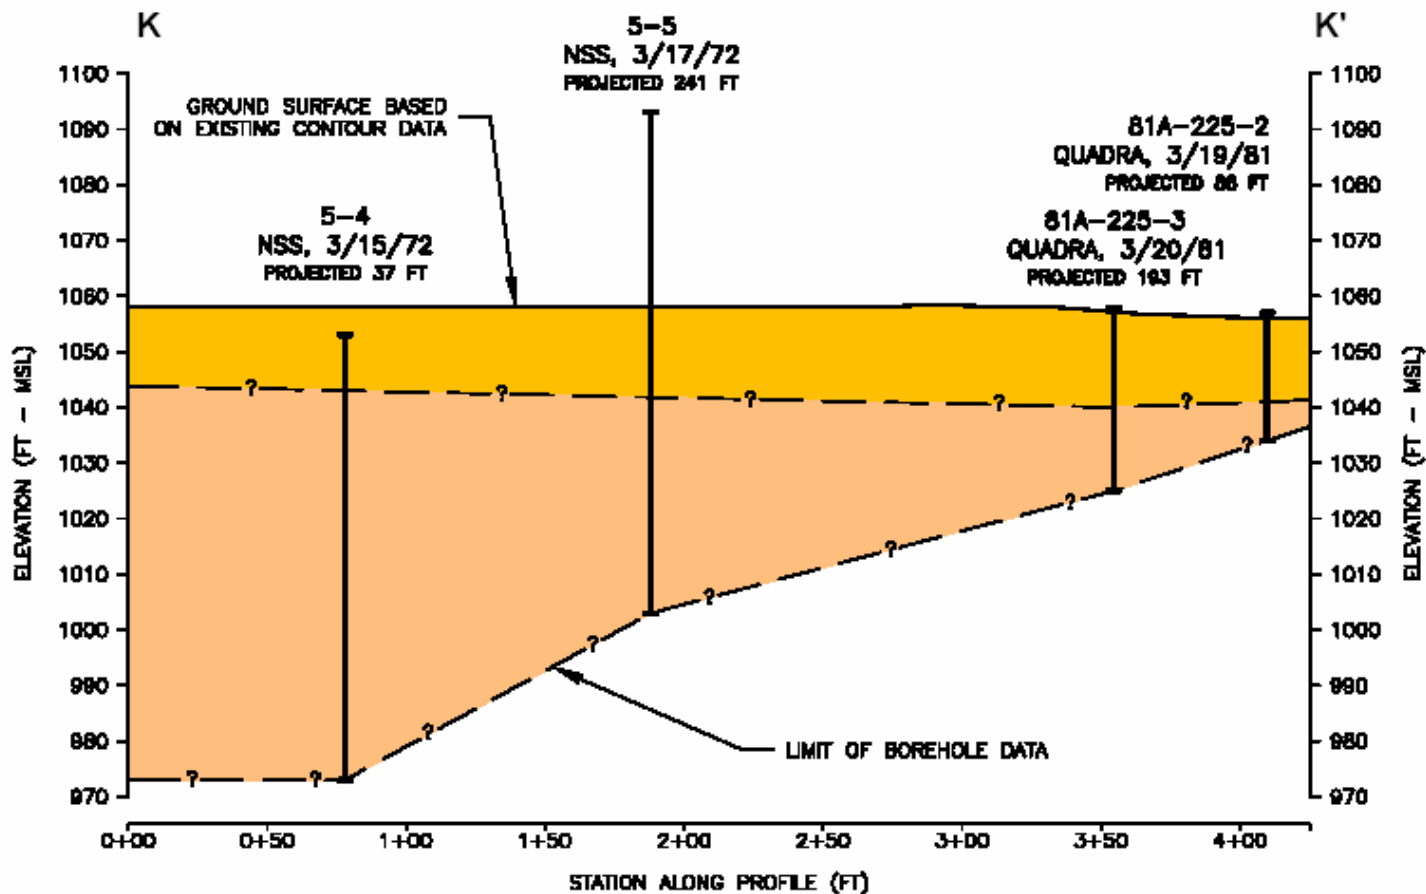
Figure 6

- LAYER 1: GRAVELLY SOILS WITH POSSIBLE COBBLES PRESENT (GW-GM)
- LAYER 2: FROZEN GRAVELLY SOILS WITH POSSIBLE COBBLES PRESENT (GW)

Note: For the location of Profile K-K' see Figure 4.

Profile K-K'

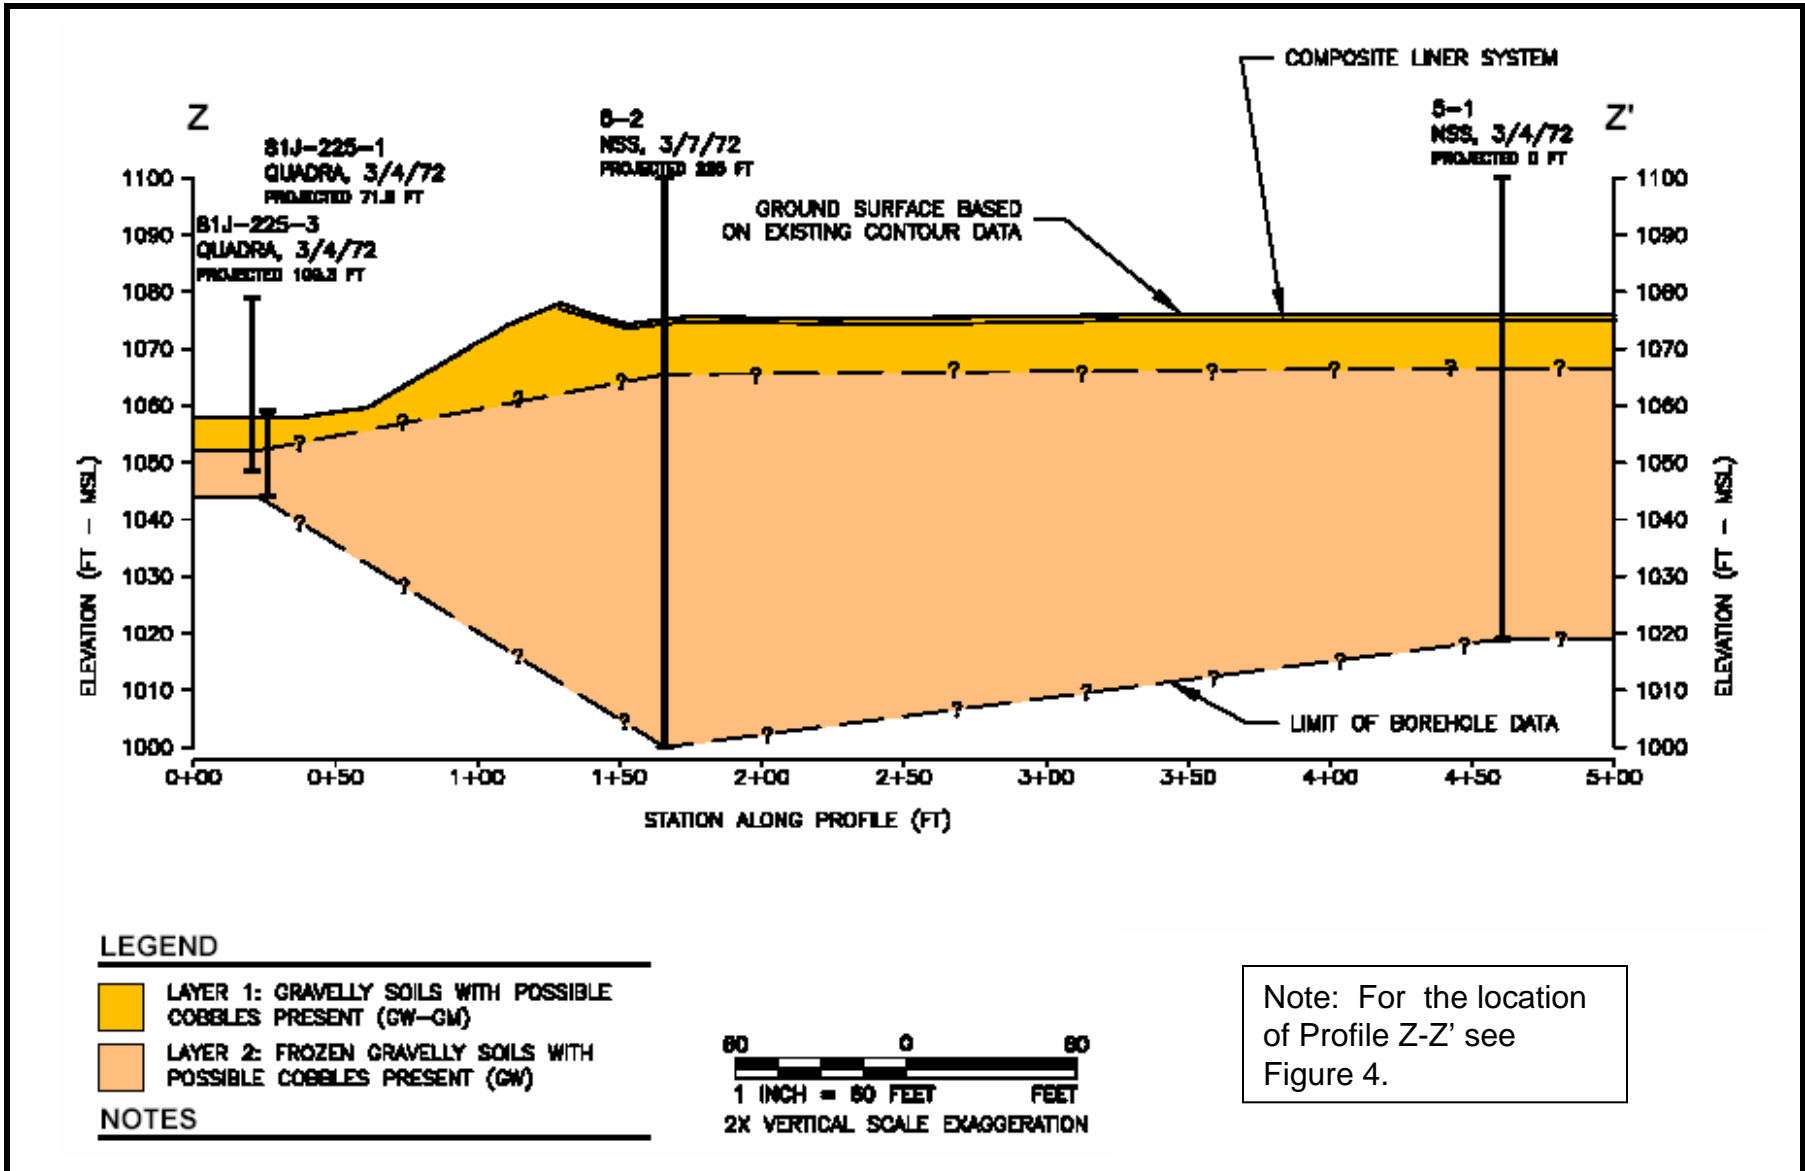
Figure 7

Profile Z-Z'
