**Subject: Slope Repeater Site Closure Report****ENSR Project Number 00550-341**

ENSR Corporation (ENSR) is pleased to submit this report on behalf of Mr. Larry Bamberger, AT&T Environmental, Health, and Safety Operations Manager, in support of a No Further Action (NFA) determination for the Slope Repeater. The following report presents the results of Site Assessment work conducted by ENSR at the Slope Repeater and summarizes all field activities performed at the site, including a review of sampling results, data quality, and site management recommendations.

The Slope Repeater, a remote communications facility, is located on a mountain top north of the Brooks Range near Pump Station 3. The repeater site is not road-accessible, and helicopters are used to access the site. The facility consists of four 1,250-gallon aboveground storage tanks (ASTs), a generator module, a battery (equipment) module, and a microwave repeater tower. The facility is level with the natural ground surface. The soils at this location occur in a thin, discontinuous horizon of poorly sorted soil and fine sand (talus fines) that overlie bedrock and talus. No groundwater was encountered at this site. The neare

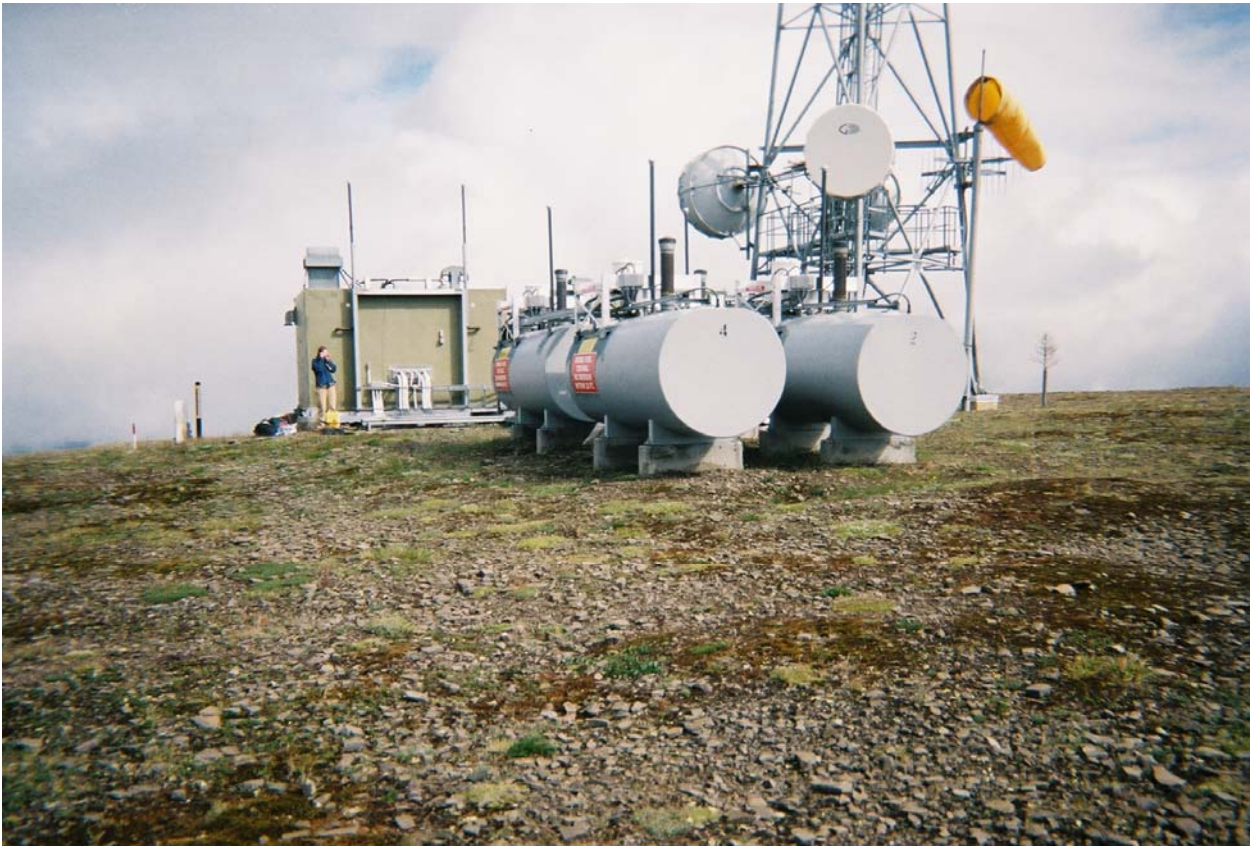
Site photograph of Slope Repeater AST area; view looking northeast.

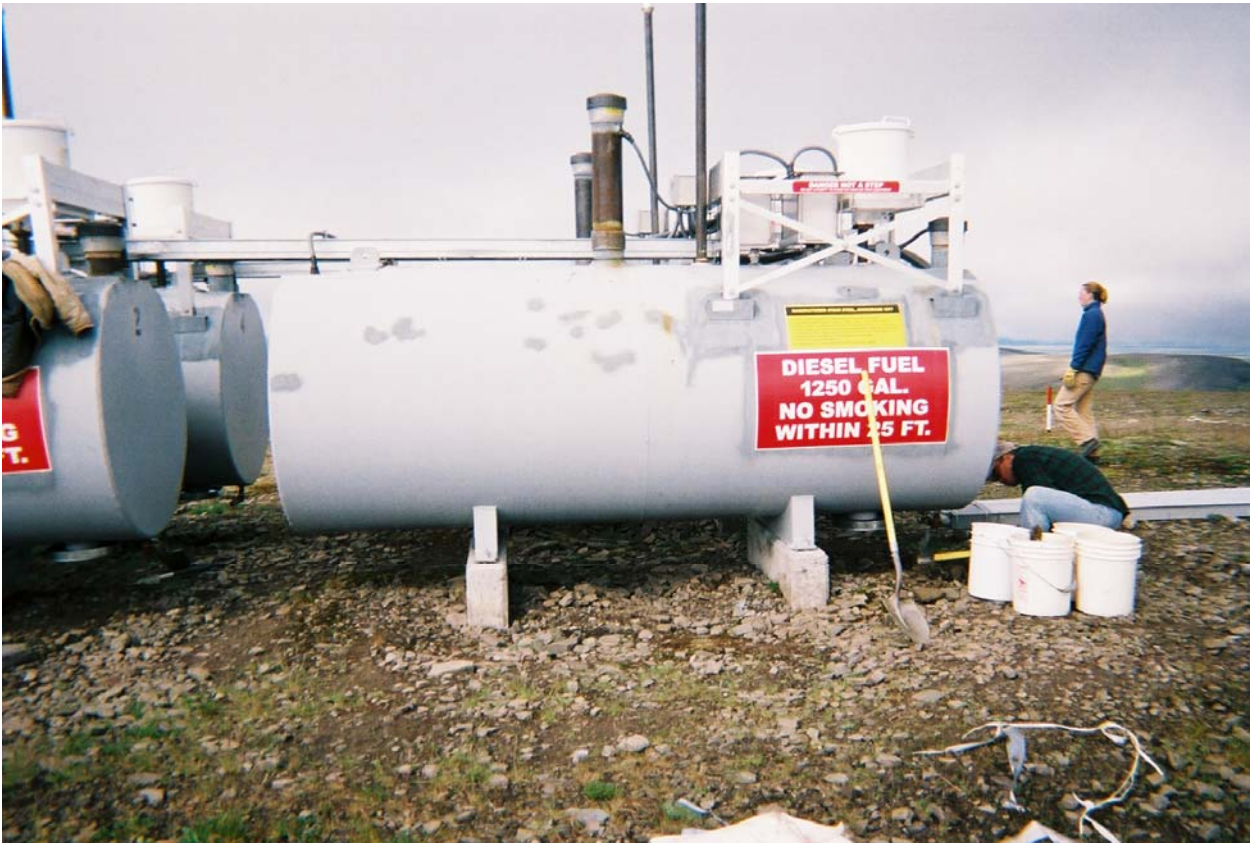
Excavation in progress beneath AST 1 valve looking west.

ENSR conducted an Environmental Assessment site inspection on July 8, 2004. Remedial action conducted in the AST area during 2004 was concentrated beneath the valve of AST 1. Approximately 0.5 cubic yards of potentially contaminated soil was removed from this excavation to a depth of 12 inches. Field screening confirmed that all potentially contaminated soils were removed from the AST area.

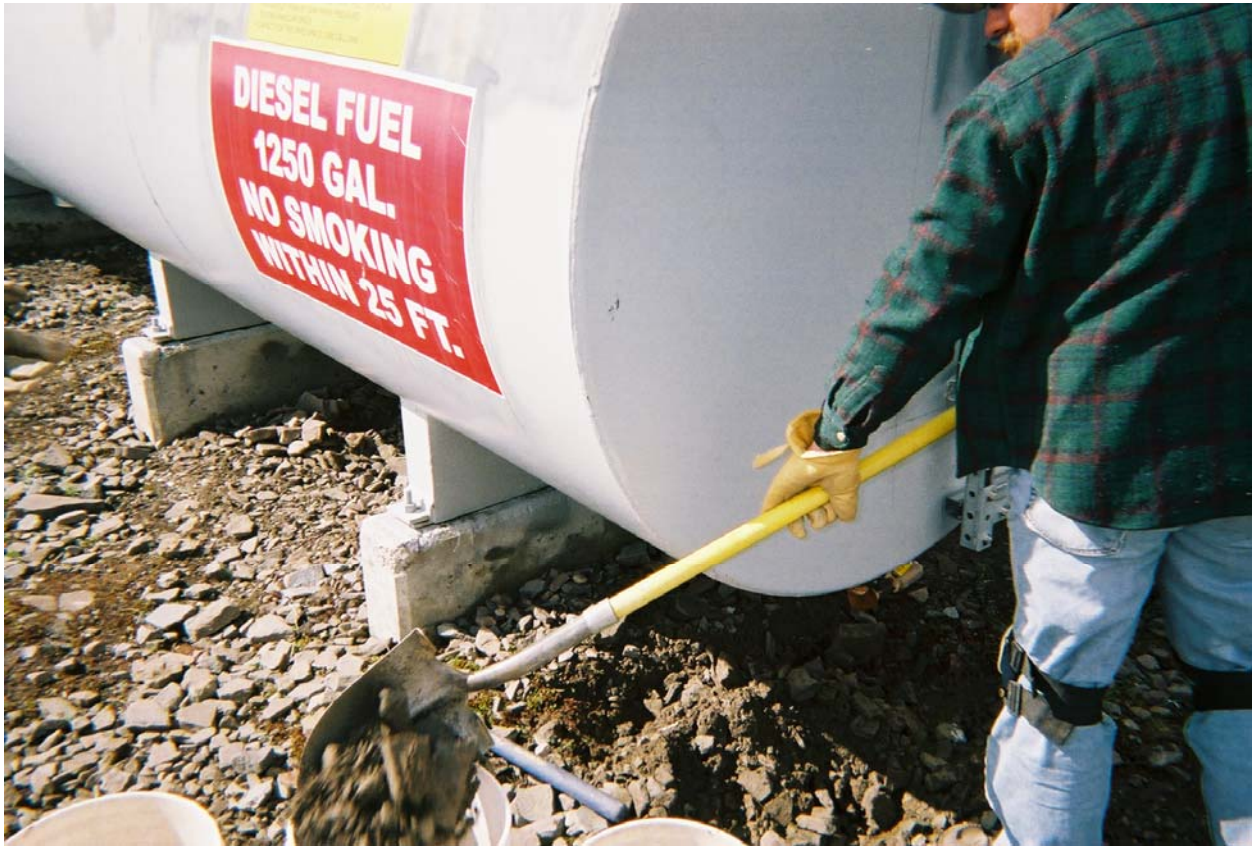
Excavation beneath AST 1 valve in progress looking southwest.

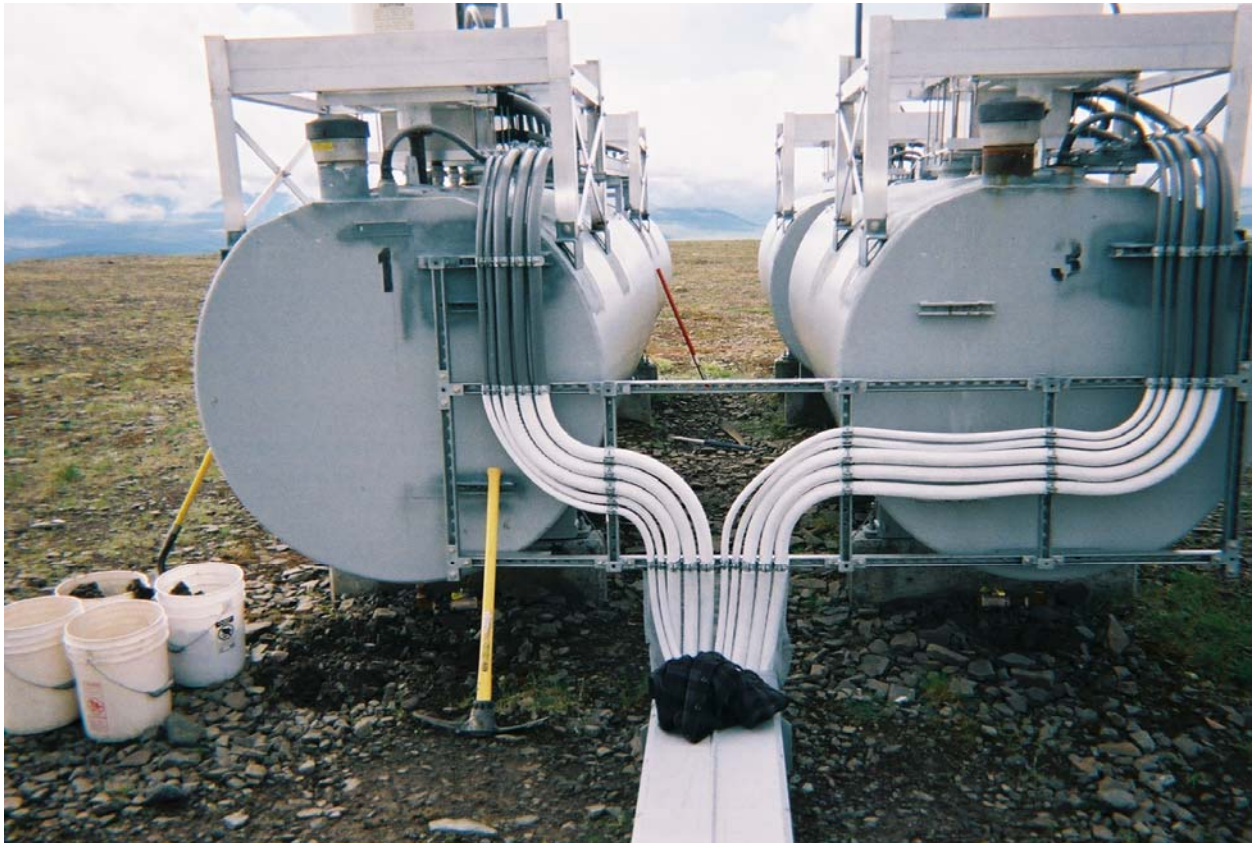
Excavation beneath AST 1 valve completed looking south.

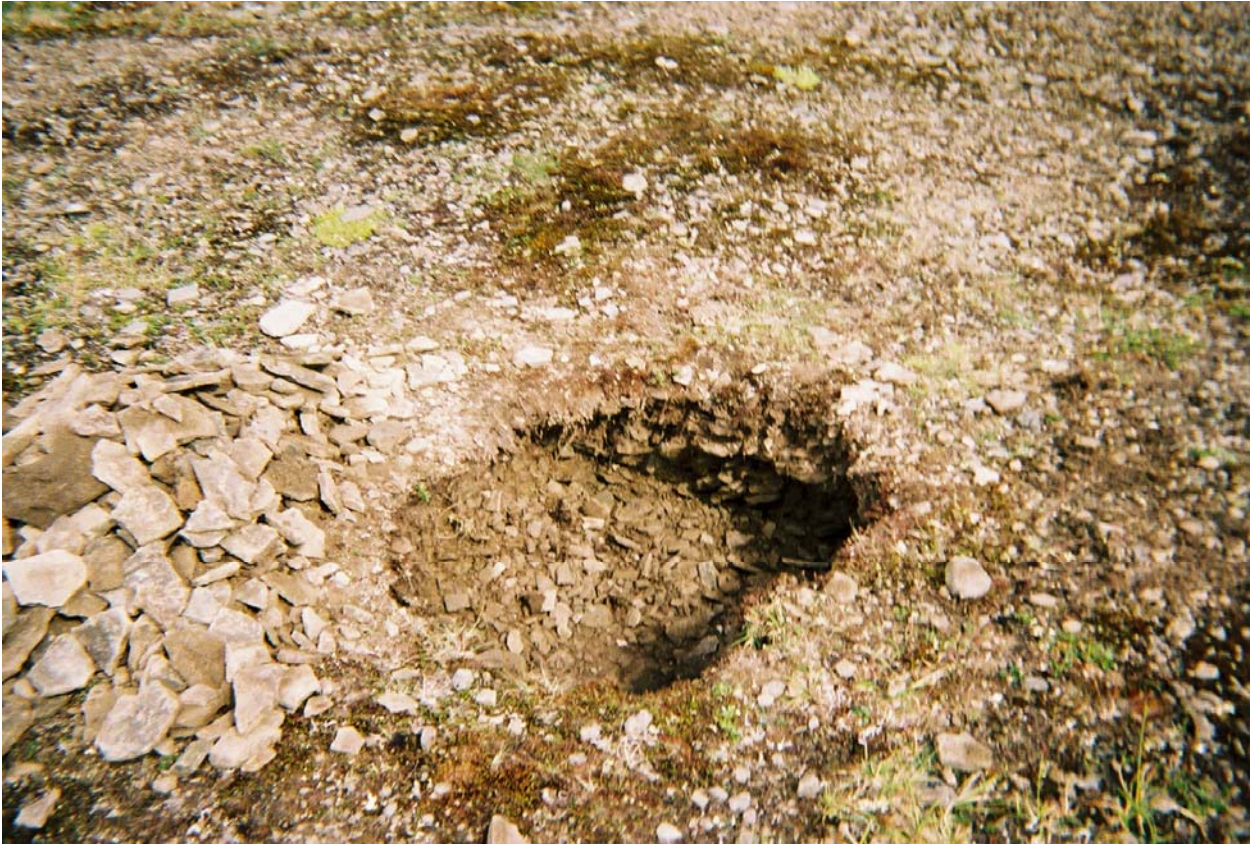
Final excavation of fuel bladder staging area looking north.

Based on a field screening grid established by the SLR Consulting, one hotspot was located in the suspected Fuel Bladder Staging area. The hotspot, located approximately 40 feet southwest of the AST area, was excavated to a depth of 18 inches below ground surface (bgs) where fractured bedrock was encountered. One analytical sample was collected from the northern sidewall of the excavation at 18 inches bgs and reported an estimated DRO concentration of 15.9 mg/kg below the practical quantitative limit. Approximately 1 cubic yard of potentially contaminated soil was removed from the fuel bladder staging area.

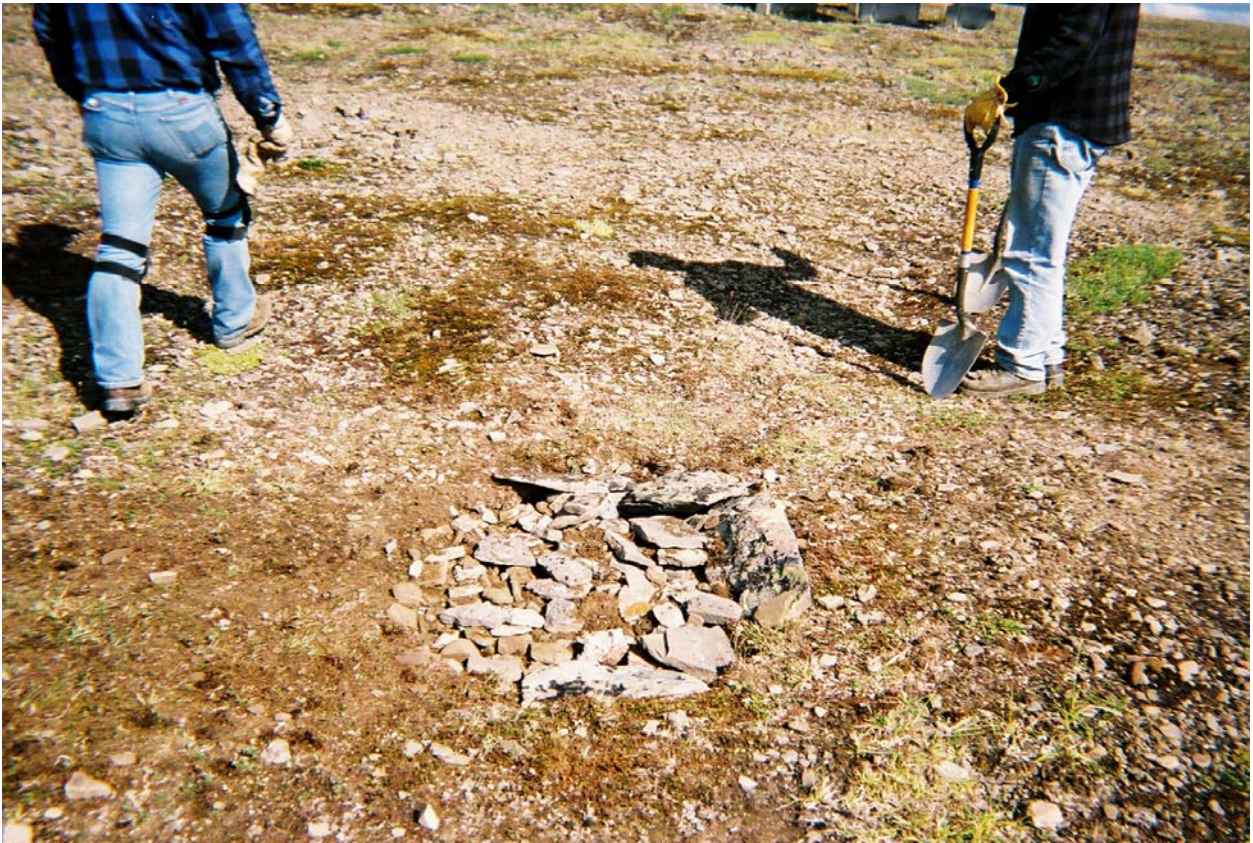
Fuel bladder staging area excavation backfilled with native material looking northeast.

Remedial excavations were backfilled and compacted using clean material available on site or clean D-1 (non-frost susceptible) material brought to the site by helicopter. Excavated soils, containerized in 1 cubic yard supersacks, were removed by helicopter and transported by truck to a facility in Big Delta owned and operated by FMW, LLC, where they were thermally remediated.

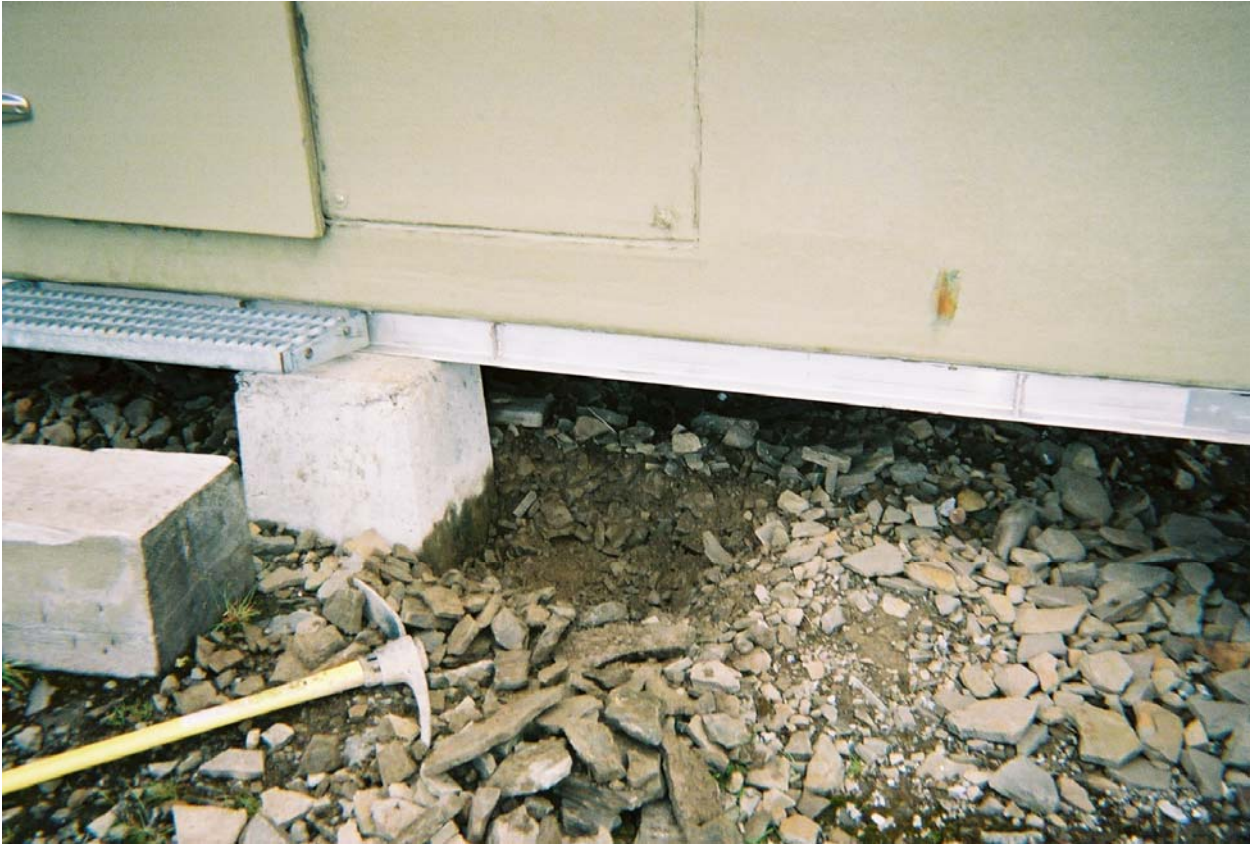
Excavation beneath north side of the Generator Module looking south.

Potentially contaminated soil was removed from three small excavations around the perimeter of the Generator Module. One excavation on the north side of the Generator Module east of the door, a second in the northeast corner of the Generator Module, and a third in the southeast corner. The excavations were continued to depths ranging from 8 to 12 inches bgs. Field screening indicated that all potentially contaminated soil was removed from the Generator Module area. Less than 0.5 cubic yard of potentially contaminated soil was removed from the Generator Module area.

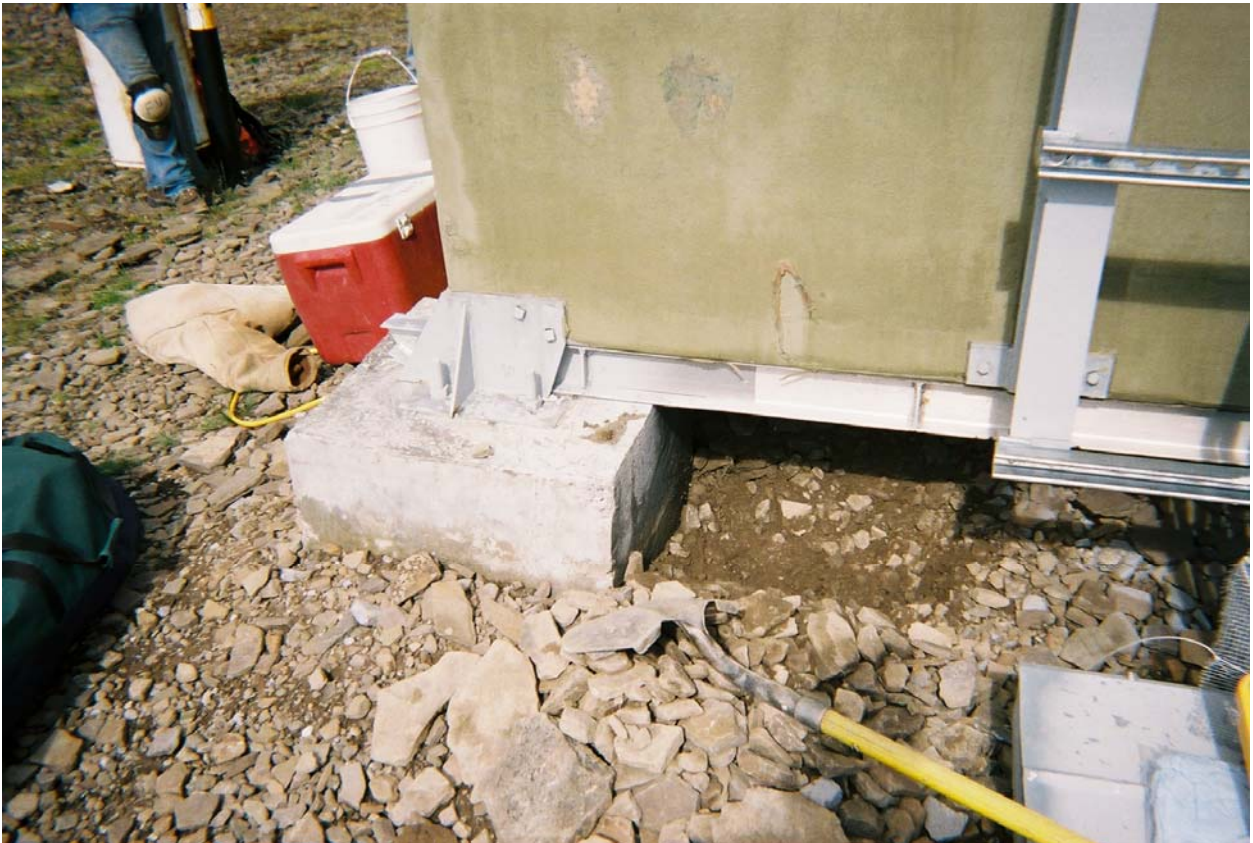
Excavation in the southwest corner of the Generator Module looking north.

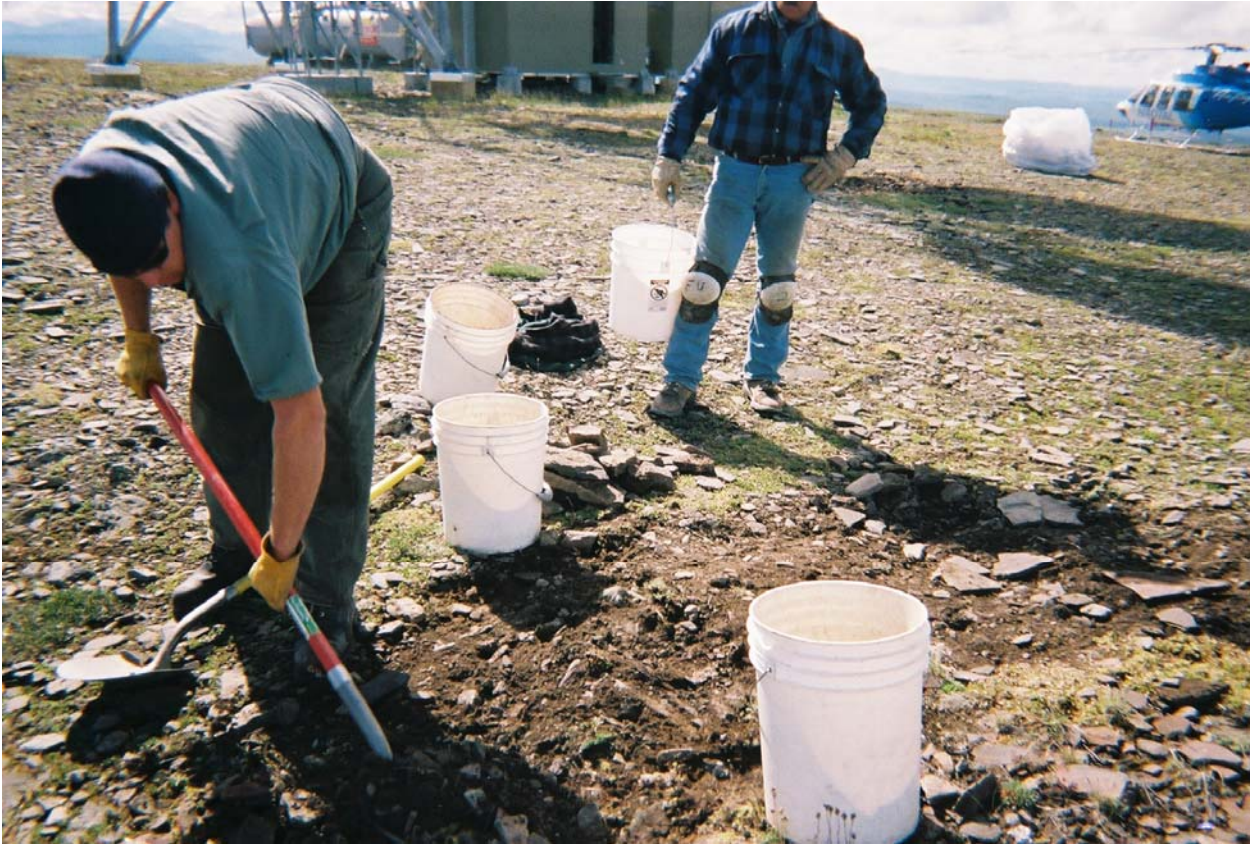
Excavation of the Burn Pit 2 looking south.

During the initial site walkover, three burn pit locations were observed. The photoionization detector (PID) results from the burn pits were below the action level of 10 parts per million (ppm), however, the burnt soil, nails, and other debris were removed. Approximately 0.5 cubic yards of soil and debris were removed from the three burn pit locations.

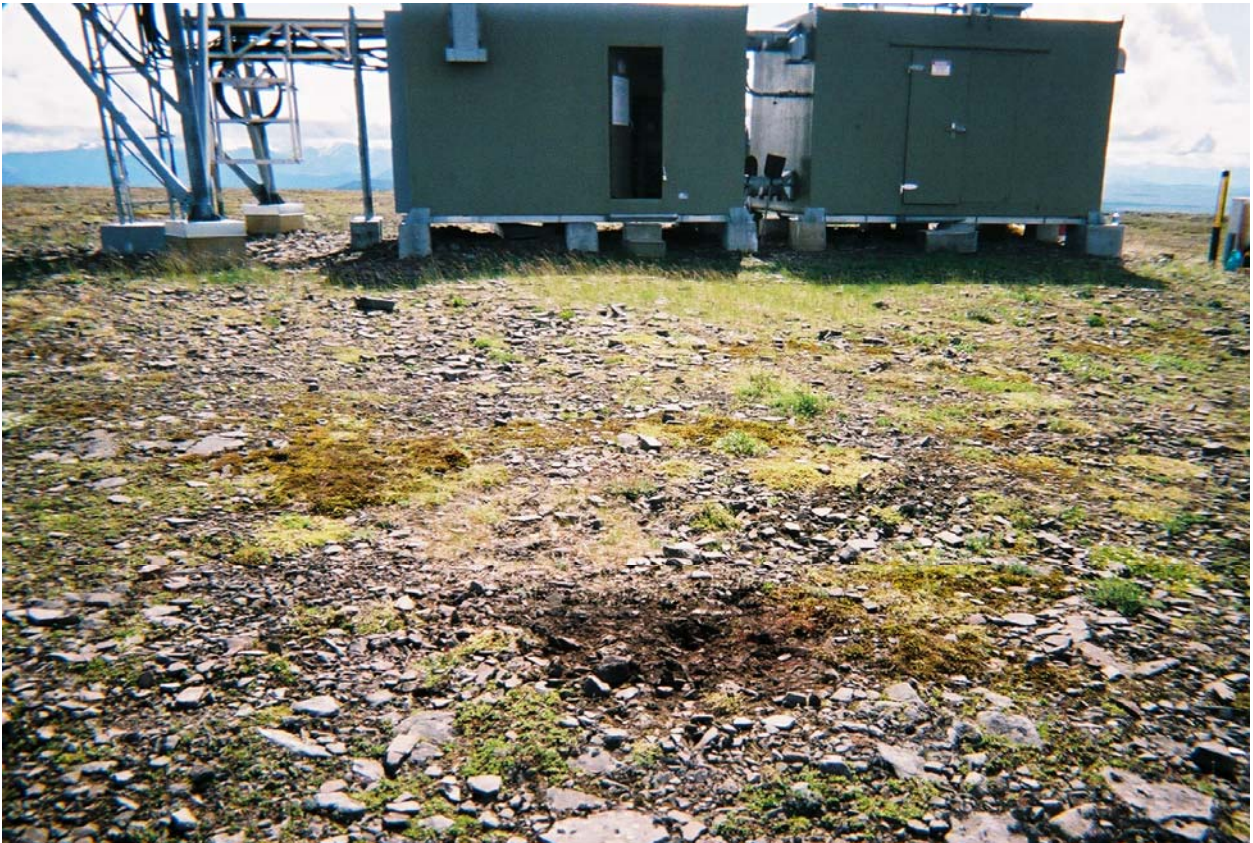
Completed excavation and backfill of Burn Pit 1 looking south.

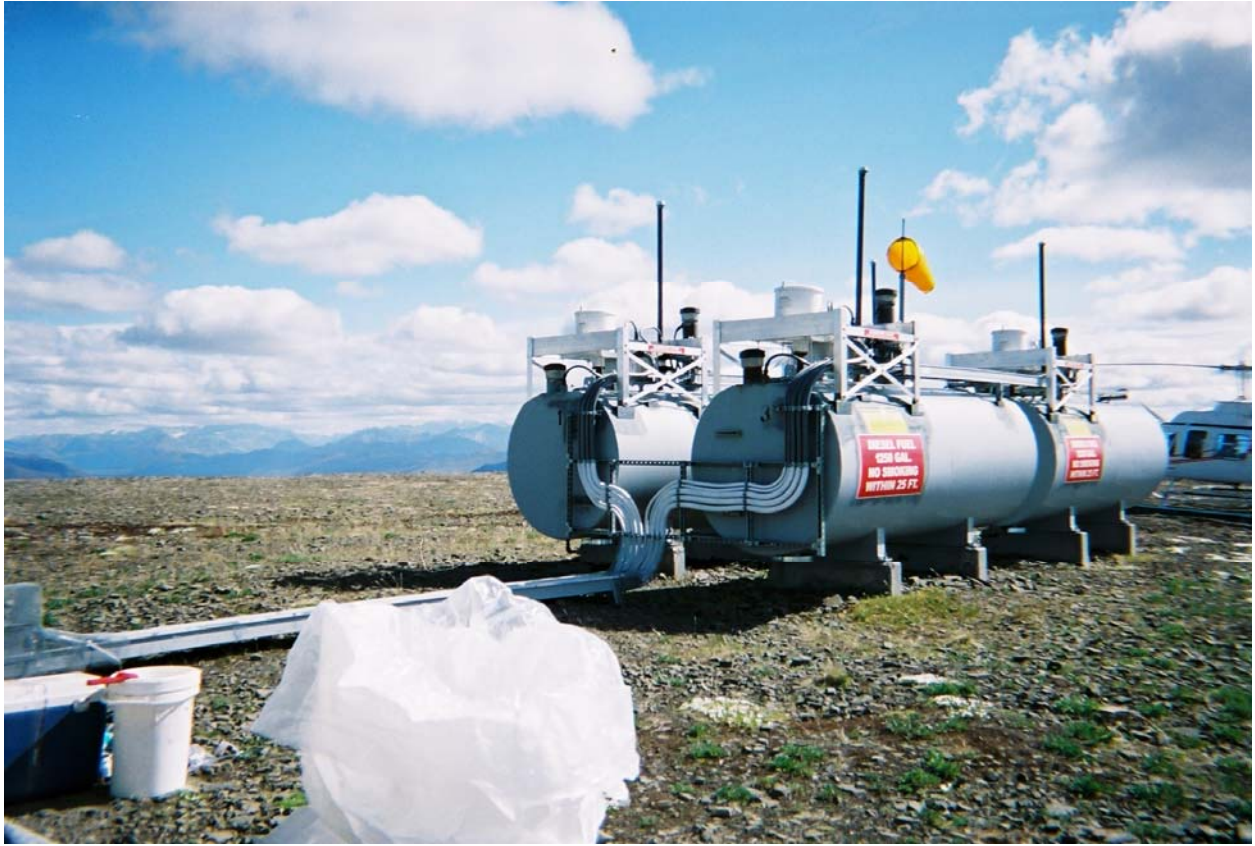
Site photograph of Slope Repeater AST area; view looking southeast.

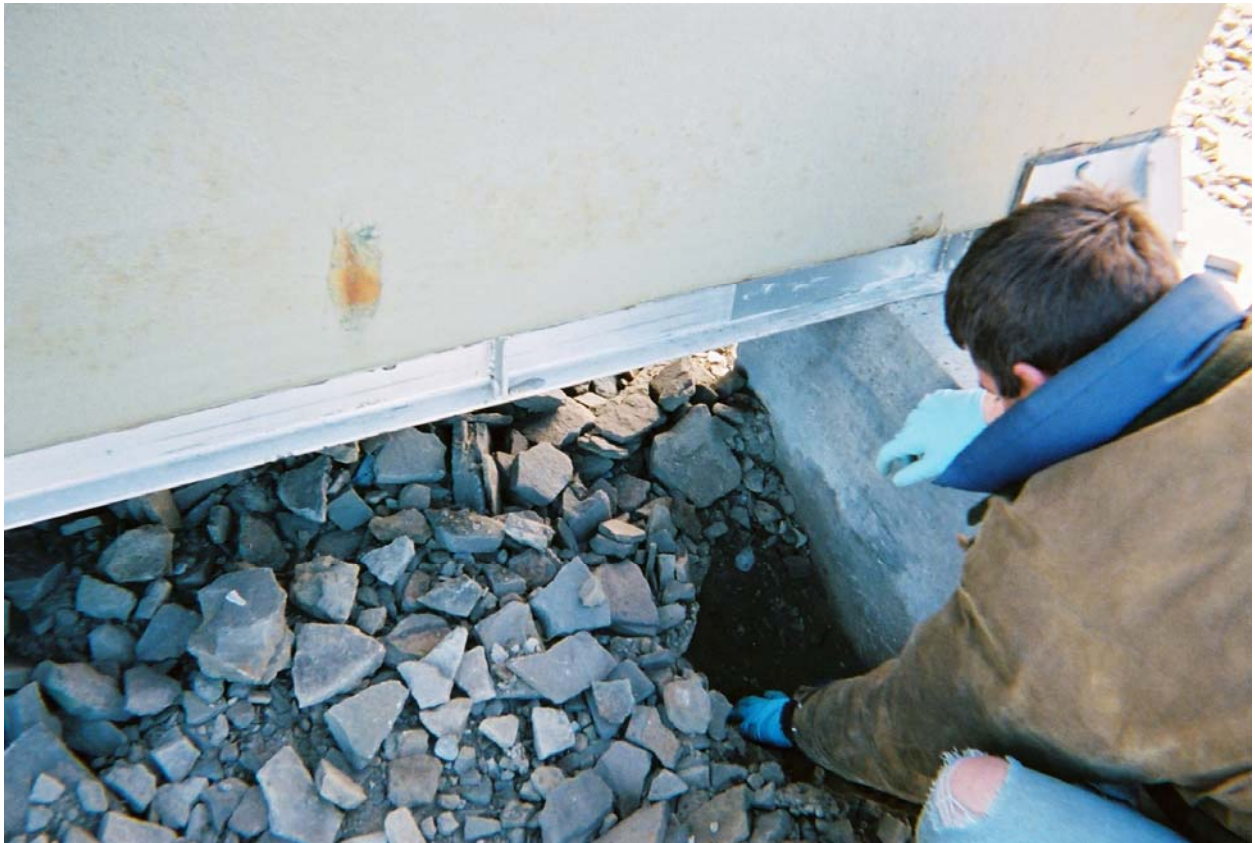
Collecting PID samples around the perimeter of the Generator Module.

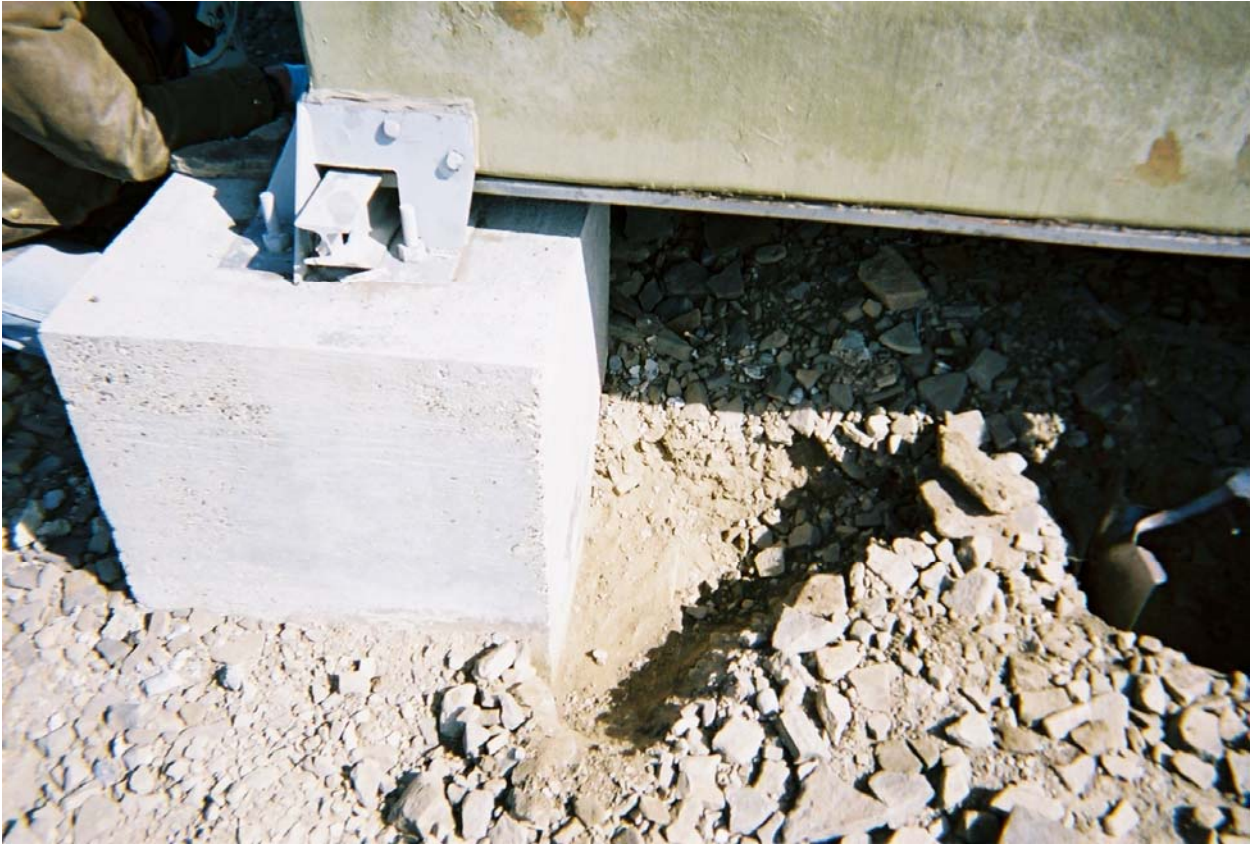
Excavation beginning beneath northwest corner of the Generator Module.

On July 15, 2005, ENSR returned to the Slope Repeater site to investigate a reported spill of lube oil beneath the Generator Module. During the 2005 field program, approximately 1 cubic yard of petroleum-contaminated soil was removed from beneath the northwest corner of the generator module. The excavation was guided using field screening with the PID meter. Two analytical samples were collected from the northern extent and the floor of the excavation. One sample, 05SLOPE02SL, collected from the floor of the excavation, reported a DRO concentration of 3,250 mg/kg, which is above the cleanup level.

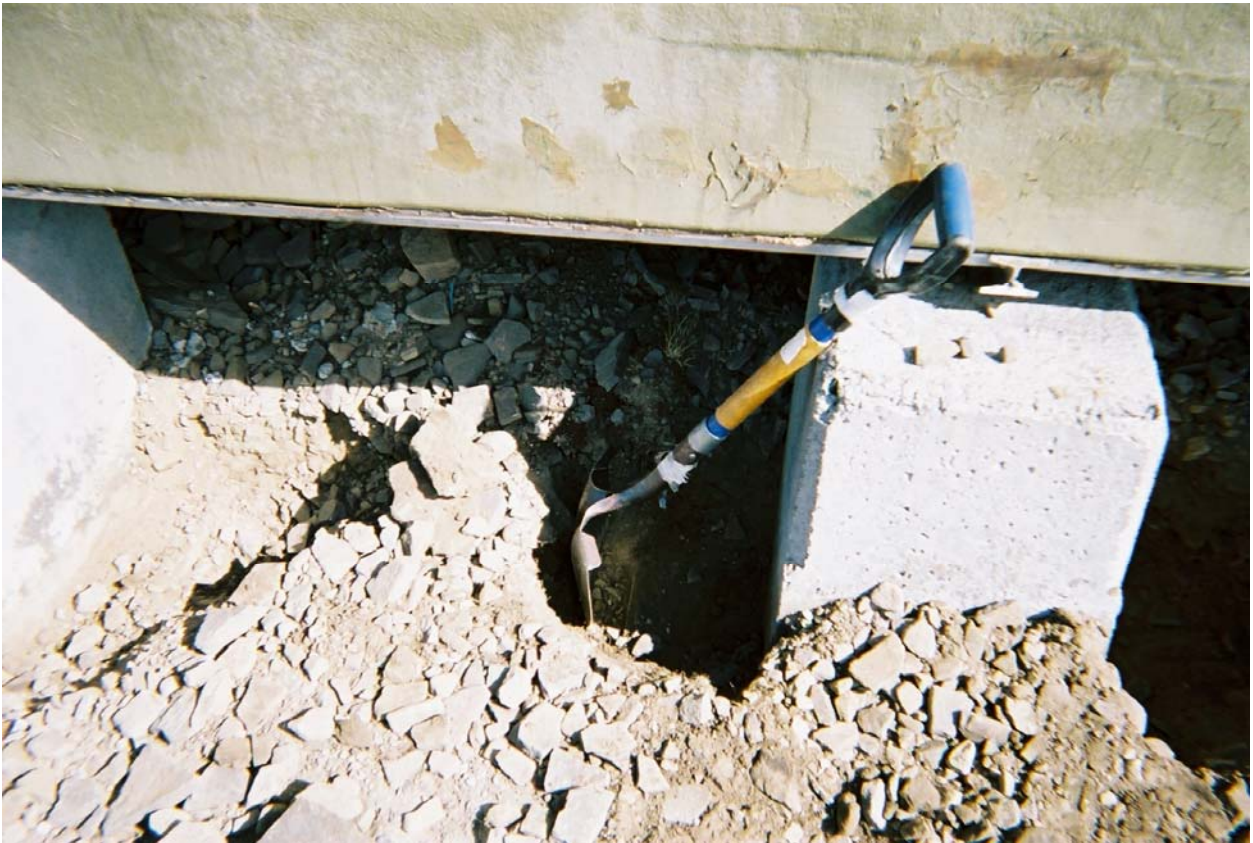
Excavation continuing along western edge of the Generator Module.

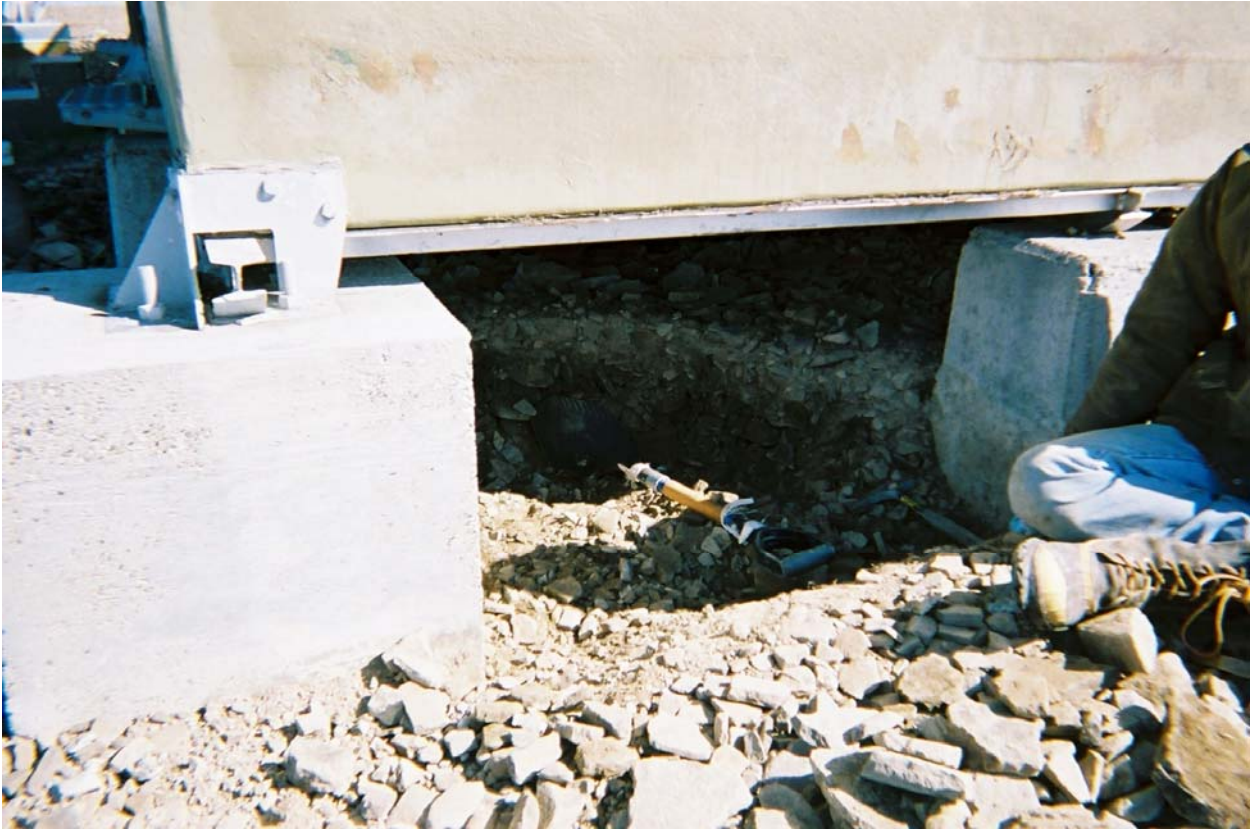
Completed excavation beneath northwest corner of the Generator Module with shovel for scale.

On August 18, 2006, ENSR returned to the Slope Repeater site to remove any remaining contaminated material from beneath the Generator Module and collect confirmation samples from the floor and sidewall of the excavation. Approximately 0.5 cubic yard of potentially contaminated material was removed from beneath the northwest corner of the Generator Module. Both samples reported DRO concentrations below the established cleanup level.

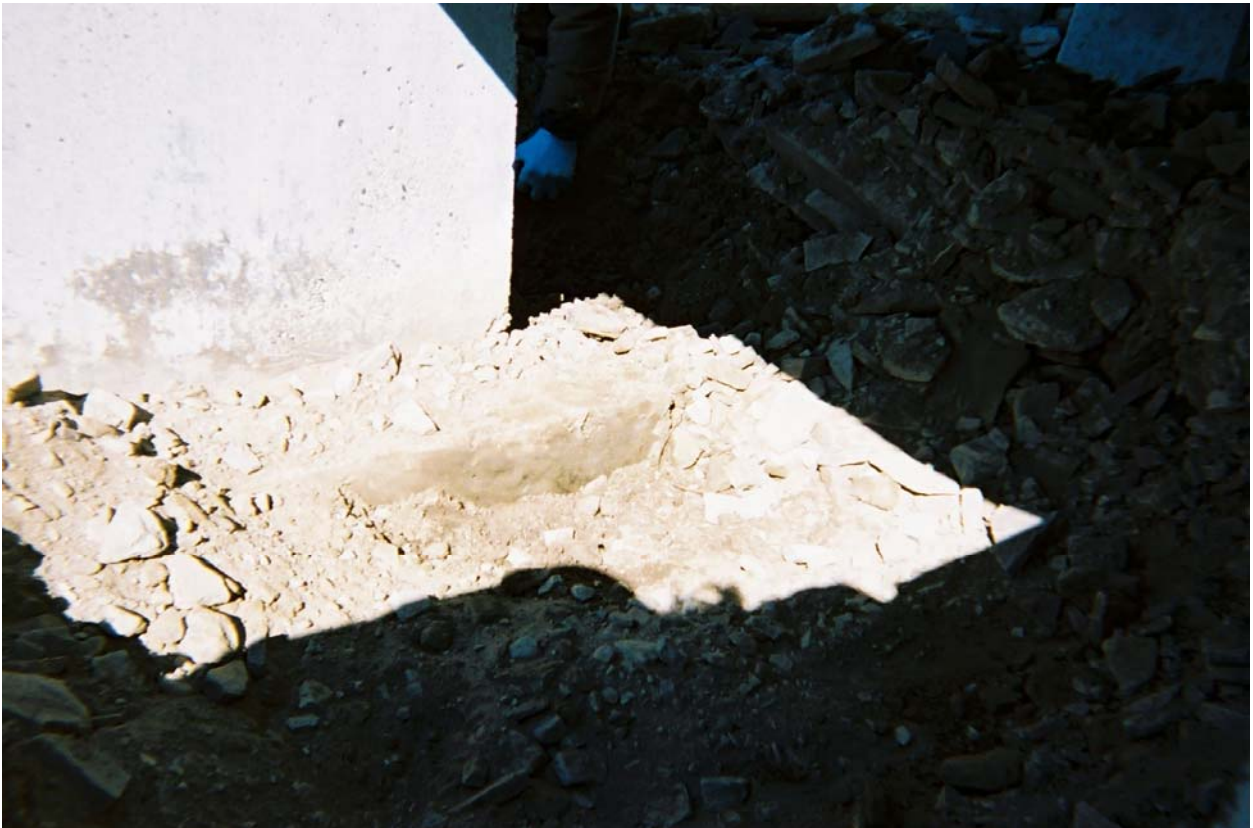
Completed excavation beneath northwest corner of the Generator Module.

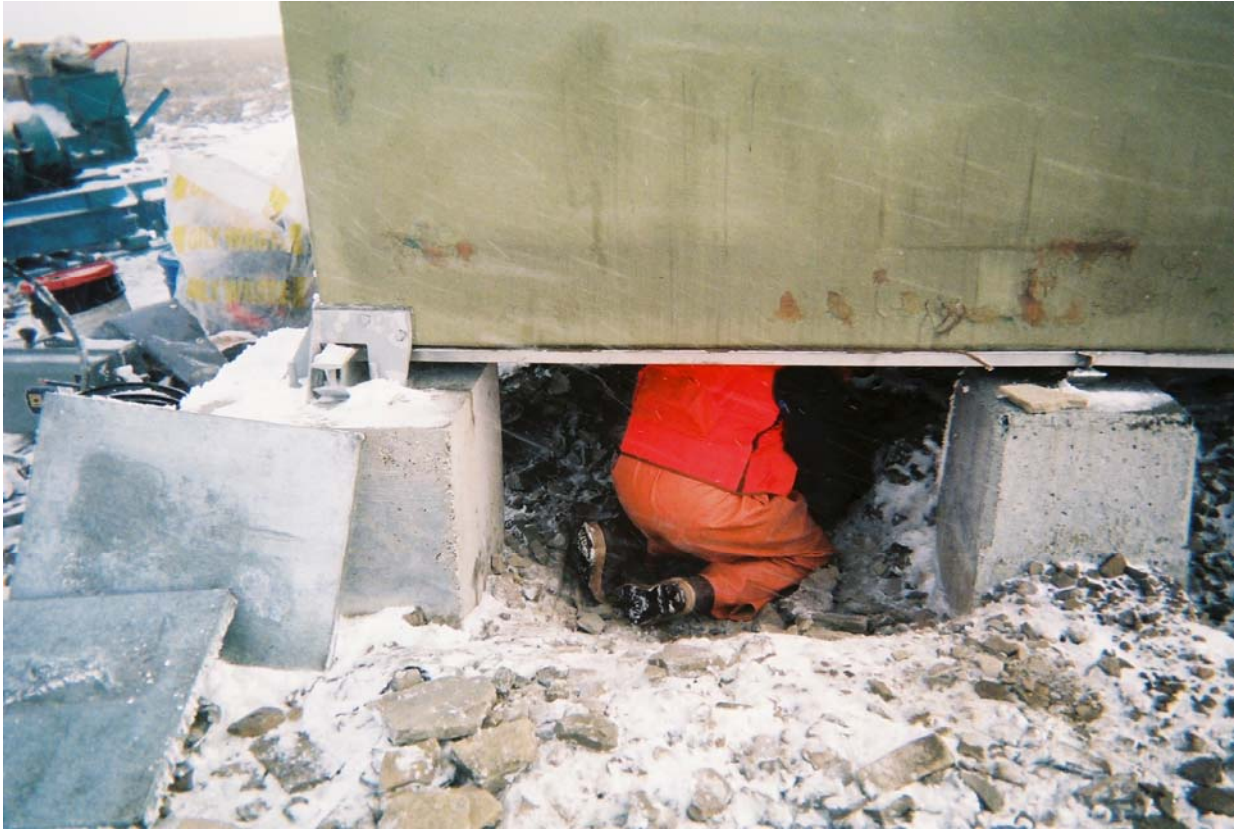
Collecting confirmation samples from the completed excavation beneath northwest corner of the Generator Module.

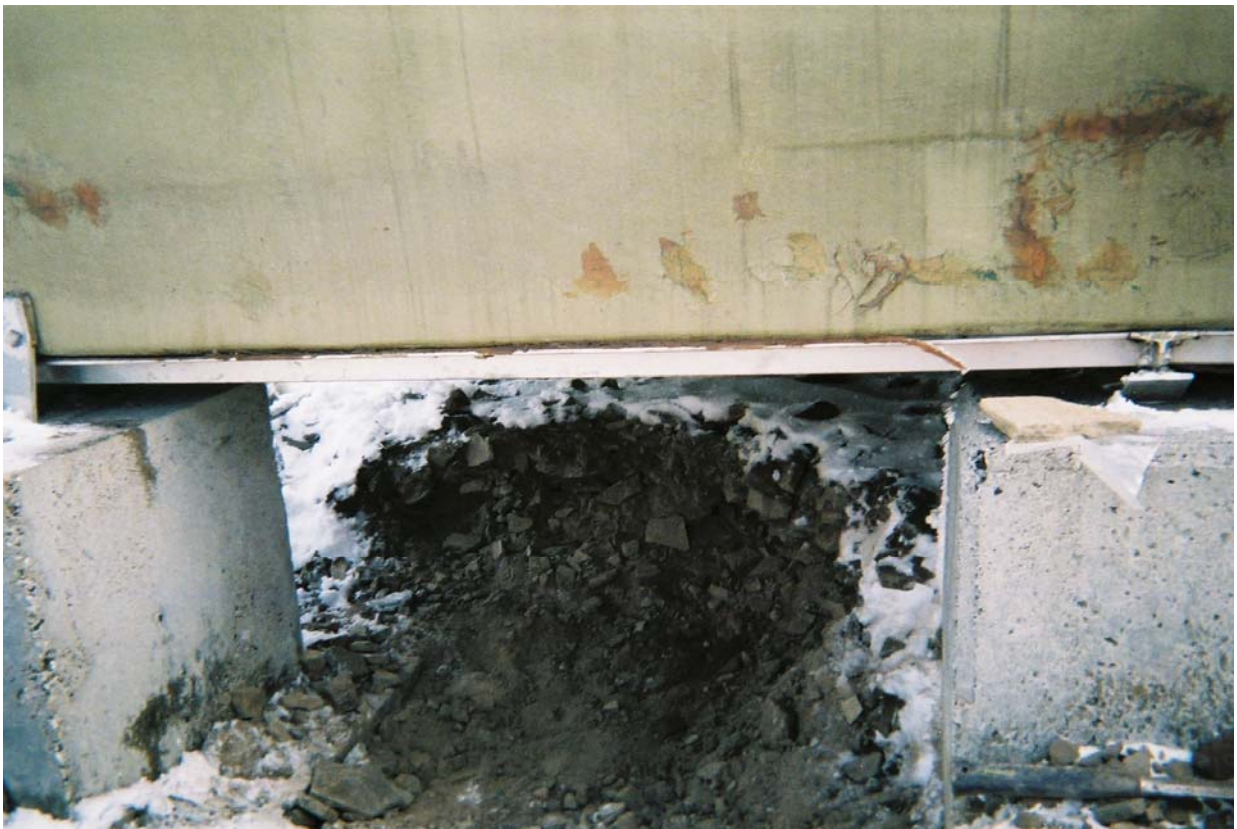
Completed excavation beneath northwest corner of the Generator Module.  
Slope

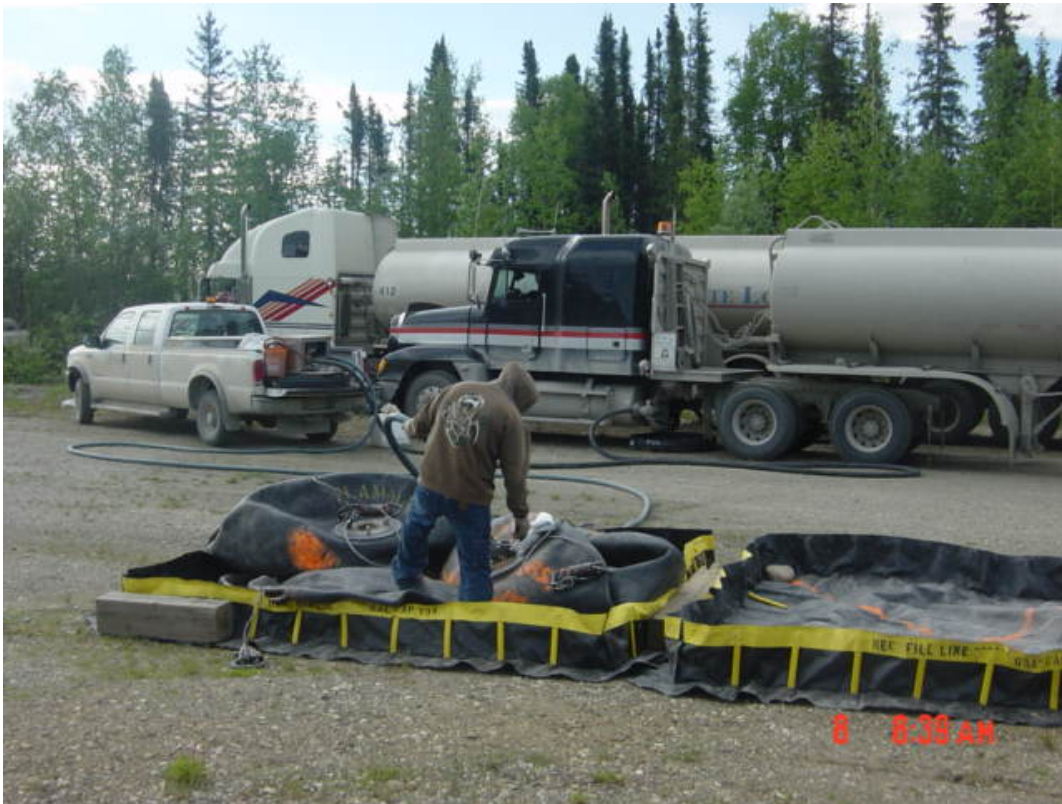
Highway site staging area. Filling fuel bladders within portable secondary containment

In 2003, the ASTs and associated piping were completely retrofitted with new spill protection equipment. This retrofit included overfill protection, double wall supply and return lines, and other current performance based fuel system upgrades. The retrofit was followed by implementation of new best management practices for the fueling operations, including new procedures for the annual refueling operations. Currently, a portable secondary containment device is sling-loaded to the site prior to delivery of the fuel bladder and set up in designated areas near the ASTs. The bladders are subsequently placed inside the secondary containment during the refueling process. The secondary containment prevents any spillage during initial fuel line connections, fueling process and disconnection activities. Photographs of the refueling equipment and process are provided in Attachment 4.
