**PORT HEIDEN RRS
ALASKA**

Preliminary Assessment Port Heiden

January 1994

Contract No. DACA85-92-D-0007
Delivery Order 0007

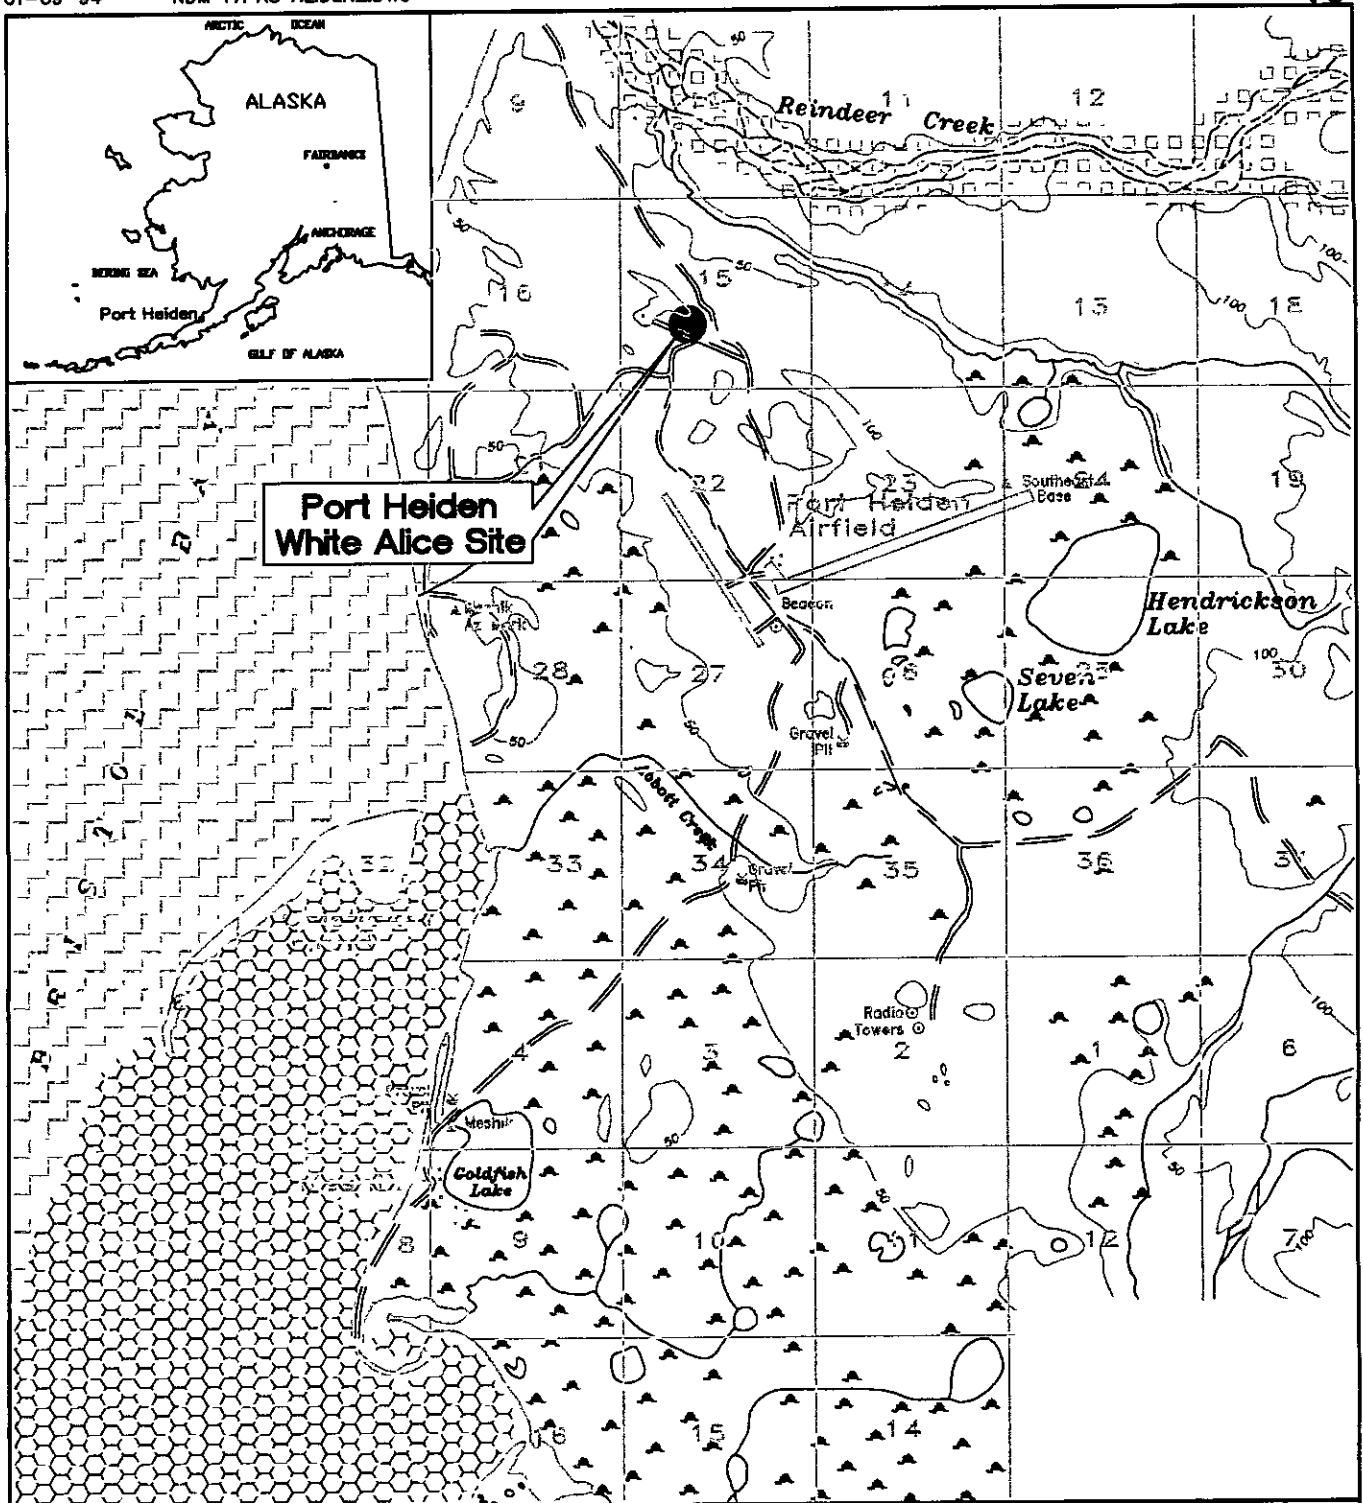
**Port Heiden
White Alice Site**

3.2-1 Sensitive Aquatic Environments for Port Heiden 3-7

Several small shallow ponds, small lakes, and creeks are found in the immediate area of the Port Heiden site. Interspersed areas of wet bog and tundra also occur throughout the site. All of these aquatic resources are shallow and support various aquatic plant species.

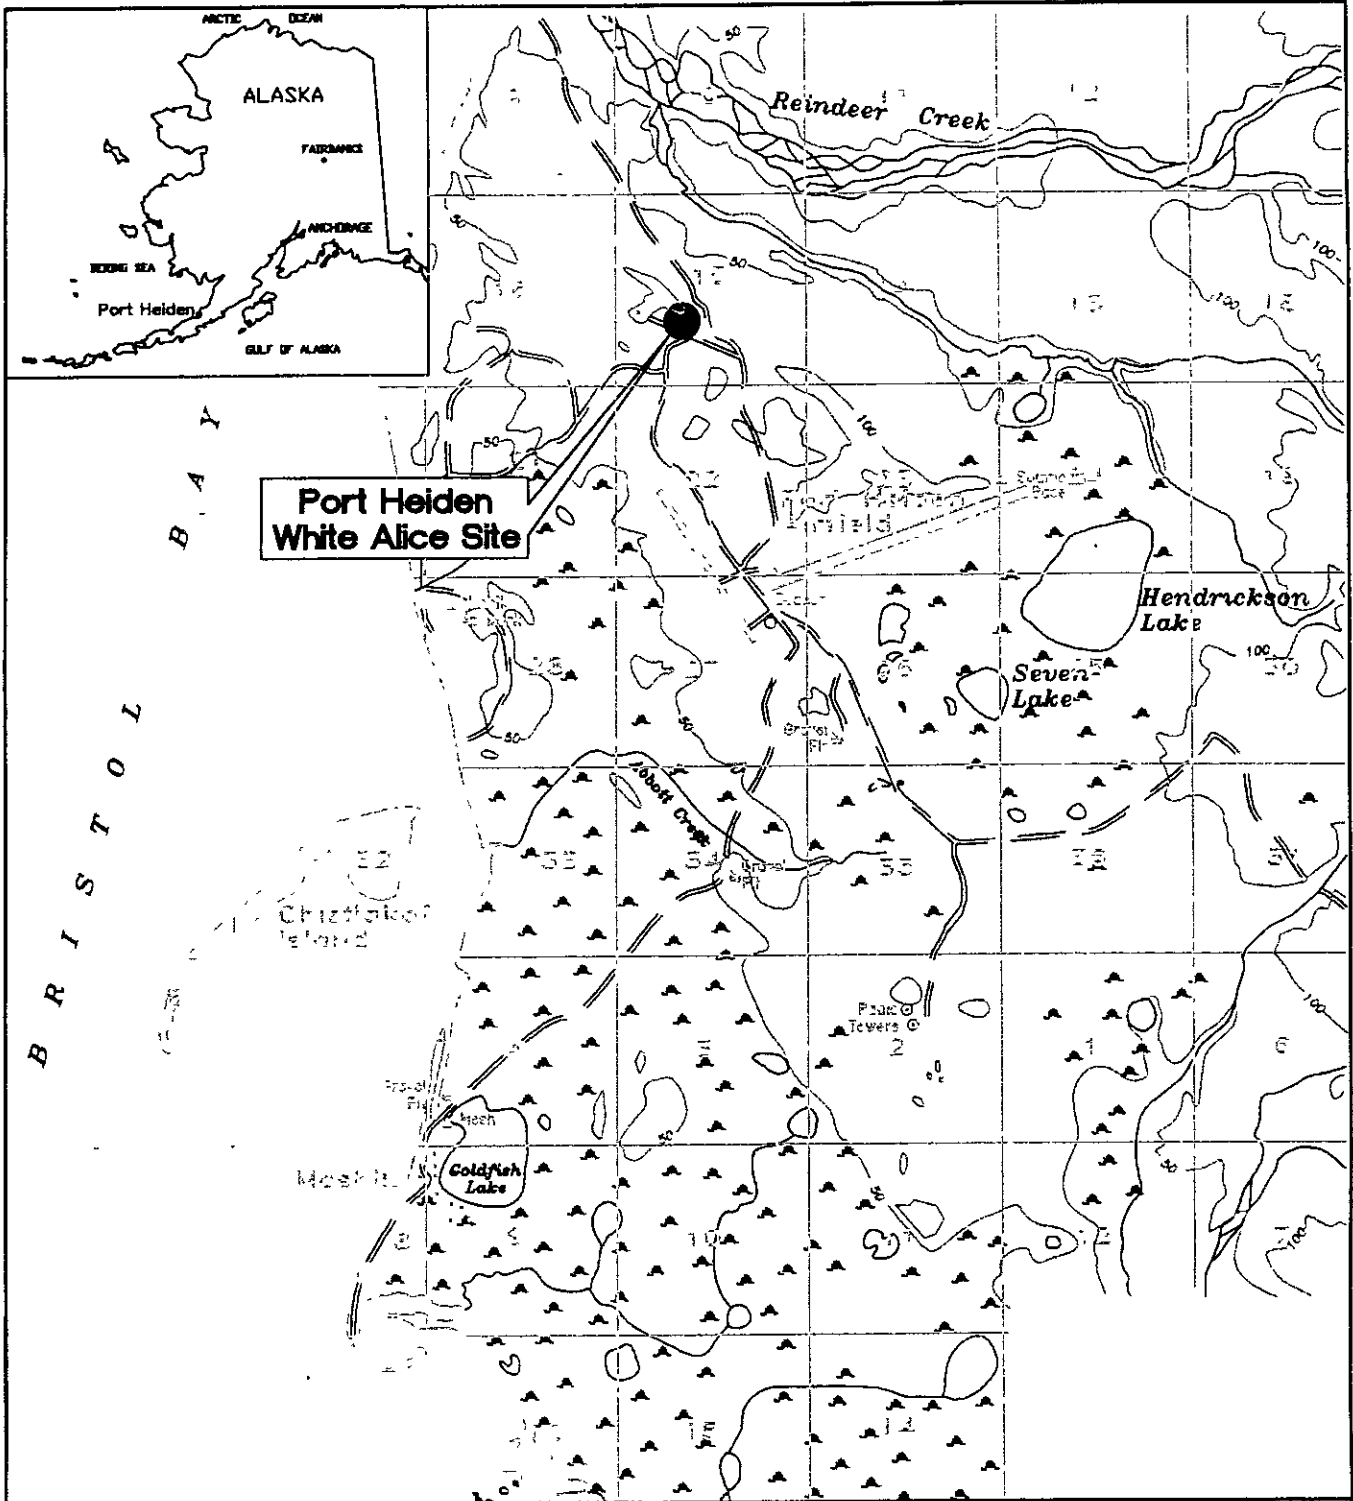
**Port Heiden
White Alice Site**

3.3-1 Sensitive Terrestrial Environments for Port Heiden 3-15
