***Final
Fort Morrow Phase II
Remedial Investigation Report
Port Heiden, Alaska***

Prepared for:
U.S. Army Corps of Engineers, Alaska District

November 2016

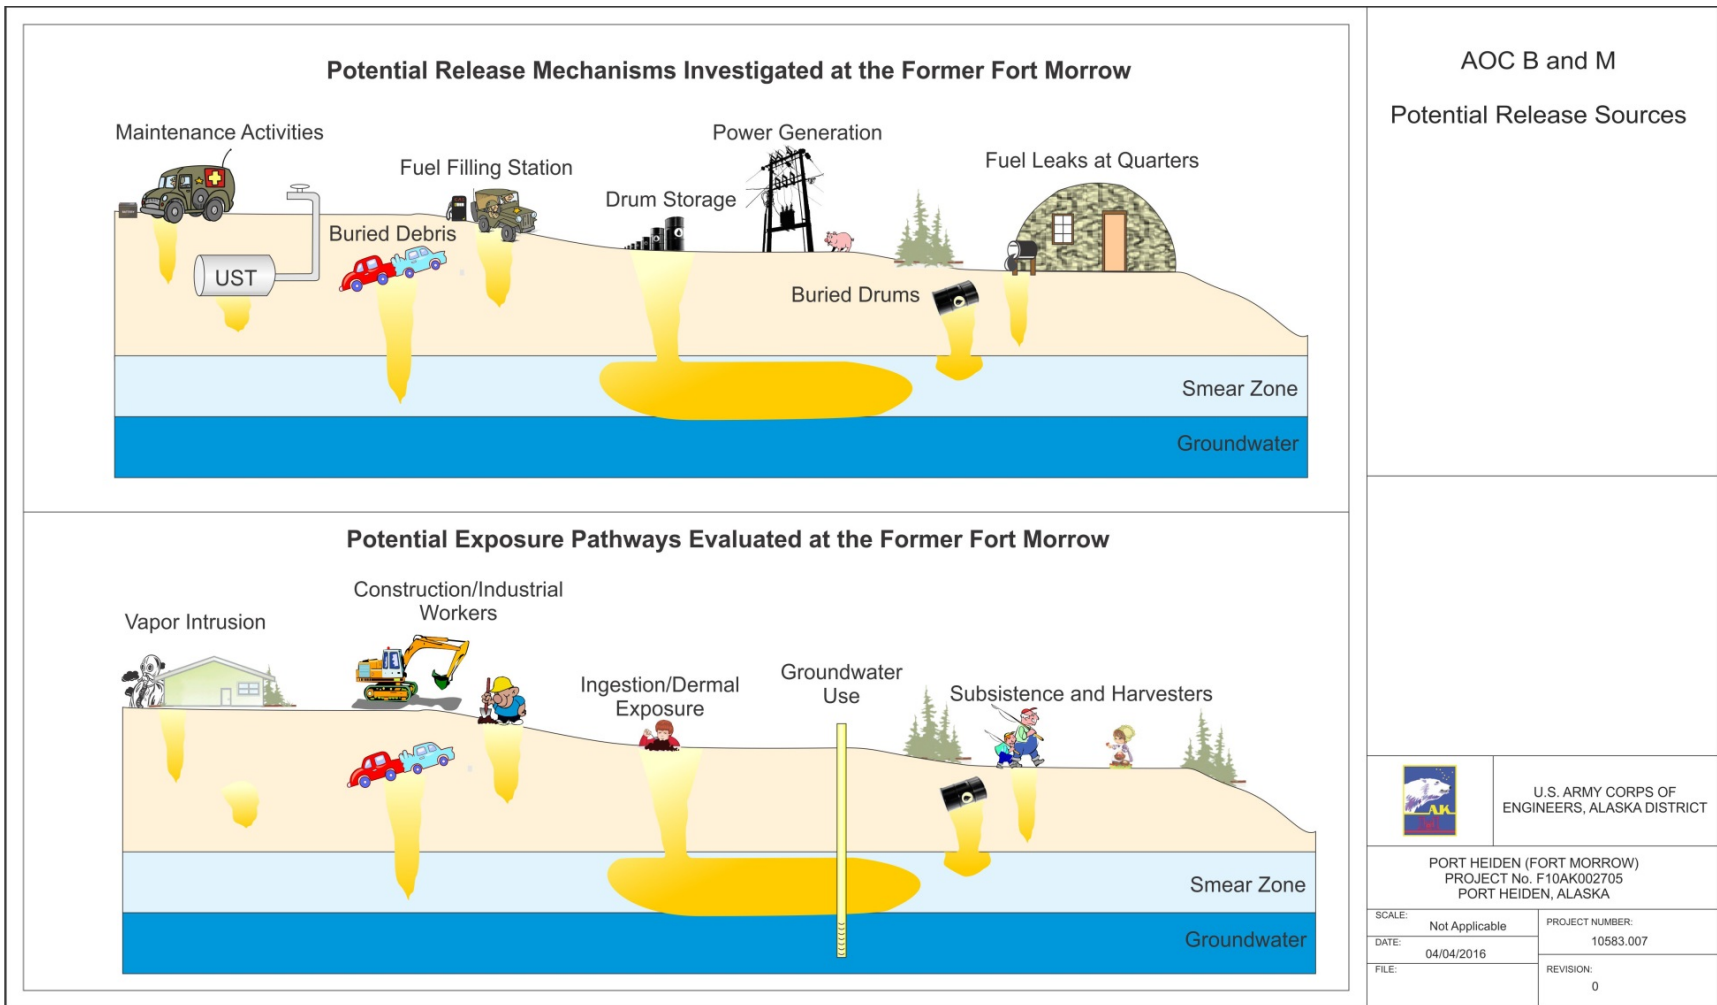
Figure 2-3. Potential Release Mechanisms and Exposure Sources at AOCs B and M.

Potential sources of contamination in AOC B included USTs, aboveground storage tanks (ASTs), fuel dispensers, drums, vehicles, landfills, and latrine plumbing. The potential release mechanisms at AOC B included spills, leaks, and direct discharge. The potentially impacted media in AOC B included surface soil, subsurface soil, air, groundwater, and biota.

Potential sources of contamination in AOC M included USTs, ASTs, fuel dispensers, drums, and vehicles. The potential release mechanisms at AOC M included spills, leaks, and direct discharge. The potentially impacted media in AOC M include surface and subsurface soil, air, groundwater, and biota.

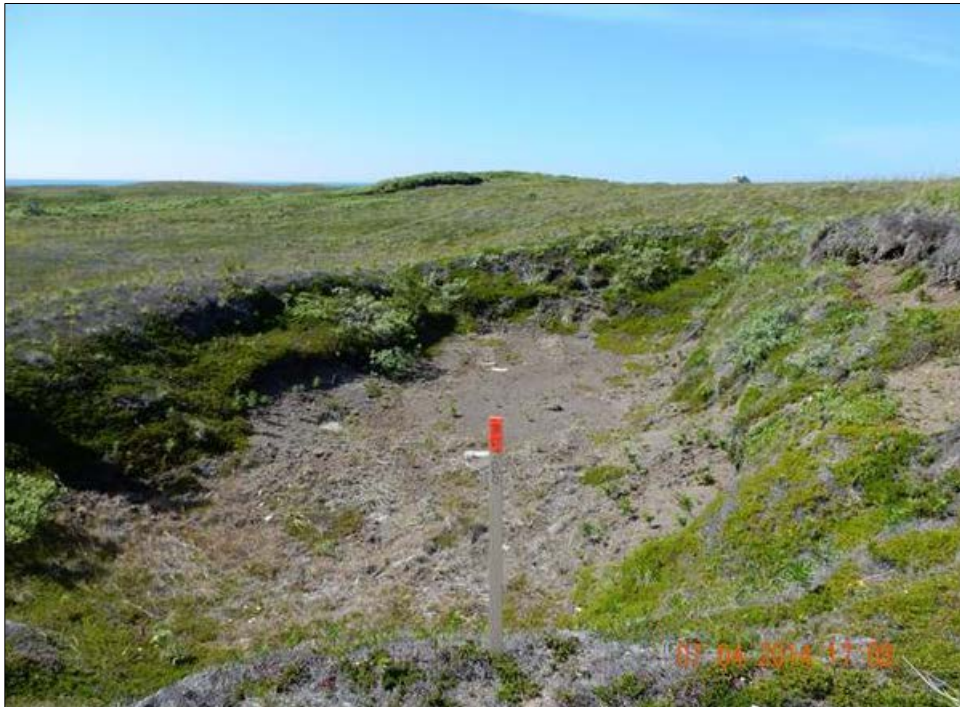
Figure 4-1. Field Marking of Feature M-QT-020, Typical Field Identification of Site Features.

Field forms documenting location, feature type, description, and vehicle accessibility were completed (see Appendix D). The presence of construction debris, metal debris, or obvious signs of contaminated soils or visual clues to contamination (i.e., distressed or discolored vegetation) was also documented. Figure 4-1 shows photo documentation and field marking of site feature M-QT-020, typical of site feature documentation.

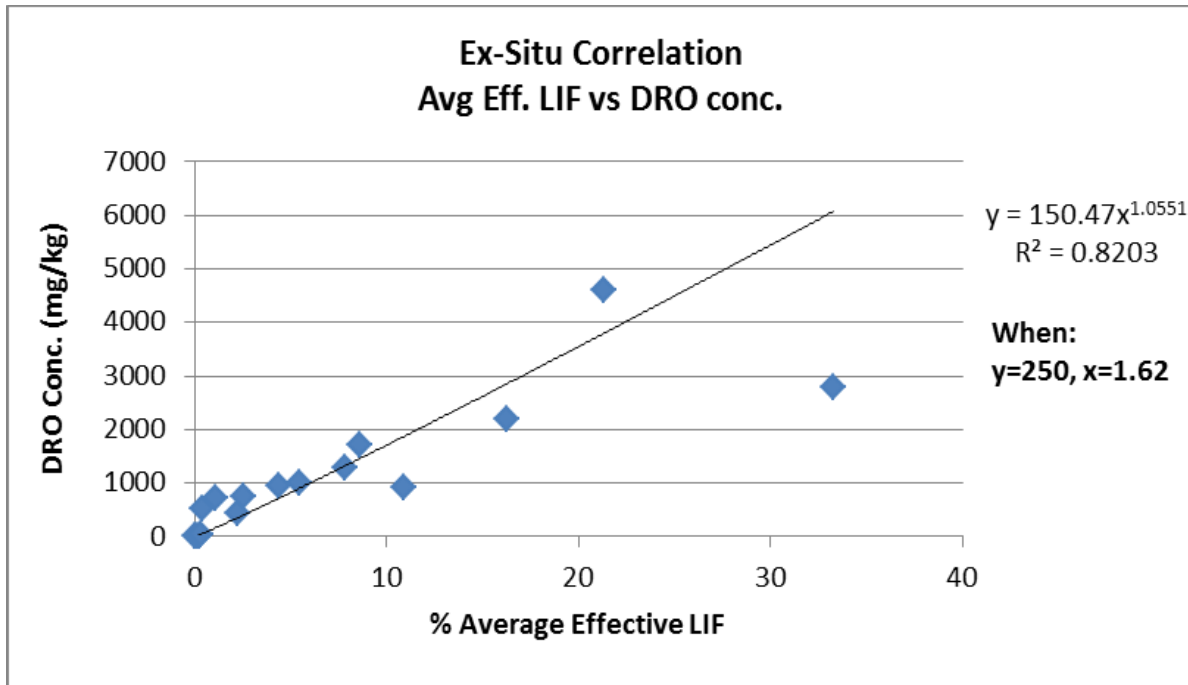
Figure 4-2. Ex-Situ Correlation of LIF compared to DRO Concentrations.

An ex-situ correlation study was conducted to establish the degree of UVOST response to known contaminant concentrations in site-specific soils. Soil samples were collected in an area known to contain DRO contamination. These samples, representative of a range of concentrations, were individually analyzed for UVOST LIF response (i.e., homogenized and placed directly on the UVOST probe sapphire window), then placed in corresponding sample containers for laboratory analyses. This correlation method excludes variability (i.e., from soil heterogeneity or preferential contaminant pathways) that is inherent in field sample collection methodology. The resulting correlation between the ex-situ LIF response and corresponding DRO concentration is provided in Figure 4-2. Supporting documentation is provided in Appendix G.

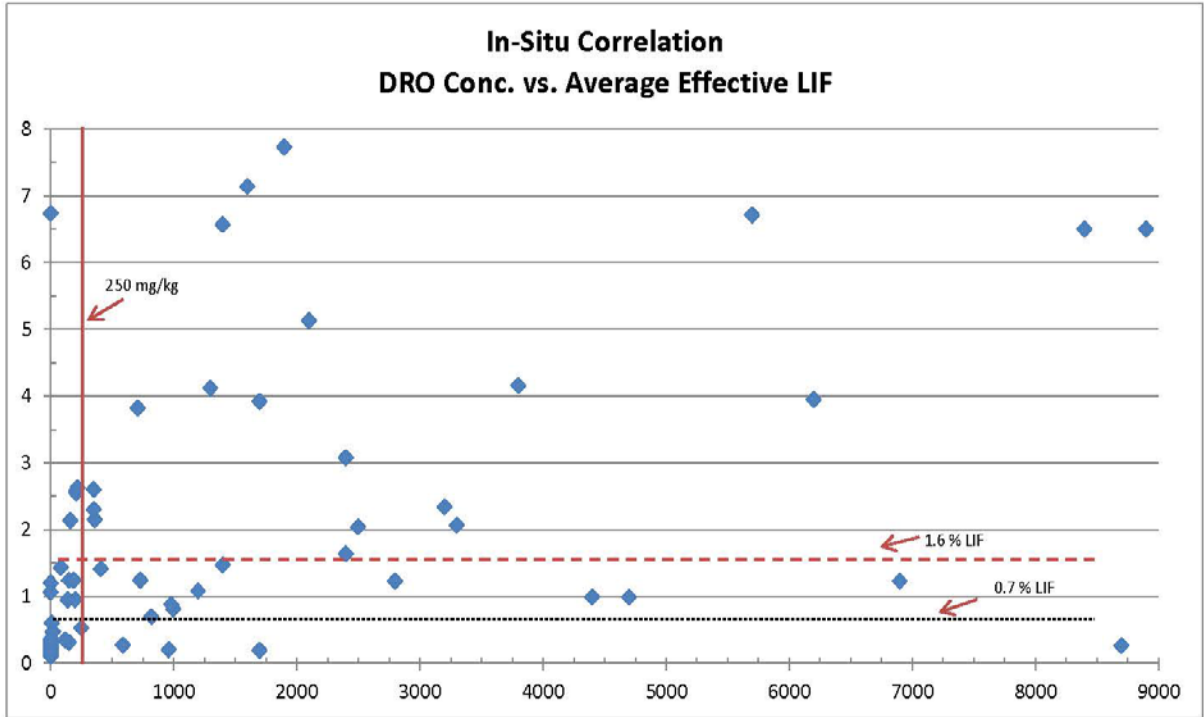
Figure 4-3. In-Situ Correlation of DRO Concentrations Compared to LIF.

- True positives – values plotted in the upper right quadrant show elevated LIF responses and also exceed the PAL. True positives account for 9.7% of the data.
- True negatives – values plotted within the lower left quadrant show LIF responses below 1.6% and do not exceed the PAL. True negatives account for 84.0% of the data.
- False positives – values in the upper left quadrant exhibit high LIF but do not exceed the PAL. False positives account for 1.6% of the data. Potential causes of false positives are discussed below.
- False negatives – values in the lower right quadrant have LIF responses below 1.6% but exceed the PAL. False negatives account for 4.7 % of the data. Potential causes of false negatives are discussed below.

This in-situ evaluation method typically provides a more concrete determination of the actual LIF correlation achieved for the site-specific conditions encountered. For this data set, an assigned LIF value of 0.7% excludes 12 of 15 false negatives, correlating more strongly to an actual LIF value representative of site conditions and variability. For data evaluation purposes, the in-situ correlation value of 0.7% was applied for determining nature and extent of contamination instead of the field acquired ex-situ value of 1.6%.

When applying a 0.7% correlation LIF value, true positives represent 13.5% of the total data set, while false negatives represent less than 1%. The four remaining false negatives are discussed as follows:

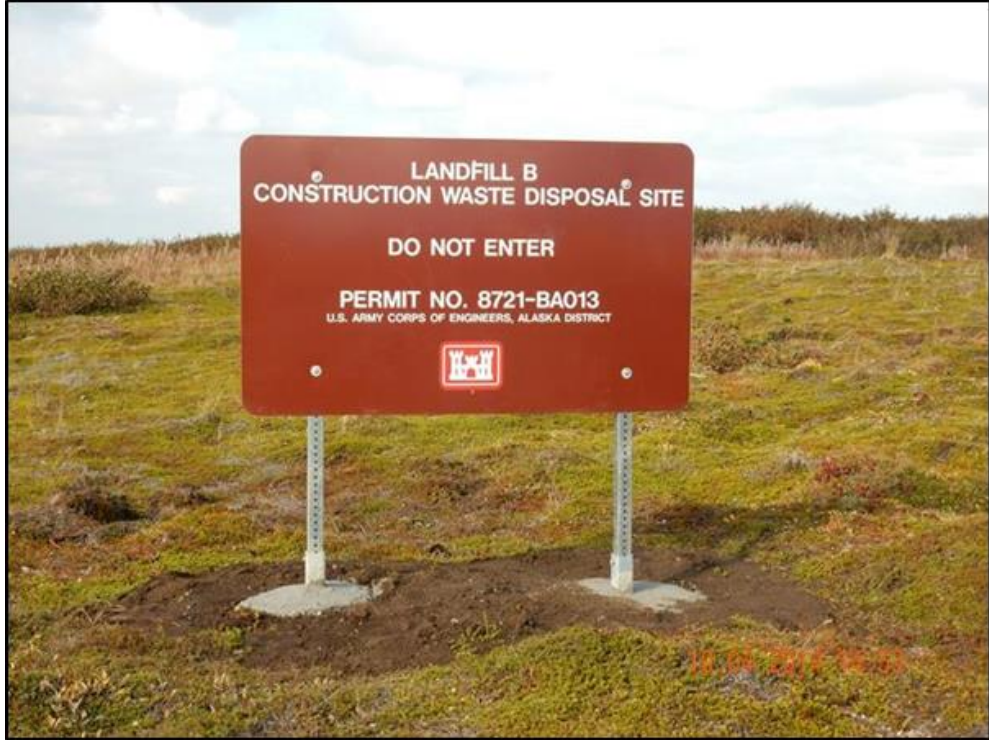
Figure 4-6. Installation of Signs for Landfill B Disposal Site.

Signs were erected in three locations around Landfill B as a reminder of its existence, and in accordance with HTRW program long-term management goals for protection of the public. Since 1991, native vegetation has been re-established and evidence of the landfill boundary is diminishing. A nearby borrow pit established by the Department of Transportation (DOT) has been steadily expanding toward the landfill.

Signs were placed where they are visible from existing non-maintained access roads to the landfill and the DOT borrow pit. Installation was designed to withstand winds up to 100 miles per hour. Four-foot sections of 10-gauge galvanized steel tubing (2-3/16 inches square) were set in high-strength concrete to roughly 3-1/2 feet deep to form a “sleeve” for 10-foot lengths of perforated 10-gauge tubing (2-1/2 inches square). Concrete was allowed 7 (or more) days to cure. Perforated tubing was installed to the bottom of the sleeves and bolted, leaving roughly 6 feet above ground. Signs were drilled and bolted to the perforated tubing in four places (see Figure 4-6).

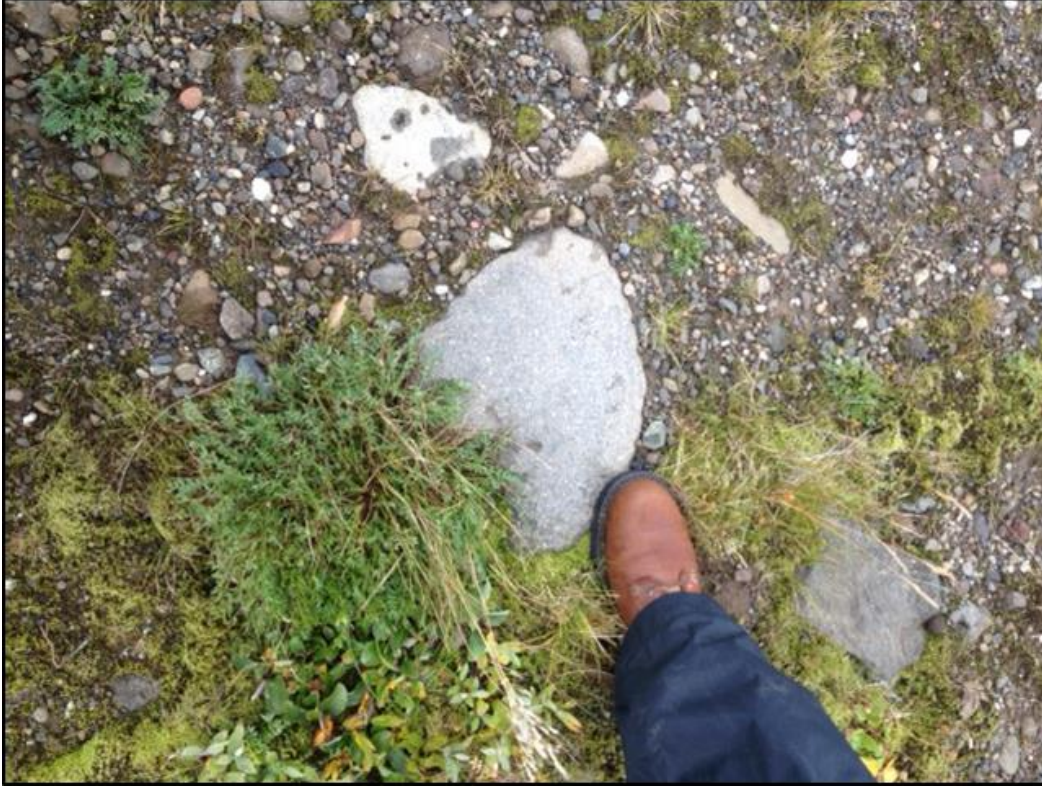
Figure 5-1. Impenetrable Soil at Feature M-RD-001.

Impenetrable soils were encountered in several areas within AOC M. The effectiveness of UVOST screening in these areas was greatly reduced and coupled with increased equipment damage. Shallow refusal depths in these areas compromised the ability to acquire good characterization data through the soil column to the groundwater interface.
