PHASE II ENVIRONMENTAL SITE ASSESSMENT /
RELEASE INVESTIGATION REPORT
SAHN INVESTMENTS PROPERTY
1406 KELLUM STREET, FAIRBANKS, ALASKA

BY
LYLE GRESEHOVER
PRINCIPAL INVESTIGATOR
ALASKA RESOURCES AND ENVIRONMENTAL SERVICES, LLC

FOR: MR. JEFF ZUCKERMAN SAHN INVESTMENTS

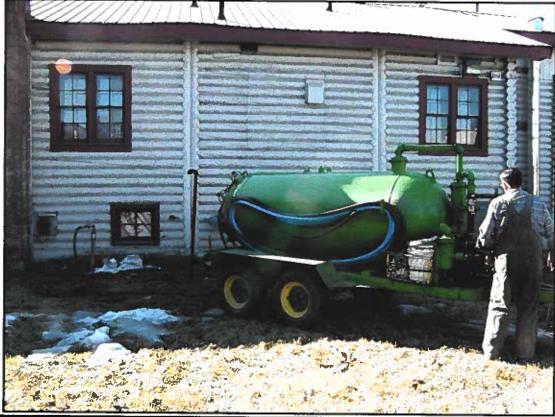
Photograph 2 Residual Fuel Removal Phase II ESA/ Release Investigation 1406 Kellum Street

Pumped residual fuel from the UST's prior to tank removal.

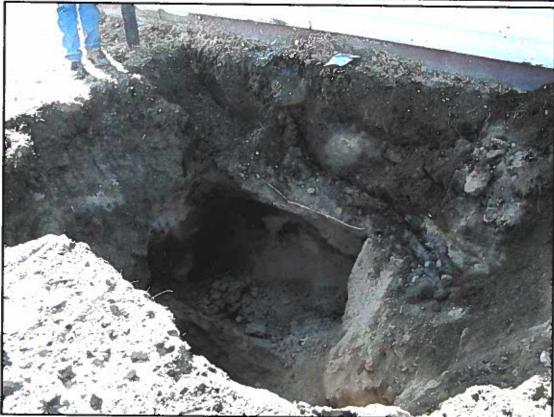
Photograph 4
Excavation pit for 300-gallon UST

Soil sample results for the 300-gallon UST site indicate that soils remain in place (10' bgs/base of excavation) above ADEC target cleanup levels. The high seasonal groundwater level for the surrounding area is generally 8-10 feet bgs. Soil samples

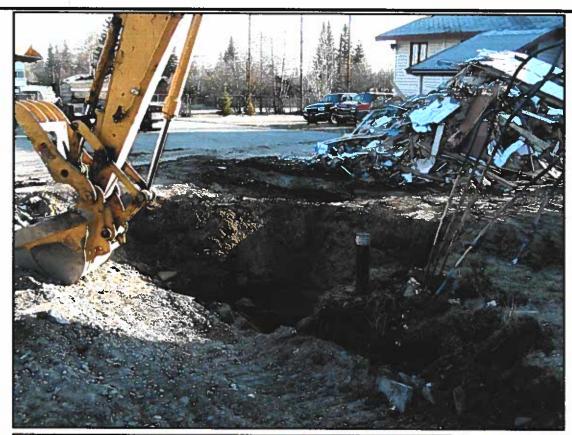
Photograph 7
Excavation Pit for 300-gallon UST

During excavation and removal of the 300-gallon UST, contaminated soils were encountered of which approximately 80 cubic yards (77 tons) of petroleum-contaminated soils were removed and hauled off-site for thermal remediation. The remainder of the excavated contaminated soils (approximately 216 yds³) was stockpiled on-site and landfarmed in accordance with ADEC approved Work Plan. Soil sample results for the 300-gallon UST site indicate that soils remain in place within the vadose zone (10' bgs) above ADEC cleanup levels for soil. Soil samples collected from the sidewalls and endwalls of the 300-gallon UST site were found to be below ADEC target cleanup levels.

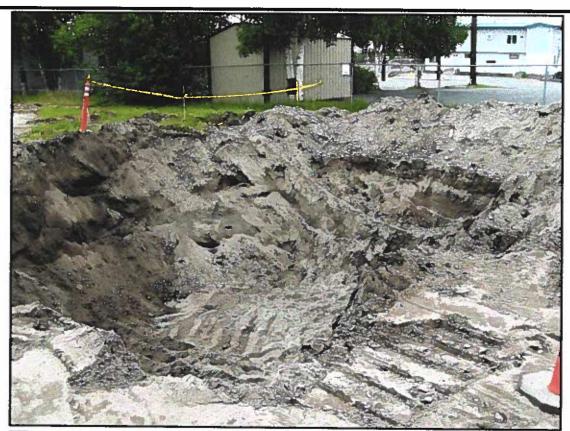
Photograph 9
Final excavation pit for 300-gallon
UST

collected from the sidewalls and endwalls of the 300-gallon UST site were found to be below ADEC target cleanup levels.

- 3. Landfarmed petroleum-contaminated soils will require post sampling upon remediation per ADEC approved Corrective Action Work Plan (May 2007) to include the following:
  - Field screen samples will be collected on an annual basis and reported to ADEC until cleanup levels for soil are achieved. Final laboratory confirmation samples for DRO and BTEX will be collected from the stockpile and the from the ground surface under the stockpile to ensure cleanup objectives are met; and
  - Upon meeting cleanup objectives, a final summary will be submitted to ADEC for site closure purposes.
- 4. Following post treatment of landfarmed soils, collect one groundwater grab sample down-gradient from source area to verify final site conditions.

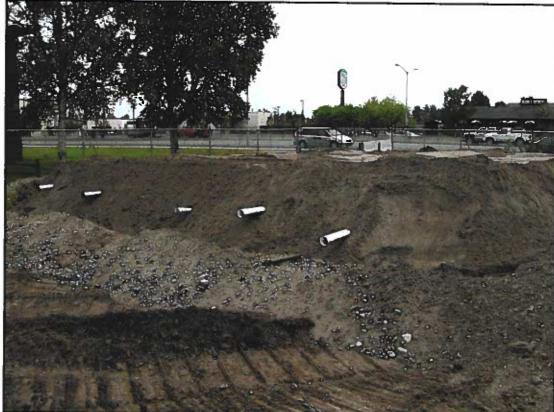
Photograph 12 Landfarm / Stockpile Phase II ESA/ Release Investigation 1406 Kellum Street

Field screen samples were collected in conjunction with excavation activities and used as an indicator to direct depth and extent of excavation (Figures 4, 5). Excavated soils that had PID readings > 25.0 ppm were considered contaminated and stockpiled on the asphalt pad. No petroleum-contaminated soils were encountered during the excavation and removal of the 1,000-gallon UST. Petroleum-contaminated soils were however encountered during the removal and excavation of the 300-gallon UST. Petroleum contaminated soils had the odor of weathered diesel. No free product or groundwater was encountered during excavation. Approximately 80 cubic yards (77 tons) were loaded into 20 yard side-dumps and transported to OIT Inc. for thermal remediation. The remainder of the contaminated material (approximately 216 cubic yards) was stockpiled

in the southeast corner of the subject property for remediation by landfarming. Perforated pipe and fertilizer was added to stockpiled soil to aid in remediation.
