2018 Groundwater Monitoring Report

**Airport Way Professional Building
1406 Kellum Street, Fairbanks, Alaska**

January 2019

**Alaska Resources and
Environmental Services, LLC.**

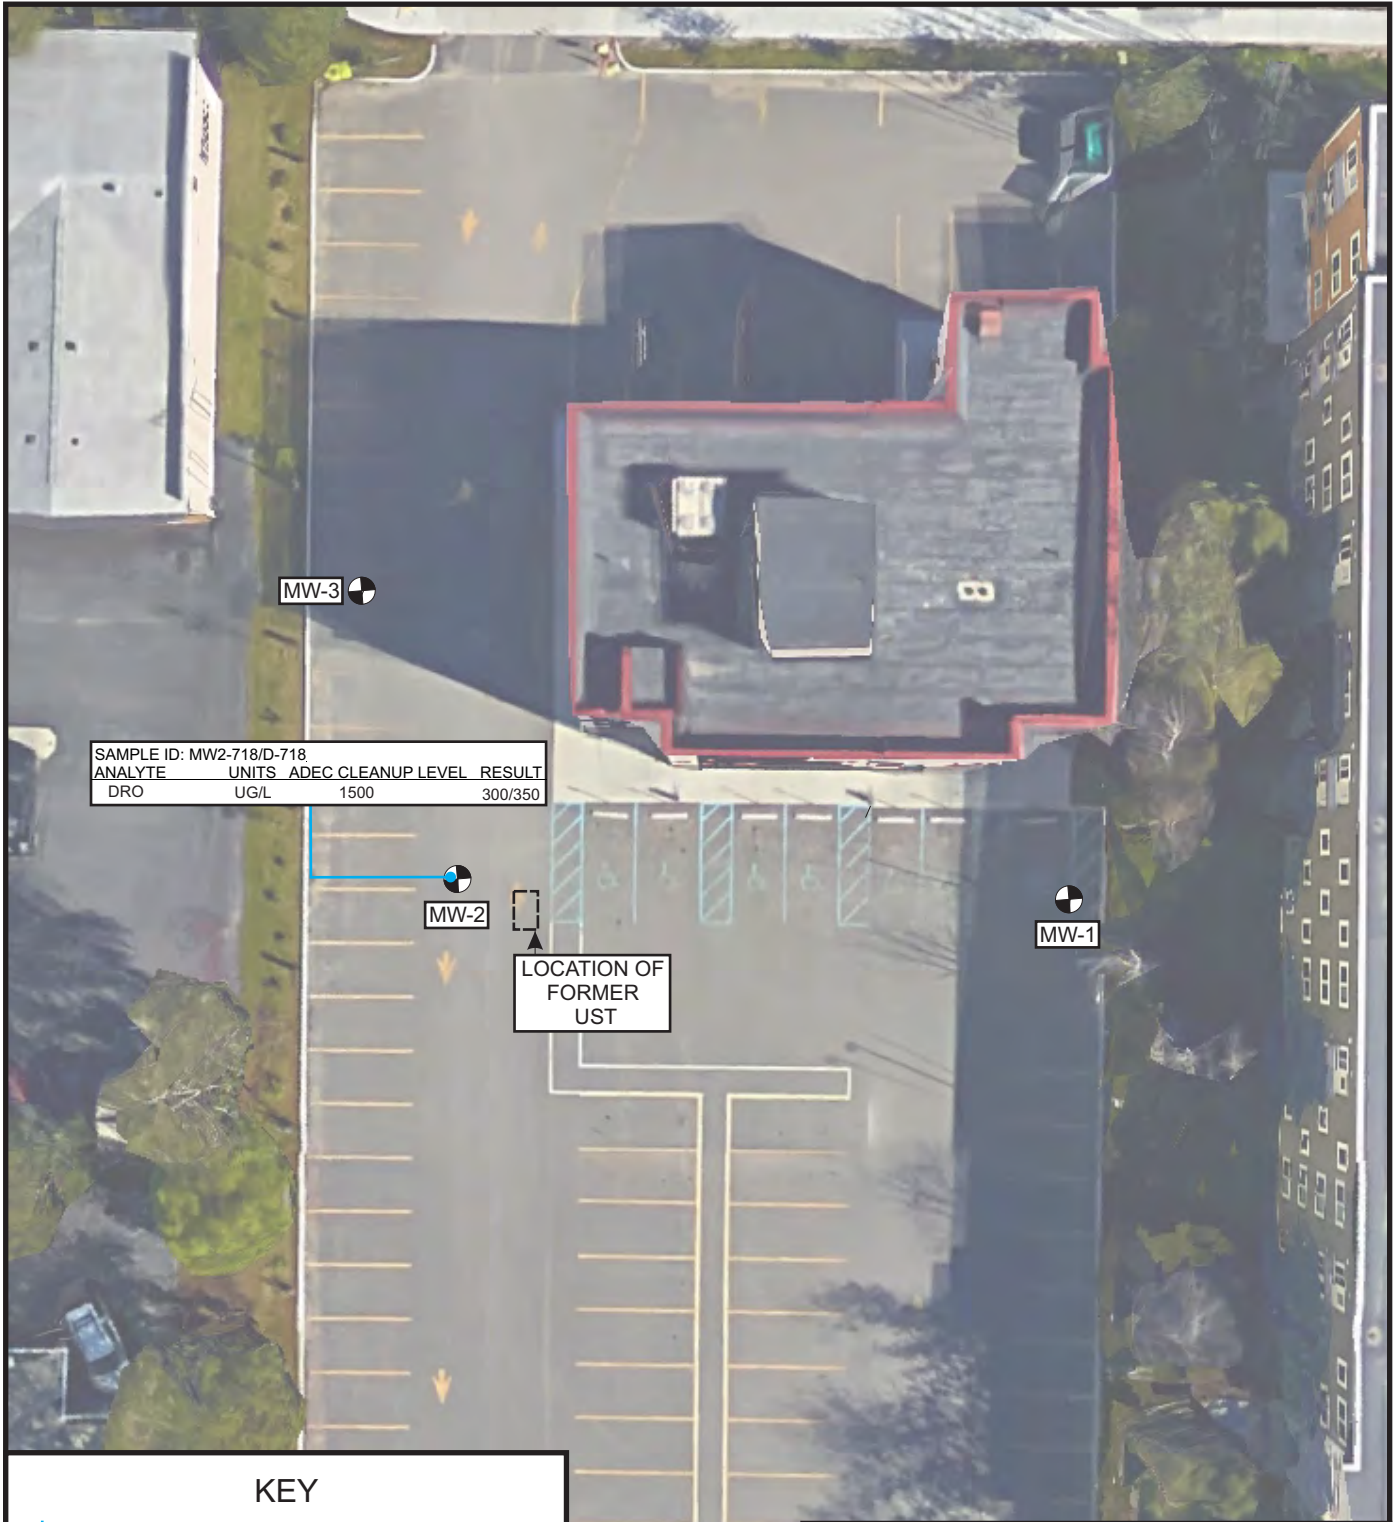
FIGURE 3

Groundwater monitoring wells MW1, MW2, and MW3 and their locations relative to each other and the project site are found in Figure 3. Wells were sampled in order of least likely to be contaminated to most likely to be contaminated.

SAMPLE ID:	MW2-718/D-718		
ANALYTE	UNITS	ADEC CLEANUP LEVEL	RESULT
DRO	UG/L	1500	300/350

LOCATION OF FORMER UST

WELL AND ANALYTICAL SAMPLE LOCATION MAP

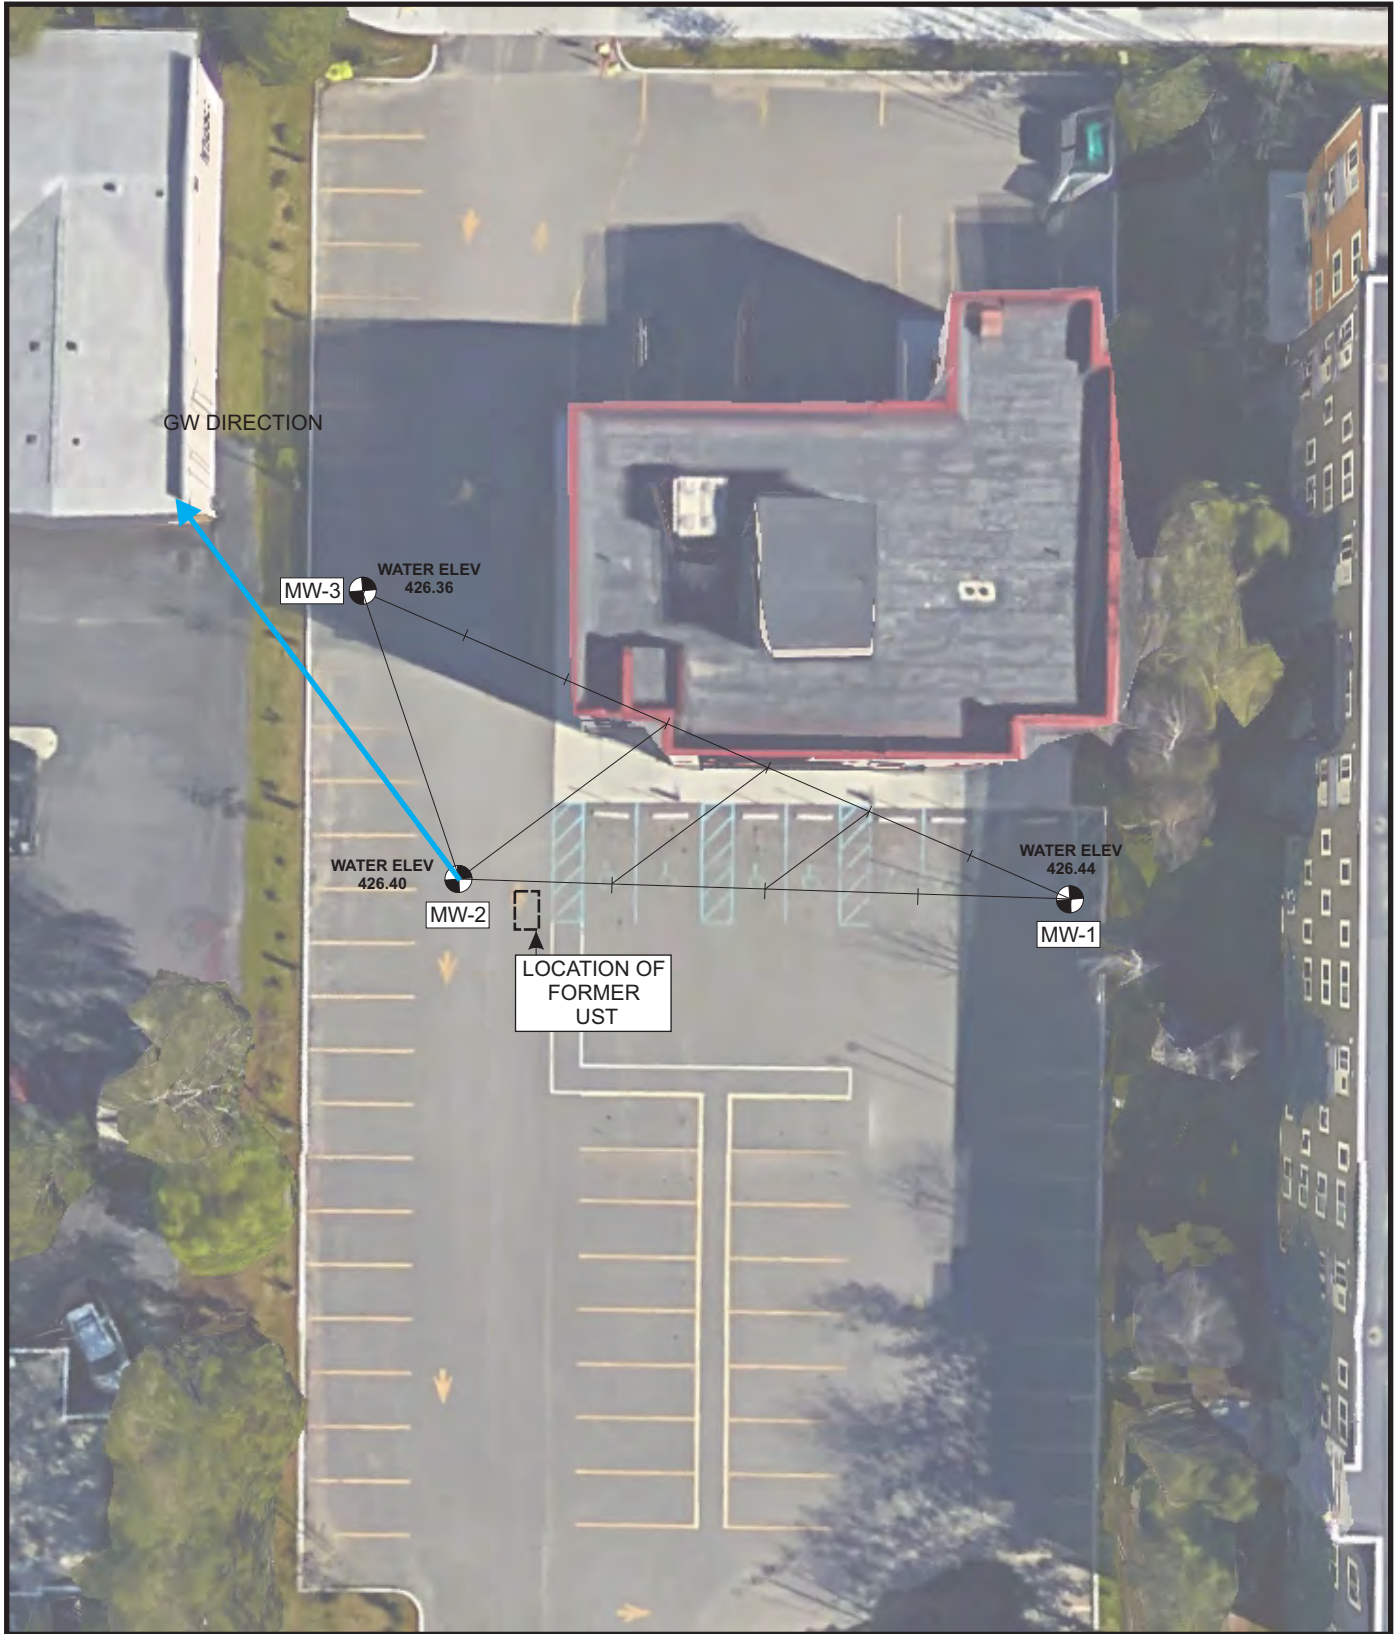
FIGURE 4

WELL LOCATION MAP and GROUNDWATER FLOW DIRECTION	DATE: 08/08/2016	SCALE IN FEET:	ALASKA RESOURCES AND ENVIRONMENTAL SERVICES, LLC PO BOX 83050 FAIRBANKS, AK 99708 PH. (907) 374-3226 FAX (907) 374-3219
