RE: ADOT&PF Dutch Harbor Airport Torpedo Building Report
Lots 6A & 6B Block 2 Unalaska Airport ADEC File No. 2542.38.010

On behalf of the Alaska Department of Transportation and Public Facilities (ADOT&PF), Restoration Science & Engineering, LLC (RSE) is providing the following report for the decommissioning of the Dutch Harbor Airport Torpedo Building monitoring wells MW-1 and MW-3 per correspondence from the Alaska Department of Environmental Conservation (ADEC) dated October 24, 2017 and an approved work plan dated September 17, 2019. The two wells were located at the Torpedo Building at the Dutch Harbor/Unalaska Airport on Amaknak Island.

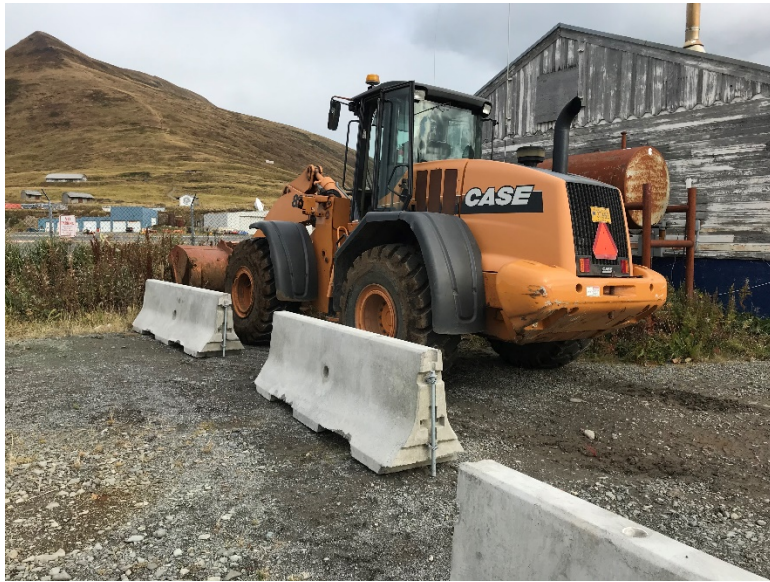
Loader scraping for MW-3, North-East

RSE mobilized to Dutch Harbor on October 10, 2019 and decommissioned the wells that day. RSE qualified environmental professional (QEP) Kyle Wiseman met with ADOT&PF employee Dale Rickman. RSE identified the locations of MW-1 and MW-3 with the assistance of a loader for scraping surface materials from the caps. The well housing of MW-3 had been previously removed and only the polyvinyl chloride (PVC) remained in-situ. RSE first attempted to knock out the bottom of MW-3 which resulted in the top of the PVC well assembly being pushed down below grade. RSE recovered the top of the well with a crowbar and removed the well assembly by hand. A total of 14.9 feet (ft) of PVC well material was removed. RSE then filled the borehole with approximately 25 pounds (lbs) of bentonite. The bentonite was hydrated with approximately one gallon of distilled water followed by approximately 20 lbs of sand. RSE sealed the cap by tamping down two minor applications of pavement repair. Mr. Rickman used the loader to restore the area to grade.

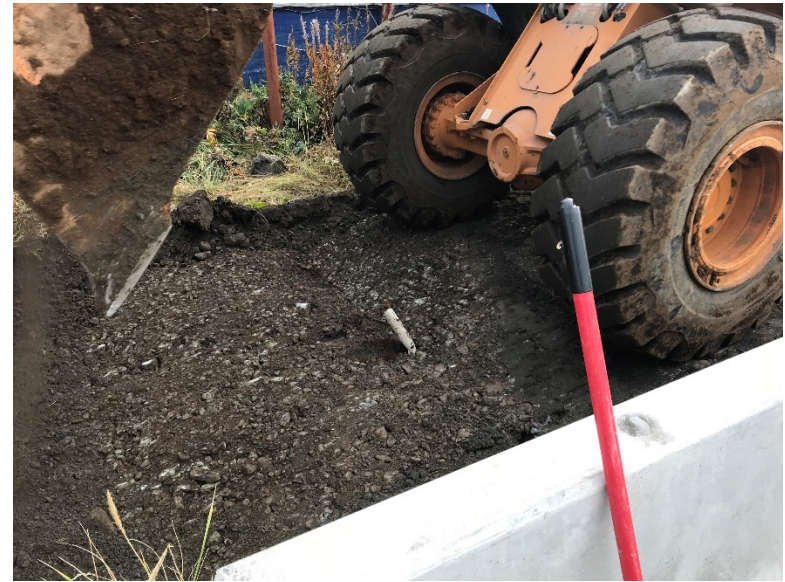
MW-3 exposed, East

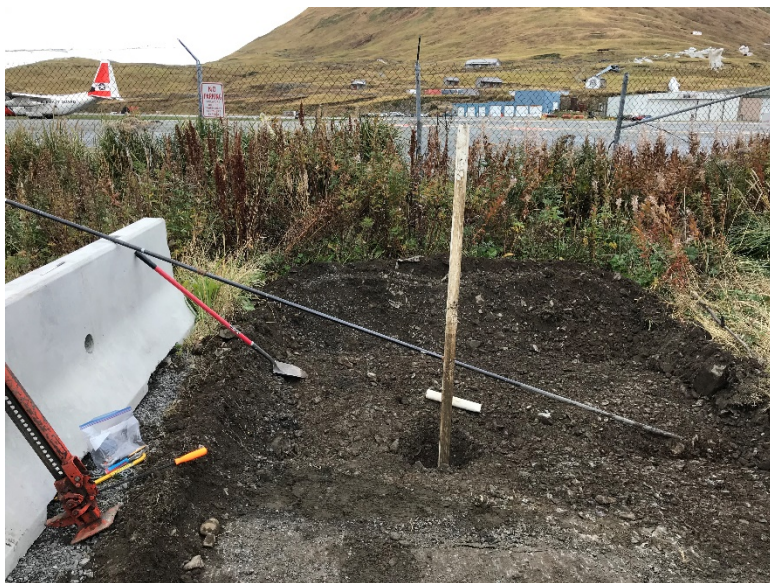
Removal of MW-3, North

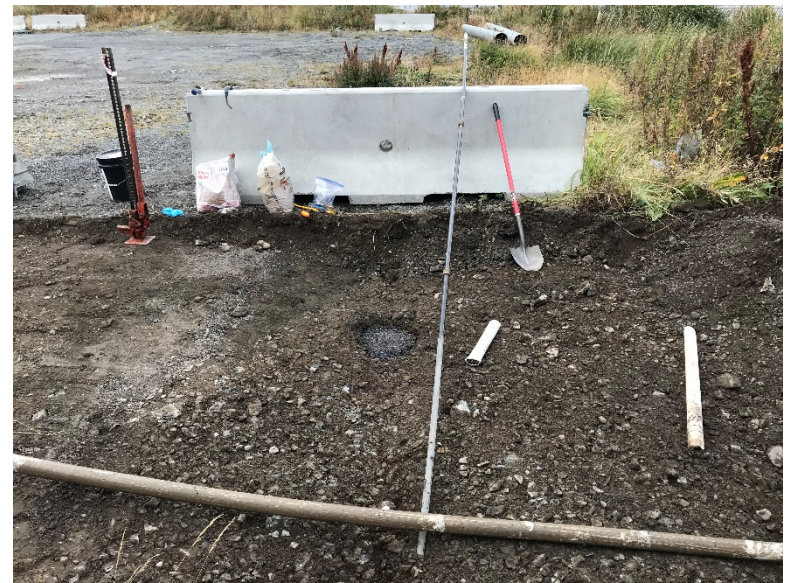
Decommission of MW-3 Complete, West

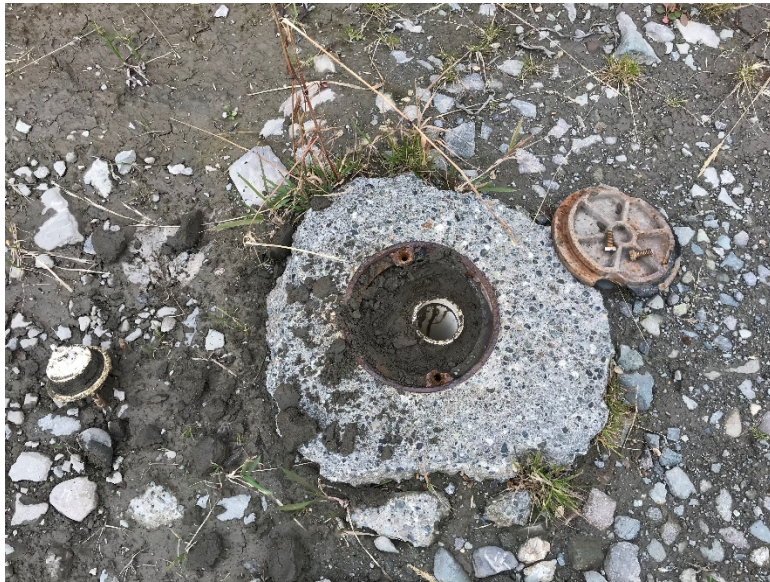
- MW-1 was identified and sampled. The cover of this well is destroyed.
- MW-2 was paved over and is presumed destroyed – note: RSE verified this well was destroyed during the October 2019 mobilization to the site.
- MW-3 was identified and sampled.
- MW-4 could not be located and is presumed destroyed – note: RSE verified this well was destroyed during the October 2019 mobilization to the site.
- MW-5 was verified destroyed.

MW-1, Down

RSE was unable to knock out the bottom of MW-1. A handyman jack was used to remove the PVC well assembly in approximate 3 ft sections. A total of 14.8 ft of PVC well material was removed. RSE filled the borehole with approximately 25 lbs of bentonite and hydrated it with approximately one gallon of distilled water. A small amount of sand was added and sealed by tamping down an application of pavement repair.

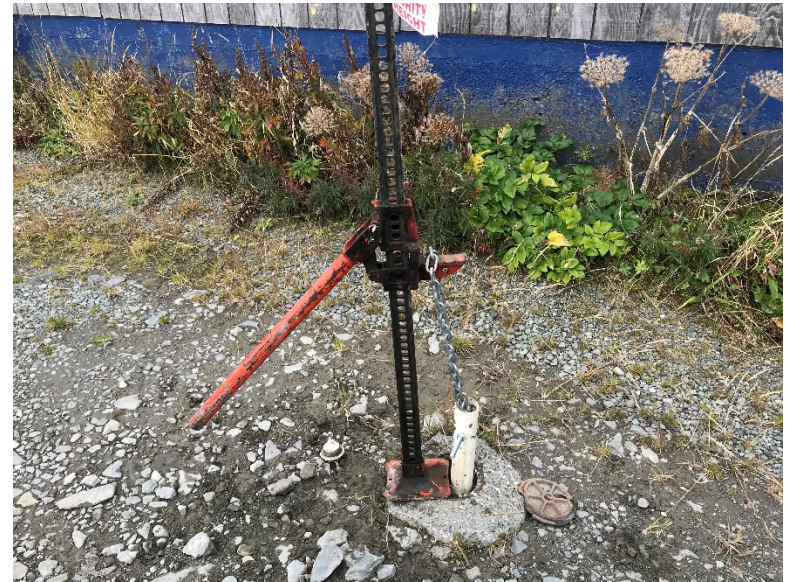
Removing MW-1, North-West

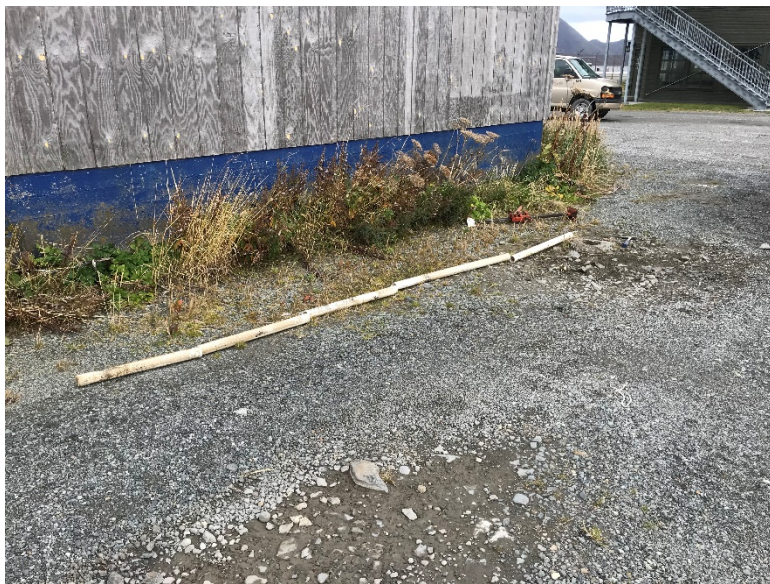
PVC Well removed from MW-1, North-East

The removed PVC well material and other waste generated during the decommissioning was disposed of in the ADOT&PF dumpster at the Unalaska Airport. No evidence of sheening or odor was observed during the removal activities. Select photos are attached to this document.

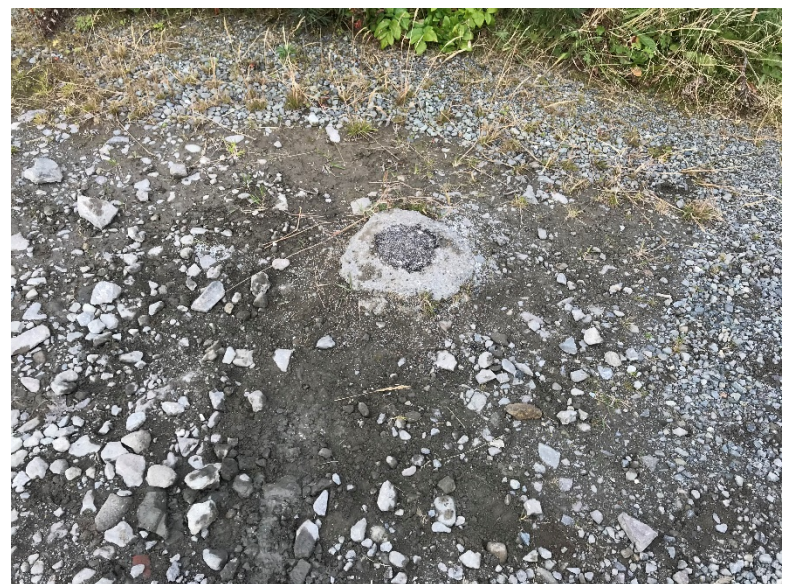
Decommission of MW-1 Complete, Down, North
