**Barrow Shop # 2 Ultra-Low Sulfur Diesel Release
Final Site Assessment Report
Barrow, Alaska**

May 21, 2015

**BARROW SHOP #2 ULTRA-LOW SULFUR DIESEL RELEASE
FINAL SITE ASSESSMENT REPORT
NORTH SLOPE BOROUGH
BARROW, ALASKA**

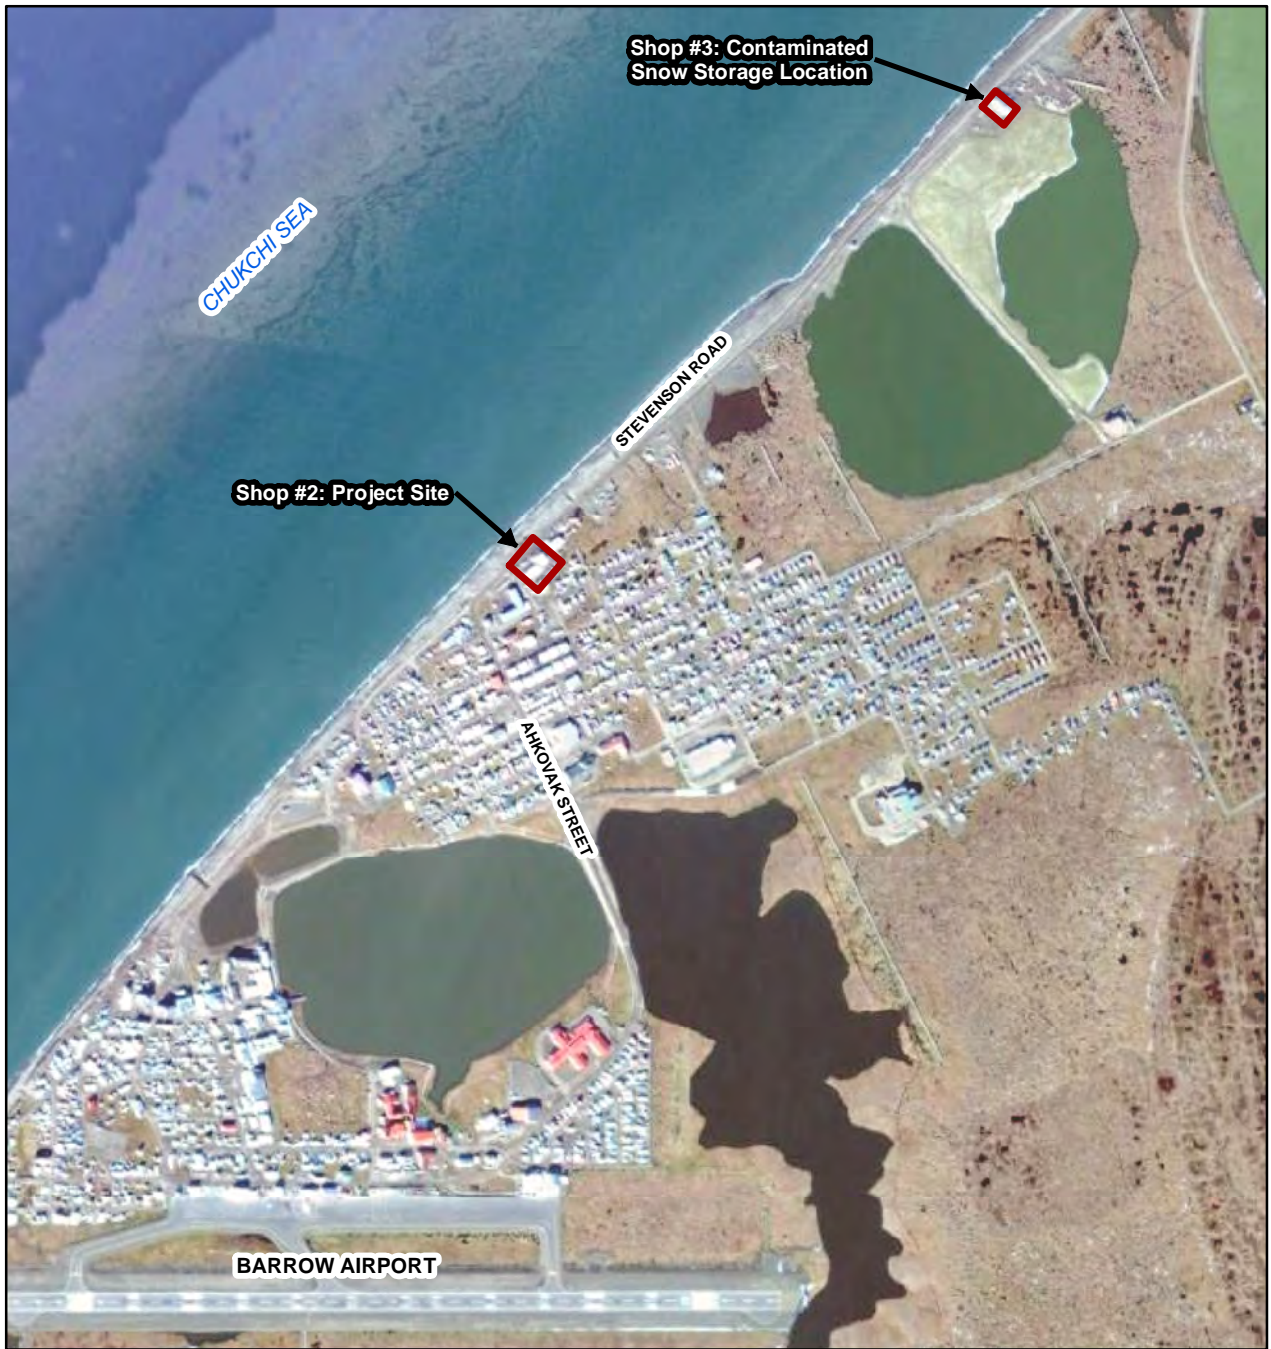
Figure 1

**PROJECT SITE &
 CONTAMINATED-SNOW
 STORAGE LOCATION MAP**

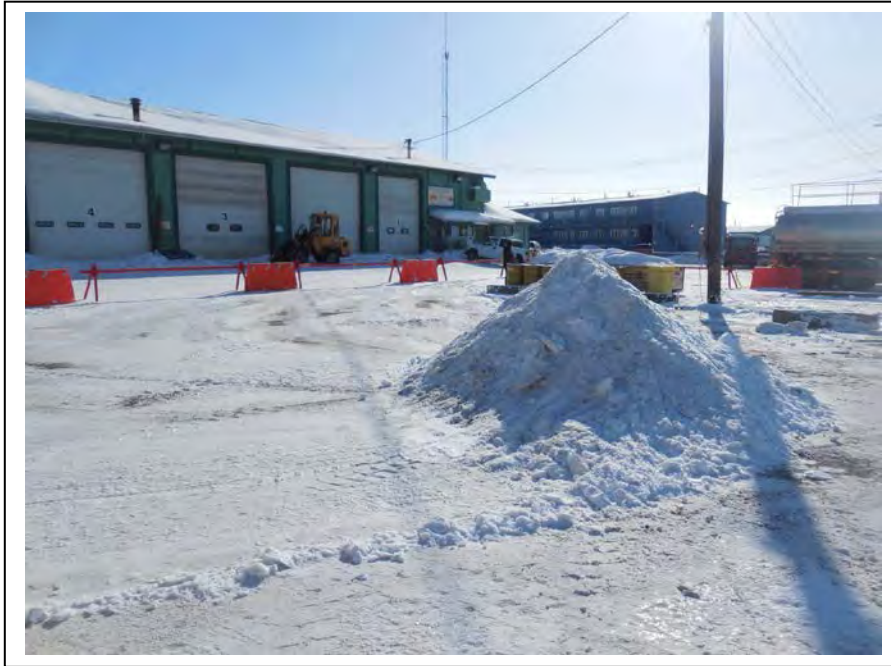
Photo 1: Location of ULSD fuel release on snow/ice pad between Shop #2 building and Stevenson Street; facing south towards Shop #2. (April 14, 2015)

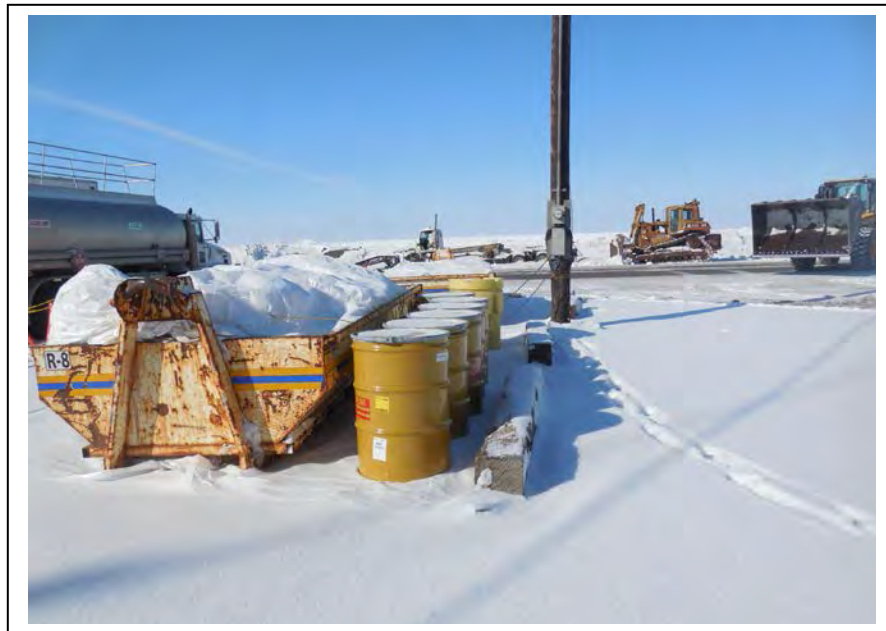
Photo 2: Seven overpack drums and one dumpster containing contaminated snow were observed at the fuel release area. (April 14, 2015)

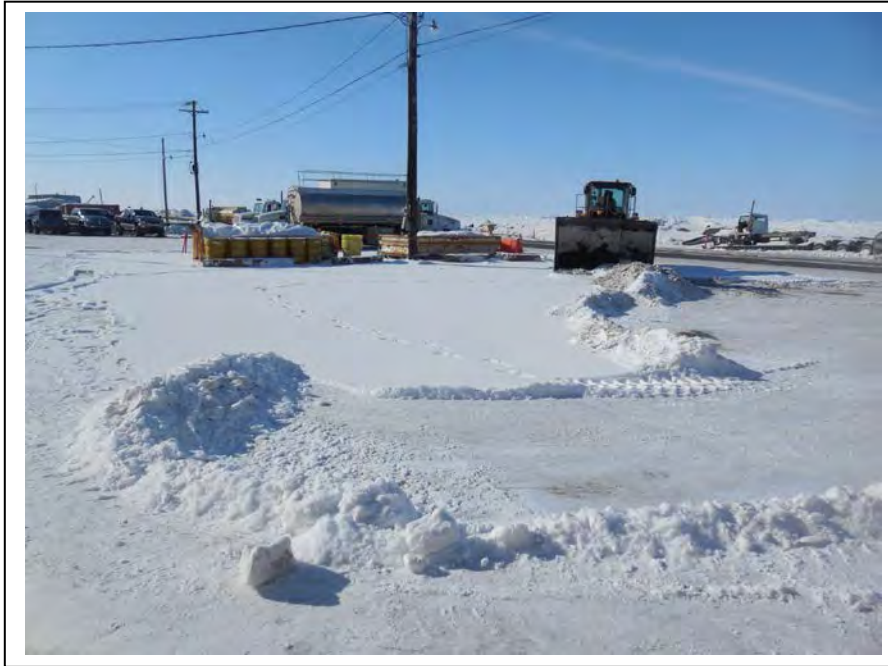
Shannon & Wilson field geologists Katie Nolan and Jenny Davis mobilized to Barrow to observe the site conditions on April 14, 2015. We arrived at the Site to meet with Mr. Lokeni Lokeni Jr., NSB Fuels Department Spill Coordinator, to identify the release area and temporary snow stockpile locations. We observed seven overpack drums (one 95-gallon and six 85-gallon) and two 10-cy dumpsters containing contaminated snow at the fuel release area (Appendix A, Photo 2). We also observed an additional approximately three inches of fresh snow covering the fuel release area (Appendix A, Photo 3).

Photo 3: Location of ULSD fuel release, release area covered in three inches of fresh snow. Facing west towards Stevenson Street. (April 14, 2015)

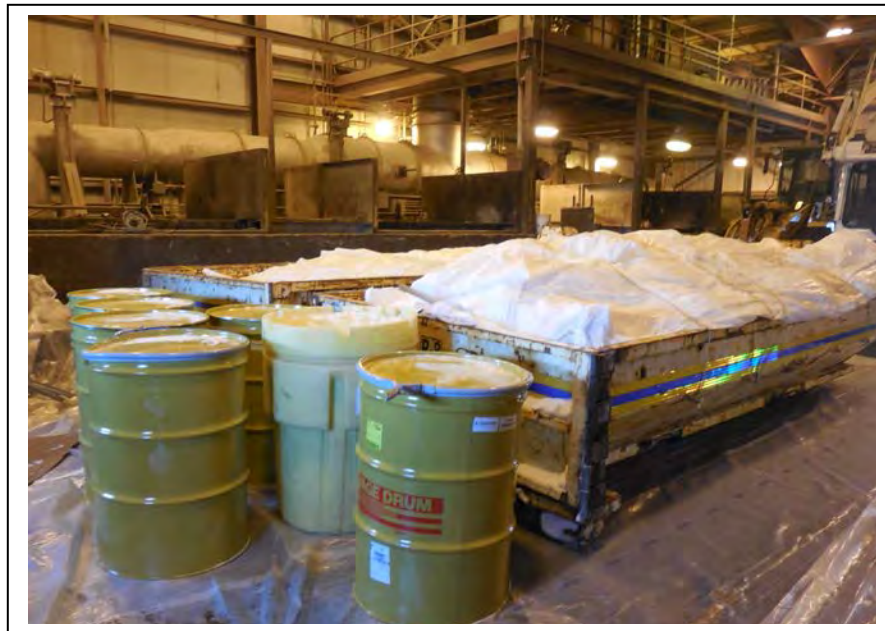
Photo 4: Containers holding contaminated snow were placed on a liner inside Shop #3, located less than one mile from the ULSD fuel release site. (April 14, 2015)

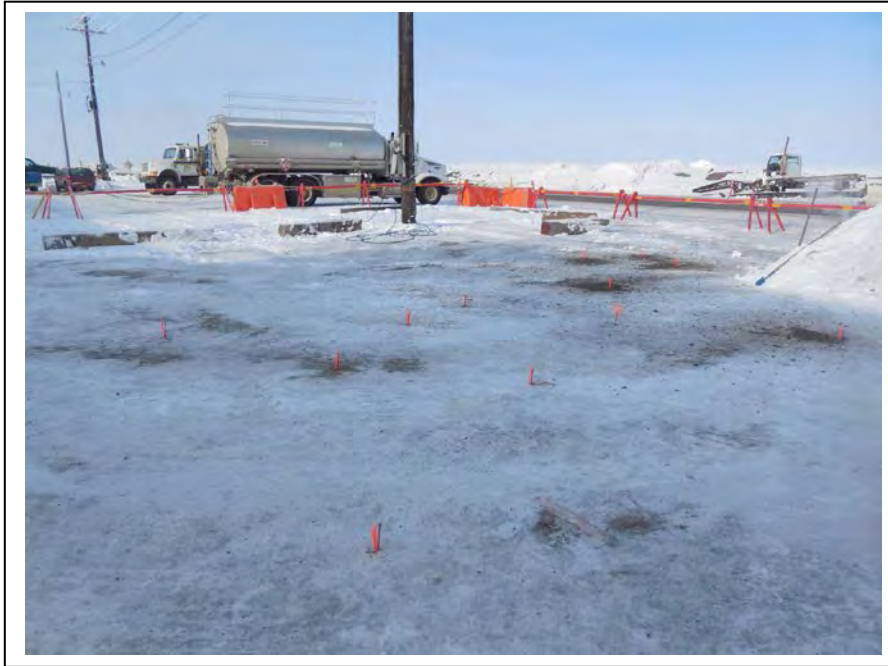
Photo 5: We field-screened surface soils at 14 locations in the fuel release (E1) area and six locations in the snow stockpile area (E2); locations marked with orange whiskers. (April 15, 2015)

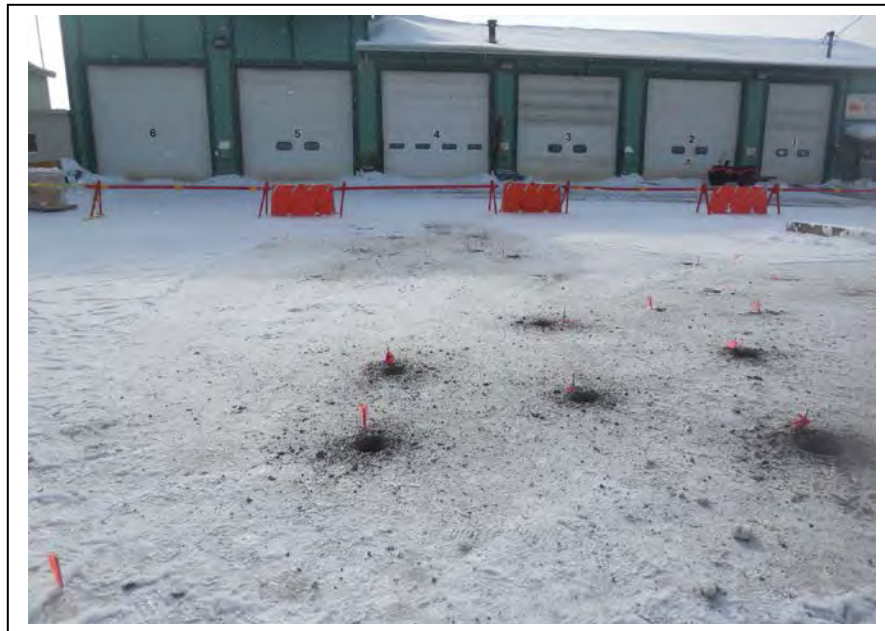
Photo 6: Ten additional field-screening samples were collected from E1 on April 16; facing southeast towards Shop #2 building. (April 16, 2015)

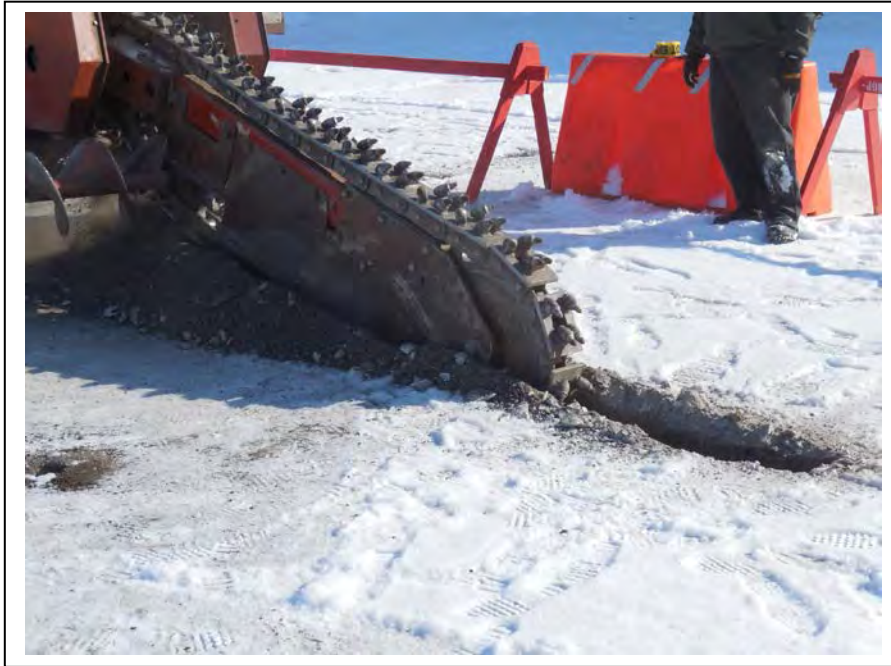
Photo 7: The ULSD fuel release area (E1) was trenched with a trencher in order to break up frozen soil prior to excavation. (April 16, 2015)

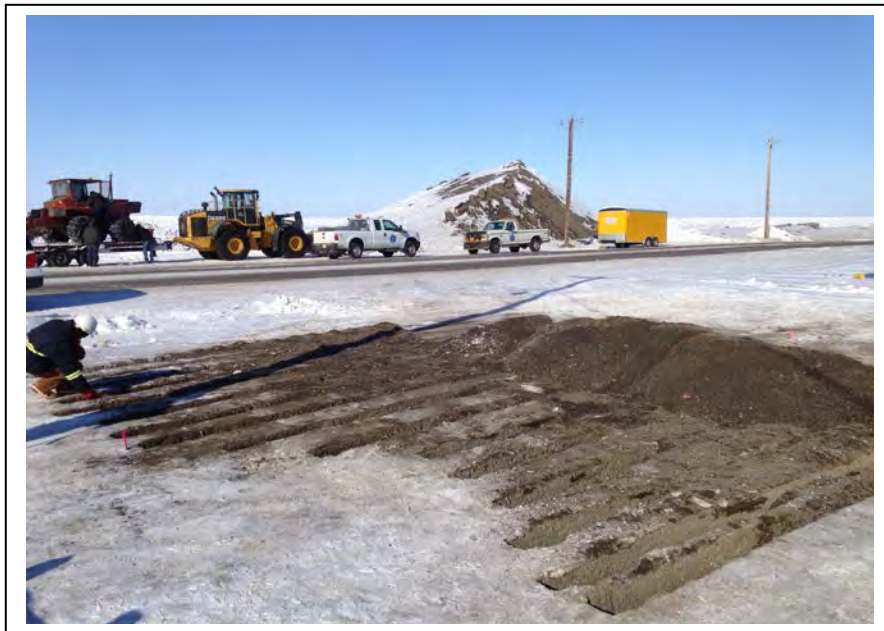
Photo 8: Barrow Utilities trenched soil in the fuel release area (E1) to approximately six to eight inches bgs, separating the trenches by approximately one foot; facing north towards Stevenson Street. (April 16, 2015)

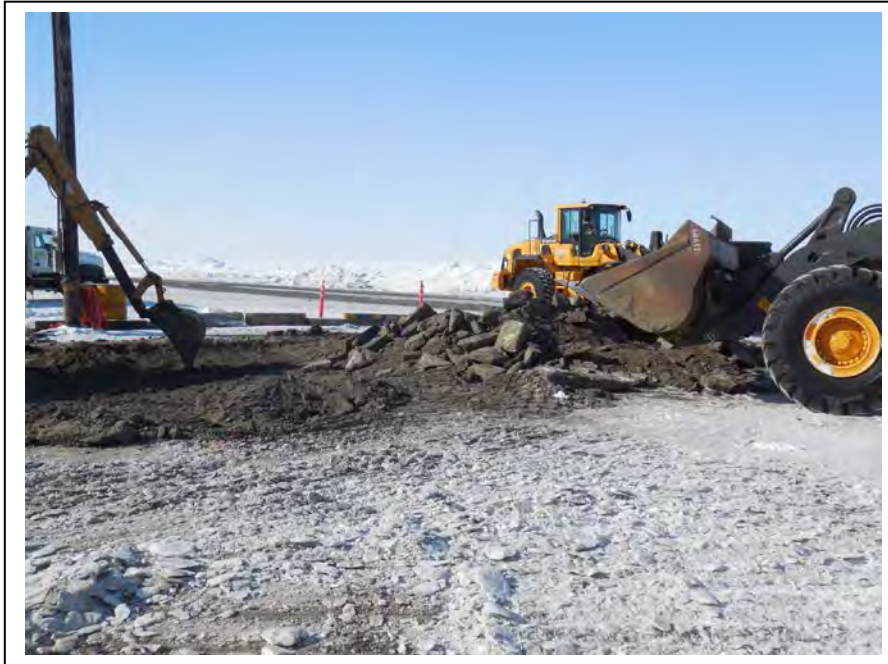
Field efforts continued on the morning of April 17, 2015. Crews used a loader and small backhoe to break up and excavate the soil in E1 (Appendix A, Photo 9). The limited mobility of the loader required the excavation be deeper (i.e., one to two feet bgs) than the originally anticipated eight inches bgs. We observed digging of the center of the excavation area to approximately two feet bgs. Excavated soils were stockpiled in the northeast corner of E1 (Appendix A, Photo 10). We observed staining throughout the vertical profile in the west corner of the excavation area (Appendix A, Photo 11). We also noted a strong hydrocarbon odor in the west corner of E1.

Photo 9: NSB crews used a loader and small backhoe to break up and excavate contaminated soil in the fuel release area (E1); facing west-southwest towards Stevenson Street. (April 17, 2015)

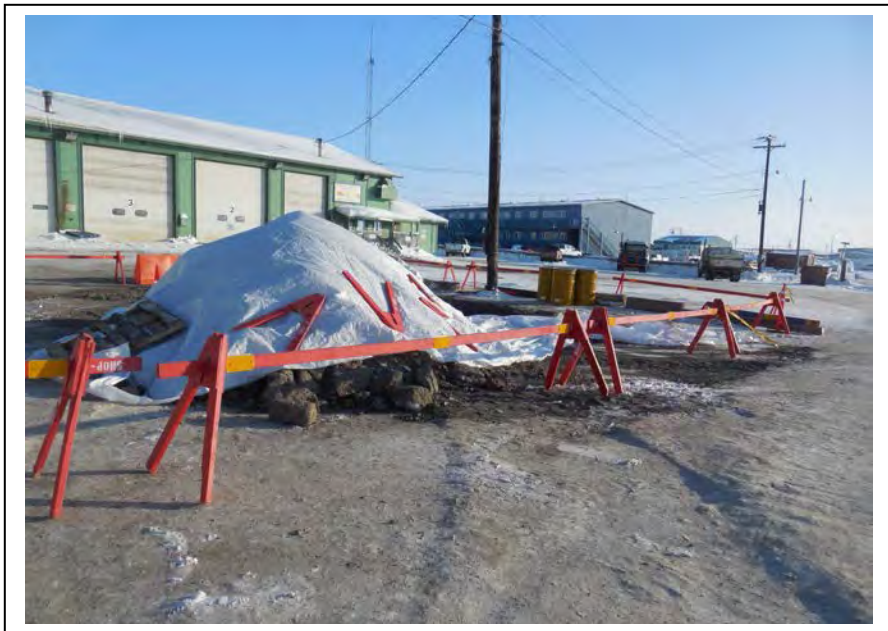
Photo 10: Excavated soils were stockpiled in the northeast corner of the fuel release area (E1). We collected five field-screening samples from the soil stockpile; facing south. (April 17, 2015)

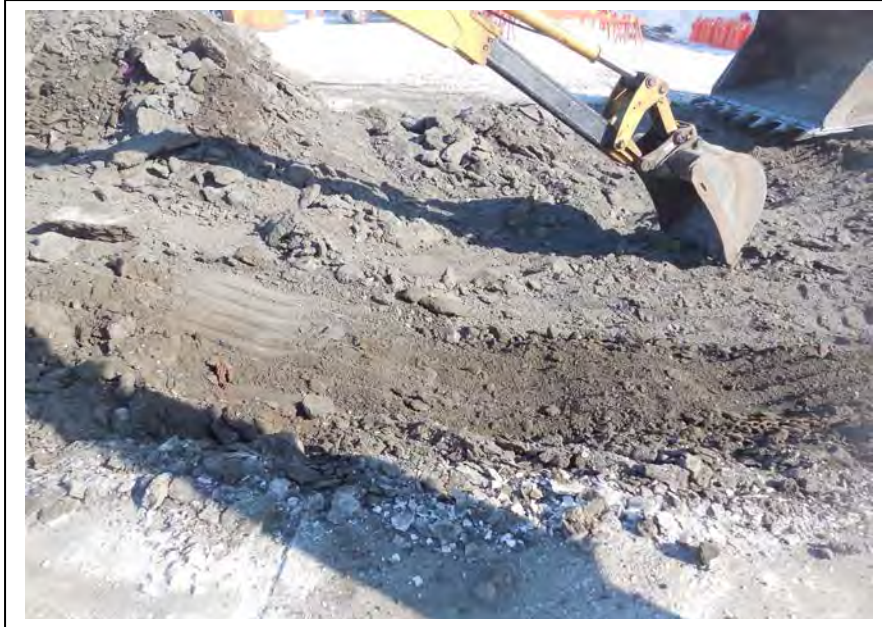
Photo 11: Staining was observed in the west corner of the fuel release area (E1); facing east. (April 17, 2015)

Field staff and NSB responders worked with frozen soils during the initial excavation effort at the Site. The frozen condition of the soils made excavation efforts challenging and inefficient. Soils from both the E1 and E2 areas should be further excavated in order to remove contaminated soil from the Site. We recommend performing the excavation as soon as the soil

conditions improve (i.e., once temperatures rise enough to thaw soils). In addition, a plan for treatment and/or disposal is needed for both the sediment from snowmelt and the excavated soil.

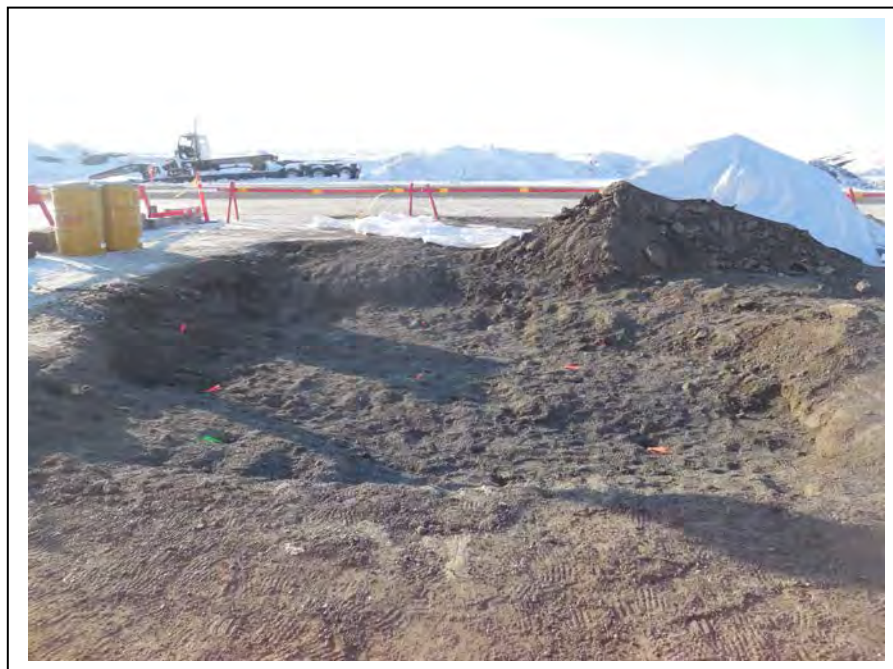
Photo 12: We collected analytical soil samples from the base and sidewalls of the excavated area; facing northwest towards Stevenson Street. (April 18, 2015)

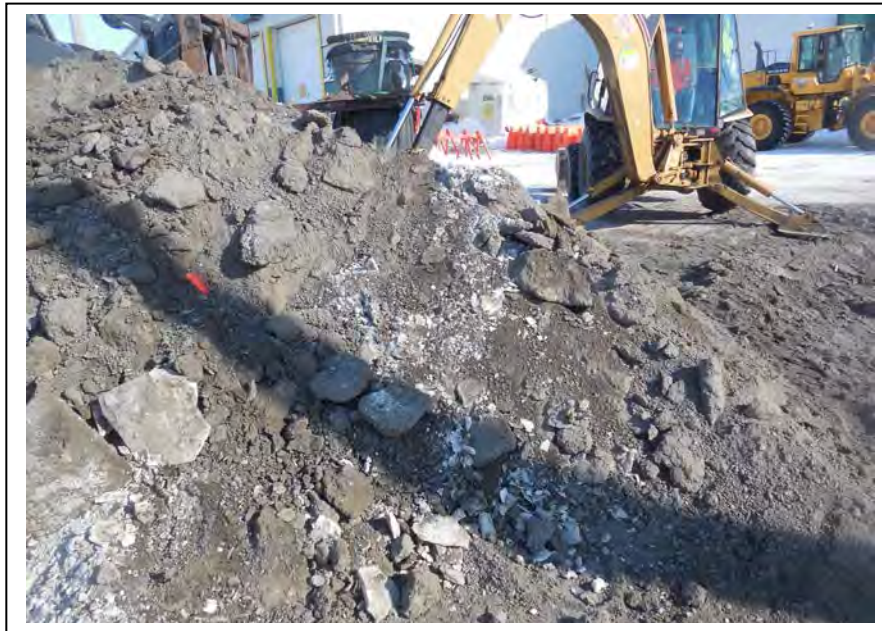
Photo 13: Field-screening samples were collected at 6-inches below ground surface at five locations in the soil stockpile, flagged by whiskers; looking north. (April 17, 2015)

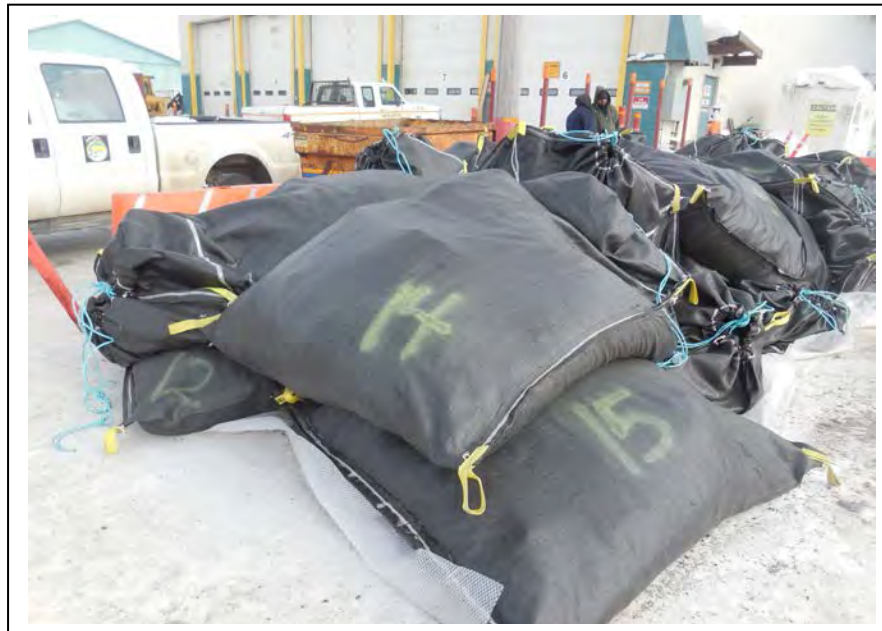
Photo 14: Excavated soils were bagged and placed on a liner at the northeast end of the Shop #2 site; facing southeast. (April 18, 2015)

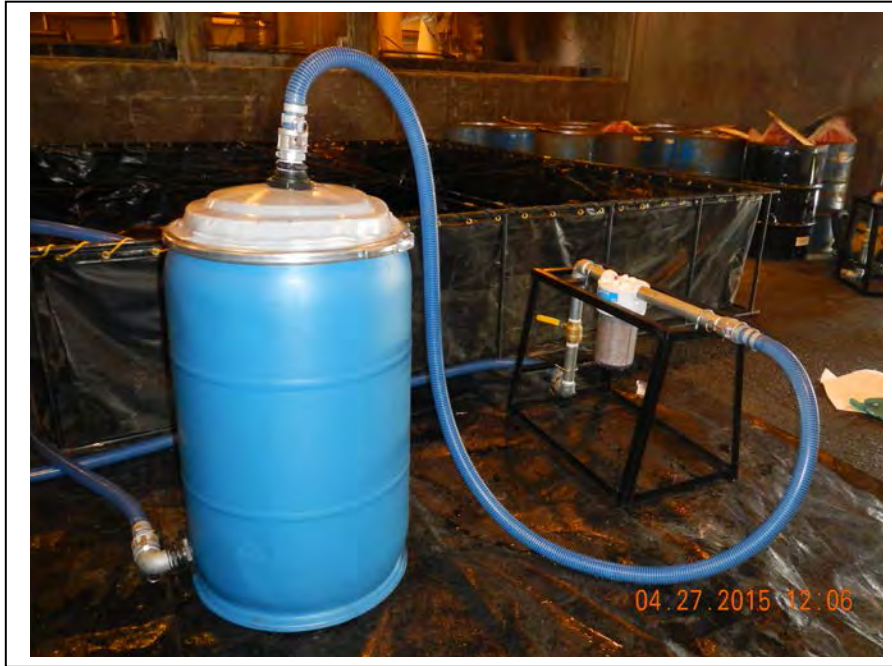
Photo 15: 55-gallon granular activated carbon (GAC) drum (on the left) and micron filter (on the right), in front of the 2,000-gallon holding tank. (April 27, 2015)

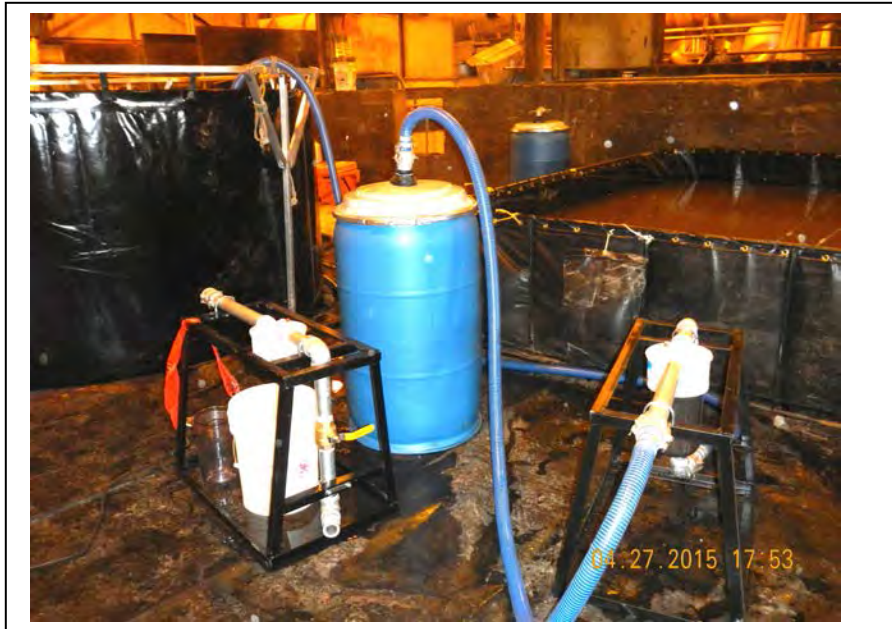
Photo 16: The GAC filtration system setup. Water in the 2,000-gal holding tank is filtered water from the round holding tank (Pictured on the left behind the GAC setup). (April 27, 2015)

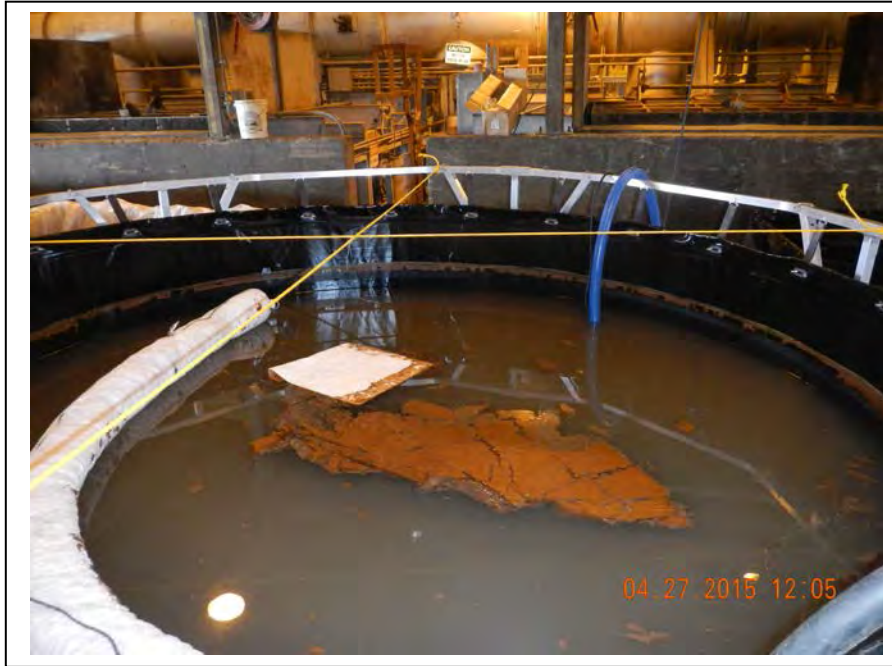
Photo 17: Pre-treated sump water in the round 1,600-gallon holding tank. (April 27, 2015).

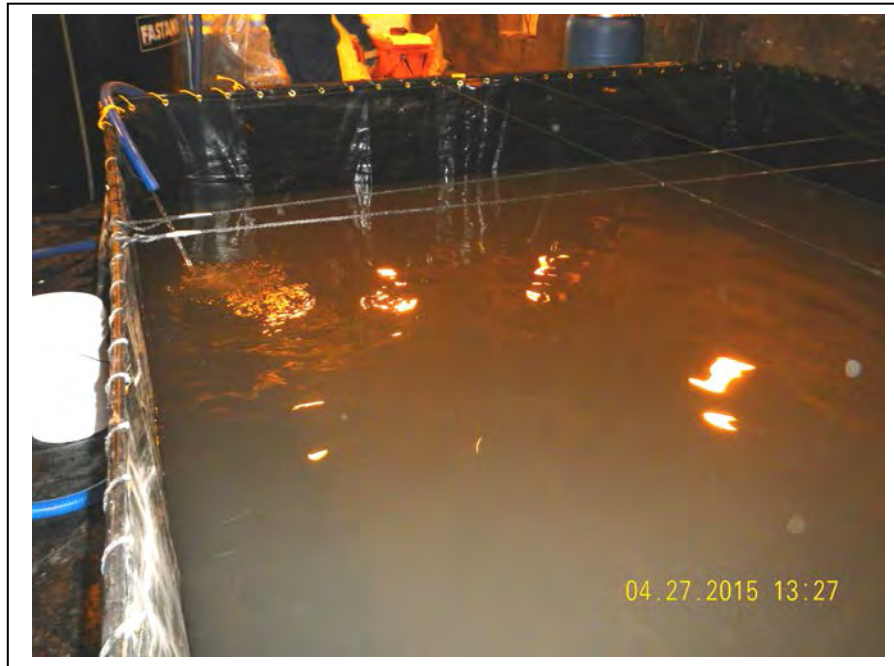
Photo 19: Post-treatment water from the pre-treatment round holding tank. (April 27, 2015).

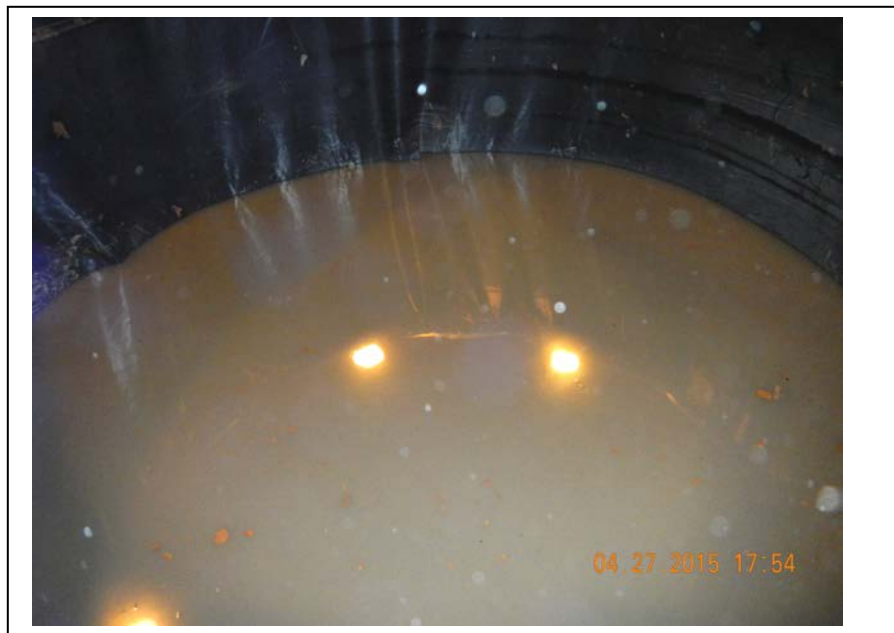
Photo 20: Post-treatment water from the pre-treatment dumpster. (April 27, 2015).

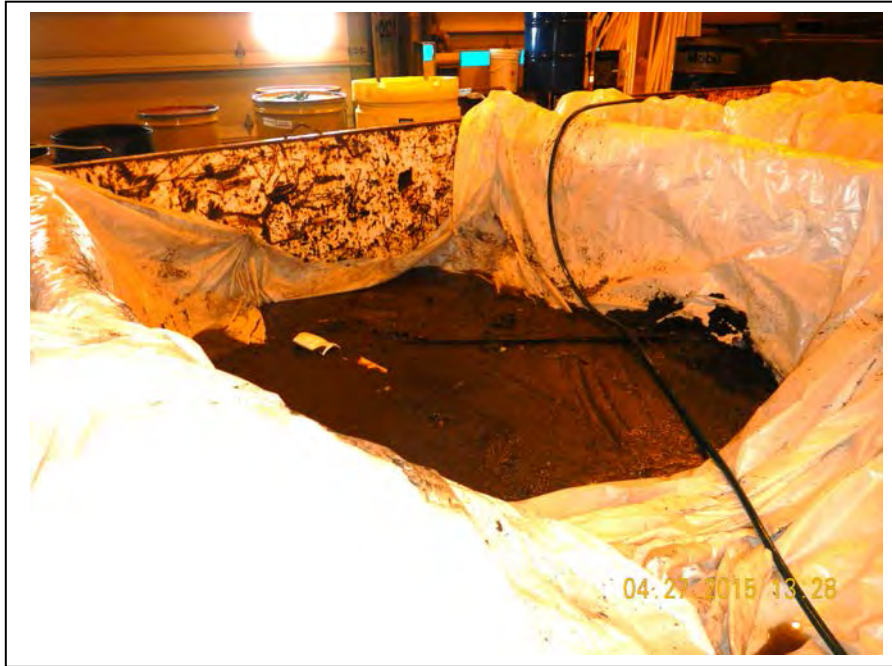
Photo 21: Contaminated sediment from snowmelt. (April 27, 2015)

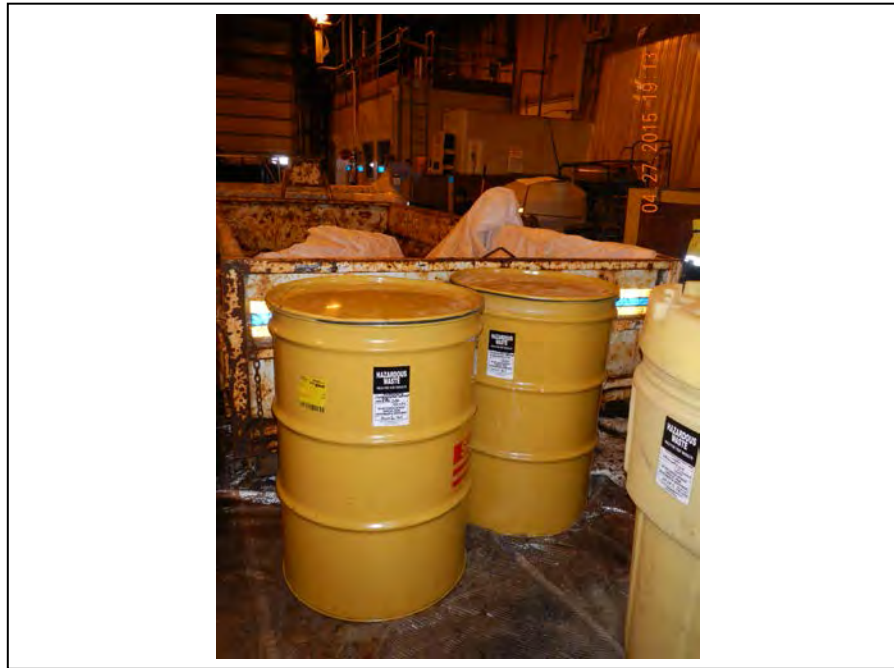
Photo 23: Drums containing sediment from snowmelt; sediment was consolidated from the two dumpsters. (April 27, 2015)
