January 22, 2019

Subject: Indoor Air and Subslab Soil Gas Assessment Report, for Karen's RV and Taylor Leasing (ARRC lease properties LP-072 and LP-125, respectively), Anchorage, Alaska

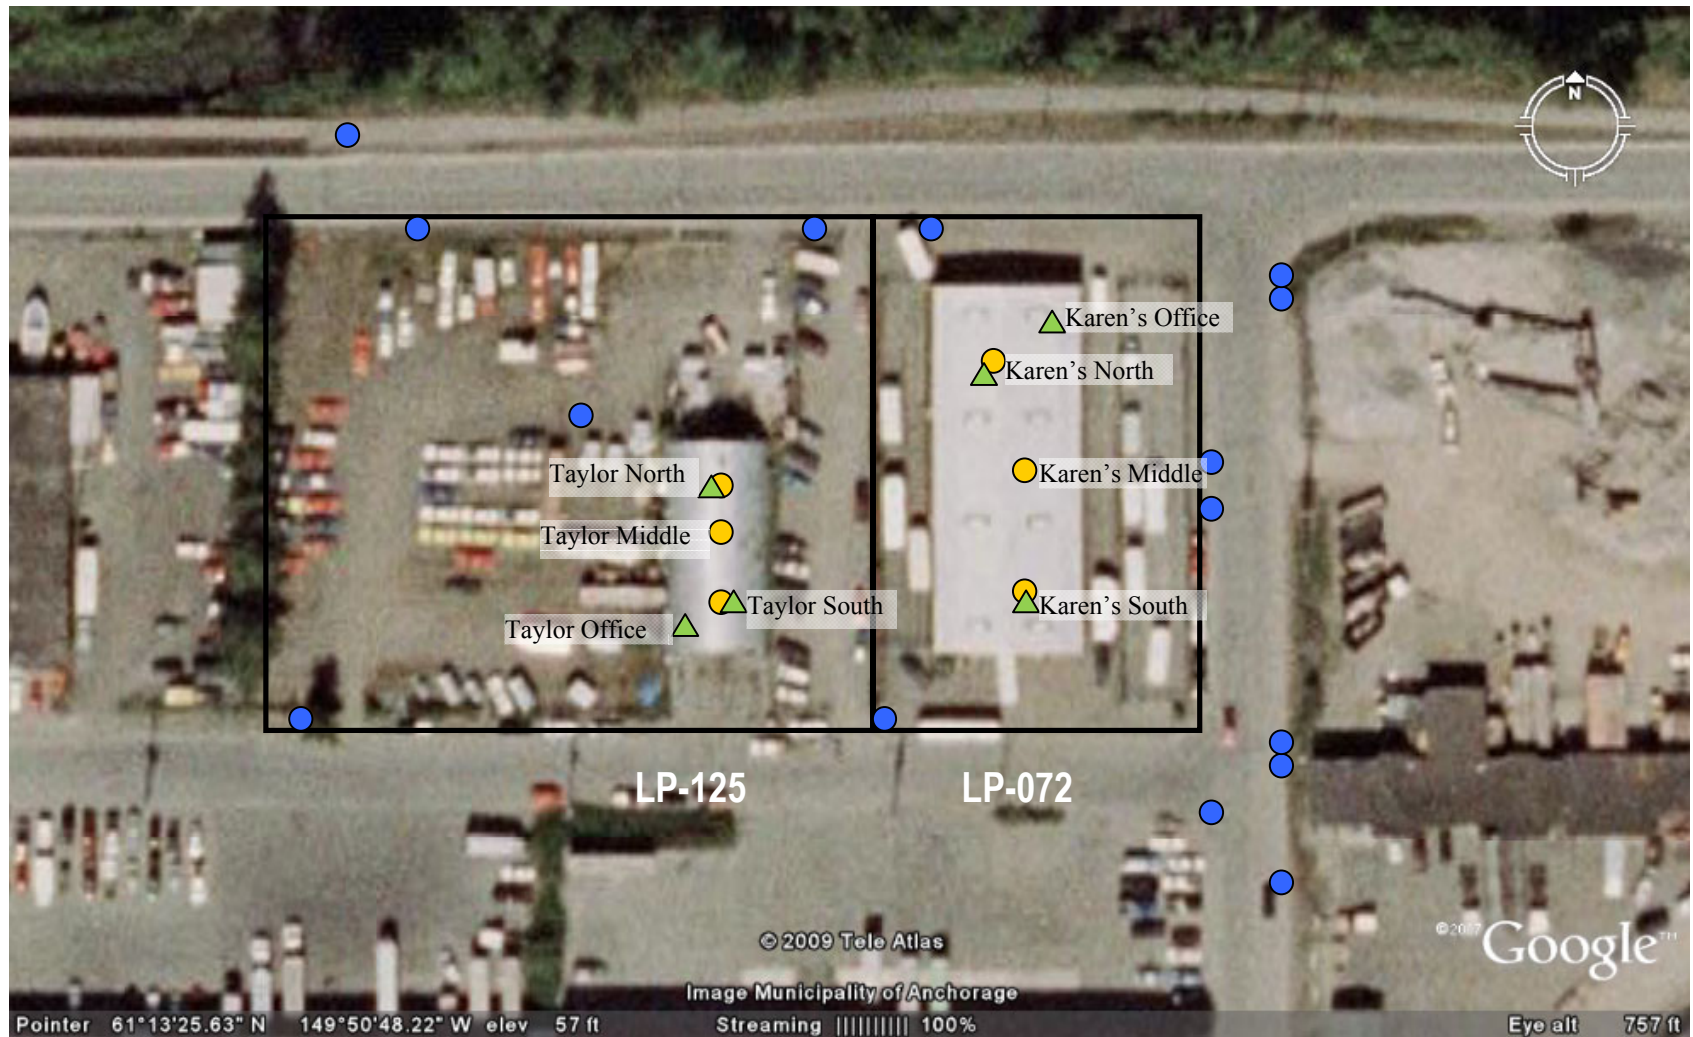
Figure 1 Approximate Sub-slab Soil Gas and Indoor Air Sampling Locations

- Subslab Soil Gas Sample Locations ●
- Indoor Air Sample Locations ▲
- Previous Groundwater Sample Locations ●

Indoor air sample locations in the Karen's RV building included one indoor sample in the office on the northeast side of the building and one sample each near the north and south subslab sample

locations in the main work area of the building. The north and south subslab sample locations had the highest concentrations measured in the Karen's RV building, in the 2009 sampling event.

Indoor air sample locations in the Taylor Leasing building included: one indoor sample in the office on the southwest side of the building, and one sample each near the north and south subslab sample locations in the main work area of the building. The north subslab sample location had the highest TCE concentration and the south sample location had the highest PCE concentration measured in the Karen's RV building, in the 2009 sampling event.

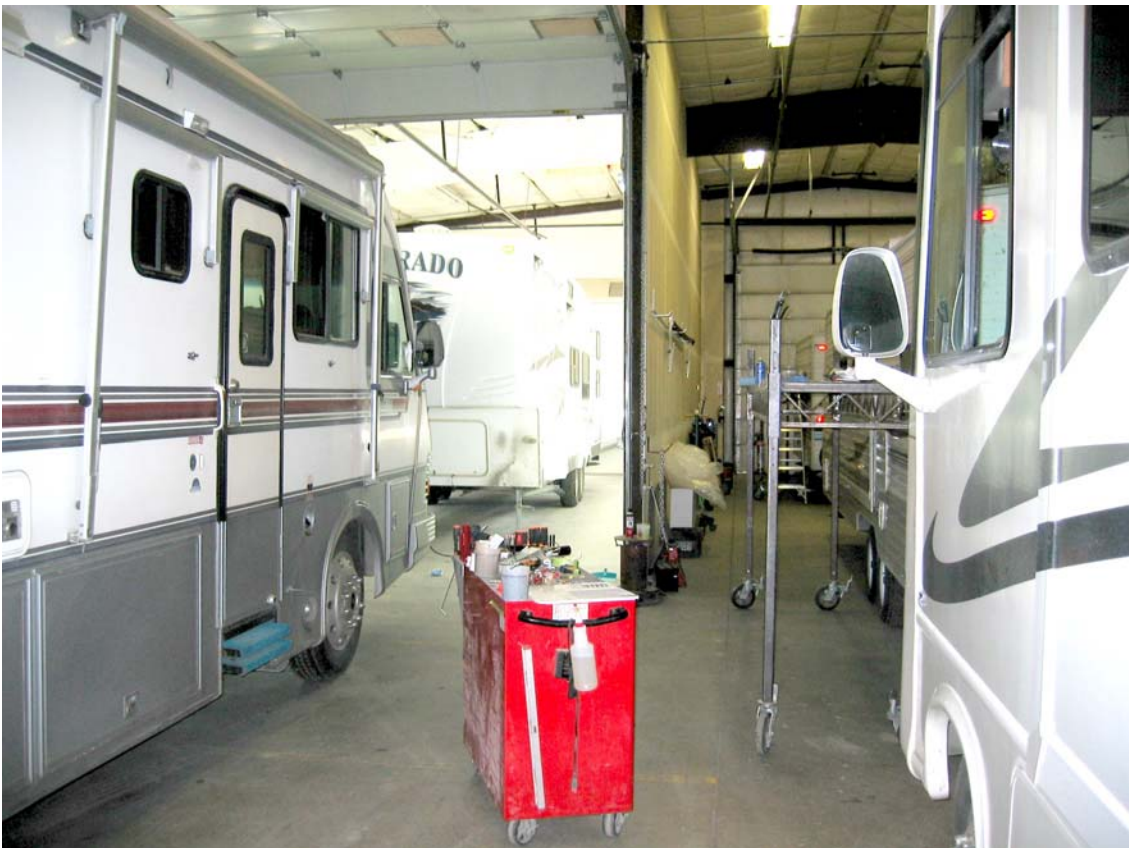
Photograph 2 Interior of LP-072 building. The paint bay is the brightly lit area to the left.

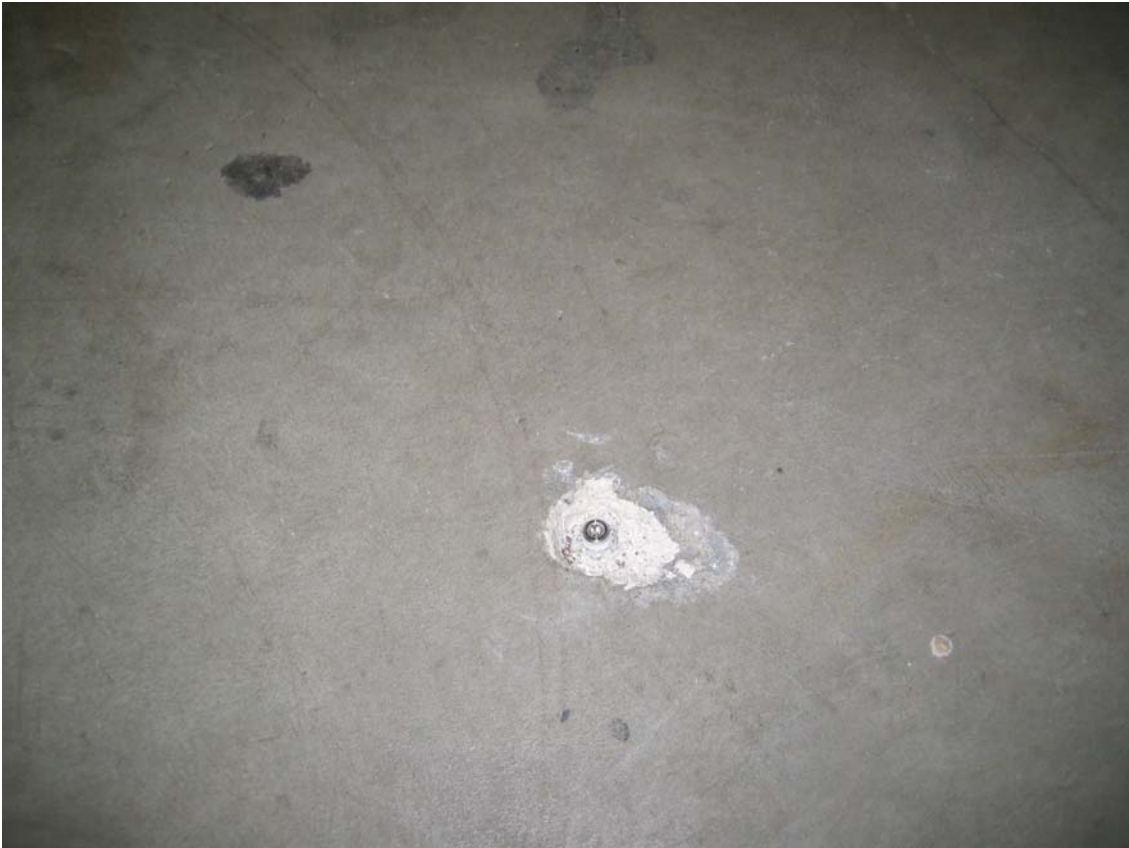
Photograph 3 A sub-slab sampling point cemented into the floor at LP-072.

The subslab soil gas sampling used the soil gas probes installed in 2009. The probes were inspected on November 1, 2017 and prior to sampling in April of 2018 and appeared to be in good condition (i.e. the Swagelok plugs were tight and the Swagelok probes were firmly grouted into place). The probe locations are shown in Figure 1. A helium leak-check was conducted at each subslab sampling location, as described in the SOP in the work plan. Two of the probes at Karen's RV and two of the probes at Taylor Leasing had subslab helium readings of zero ppm helium. One of the soil gas probes at Karen's RV and one of the soil gas probes at Taylor Leasing passed the initial helium leak test but did have subslab helium detections. The soil gas sampling ports were sealed with "FIX-IT-ALL" gypsum patching compound as per the SOP and the helium leak test was repeated. Both sample ports again passed the helium leak test and had lower helium detections after being re-sealed, allowing the soil gas samples to be collected. The helium concentrations measured under the leak-check enclosure and in the subslab soil gas were recorded in the field notes and are presented in Table 2. While conducting the helium leak-check and collecting the subslab soil gas samples the quantity of subslab soil gas removed was minimized to the extent practicable. Work was conducted by Lawrence Acomb of Geosphere, who meets the ADEC definition of a Qualified Environmental Professional (QEP), as defined by 18 AAC 75.990(100). Mr. Russ Grandel, of the ARRC, participated in the collection of several gas samples in both buildings. ADEC building inventory and indoor air sampling questionnaire forms are attached.

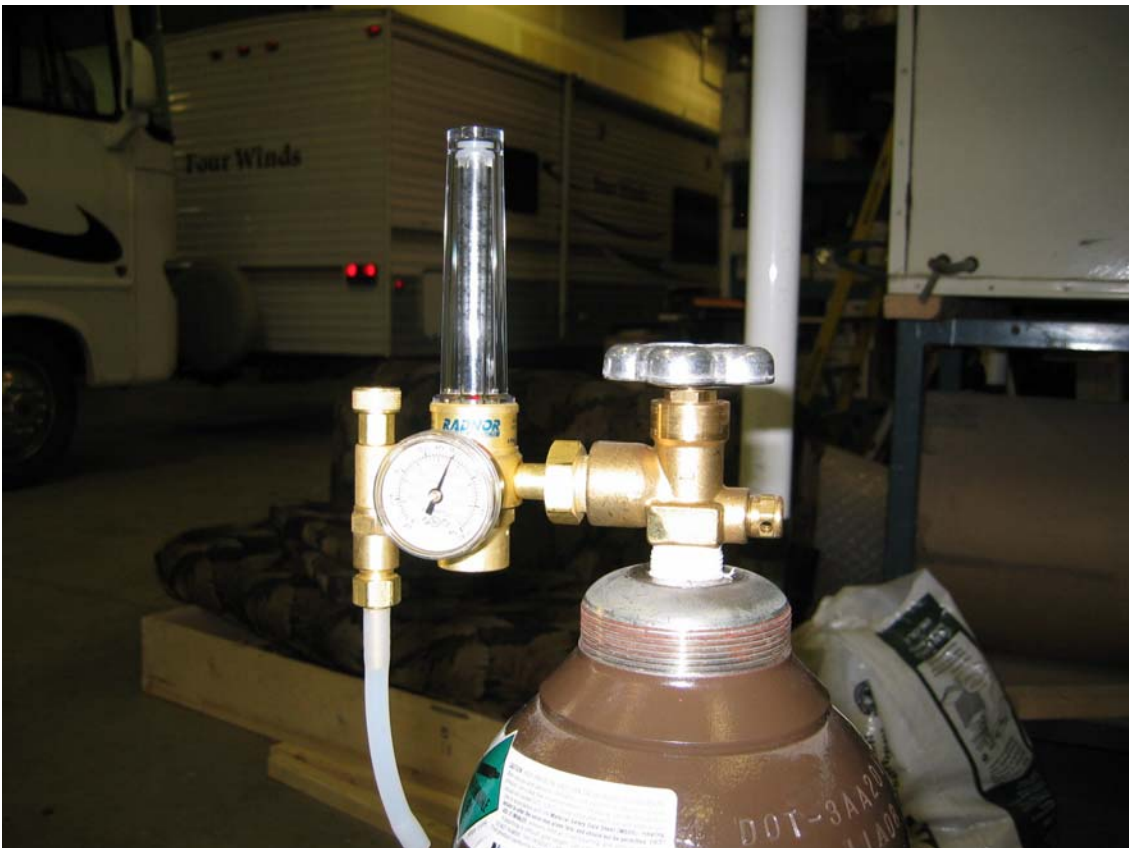
Photograph 4 Helium tank and regulator used in leak testing.

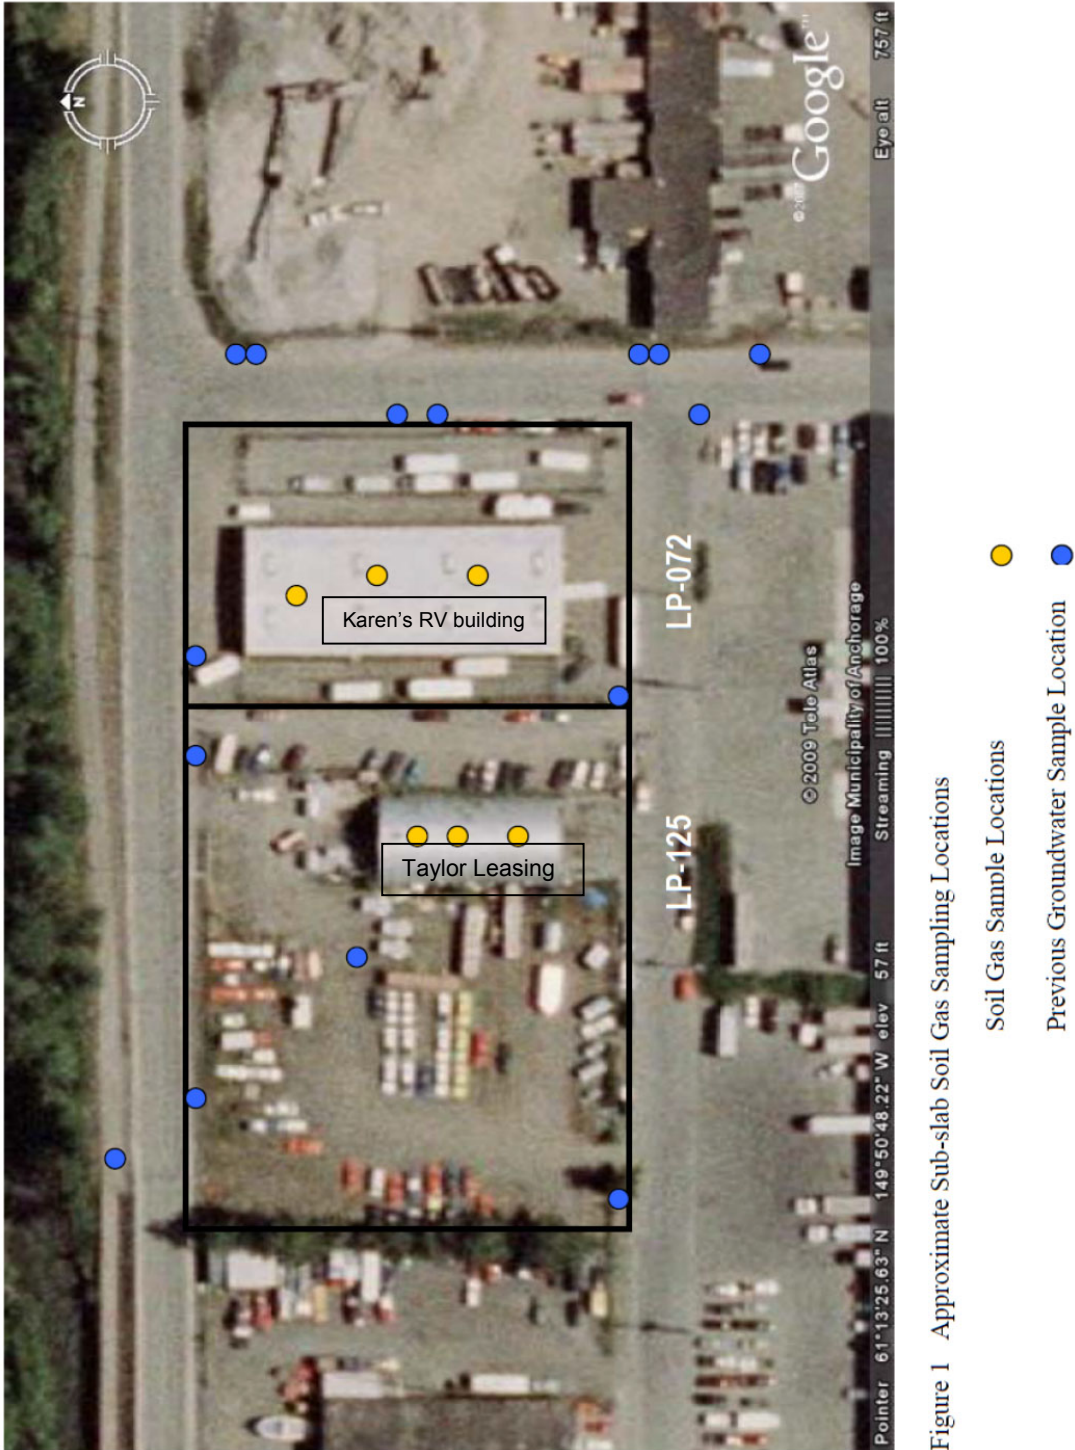
Figure 1 - Approximate Sub-slab Soil Gas Sampling Locations

- Soil Gas Sample Locations
- Previous Groundwater Sample Location
