A Report Prepared for

**PORT GRAHAM BULK FUEL SYSTEM  
RELEASE INVESTIGATION  
PORT GRAHAM**

HLA Project No. 24547

November 29, 1993

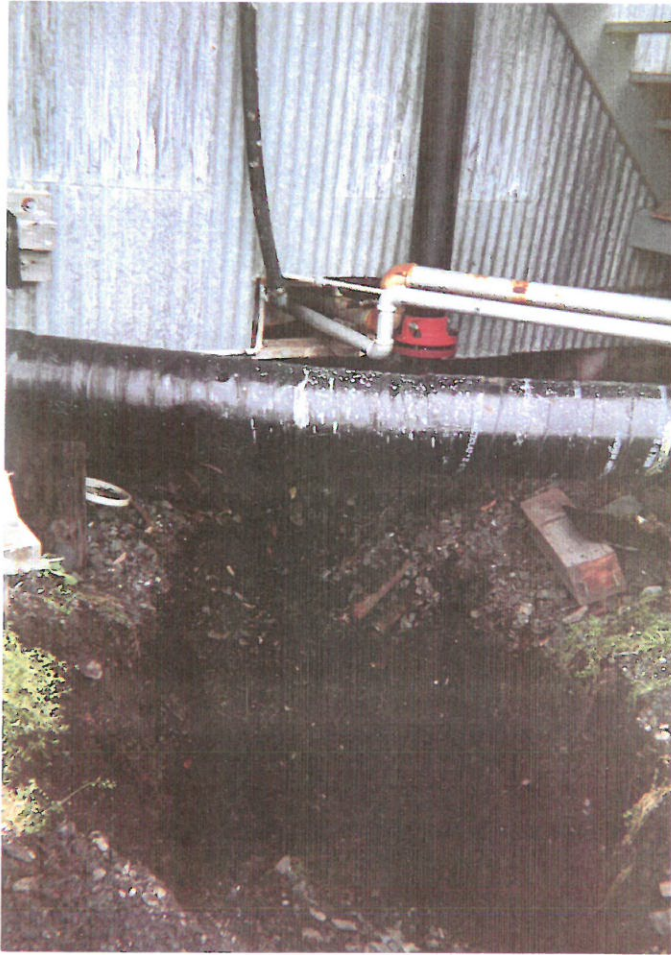
The zone of contamination with chemical concentrations above site action levels appears to be in three separate areas (Plate 11). The first area coincides with the location of Test Pits 1 and 2, and Excavation A, directly underneath the product piping along the west wall of the cannery. This site was identified by the PGC as the location of previously leaking pipeline. This area is partially bounded by Test Pits 2 and 13, which had soil contamination concentrations beneath action levels at depths of 10 and 5 feet, respectively. Field-screening (infrared spectrometer) results from soil in Test Pit 2 at a depth of 2 feet were 930 mg/kg. However, the detected concentration of DRO in the bottom of Test Pit 2 at a depth of 10 feet is 22 mg/kg, which is below the site cleanup level. The eastern limit of contamination could not be ascertained because of the obstacle posed by the location of the cannery building.

Test pit number one, western wall of cannery building, directly beneath product piping, adjacent to excavation "A". This was apparently the location of an abandoned septic tank leach field.

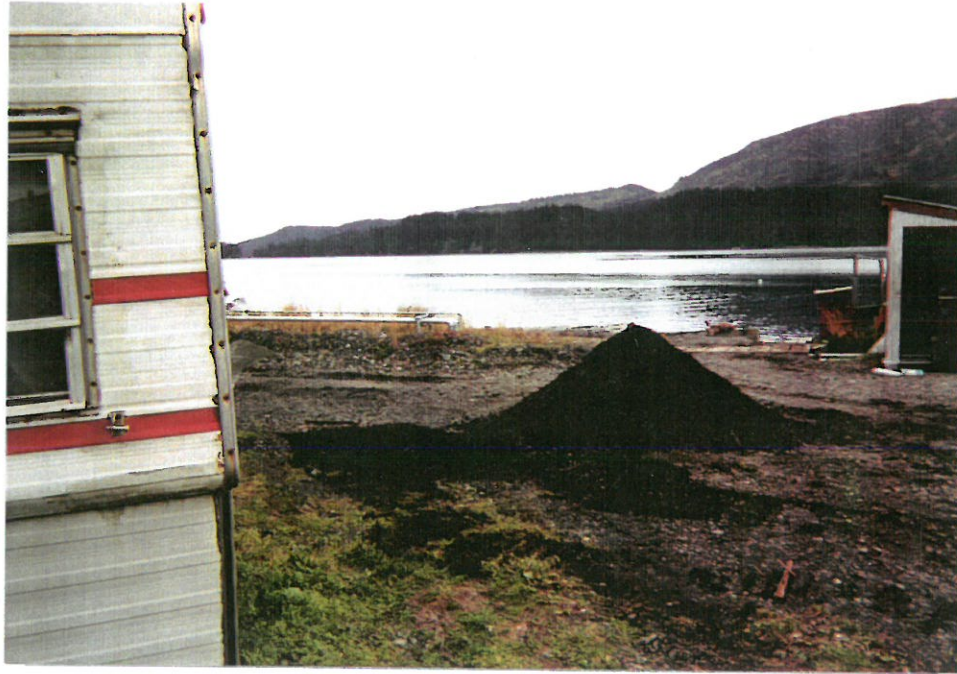
Test pit number three

The third area of contamination coincides with the location of Test Pit 4. This area may be contaminated due to a past pipeline leak in the vicinity, or may be an extension of the contamination detected at Test Pit 5. The area is partially bounded by Test Pits 3 and 12, which had soil contamination concentrations beneath action levels at depths of 4 and 6 feet, respectively.

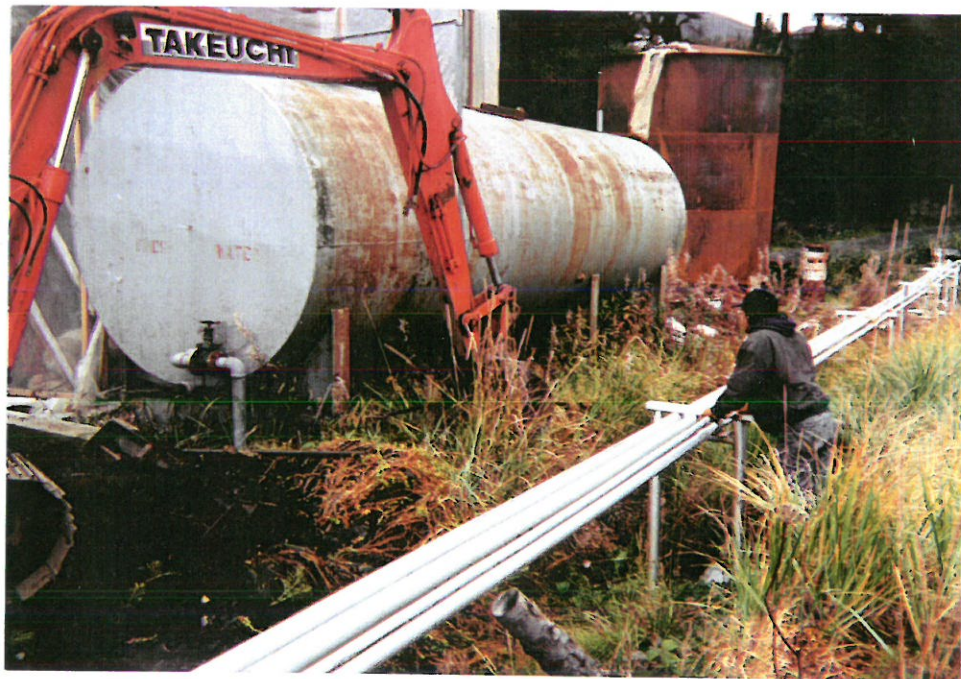
Test pit number four

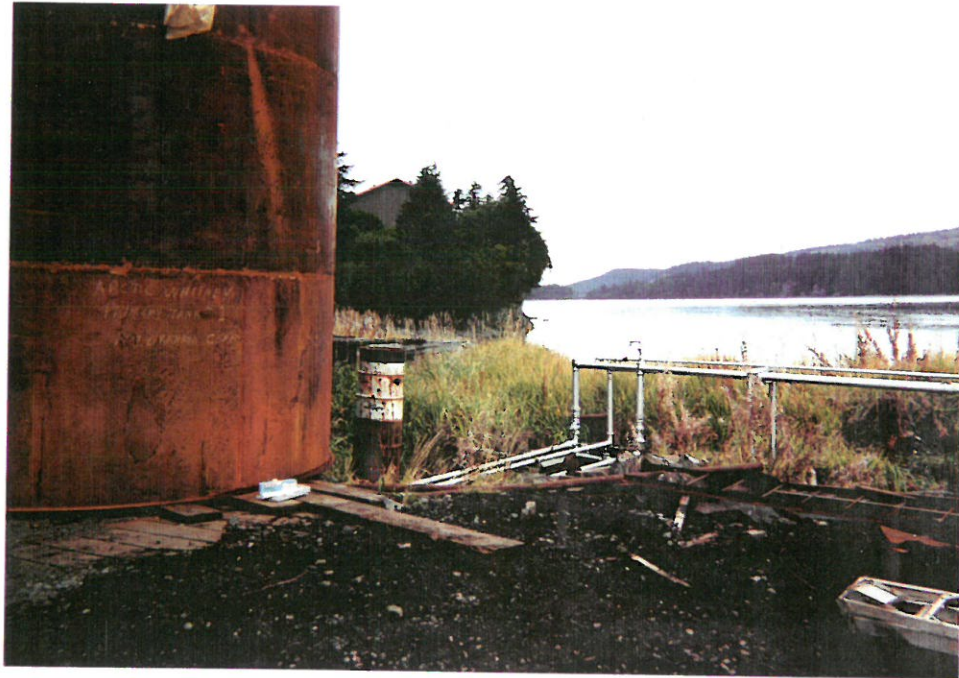
Vicinity of excavation "C"

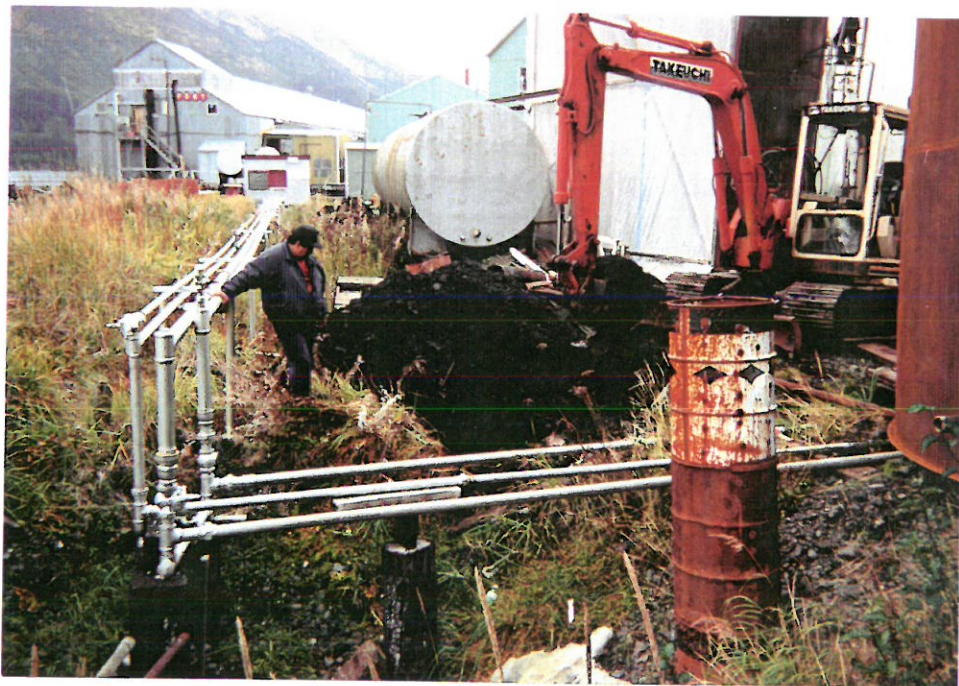
The second area of contamination extends from Test Pit 5 to the southern edge of the Tank Farm site. Releases adjacent to AGTs were probably caused by leaking tanks and piping. Test Pit 5 was located in an area identified by the PGC as the site of previously leaking pipeline. This contaminated area is partially bounded by the embankment to the west, and by Test Pits 9,

Test pit number five, adjacent to excavation "C"

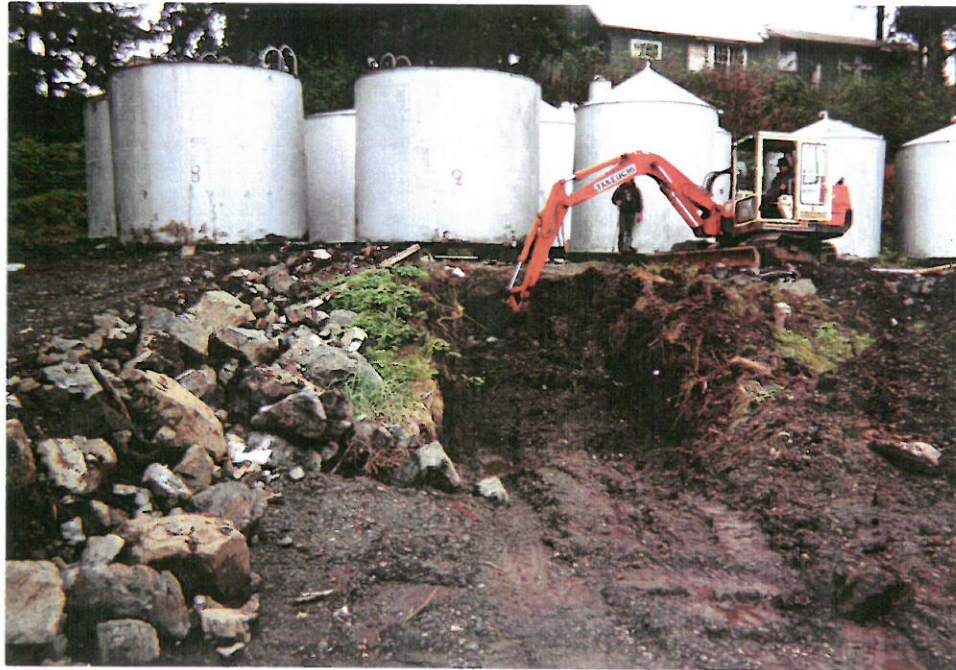
Sample field-screening and analytical results are presented in Table 1. Analytical results from the bottom of the test pits are summarized on Plate 11. CT&E laboratory data reports are presented in Appendix A. Soil contamination levels above site action levels were found in Test Pits 1, 4, 5, 6, 7, and 8. The highest concentrations of DR0 were found in Test Pit 1 (13,400 mg/kg), Test Pit 5 (8,220 mg/kg), and Test Pit 6 (19,500 mg/kg). A petroleum hydrocarbon sheen was noted on the perched water observed seeping

Test pit number six, adjacent to embankment

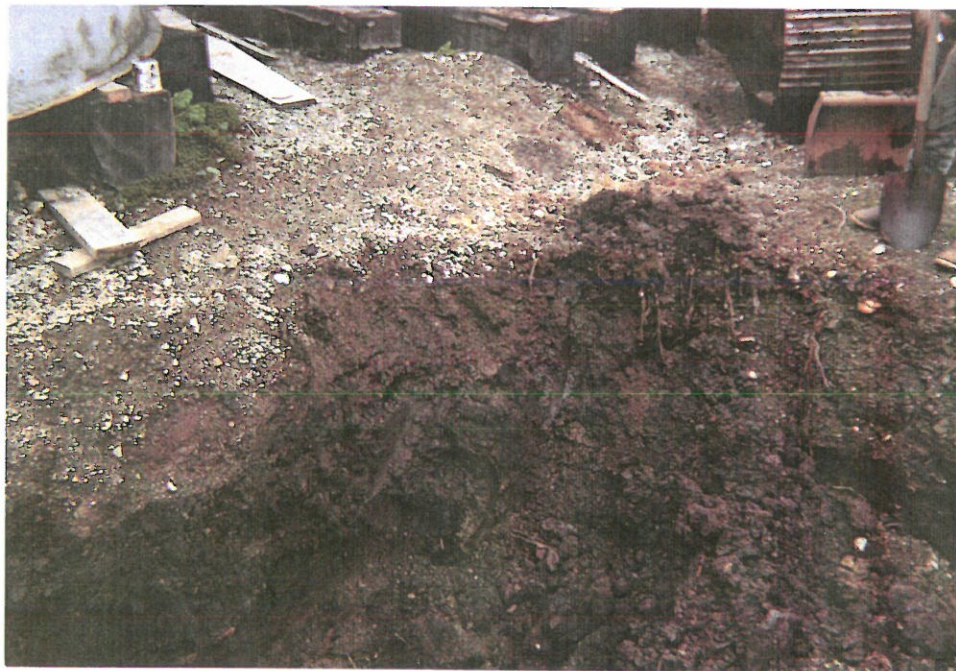
from the sidewall of Test Pit 6. The highest concentrations of GRO were found in Test Pit 4 (479 mg/kg), and in Test Pit 8 at a depth of 6 feet (328 mg/kg). The detected concentrations of DRO and GRO in the bottom of Test Pit 8 (9 feet deep) were below site cleanup levels. Detected concentrations of benzene and total BTEX did not exceed the respective action levels in any of the test pits.

Seep exposed during excavation of test pit number six

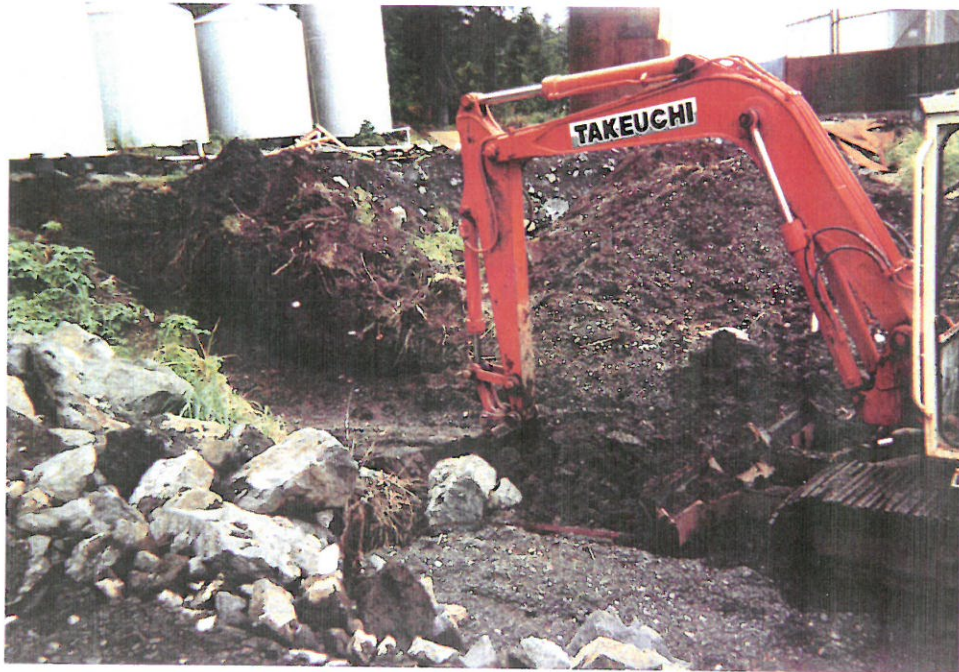
Test pit number nine

Groundwater was encountered at approximately 5 feet below the surface at Test Pits 9, 11, and 13.

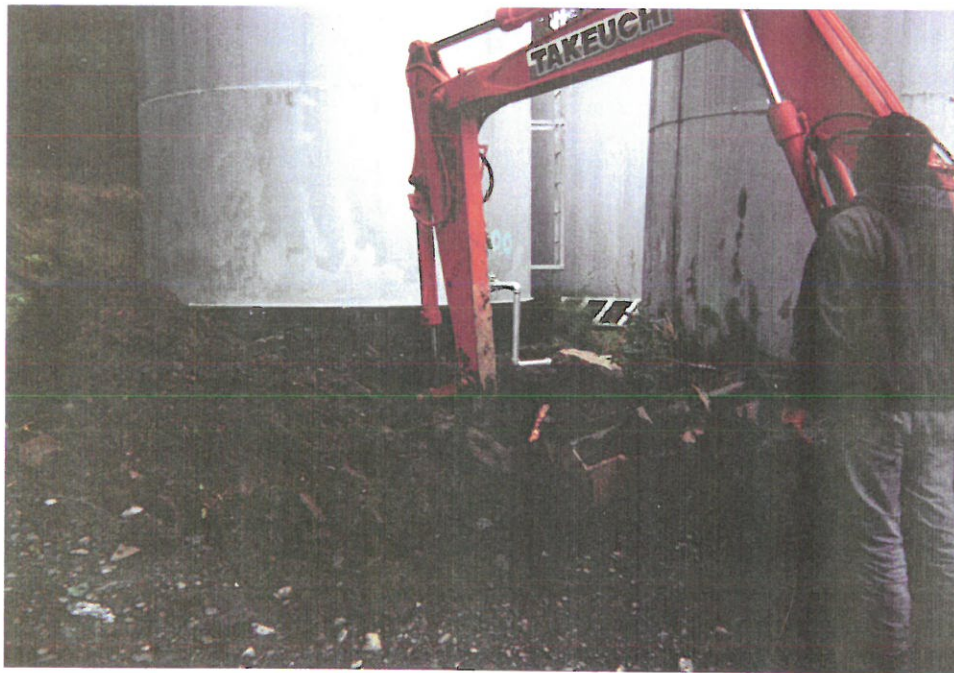
Test pit number ten

10, 11, and 12, which had soil contamination concentrations beneath action levels at depths of 5, 4.5, 5, and 6 feet, respectively.

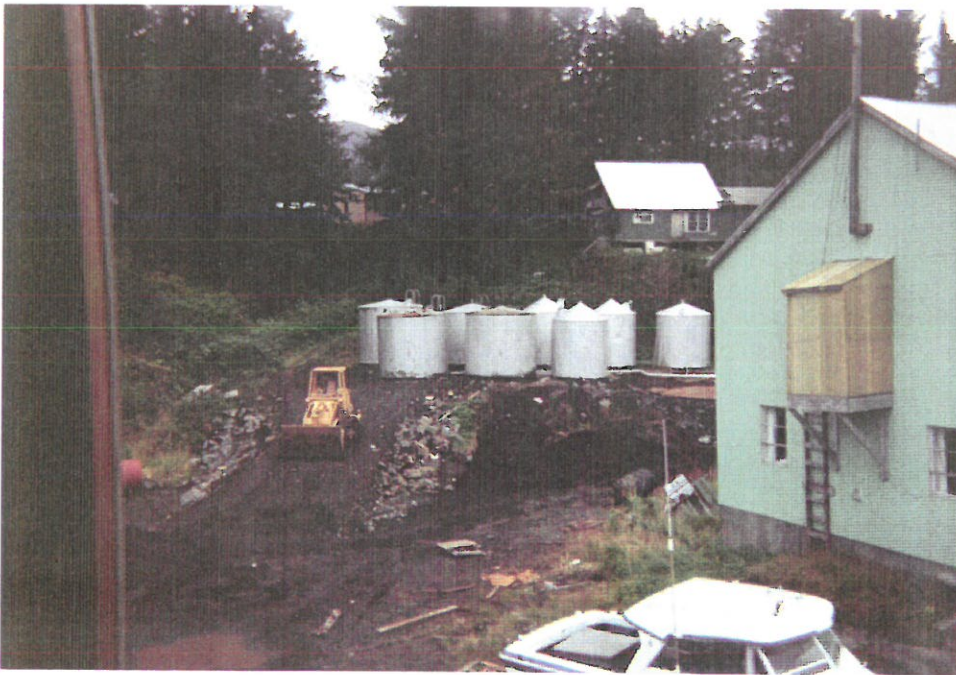
Port Graham tank farm,  
viewed from window  
of general store.
