Re: Decommissioning Monitoring Wells

Travis/Peterson Environmental Consulting, Inc. (TPECI) was contracted by ASRC Energy Services, Inc. (ASRC) to decommission monitoring wells located at 3319 Industrial Avenue, in Fairbanks, Alaska (Figure 1).

FIGURE 2
SITE PLAN

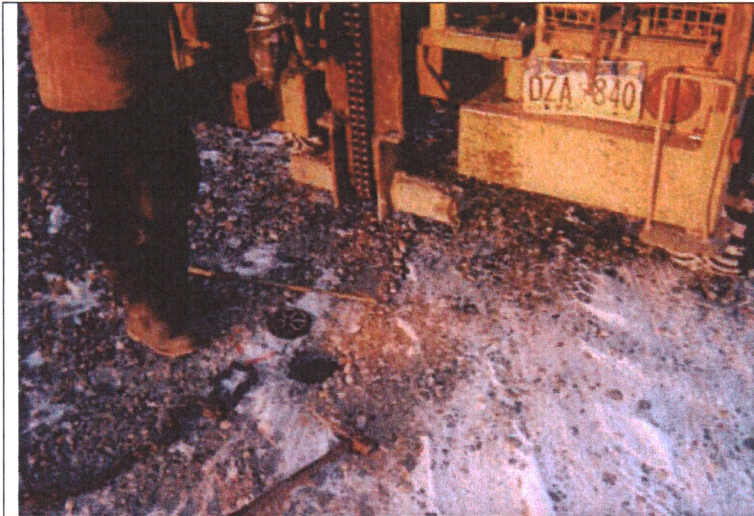
Photo 1:
Well MW-5 prior to it's removal.

MW-1, MW-2, and MW-3 were 0.5" stick up wells. These wells were pulled from the ground using a chain (See Photographic Log attached). MW-4 and MW-5 were 1.5" steel flush mount wells. These wells were pulled from the ground using a chain. All wells were filled using benseal bentonite and sand. Well monuments were removed from the ground using a chain.

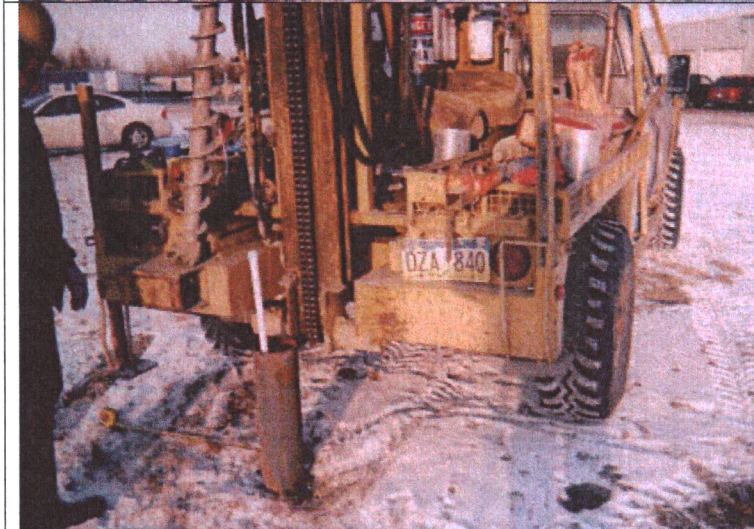
Photo 2:
Well MW-1 Prior to its removal.

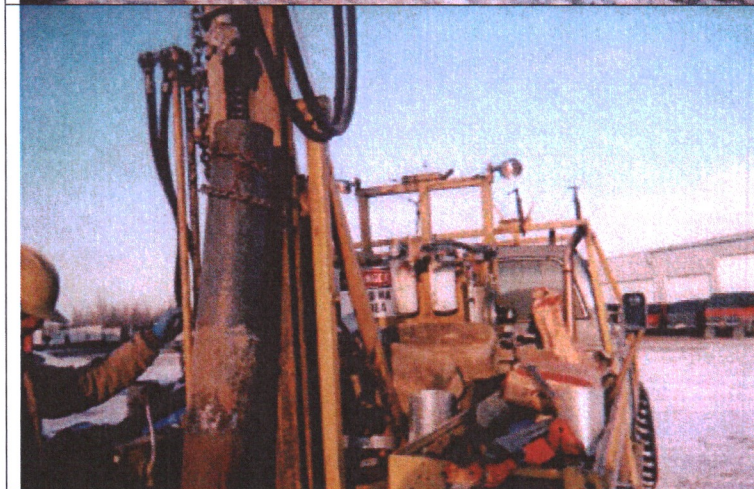
Photo 3:
Removal of well MW-1 monument.

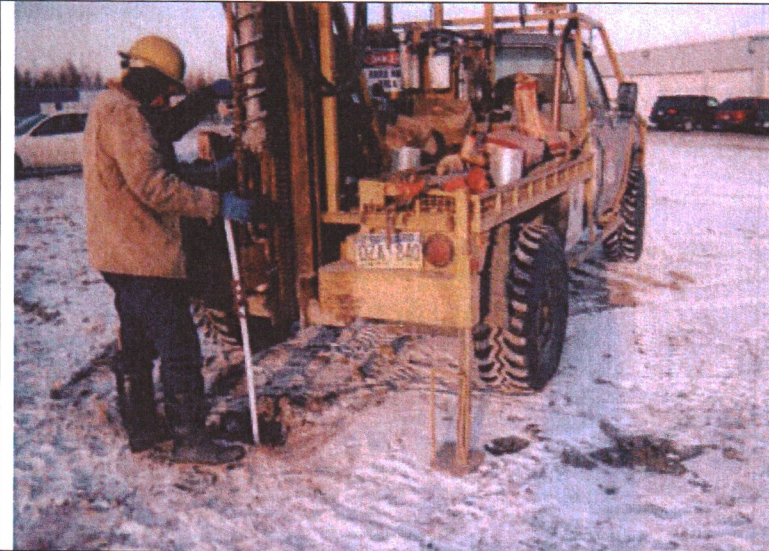
Photo 4:
Removal of Well MW-1.

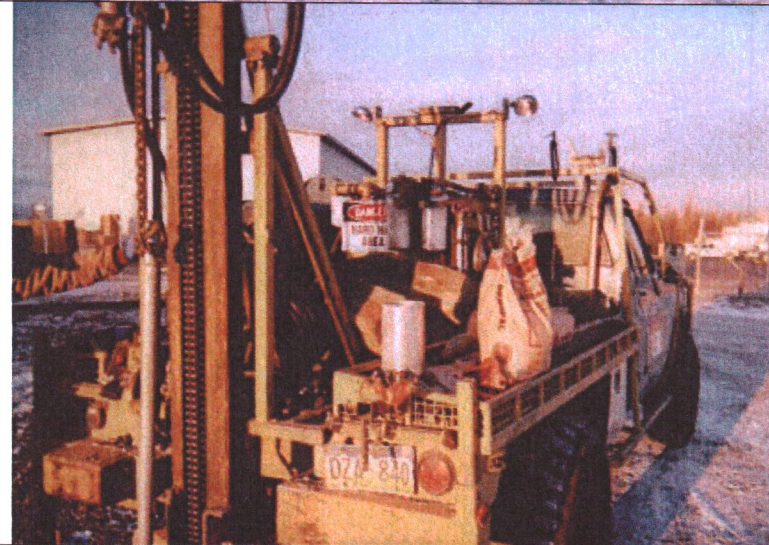
Photo 5:
Removal of well MW-5.

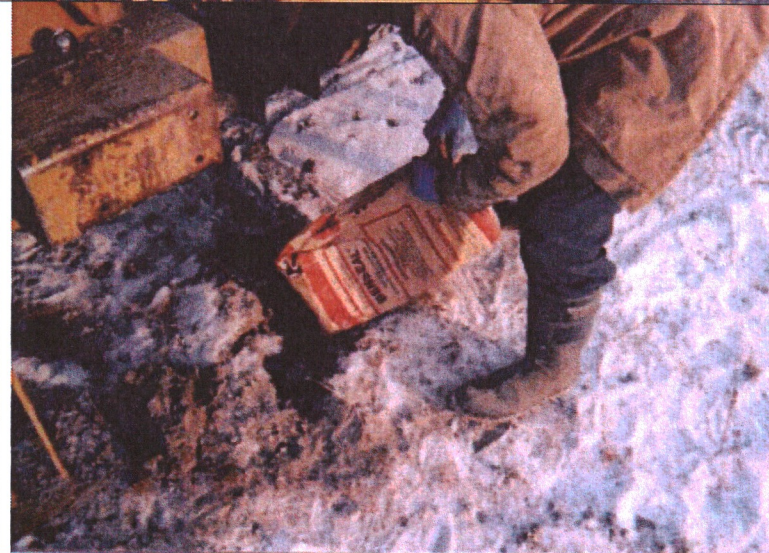
Photo 6:
Applying Benseal
Bentonite grout after
removal of well MW-1.

The bentonite was poured dry into the auger hole. Water was then added to hydrate and harden the bentonite.

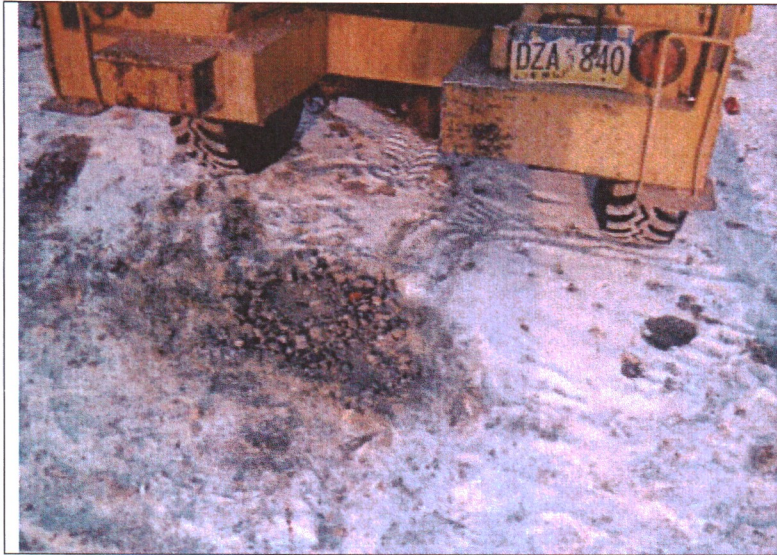
Photo 7:

Location of well MW-1
after its removal.
