Subject: Underground Tank Removal and Cleanup Report
Doyle's Fuel Storage Facility, Reckey # 98-23-01-289-01
SE 1/4 B.L.M. Lot 51, S34, T6S, R11W, City of Kenai, Alaska

This report presents the results of the underground fuel tank removal and soil cleanup performed at the subject property that was formerly occupied by Doyle's Fuel Service (maintenance shop, office, and house). Two 500-gallon gasoline tanks and two 500-gallon heating oil tanks were excavated and removed from the property. Contaminated soil from one tank pit and from a waste oil pit was thermally remediated at an off-site location. Analytical results for both the UST closure and thermal remediation are included in this report.

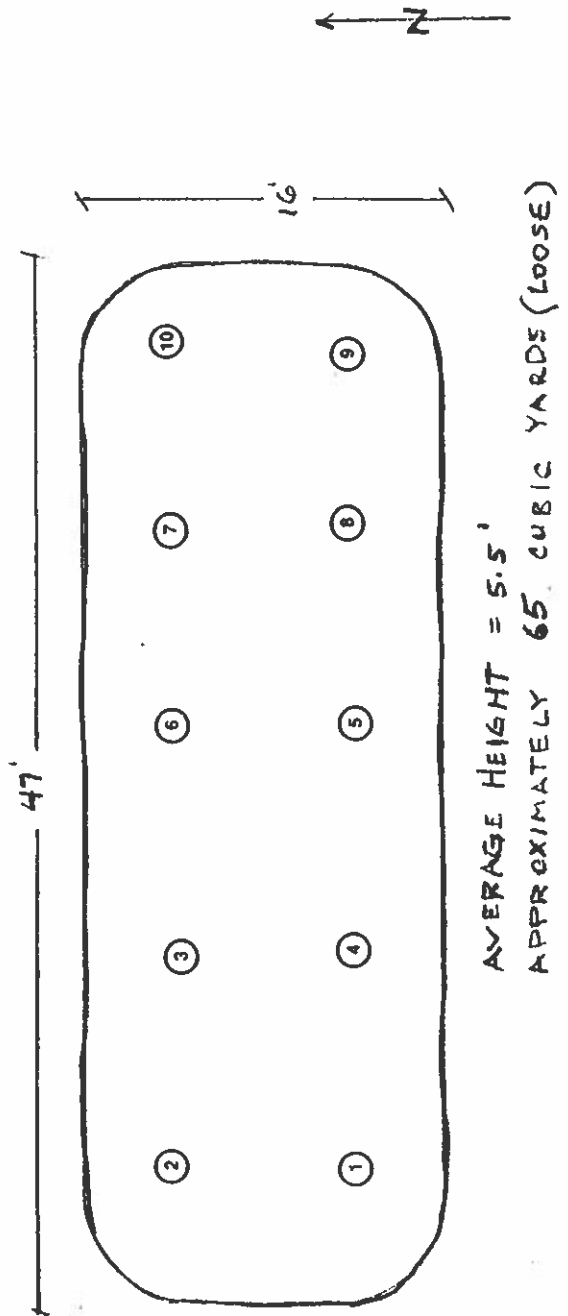
FIGURE 5. SOIL SAMPLING PLAN
 (AFTER STOCKPILE HAD BEEN REMOVED)
 DOYLES FUEL SERVICE
 MAP. 11-9-99

After the soil had been hauled to SPI, on 7-15-99, the soil under the liner was field screened for contamination. Ten field screen samples were collected at about 0.5 feet below ground. PID measurements ranged from <1 to 11 ppm, indicating soil under the stockpile had not been contaminated by the stockpile material. Thermally remediated soil was field screened and sampled by Crowfalls Environmental & Consulting prior to being hauled back to the site and used to fill the excavated areas. Ten field screen samples and five analytical samples were collected from the remediated soil stockpiles.

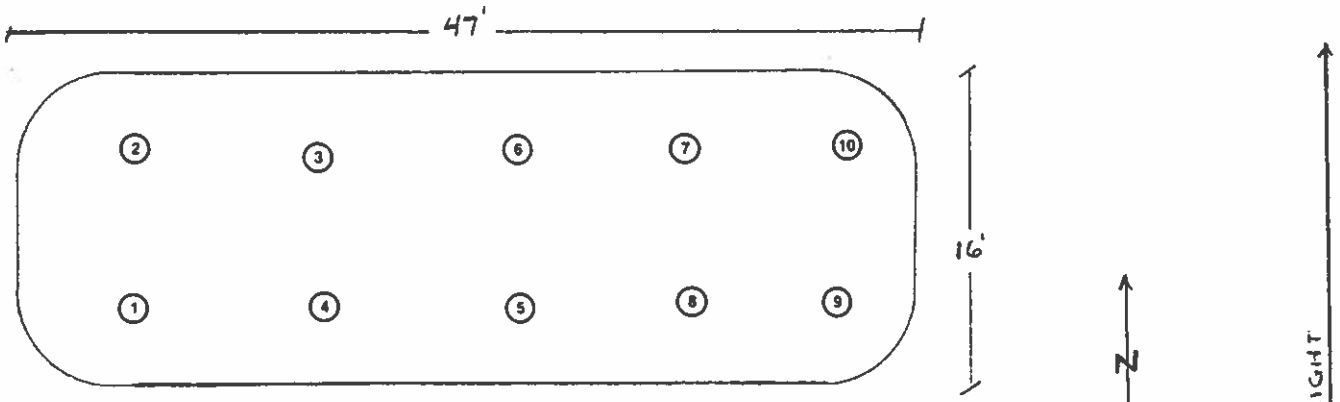
AVERAGE HEIGHT = 5.5'
 APPROXIMATELY 65 CUBIC YARDS (LOOSE)

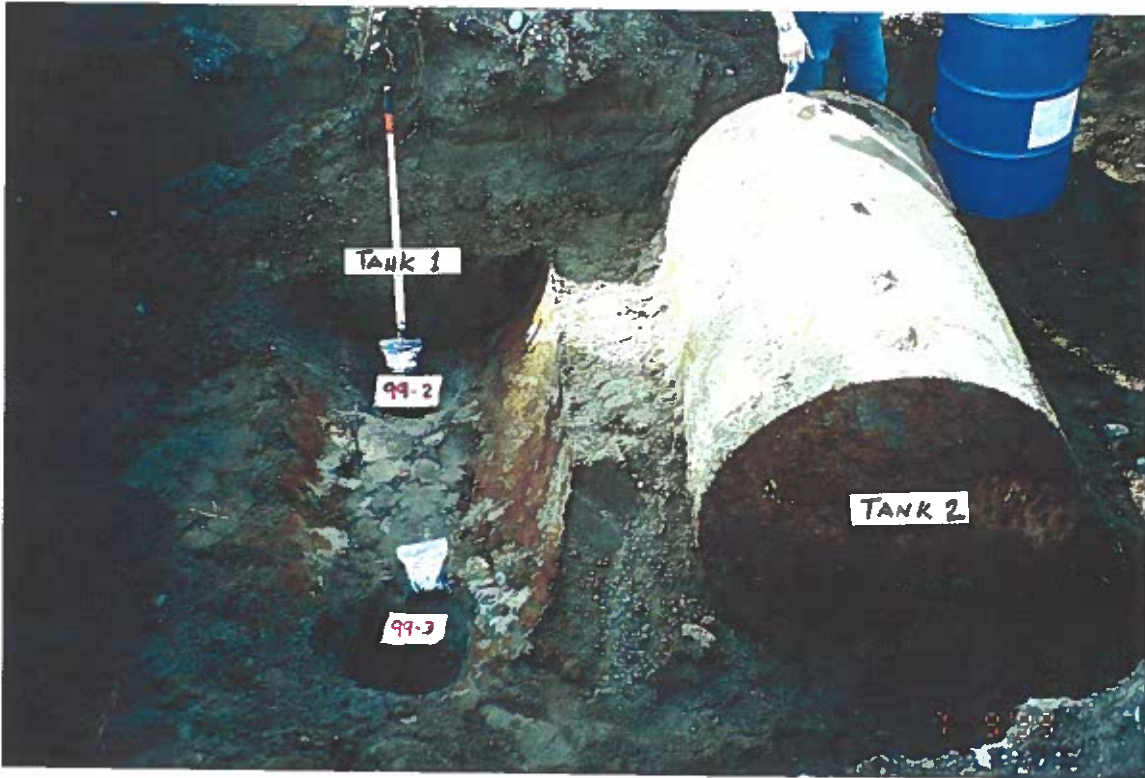
Tank #1 (gasoline tank) was excavated and removed first. Field screen samples were collected 1 foot below the bottom of the tank at the north and south ends of the tank (see Photo 1). PID measurements of the field screen samples detected volatiles at less than 1 ppm. There was a slight hydrocarbon odor in the soil at the south end of the tank, but none at the north end of the tank. **Tank #2** (gasoline) was excavated and removed next. Field screen samples were collected from 1 foot below the bottom of the tank at the north and south ends of the tank. There was no hydrocarbon odor in the field screen samples and PID measurements were less than 1 ppm. The soil excavated from around the tanks was a medium sand. All piping was connected to the top of the tanks and extended vertically to the surface, without any couplings, elbows or swing joints. Lab samples were collected under the tanks, and the tank pits were backfilled with clean gravel fill. The soil was compacted using the bucket on the backhoe.

View to south. Lab sample locations shown

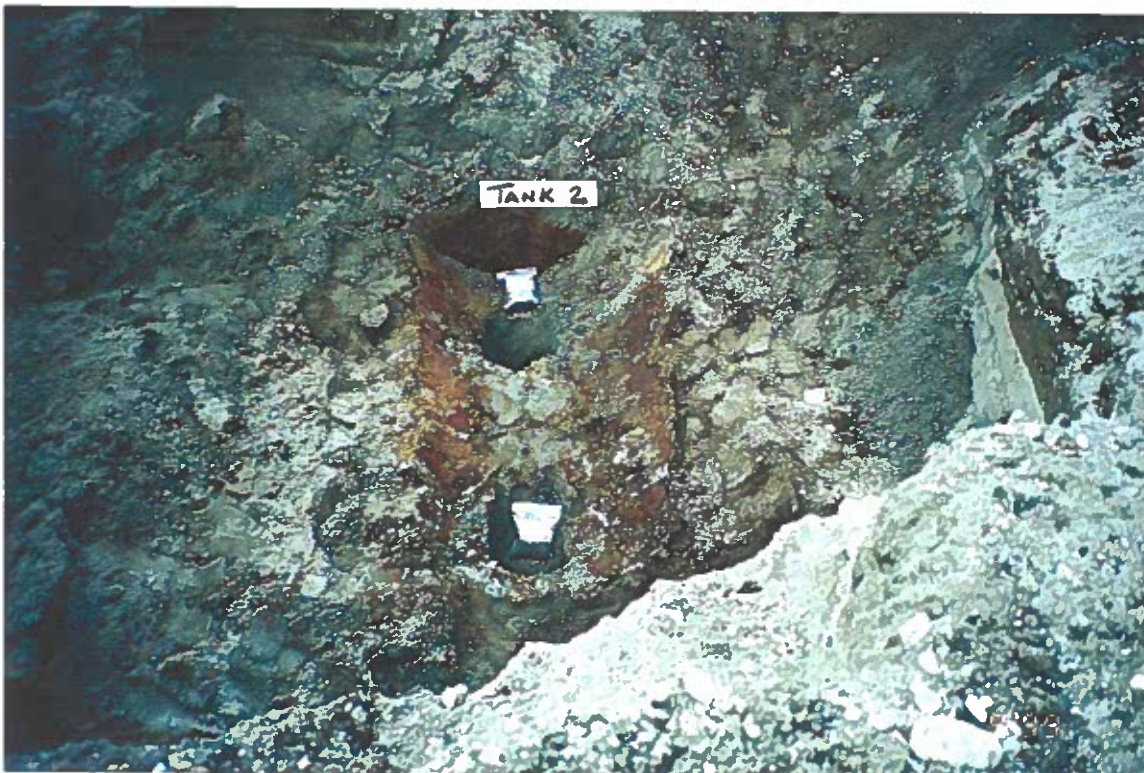
View to south. Field screening locations shown.

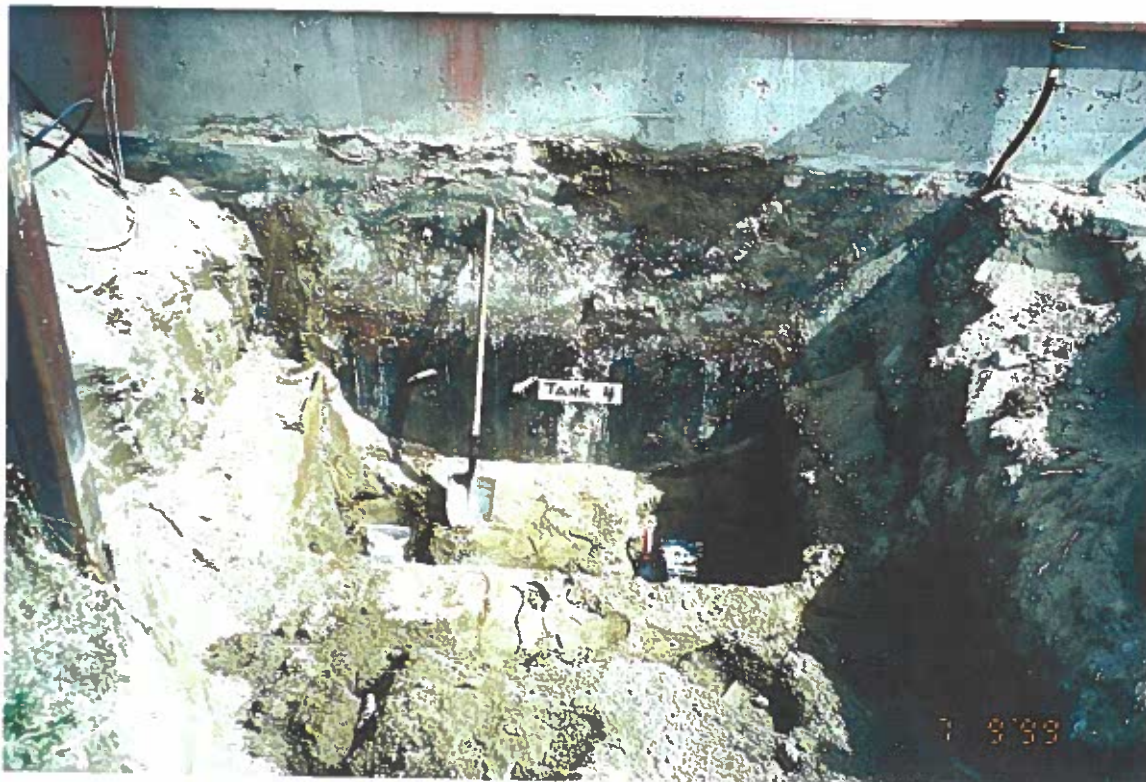
View to east. Field screening locations shown

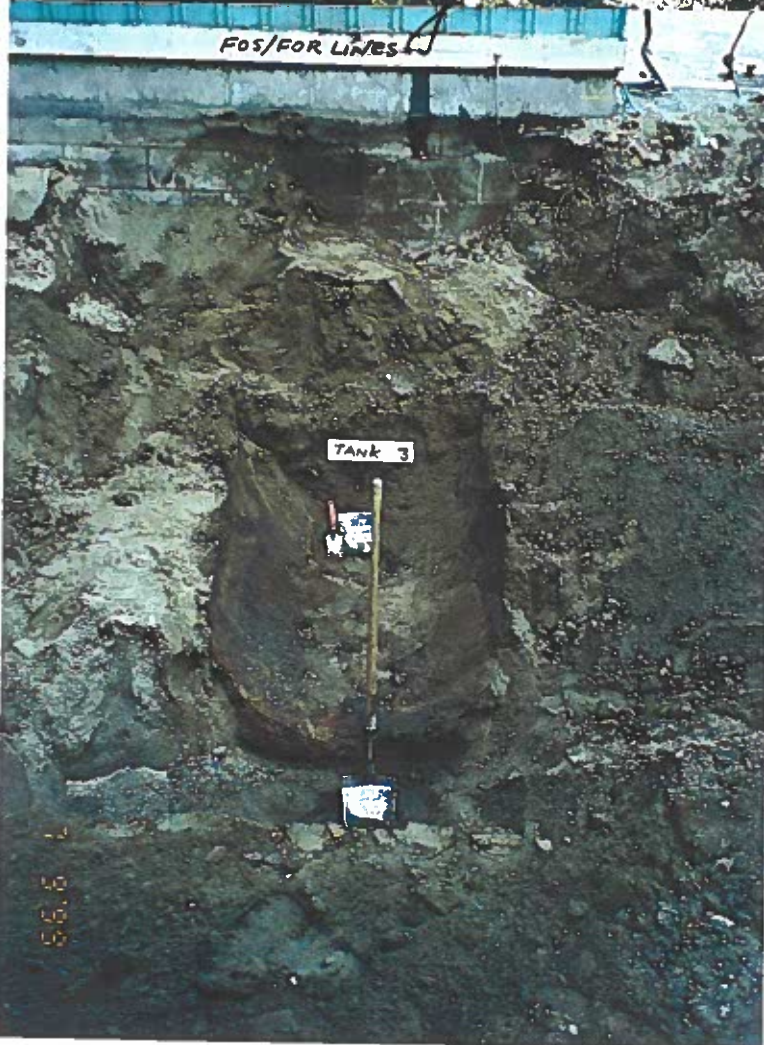
View to north.
Lab sample locations shown

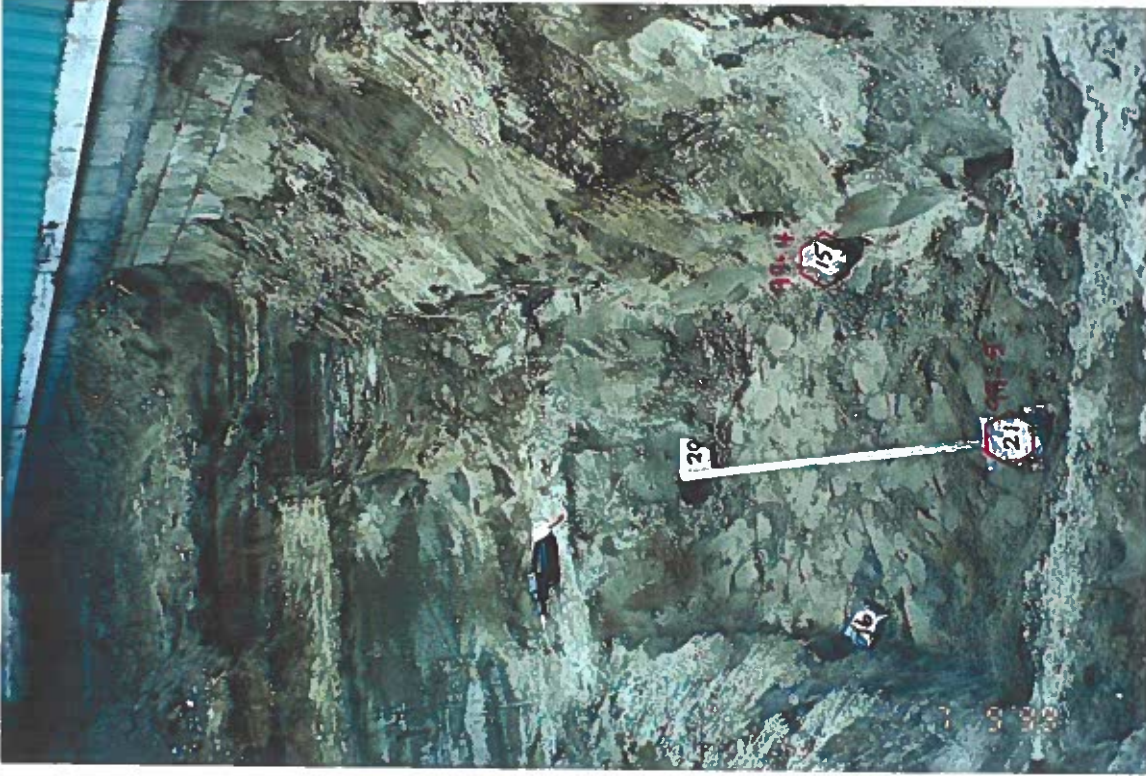
Contaminated soil was excavated around Tank #3 to a depth of almost 9 feet below ground surface. About 25 cubic yards of contaminated soil was excavated. Elevated PID readings were detected in the pit bottom at the north end of the tank, but excavation was halted because deeper excavation would have undermined the shop foundation.

View to west, of pit bottom.
Field screening and lab sample locations shown. (7-9-99)

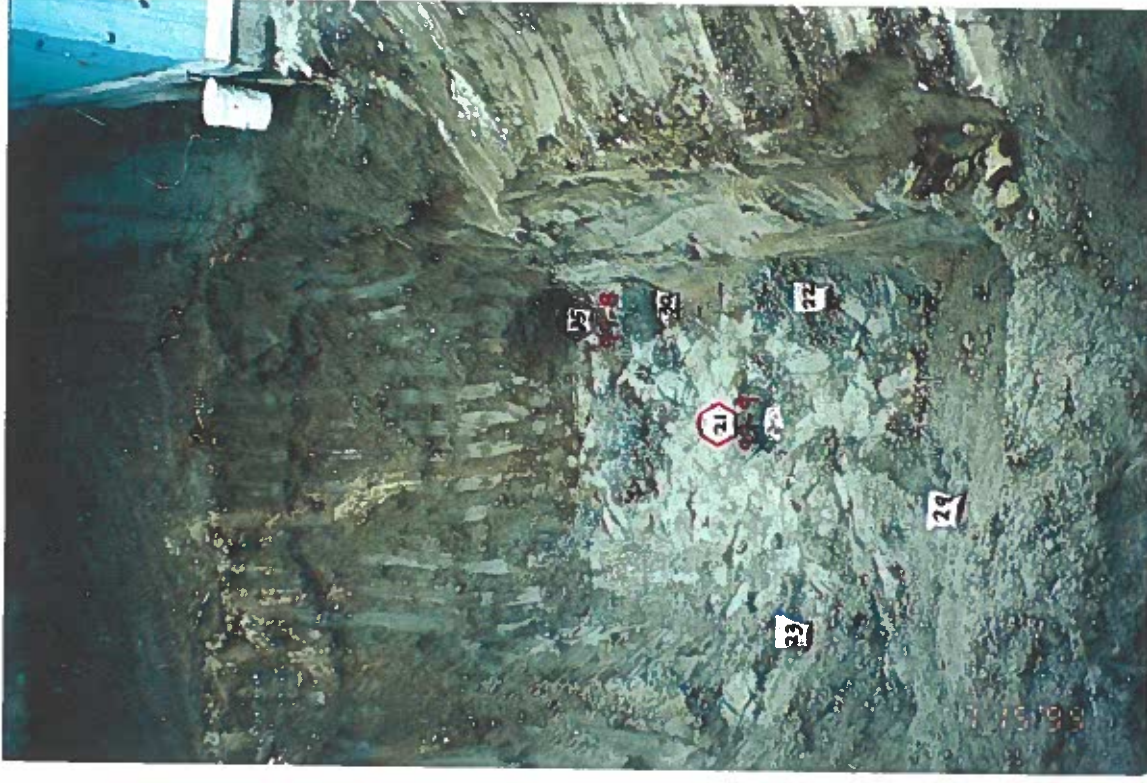
On 7-15-99, the **Tank #3 pit was re-excavated** to within several inches of groundwater [Photo 8]. An additional 10 to 12 cubic yards of moderately contaminated soil was removed, placed directly in a dump truck, and hauled to Soil Processing Inc. (SPI) for thermal remediation. The contaminated soil was from 7 to 9 feet below ground, between locations #15 and #29. The pit was excavated one foot closer to the shop than the excavation on 7-9-99. The strongest petroleum odor and PID readings was on the north and east portion of the pit between locations #24 and #30. Elevated PID readings were still detected at locations #15, #21 and #30, but excavation was stopped, just above groundwater, to ensure soil under the southeast corner of the shop footing was not undermined. Two lab samples were collected from the pit bottom, above groundwater. There was no sheen or evidence of free product on the water.

View to west, of pit bottom.
Field screening and lab sample locations shown. (7-15-99)
