**FINAL
ADDITIONAL MONITORING AND RISK EVALUATION
FORMER TRAILSIDE GENERAL STORE
HOMER, ALASKA**

PROJECT # 005.0065.05003

January 2006

SLR Alaska
2525 Blueberry Rd., Suite 206
Anchorage, AK 99503

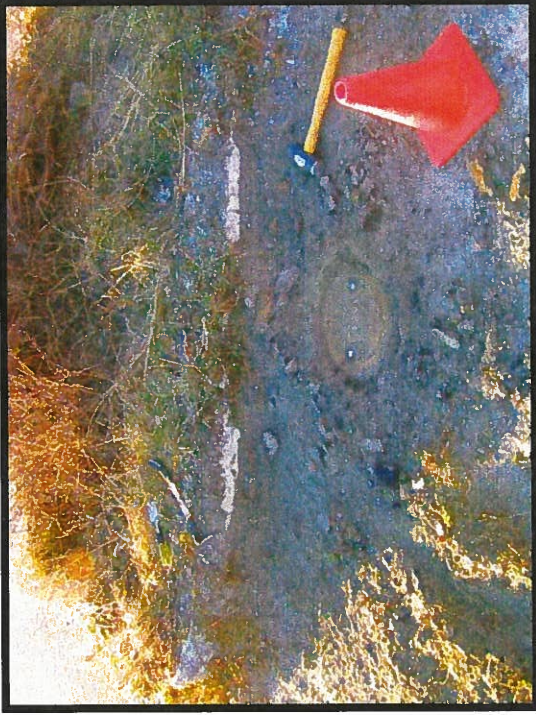
Photo #6: MW-4 buried underneath sand/ice mixture

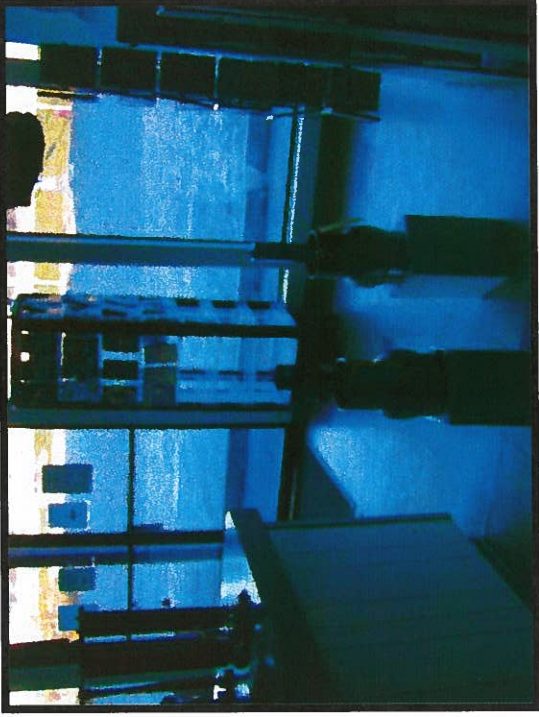
Photo #10: Video Store and Duplicate Air Sample location

The video store has four operational ceiling fans; all of which were off during the sampling period. Therefore, ventilation was lower than normal during the sampling event, which should provide a conservative estimate of typical indoor air concentrations during the store operating hours. The current building use is commercial, and no residences are located within the structure. Subtracting the ambient benzene concentration detected in outdoor air from the indoor results, the maximum benzene concentration was $2.5 \mu\text{g}/\text{m}^3$. This benzene result could be a result of contamination remaining in the soil beneath the building, but the concentration is below both commercial and residential screening criteria. As a result, indoor air concentrations of BTEX under current land use appear to be below levels of concern to human health.
