November 15, 2021

Soil Investigation Report, Heating Oil Tank Release, University Park Condos, 656 Fairbanks St, Fairbanks AK

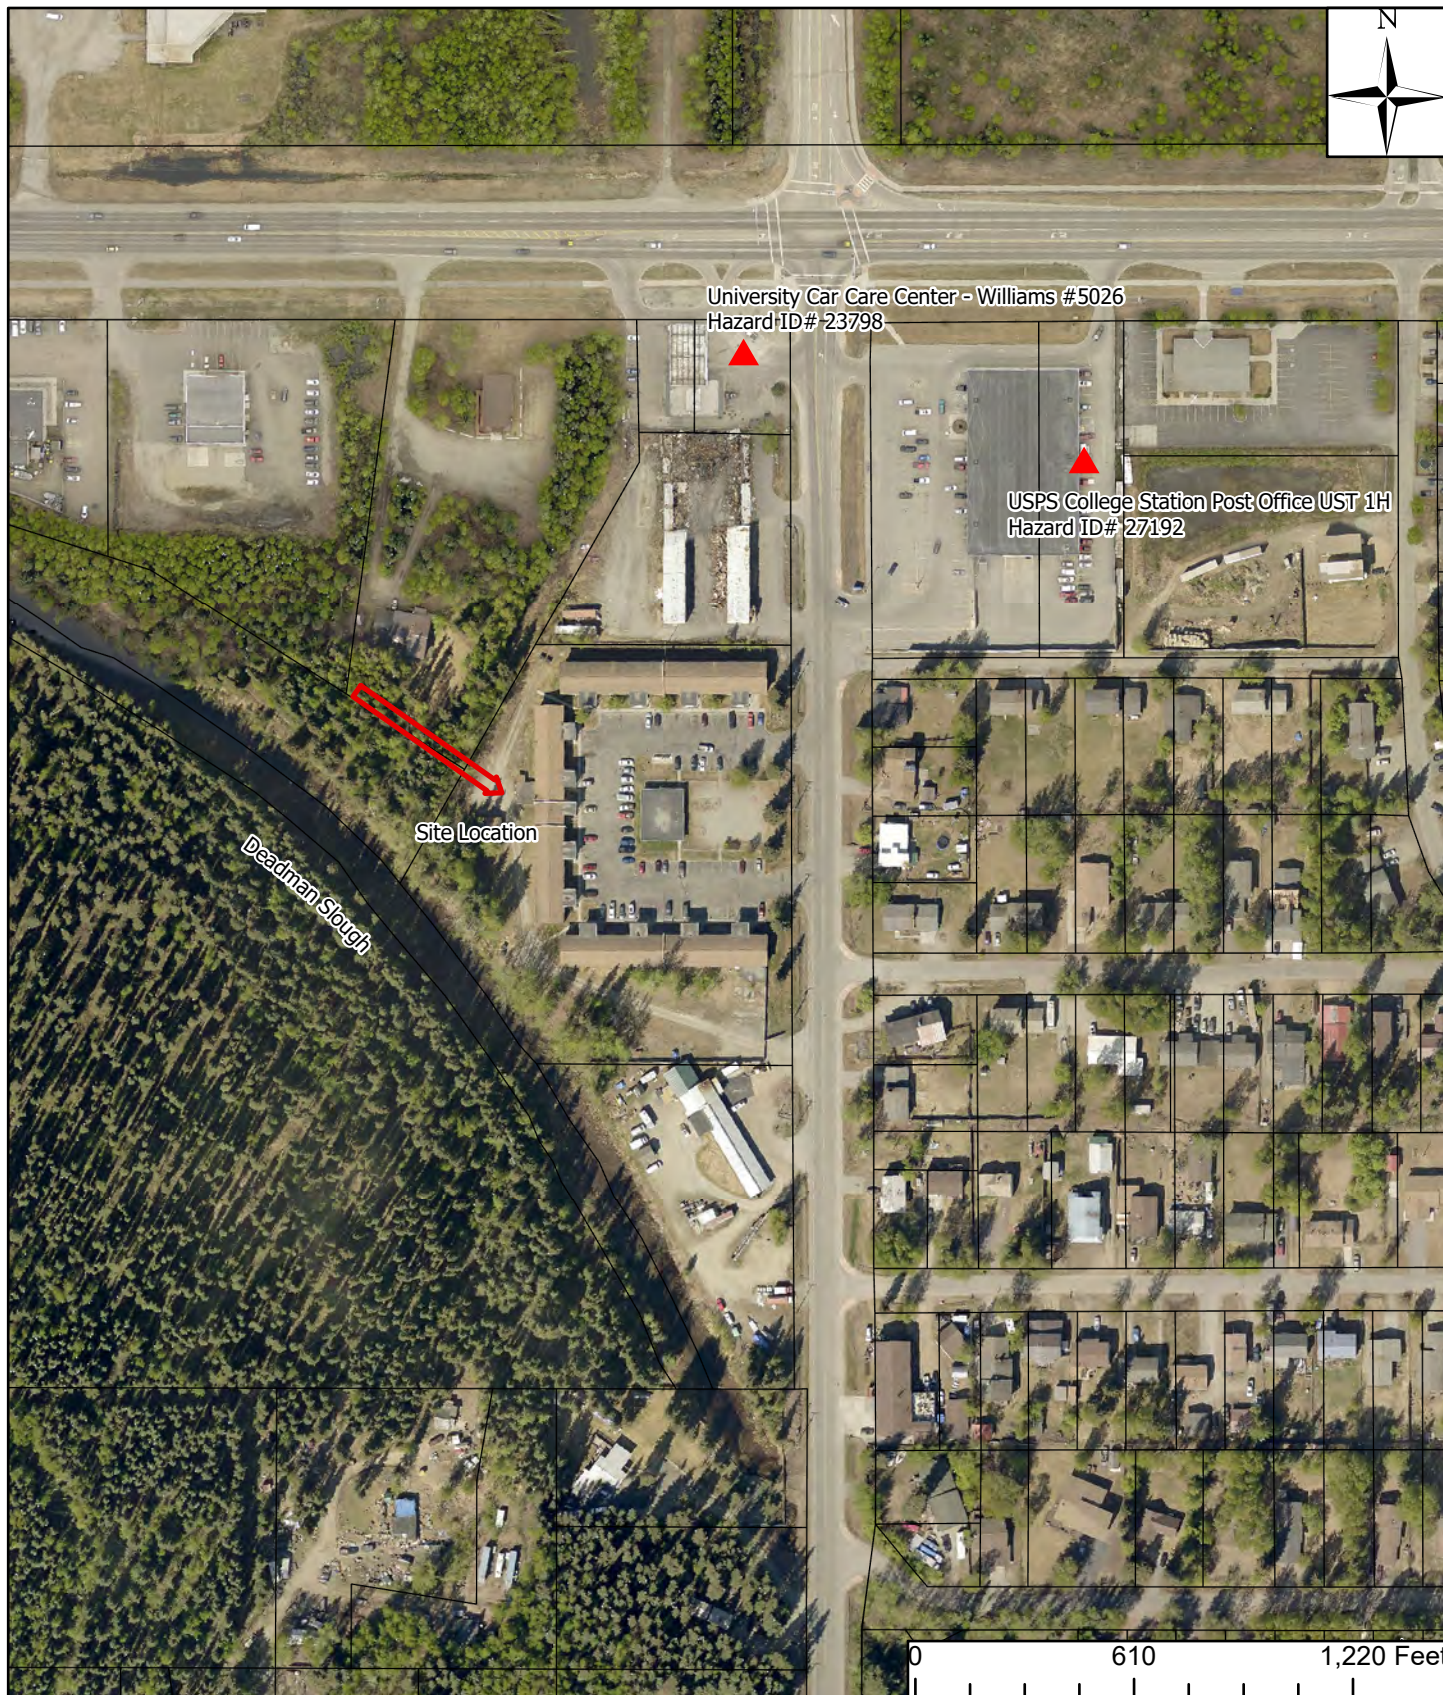
Figure 1 - Site Location and Vicinity
656 Fairbanks St, Fairbanks, Alaska

- Approximate Property Boundaries
- ▲ Contaminated Site

Immediately north of the property is the former College Inn, which burned down in September, 2019, and has yet to be demolished and cleaned up. Further to the north is a Holiday gas station, which is the University Car Care Center - Williams #5026 contaminated site (hazard ID 23798). To the northeast is the Geist Road post office, which is also a contaminated site (hazard ID 27192). These sites are roughly 500 to 750 feet away from the subject property, and are likely cross-gradient in terms of groundwater flow (see below). To the east is a residential development, and to the west is largely undeveloped land. There is one residence, associated with the Light of the World Lutheran Church at 4155 Geist Road, that is approximately 200 ft to the northwest (presumed downgradient), across a seasonal slough channel (see Figure 1 for site location and vicinity).

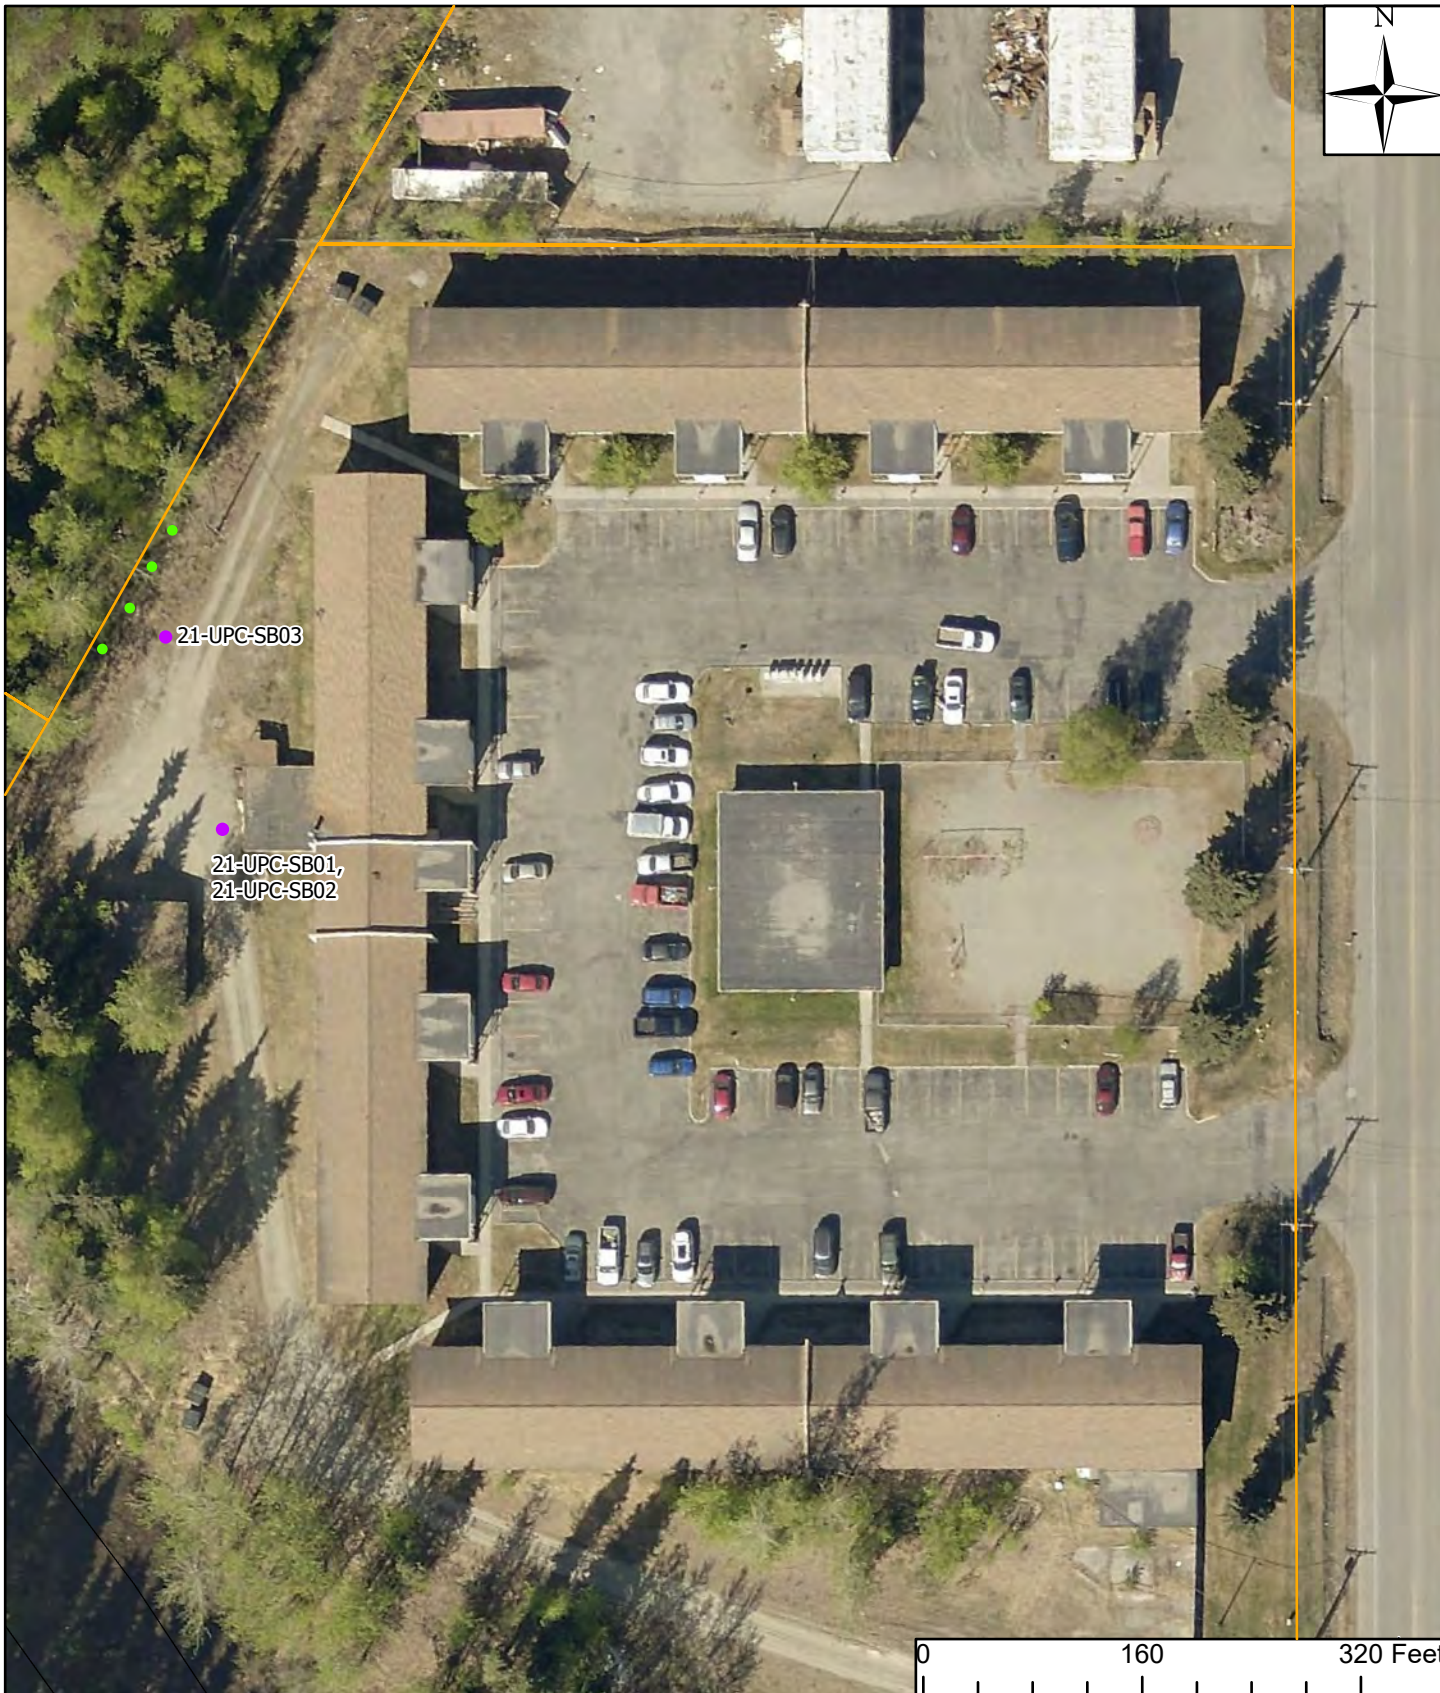
Figure 2 - Site Plan
656 Fairbanks St, Fairbanks, Alaska

21-UPC-SB03

21-UPC-SB01,
21-UPC-SB02

- Shallow Field Screening (1.5-2 ft bgs) - PID result below 20 ppm
- Analytical Soil Sample
- Approximate Property Boundary

Shallow surface test holes were dug from 1.5 to 2 feet bgs along a transect parallel and adjacent to the downgradient seasonal slough channel, to determine if shallow surface contamination remained along the slough and to identify potential ongoing ecological impacts. Soil type was brown silt at all locations, and HHS PID field-screening results ranged from 1.1 to 2.6 ppm, with no observable hydrocarbon odor. See attached field notes (Attachment B) for results and site plan (Figure 2) showing field screening locations.

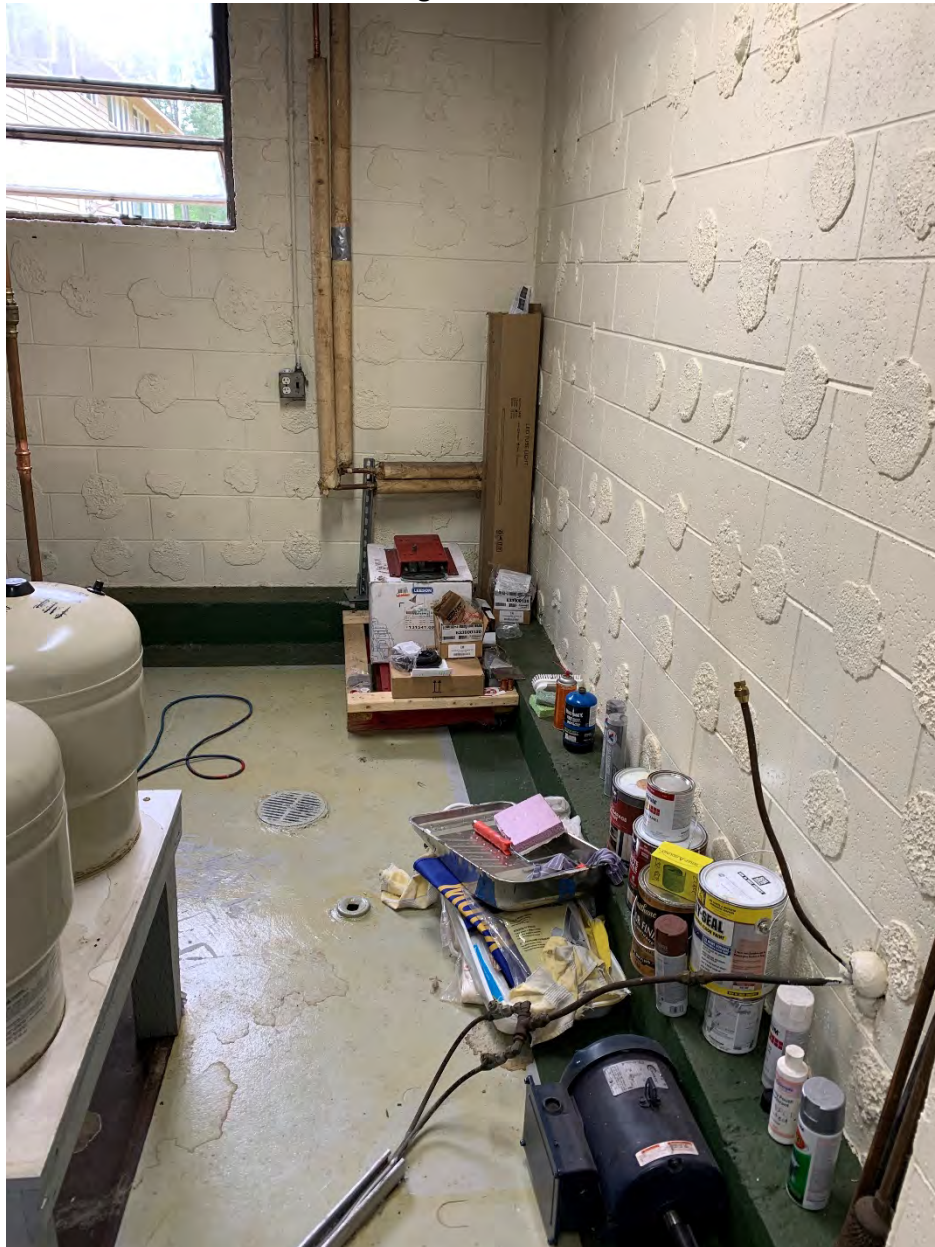
Photo 1. Interior of boiler room facing south

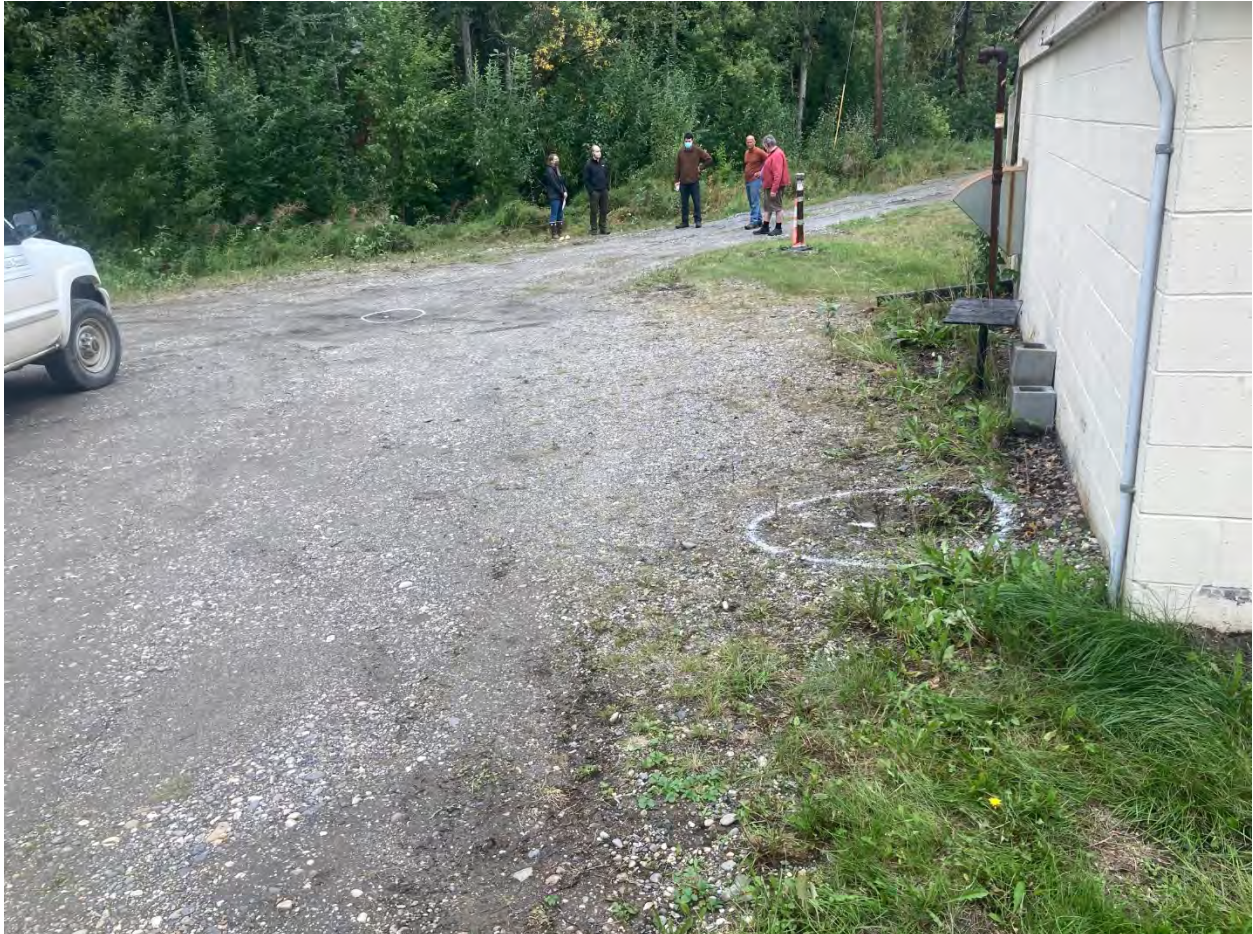
Photo 2. Release location marked near boiler room, downgradient borehole was moved to where ADEC, ADS, and University Park Condo Association personnel are gathered due to refusal in roadbed

After decontaminating sampling tools, a soil boring was advanced downgradient of the source location. Refusal was encountered at 1 foot bgs at two locations in the low spot of roadbed, where historic photos showed pooled fuel (See Attachment D for historic site photographs). The borehole was moved to a location closer to the seasonal channel as shown on the attached site plan (Figure 2), where the ground surface was roughly 1 to 2 feet lower in elevation compared to the source location. The initial 3 feet bgs was grey gravel fill, followed by a black silty organic layer from 3 to 4.5 feet bgs, fine grey silt from 4.5 to 5 feet bgs, and saturated g sandy silt with trace organics from 8 to 10 feet bgs. A soil sample was collected from 8 to 10 feet bgs for analysis of GRO, DRO, petroleum-related VOCs, and PAHs. The soil from 8 to 10 feet bgs was saturated with water but no hydrocarbon odor was observed. HHS PID field screening yielded results of 2.3 ppm from 3 to 5 feet bgs, and 1.2 ppm from 8 to 10 feet bgs.

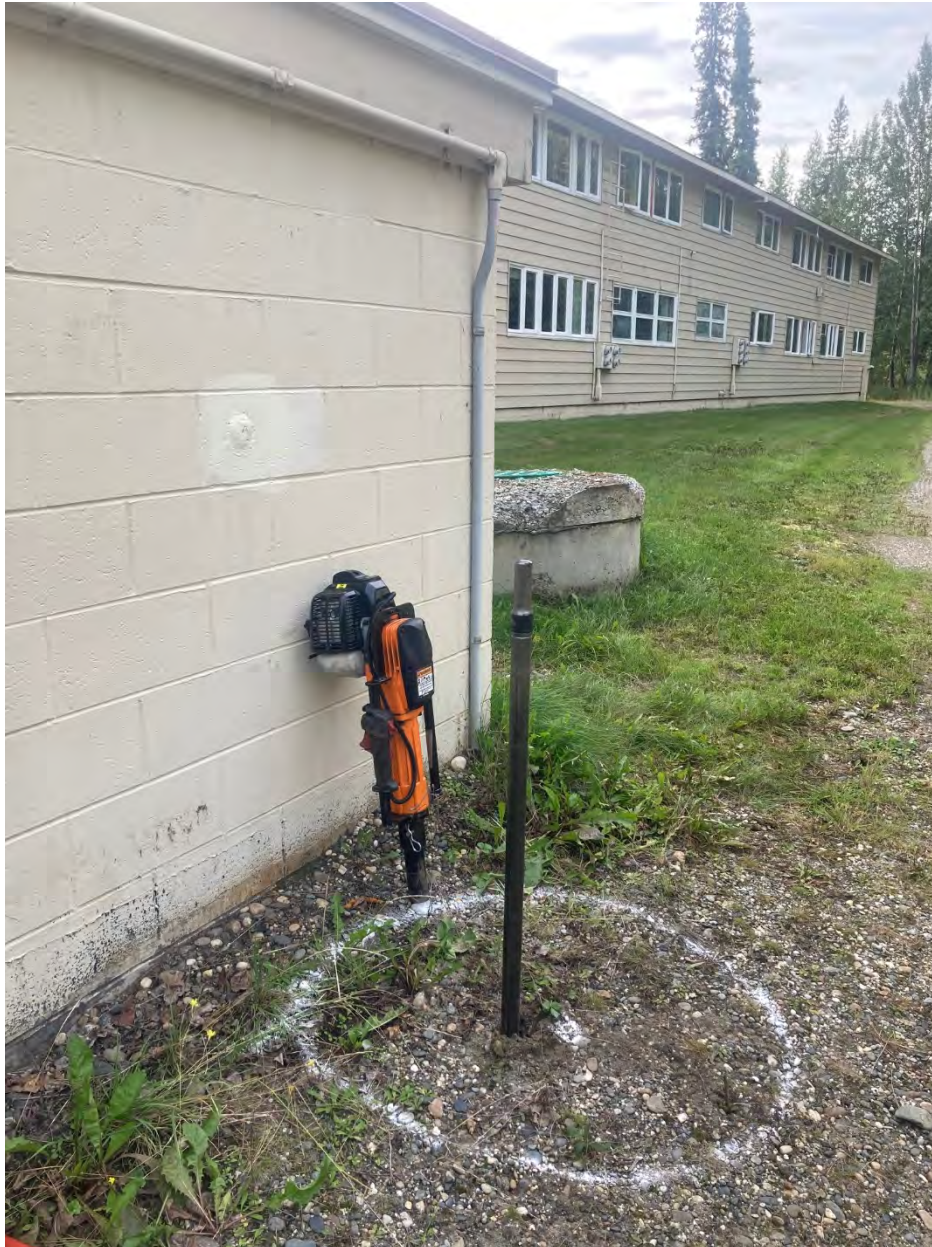
Photo 3. Release location marked near boiler room, with Geoprobe LB sampler rod driven with Skidril G20D powered driver

Field work commenced by advancing a soil boring at the source release point. The initial 3 feet bgs was grey gravel fill, followed by sandy gravel from 3 to 5 feet bgs, sand from 8 to 9 feet bgs, sandy gravel from 9 to 10 feet, and saturated grey fine sand with hydrocarbon odor from 13 to 15 feet bgs. Heated headspace (HHS) field screening with a photoionization device (PID) yielded results of 50.8 parts per million (ppm) from 3 to 5 feet bgs, 275.8 ppm from 8 to 10 feet bgs, and 460.6 ppm from 13 to 15 feet bgs. The target sample depth was 11 to 13 feet bgs, estimated to be directly above the water table. Water was not detected using water-finding paste at 11 feet bgs; the tape measure could not be advanced further than 11 feet due to the borehole caving in. An adjacent boring was overdriven to 14 feet bgs to ensure adequate sample collection volume; one soil sample and a field duplicate were collected for analysis of GRO, DRO, petroleum-related VOCs, and PAHs from this adjacent boring.

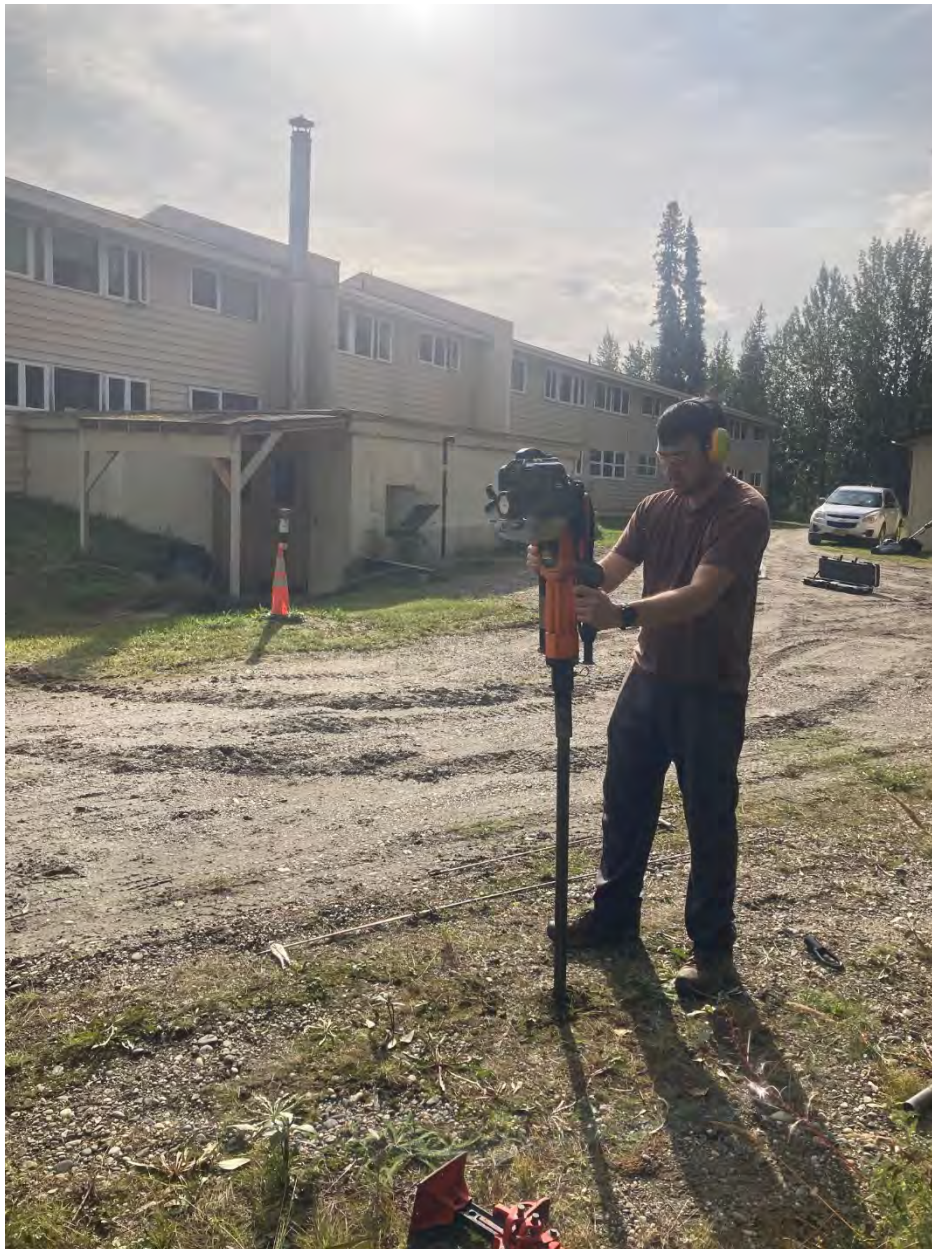
Photo 4. Downgradient borehole location, with Geoprobe LB sampler rod being driven with Skidril G20D powered driver by ADS principal chemist Rodney Guritz
