**Subject Akiak FSRC Monitoring Well Decommissioning Technical Memorandum**

**DECOMMISSIONED MONITORING WELL LOCATIONS**  
**AKIAK FEDERAL SCOUT READINESS CENTER**  
**ALASKA ARMY NATIONAL GUARD**  
 Akiak, Alaska

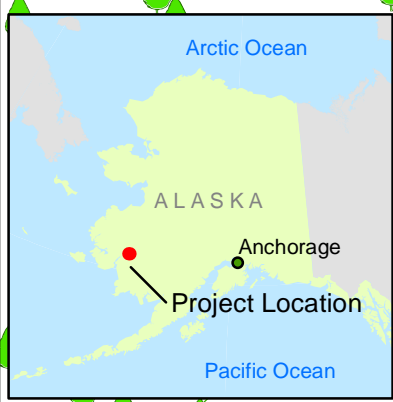
PROJECT MANAGER	DATE	FIGURE NUMBER
	Brad Ramsay	6 July 2022	1

To close out the site, three monitoring wells were decommissioned on 9 June 2022 in accordance with the Akiak FSRC *Monitoring Well Decommissioning Letter Work Plan* (Paragon 2021b) and the ADEC *Monitoring Well Guidance* (ADEC 2013). Locations of the decommissioned wells, MW1A, MW2A, and

MW3A, are displayed on Figure 1, below. A photograph log of well decommissioning activities is included at the end of the document.

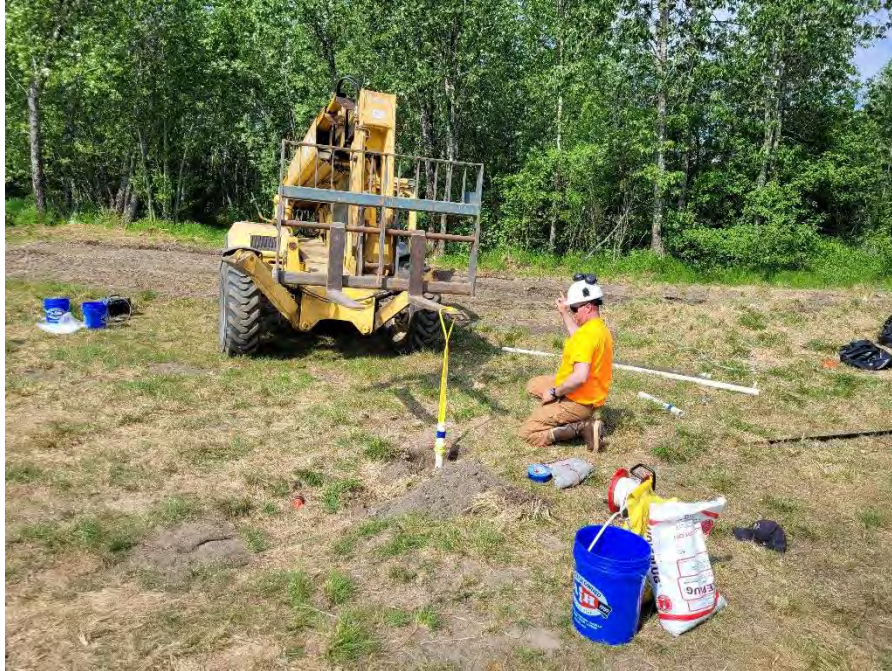
**Photograph #1** – 6 June 2022. Paragon staff directs the boom lift operator while decommissioning monitoring well MW1A. One end of the tow strap was hooked to the boom lift fork, and one end was wrapped around the well. A strip of duct tape maximized the bite of the tow strap. View facing northwest.

After measuring the depth to water (static water level), the casing and concrete finish were removed. A spade was used to remove approximately 1 foot of soil around the top of the well to be able to grip the riser for extraction. A 1-inch black iron pipe with connector fittings that fit into the well was then used to break out the bottom cap of the 2inch diameter well screen, allowing the well to be used as a tremie pipe. The well risers were removed by a telescoping boom forklift and tow straps. Wells were extracted approximately 7 feet until the bottoms of the wells were just above the groundwater interface, which allowed the aquifer material to collapse into the borehole. Risers were cut to a height of approximately 1-2 feet above the ground surface, at which time bentonite chips were added until the well was filled to about 2 feet below the surface. Riser was pulled and trimmed, and more bentonite was added to maintain the level at approximately 2 feet below the surface. After removing the screen, the bentonite was hydrated and topped off to 2 feet below the surface as necessary. Pea gravel was placed above the bentonite and the surface material removed by spade was used to top the pea gravel. All three wells were removed in their entirety with no pieces decommissioned in place. Site refuse including disposable PPE and retrieved well parts (cut into manageable lengths) were bagged in heavy duty plastic garbage bags and disposed of at the local landfill in Akiak.

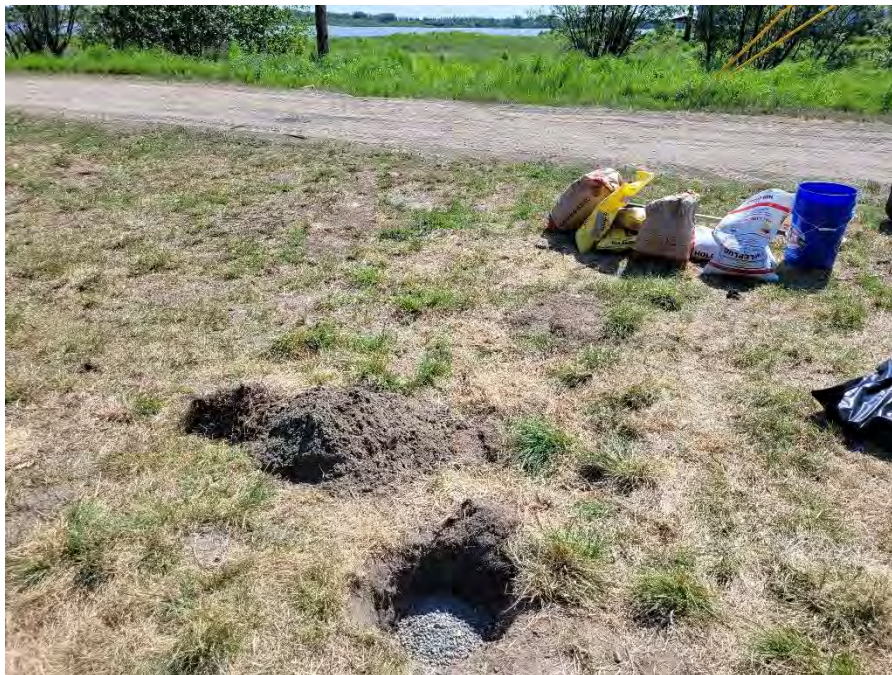
**Photograph #2** – 6 June 2022. The decommissioned borehole for monitoring well MW1A, topped with pea gravel. The soil pile to the left and above the borehole was backfilled on top of the pea gravel. View facing east.

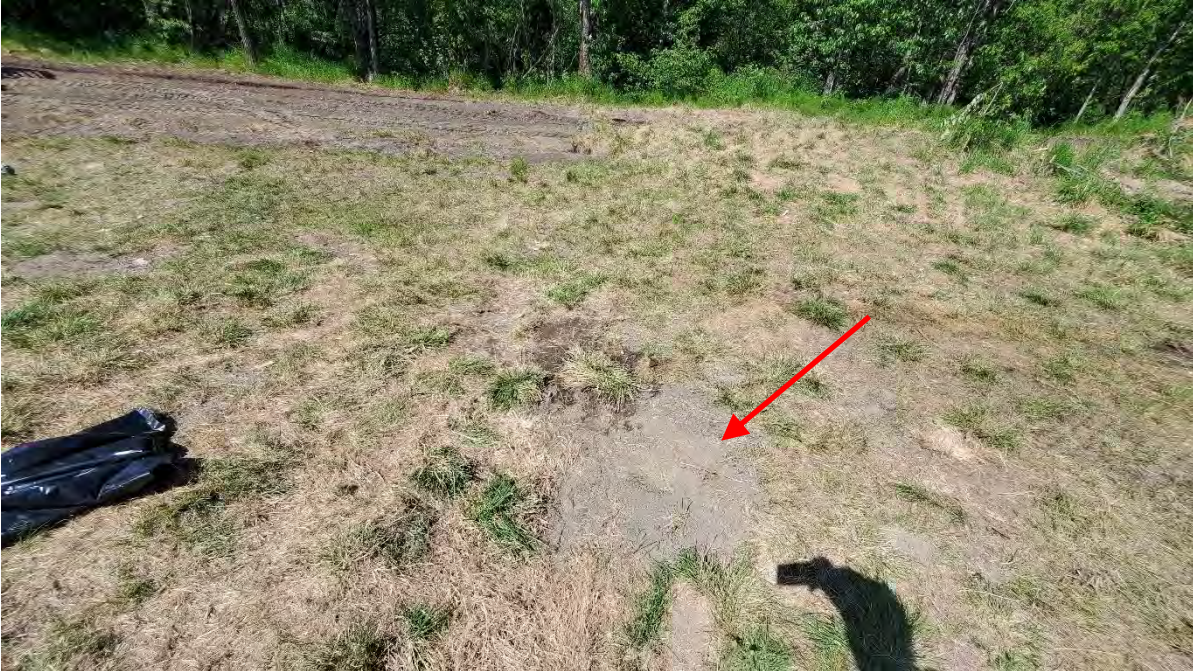
**Photograph #3** – 6 June 2022. Decommissioned monitoring well MW1A (marked with a red arrow) after backfilling the soil above the pea gravel. View facing northwest.

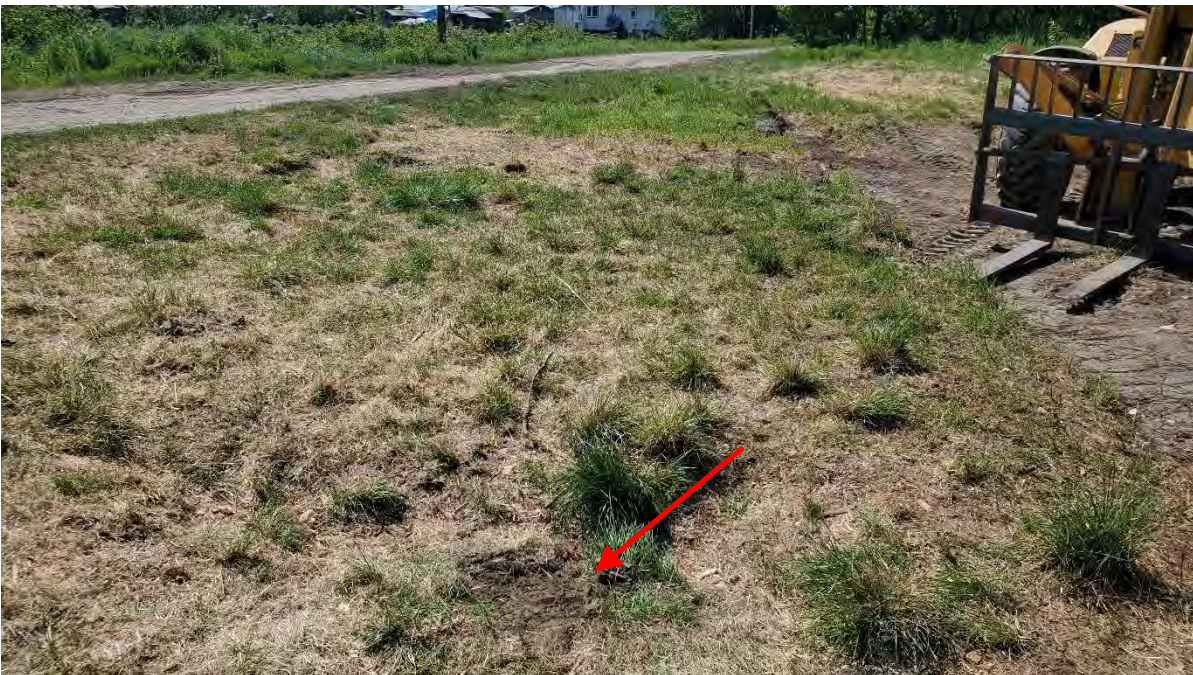
**Photograph #4** – 6 June 2022. Decommissioned monitoring well MW2A (marked with a red arrow) after backfilling the soil above the pea gravel. View facing southwest.

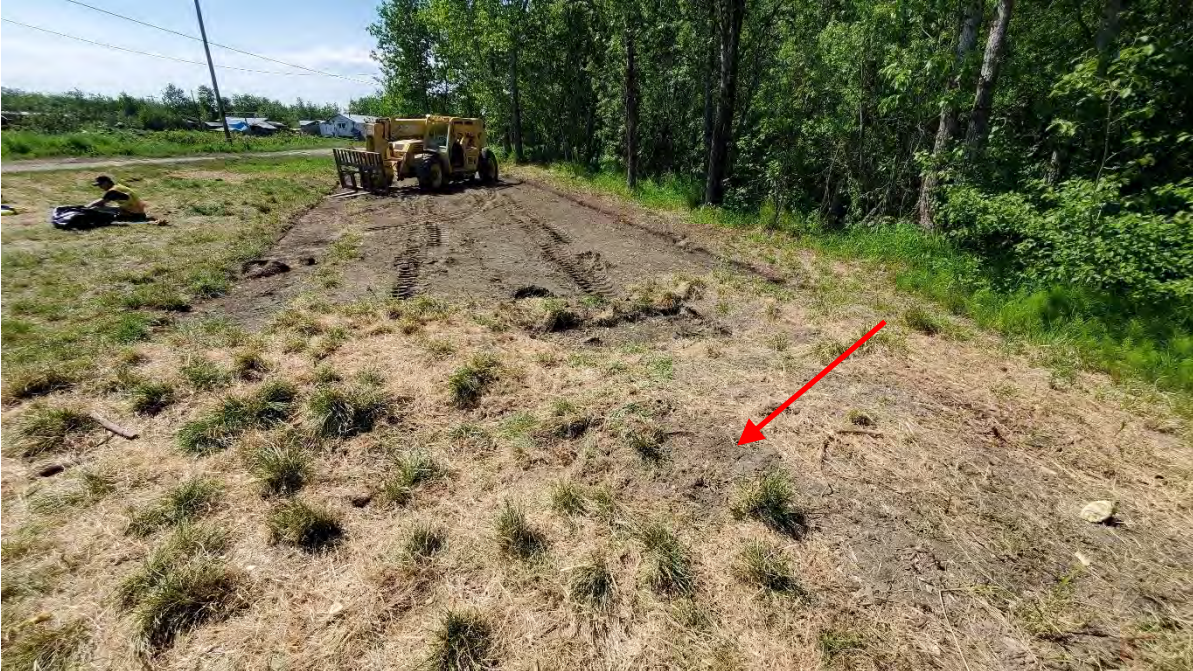
**Photograph #5** – 6 June 2022. Decommissioned monitoring well MW3A (marked with a red arrow) after backfilling the soil above the pea gravel. View facing southwest.
