CONTAMINATED SITE CLOSURE REPORT  
Grant Mine Primary Mine Tailings  
Impoundment  
ESTER DOME, ALASKA

Subject: CONTAMINATED SITE CLOSURE REPORT, GRANT MINE PRIMARY  
MINE TAILINGS IMPOUNDMENT, ESTER DOME, ALASKA

# Grant Mine

## TAILINGS IMPOUNDMENT CLOSURE

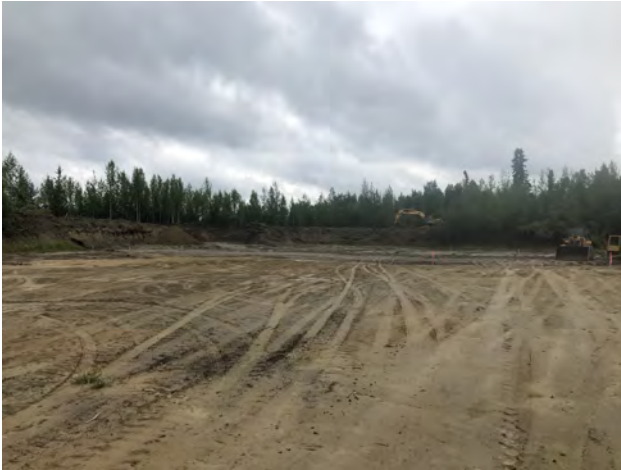
Photo 1: 20210728 Initial Lifts looking south

Mr. Burggraf began the closure construction on July 28, 2021 using his own equipment and staff. Stutzmann Engineering Associates, Inc. (Stutzman) laid out survey control; Mr. Burggraf's crew removed the fence, stripped the berm of vegetation, and contoured the tailings surface to mimic the final cap surface. Once the vegetation was stripped, the operator began dismantling the earthen berm and spreading the silt from the berm over the tailings. Generally, the operator spread the soil in the east to west direction to optimize the compaction with the loaded, rubber-tired loader; compaction testing results are discussion in Section 4.3.1. The capping advanced from the south to the north.

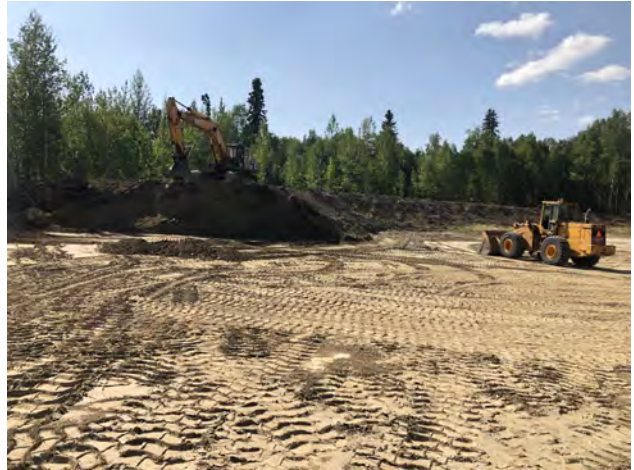
Photo 2: 20210804 Dismantling southern berm

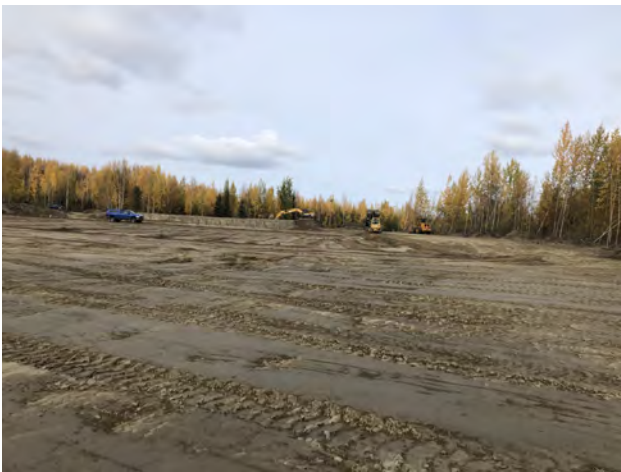
Photo 3: 20210921 Dismantling northern berm

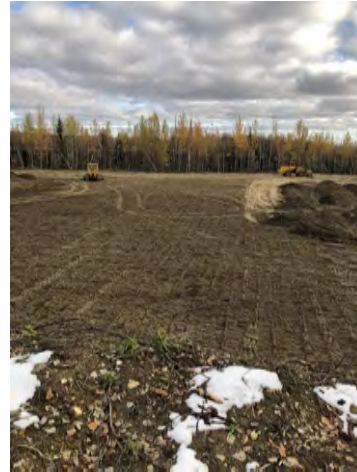
Photo 4: 20210927 final surface looking east

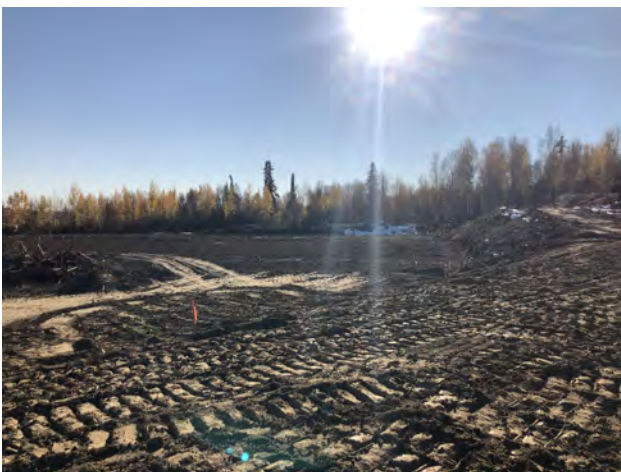
Photo 5: 20210928 End of 2021 activities looking south

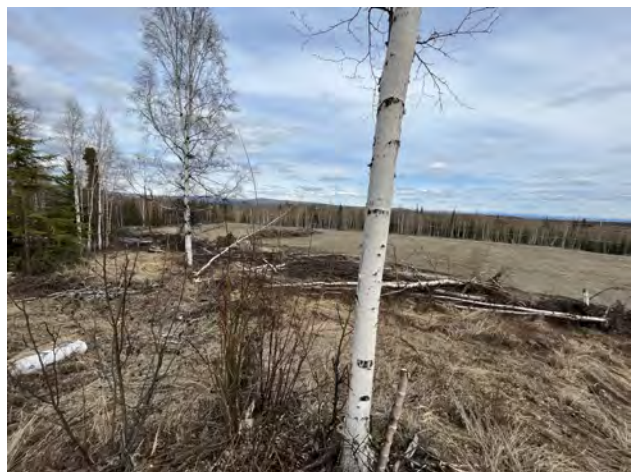
Photo 6: 20220511 Northern portion looking east

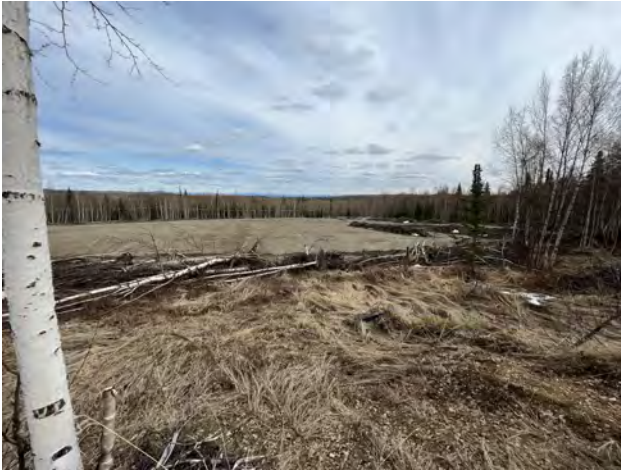
Photo 7: 20220511 Southern portion looking east

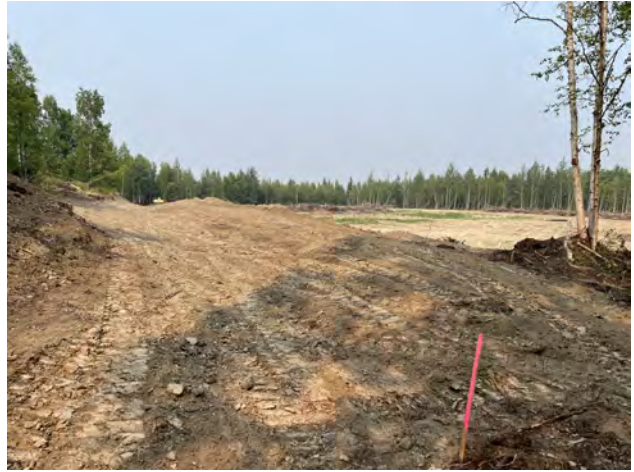
Photo 8: 20220630 Beginning of Diversion Ditch looking North

The drainage diversion channel was constructed in accordance with the specifications of the C&A Plan, with only the exception noted in Section 4.3.2. Photos of the closure construction are presented in Appendix A. Stutzmann surveyed the site on September 16, 2022 after the capping and diversion channel was completed and prepared the *Record Drawing As Built* presented in Appendix B. Based on Stutzmann's survey, the thickness of the cap is at least 24 inches.

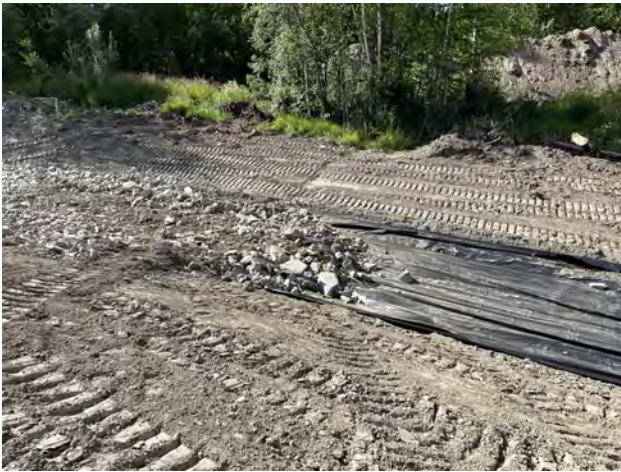
Photo 9: 20220723 Placing Riprap looking west

In accordance with the C&A Plan specifications, Mr. Burggraf placed 460 cubic yards of Class I riprap in two sections of the drainage diversion channel as specified by AWR Engineering, LLC. The local source of rip rap varied slightly from the specifications; the material was more tabular than blocky. In an e-mailed dated September 22, 2021, Ms. Janie Dusel, PE, with AWR concurred the material was acceptable for use in the diversion ditch.

On August 10, 2021, Shannon & Wilson, Inc. subjected a subsample of the riprap to L.A. abrasion test (ASTM C131/C535 AASHTO T96). The results indicate the material met the soundness requirements set forth in design; the test results are presented in Appendix D.

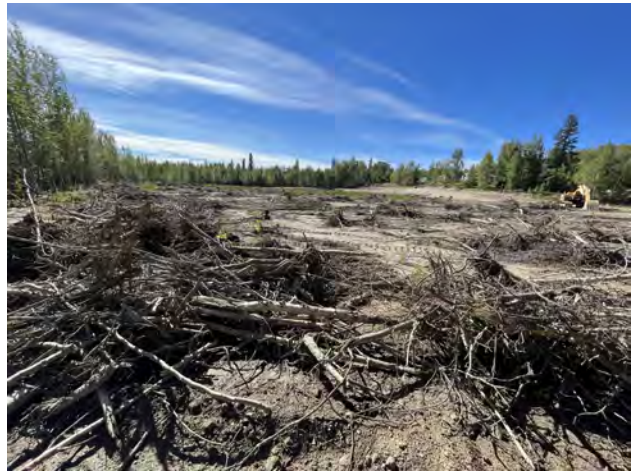
Photo 10: 20220811 Final Surface looking south

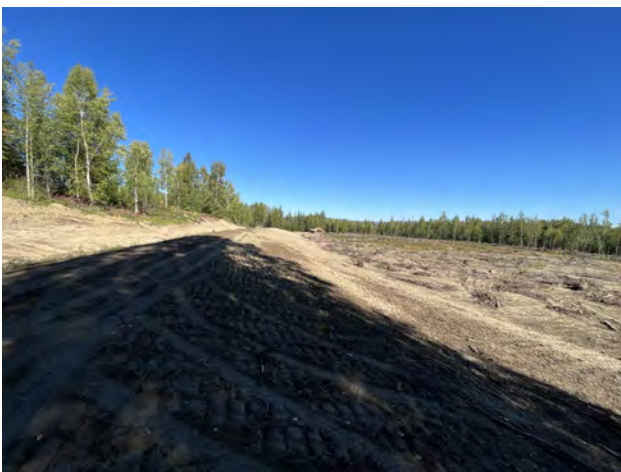
Photo 11: 20220811 northern portion looking east

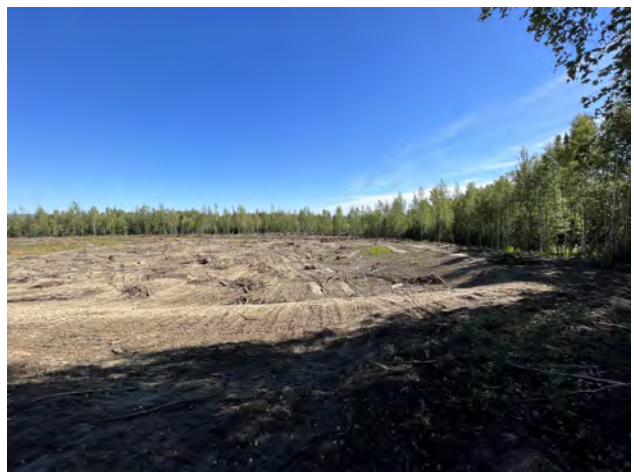
Photo 12: 20220811 southern portion looking east

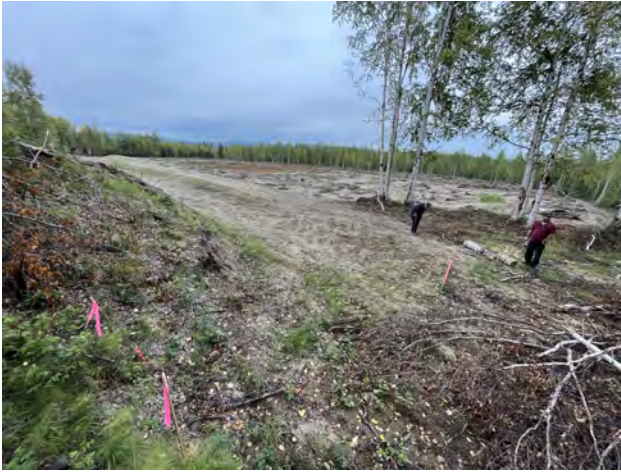
Photo 13: 20220824 looking NE complete

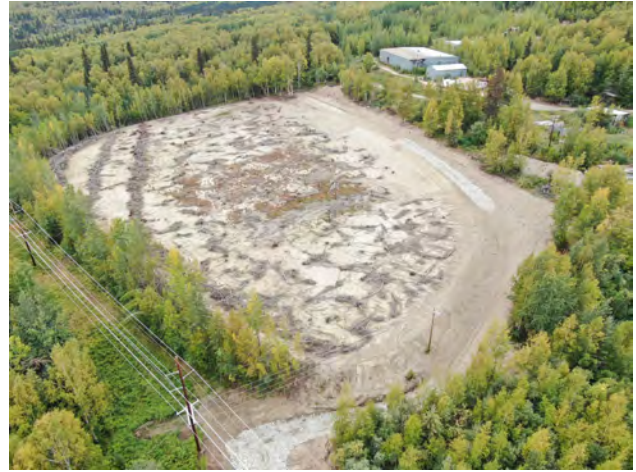
Photo 14: 20220831 Drone looking SW

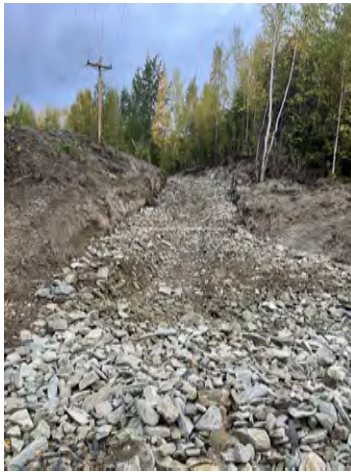
Photo 15: 20220916 lower portion of channel

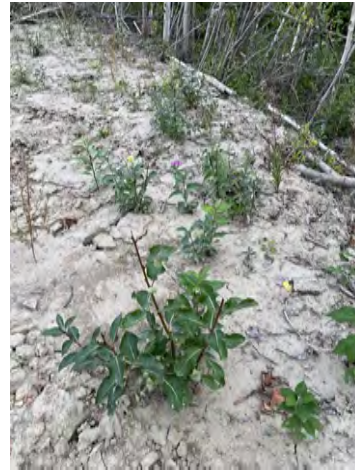
Photo 16: 20220916 Natural Revegetation

Once the earthwork was complete, Shannon & Wilson staff spread a seed mixture a rate of 1.5 pounds per 1,000 square feet. The seed mixture contained 50-percent Nortran Tufted Hairgrass, 35-percent Arctared Fescue, 10-percent Wainwright Wheatgrass, and 5-percent Annual Rye. The seed was placed in the unlined ditches and the exposed top of the berm in accordance with the specifications. Natural vegetation has begun to populate the disturbed area.

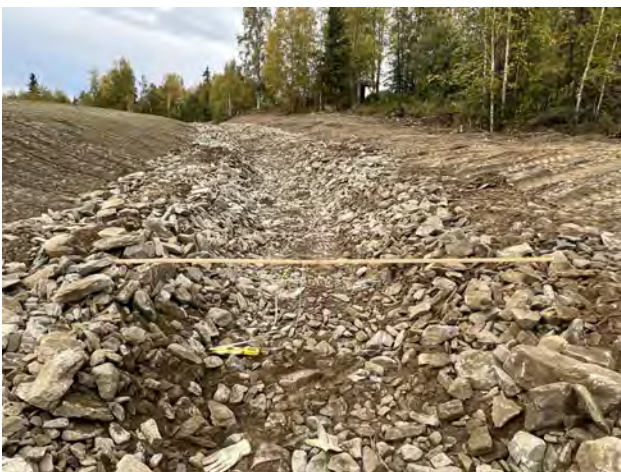
Photo 17: 20220916 upper portion of channel
