**Hydrocarbon Investigation
GTE McGrath Central Office
McGrath, Alaska**

July 21, 1999

AGI Project No. 15,169.268

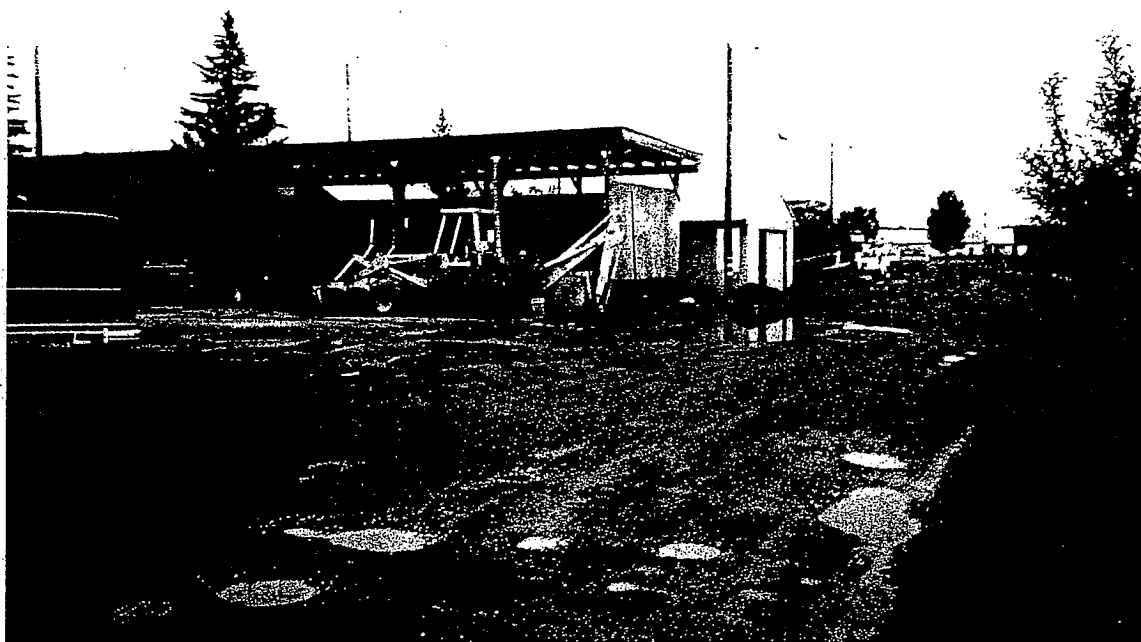
PHOTO-2: Fuel Pole Barn and GTE Storage Building, Looking West

The GTE site is bordered on the east by a pole barn owned by BJ Fuel (Appendix A, Photo 2). BJ Fuel maintains an 11,000-gallon aboveground unleaded gasoline fuel tank immediately off the southeast corner of the site. A radio station is south of the site. West of the site are an office and hangar for Redline Air Charter Service. To the north is the frontage road followed by the airport runway.

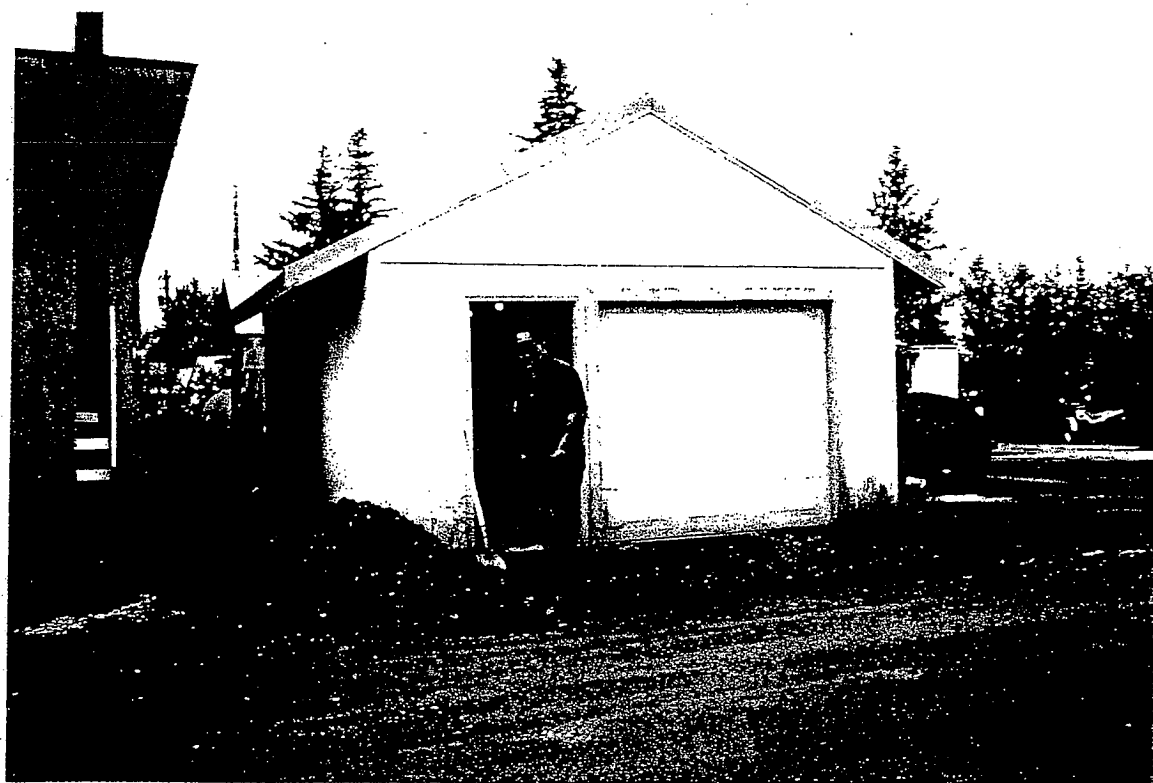
PHOTO-4: Contaminated Grounding Trench Between Storage Building And Pole Barn

AGI Technologies (AGI) arrived in McGrath June 26, 1999 to evaluate the contaminated area. At the time of our arrival the grounding system was installed and in service. The approximately 1-foot deep trench between the GTE storage building and the BJ Fuel Pole Barn was still open (Appendix A, Photos 4, 9, and 10). The apparent odor of petroleum fuel vapors could be detected in the area. Dead vegetation surrounded the fill port of the above ground tank located on the BJ Fuel property (Appendix A, Photos 7 and 8). Vegetation between the GTE storage building and BJ Fuel Pole Barn (Appendix A, Photo 9) was also dead. Containers with fuel absorbent materials and oil were situated at the north end of the BJ Fuel tank. These observations suggest fuel releases have occurred at the BJ Fuel property in these two areas.

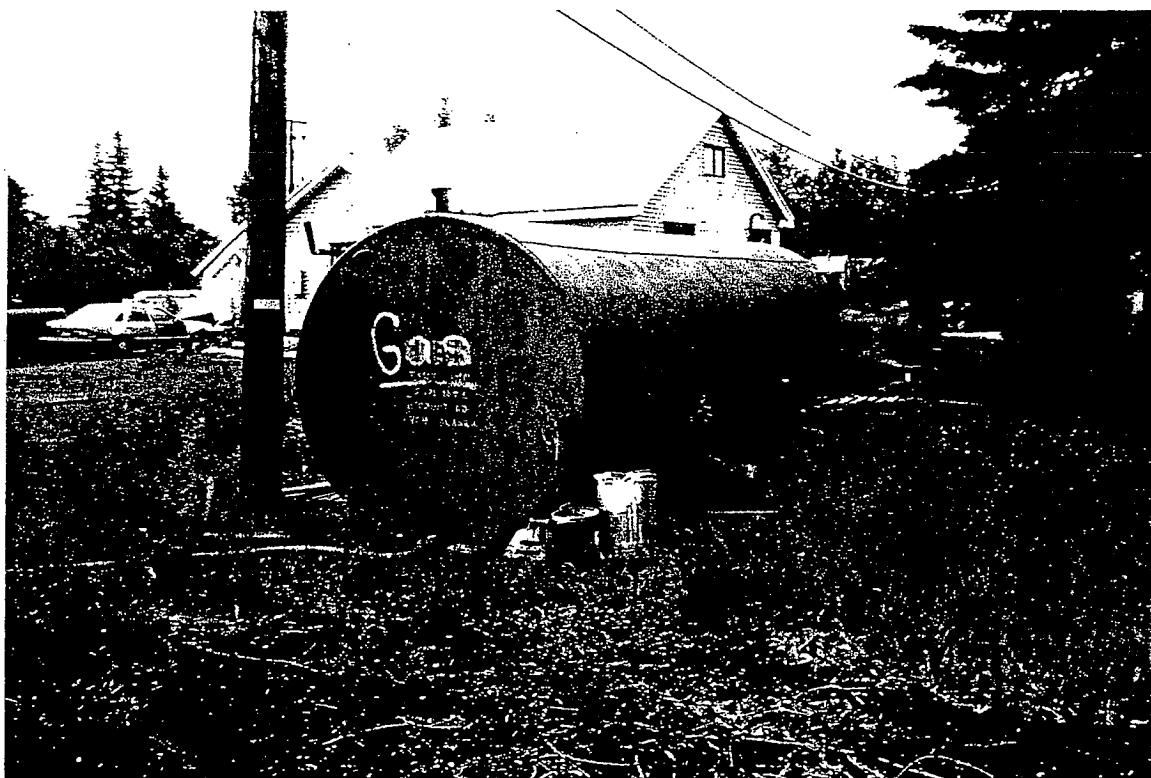
PHOTO-6: BJ Fuel Gasoline Storage Tank Located at Southeast Corner of GTE Site

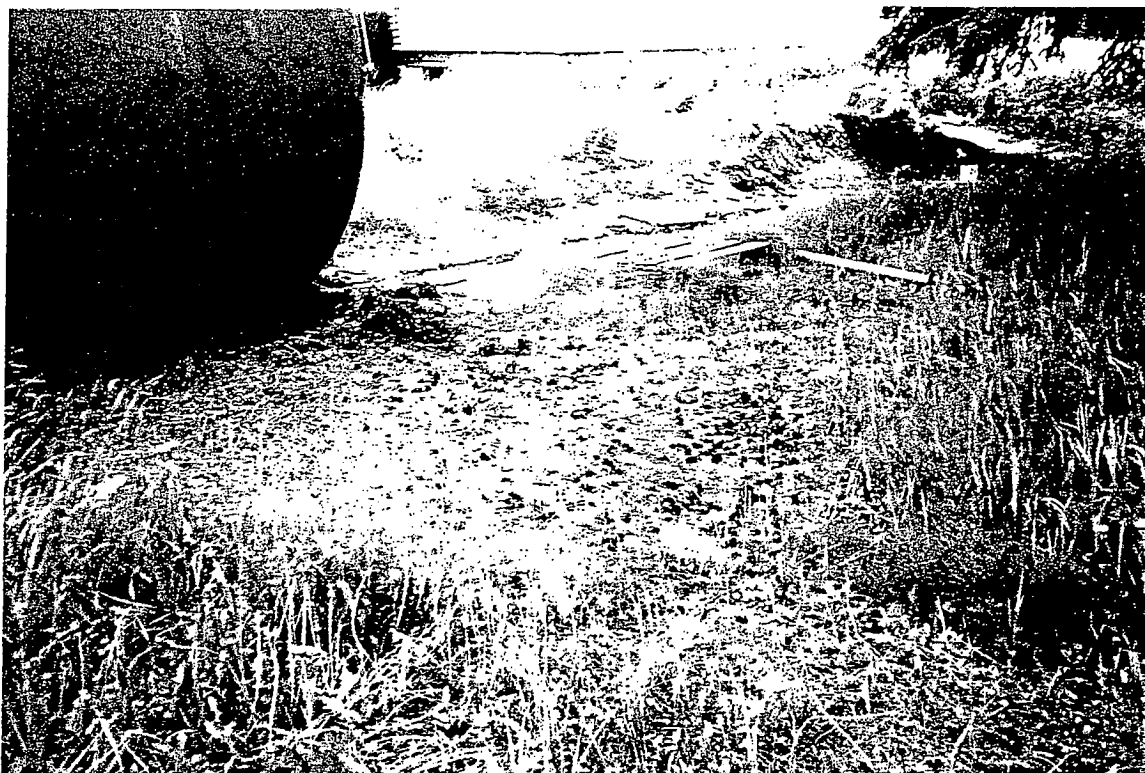
PHOTO-7: Dead Vegetation at South End of BJ Fuel Tank

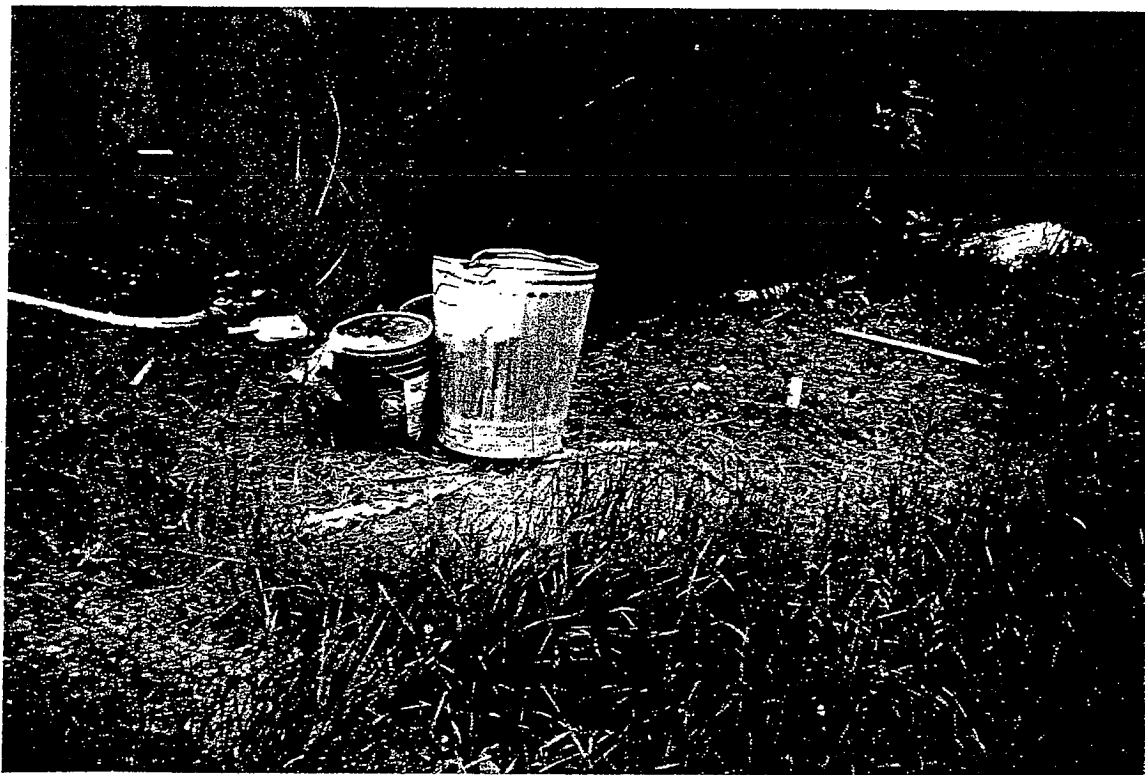
PHOTO-8: Dead Vegetation at North End of BJ Fuel Tank. Containers are Partially Filled with Fuel, Absorbent Pads and Water

Two areas of the BJ fuel property appear impacted by gasoline spills: the area of the fuel pipeline quick connect and pipeline tee near the northeast corner of the GTE property and the area around the fill port at the north end of the BJ Fuel aboveground tank. Review of the analytical chromatograms and BETX concentrations indicates the gasoline sampled near the pipeline quick connect and tee is from a recent release, or from recent and long-term ongoing releases. Dead vegetation, field screening for VOCs, and the presence of spill cleanup materials at the north end of the BJ Fuel aboveground tank indicates gasoline was also recently released in that area. There are no secondary containment or other spill prevention devices surrounding this tank, and the fuel pipeline and pipeline couplings have no safety devices to prevent accidental discharges to the environment.

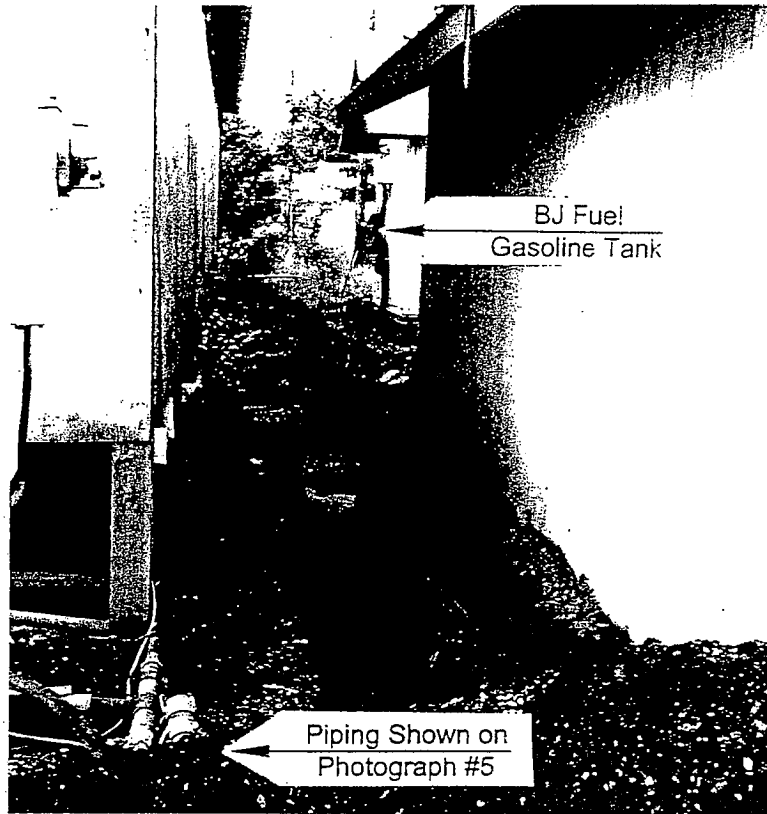
PHOTO- 9: Contaminated Grounding Trench Along East Side of GTE Storage Building
View Looking South

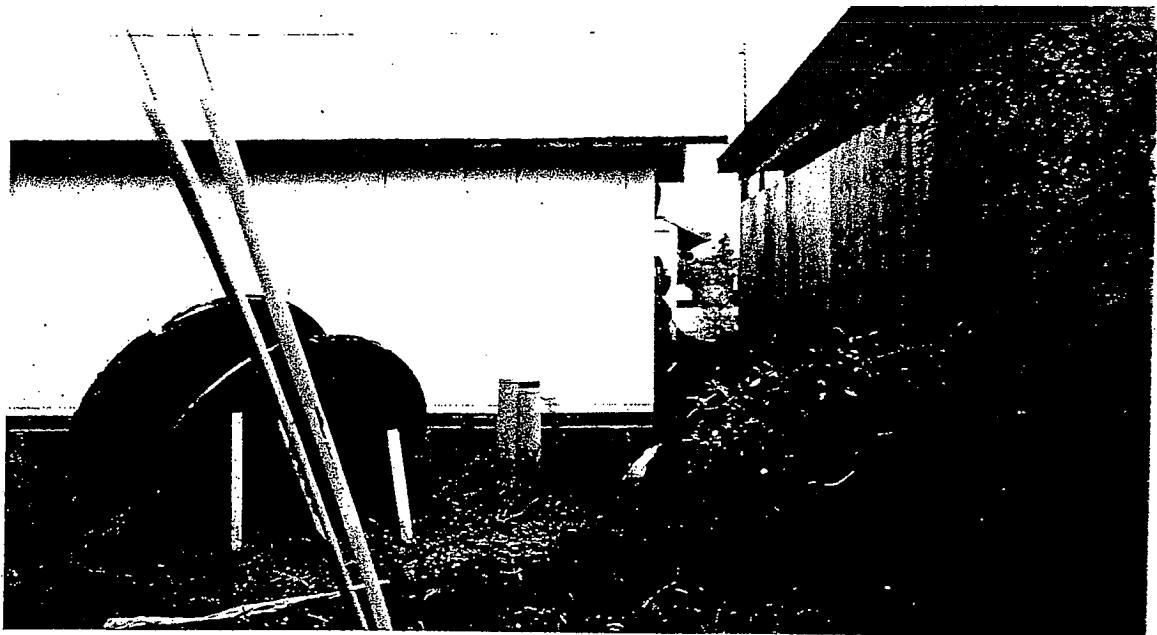
PHOTO-10: Contaminated Trench Area Between GTE Storage Building and BJ Fuel Pole Barn
View Looking North
