Former Utica Mine Camp Site

Remedial Investigation

Site Cleanup Report

WHPacific

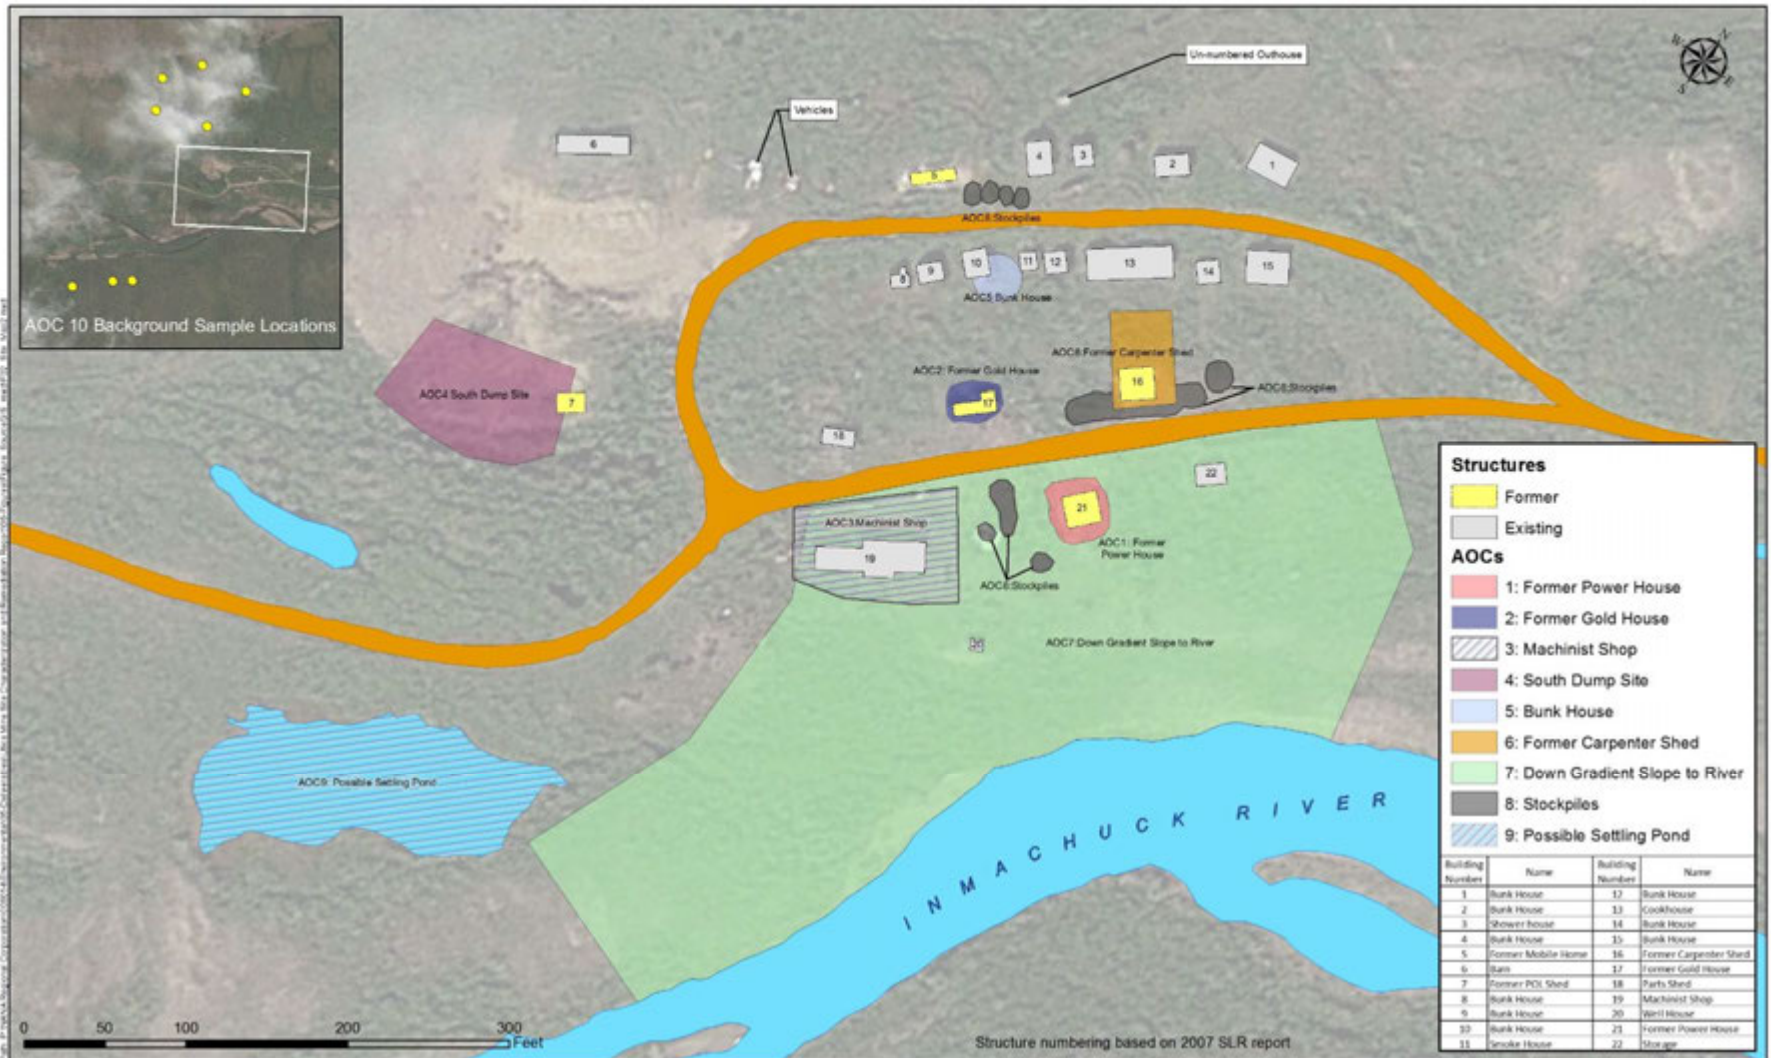
Work was conducted in accordance with the 2012 Former Utica Mine Camp Site Characterization and Remediation Work Plan, including the Site Specific Health and Safety Plan (SSHSP) (Sivuniq, 2012), except deviations noted in each AOC section in this report. Table 3 below summarizes the planned tasks; locations are shown on Figure 2.

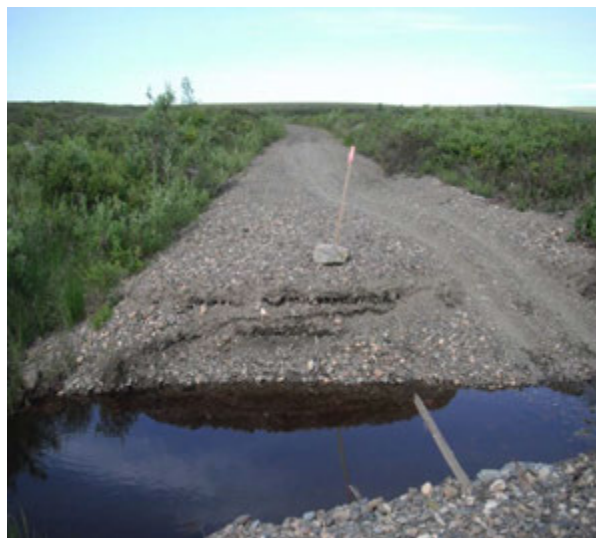
The condition of the AOC 9 potential settling pond was photographed to determine the sampling methods required. The mercury containers were found to be empty. The airstrip approximately one half mile north of the Utica Mine Camp Site was found to be usable for small aircraft. The road to Deering was passable for four wheeler all-terrain vehicles. However, a washout was discovered to be impassable for road vehicles.

The washout on the Deering to Utica road view looking south on 9/2012

In the interim and until further remediation action is taken at the site, an annual site visit and public meeting should be conducted (in Deering) and road repairs need to be implemented. After the road is repaired and the course of action is agreed upon, the reclamation can be implemented and the site can move into a reuse phase.

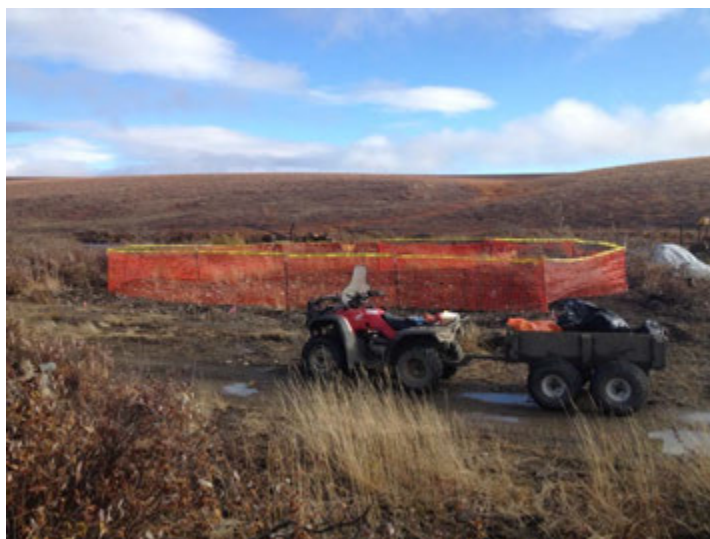
Further work on this AOC had to be postponed due to malfunctioning equipment. The stockpiled soil was covered securely with a 6 mil reinforced polyethylene top cover. Soils will be land farmed in a future field season. The excavation was secured with steel fence posts, orange safety fencing, and caution tape to restrict access until further remedial action can be accomplished.

AOC 1 excavation fencing, looking north, as left by the WHPacific Field Crew on 9/23/2012

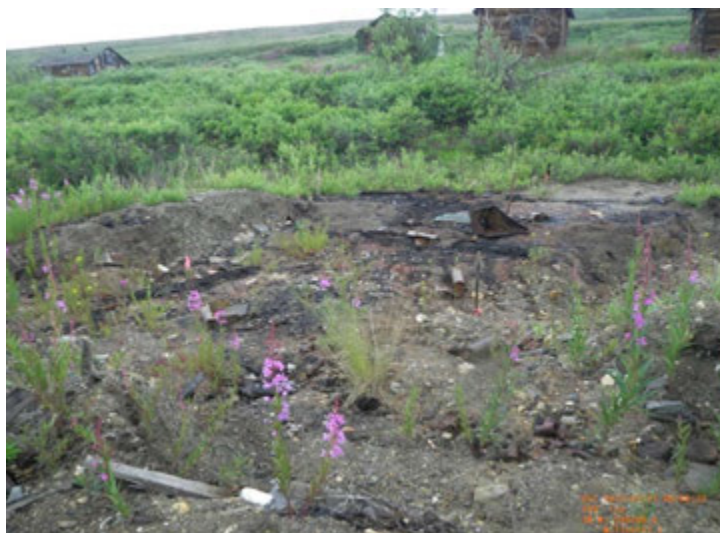
The Former Gold House (Building #17) was demolished and the remains were burned in 2008 or 2009. When WHPacific examined AOC 2 in June of 2012 there was a pile of disturbed soil of unknown origin that was intermixed with burned wooden building remnants, machinery consistent with small mill operations, and three mercury flasks.

Westward facing view of AOC 2 on 7/12/2012

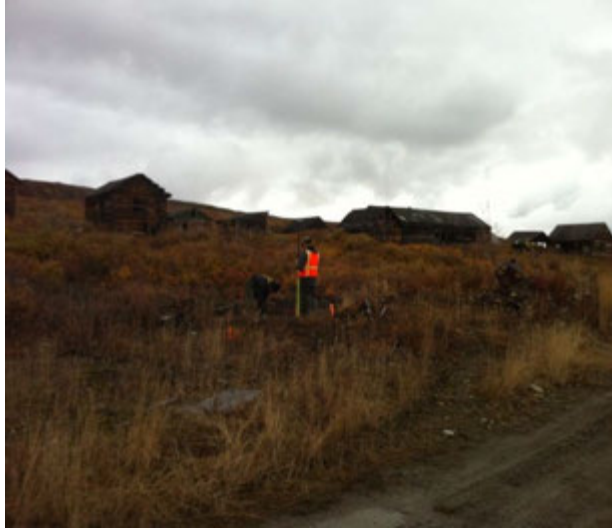
View looking north of AOC 2 on 9/19/2012.

The empty mercury flasks were containerized in plastic tubs for transport offsite. To limit the spread of contaminated soils due to wind-blown dust or water infiltration, the area of disturbed soil was covered with 6 mil reinforced polyethylene liner material pending analytical results and possible removal action.

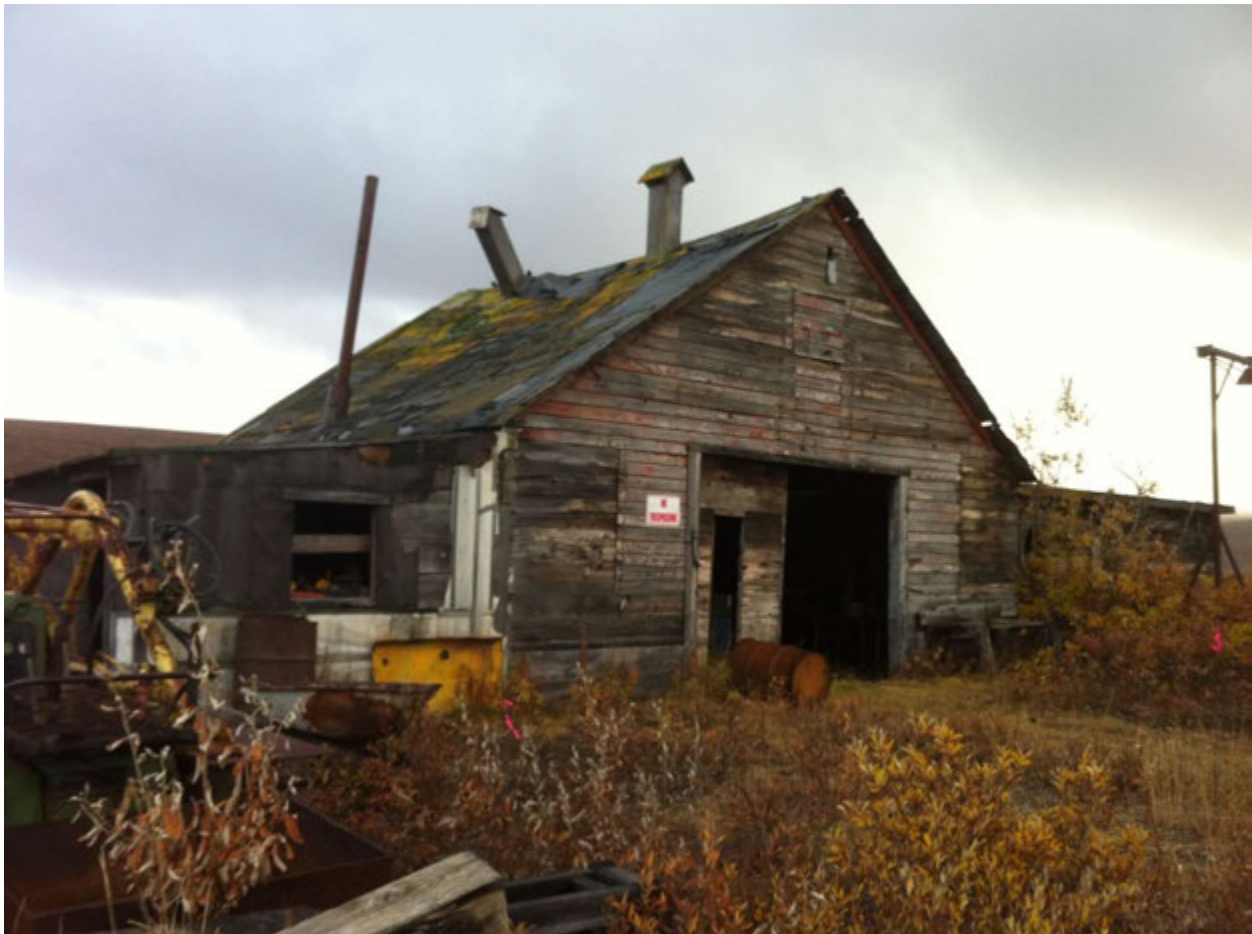
On September 9, 2012 eleven drums previously identified by the TPECI investigation were found at the south end of the Machinist shop. Three of the drums contained enough non-aqueous liquid product to collect samples. Samples were submitted to a laboratory for oil burn specification analysis

View looking north of AOC 3 on 9/19/2012.

The lack of appropriate equipment for the transportation of drums precluded moving them offsite. The drums were placed on a 20 mil liner and covered with 6 mil plastic sheeting to minimize stormwater impact. Field screening of the soils under the drums was not completed as they are stored in the same location as found. The soils will be screened once the drums are moved offsite.
