Site Inspection Report Kennicott Mine Kennicott, Alaska

Contract No. 68-W9-0046
Work Assignment No. 46-23-0JZZ
Work Order No. 4000-019-010-4100
Document Control No. 4000-019-010-AAAY

April 1995

SITE INSPECTION REPORT
Kennicott Mine
Kennicott, Alaska
Site Identification No. AKD983073123

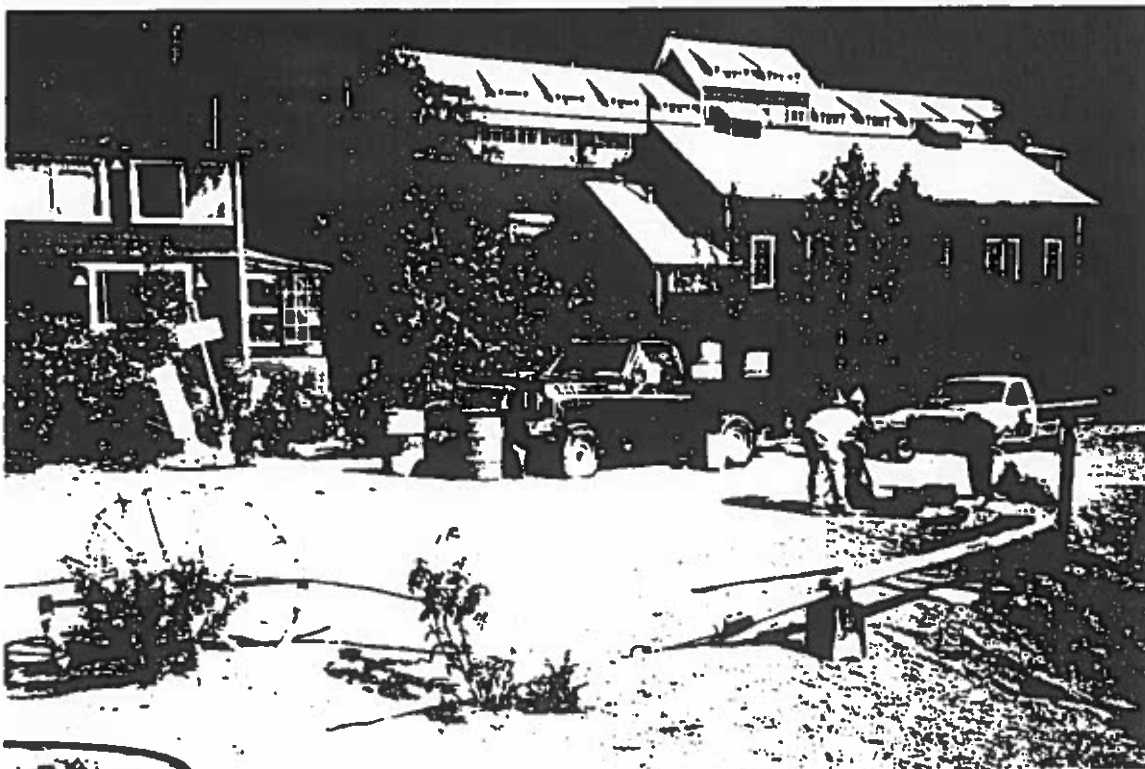
View of south mill town buildings. Cottage #24 at left, Kennicott Lodge in background. Soil boring station SS007 located at right.

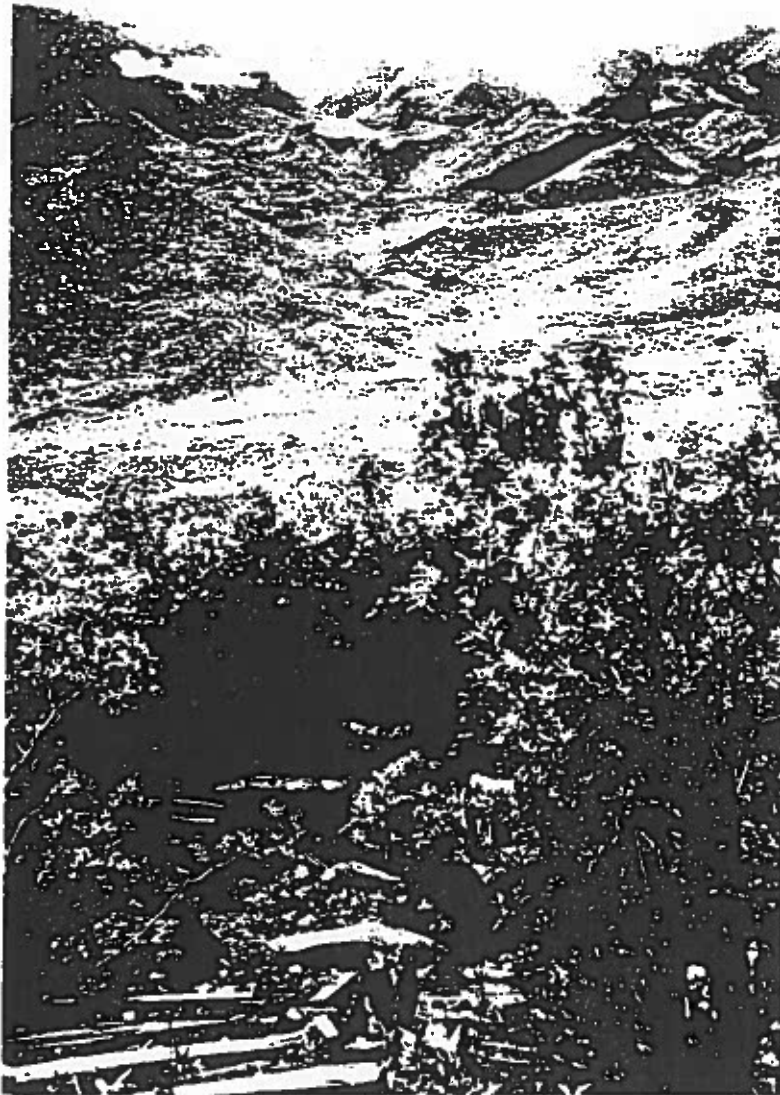
Table 4-1 contains inorganic results for samples collected in the Power Plant Oil Spill area. In oil-saturated soil samples collected near fuel tanks 4(3) and 4(2) (Stations SS001 and SS003), 12 inorganic elements were detected at elevated concentrations, indicating areas of observed contamination. Maximum concentrations of elevated inorganics included antimony (479 mg/kg), arsenic (50.7 mg/kg), barium (316 mg/kg), cadmium (4.5 mg/kg), cobalt (68.7 mg/kg), copper (1690 mg/kg), lead (359 mg/kg), mercury (1.3 mg/kg), nickel (1500 mg/kg), selenium (9.4 mg/kg), vanadium (1800 mg/kg), and zinc (266 mg/kg).

Oil spill area below fuel tanks 4(2) and 4(3).

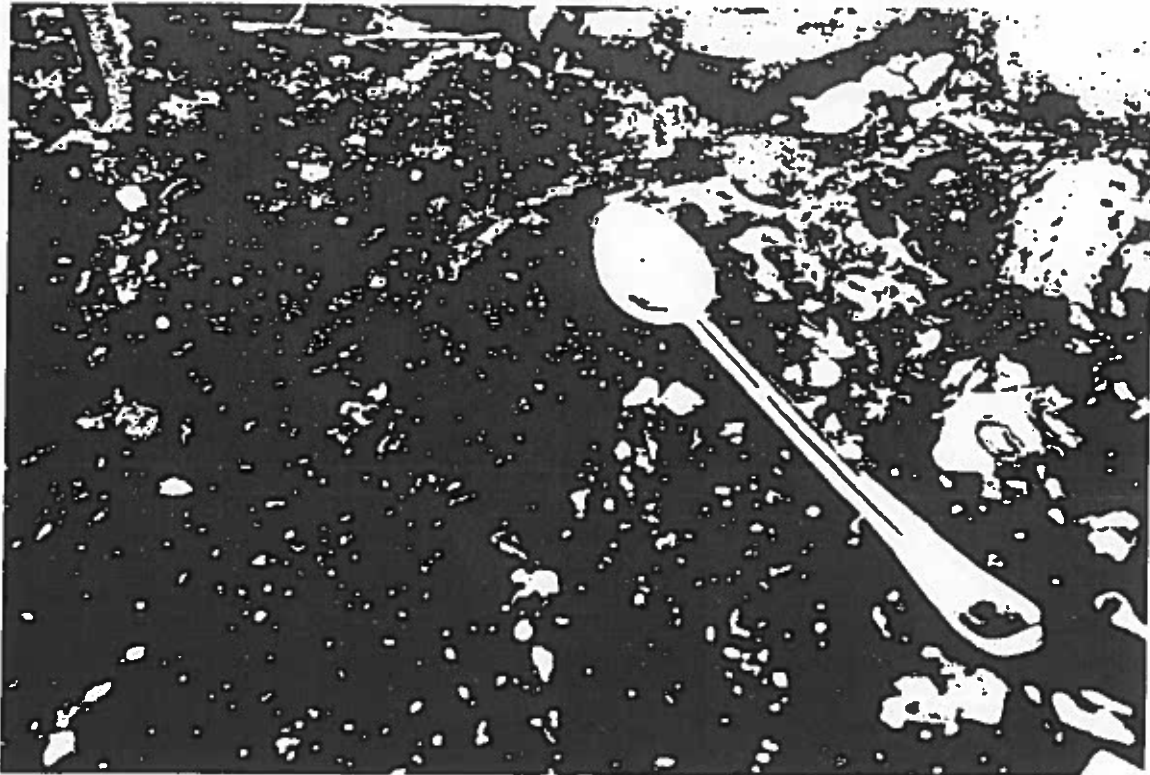
Asphalted soil in oil spill area. Location of sample station SS003.

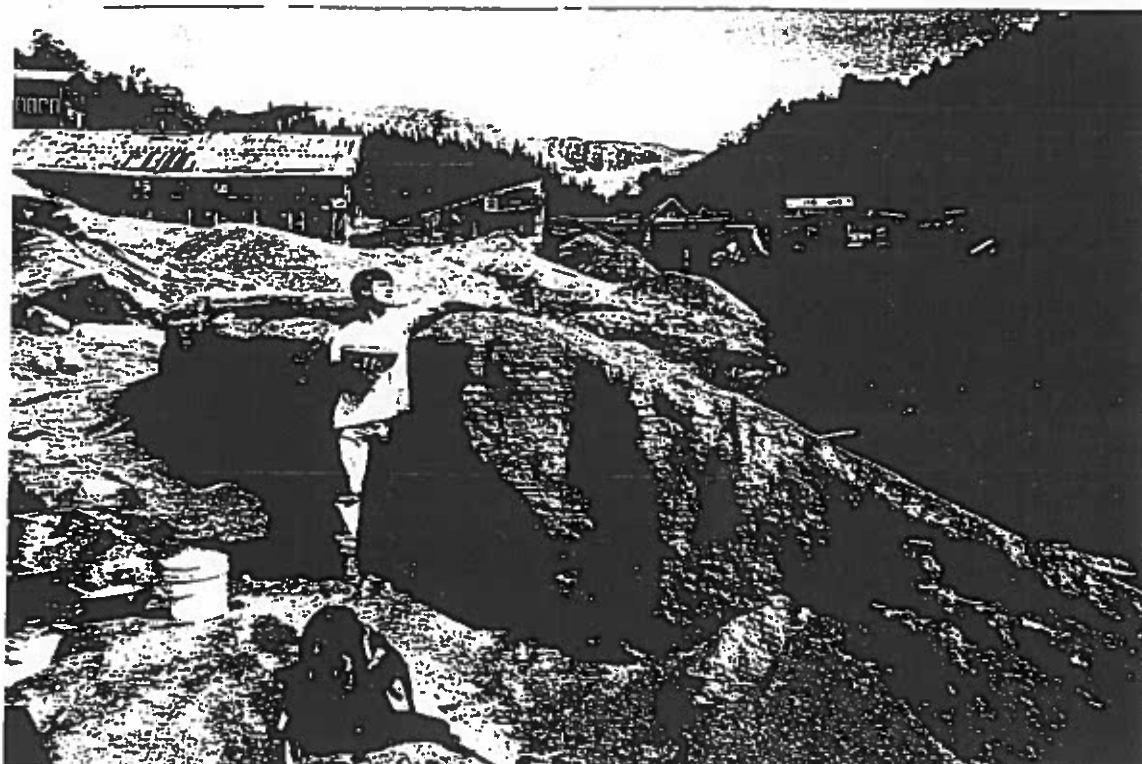
In two roads cut through the tailings pile below the leaching and flotation plant, layers of oil were seen as deep as 5 feet. The oil appeared to have migrated downward through the coarser grained tailings and had a strong hydrocarbon smell. Below the leaching and flotation plant, a seep flowed from beneath the tailings pile over bedrock. The seep had stained surrounding rocks red.

Tailings pile road cut exposing oil layers, looking east. Note darkened oil lenses throughout road cut and stained tailings at left.

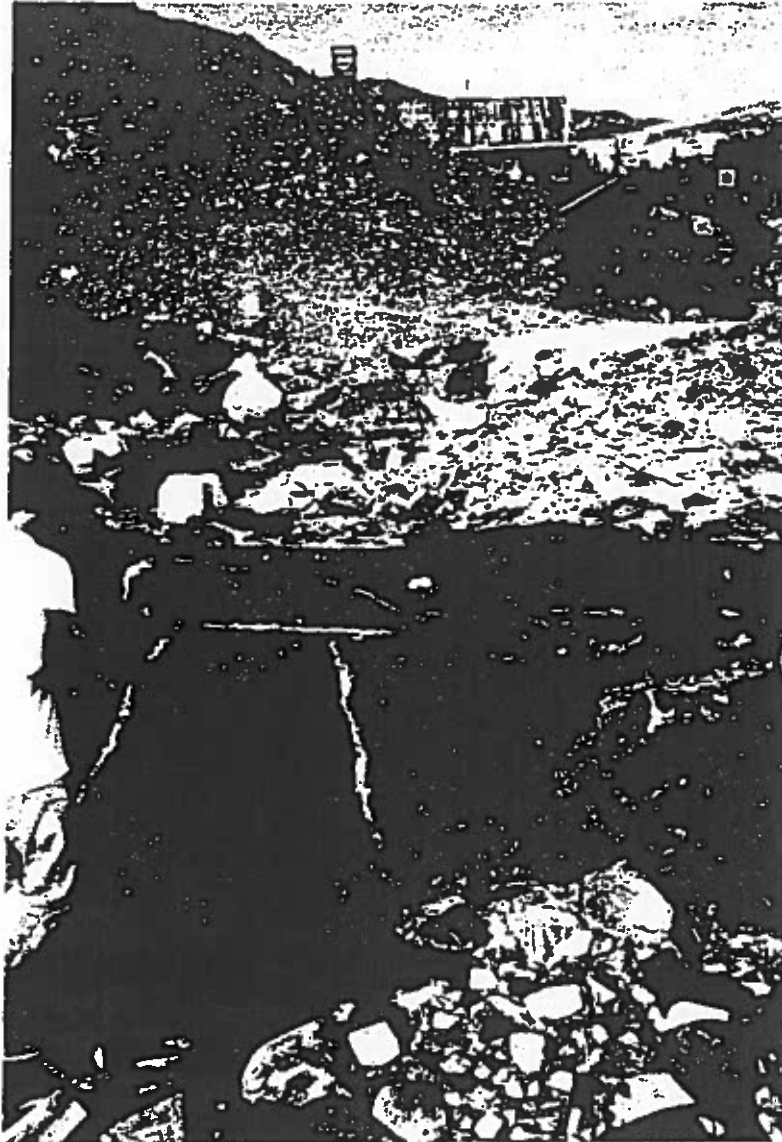
Copper and arsenic qualified as observed releases in the tailings pile seep sample at concentrations of 74.8 µg/L and 8.34 µg/L, respectively. The copper concentration is below applicable drinking water standards, and arsenic is below its proposed MCL but above the cancer risk screening level. Barium was positively identified but did not qualify as an observed release. The seep is not a known drinking water source, but is a migration pathway for metals from the tailings pile to National Creek surface water.

Seep over bedrock in tailings pile. Located below leaching and flotation plant, looking east. Corresponds to sample station SP001.

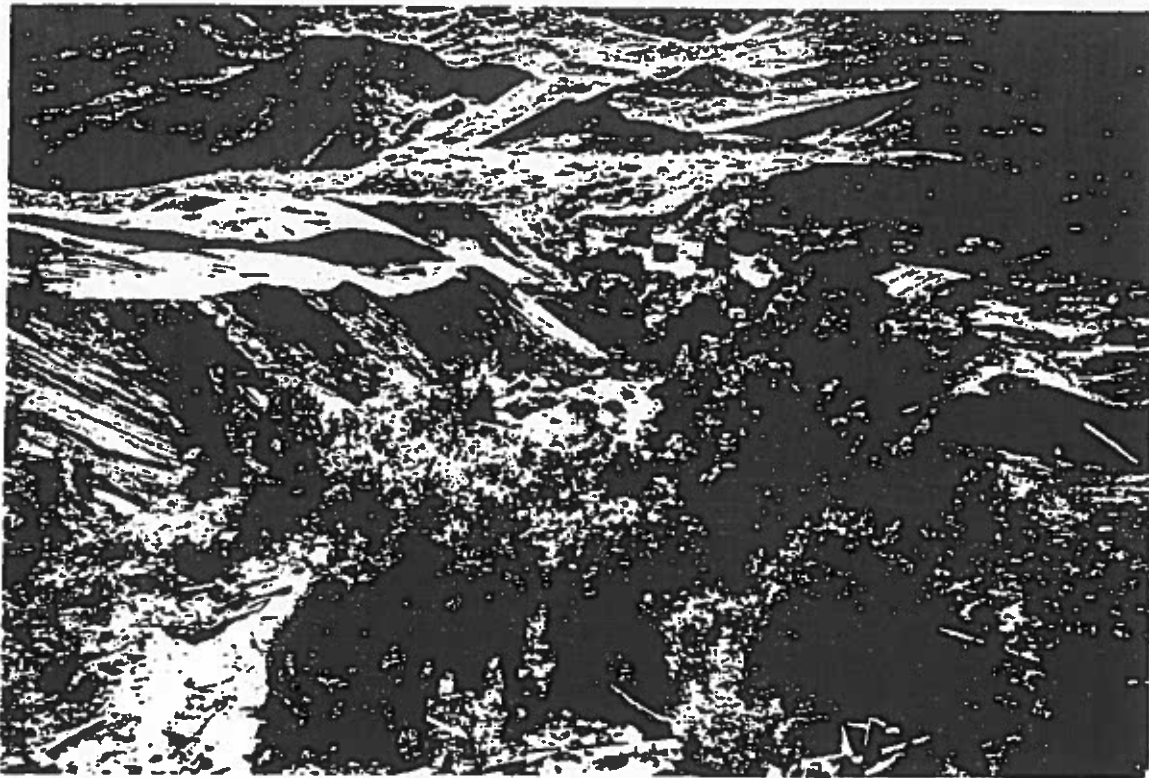
In sediment samples collected from National Creek, arsenic, cadmium, copper, and mercury were elevated above background. Arsenic, at a maximum concentration of 129 mg/kg, and copper, at a maximum concentration of 1,100 mg/kg, were higher at the sample collected just below the tailings pile (SD002). Further downstream (Station SD003), cadmium was found at a maximum concentration of 15.7 mg/kg and mercury at a maximum concentration of 0.84 mg/kg.

National Creek below mill town as it cuts through the tailings pile, looking west.

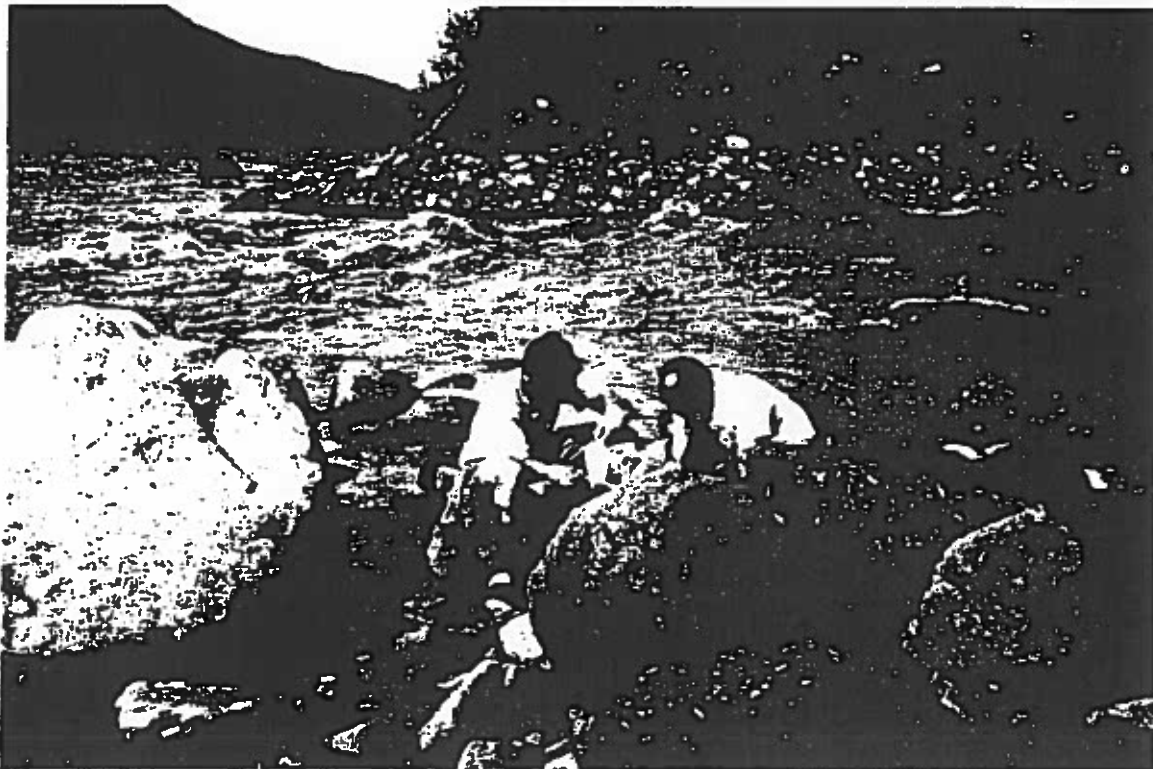
Kennicott River near McCarthy, looking north. Location corresponds to sample station SD007. Note silt in water.
