**Cleanup Action Report  
for the  
Calder Bay Limestone Project**

-----  
**Prince of Wales Island, Southeast Alaska**

November 2004

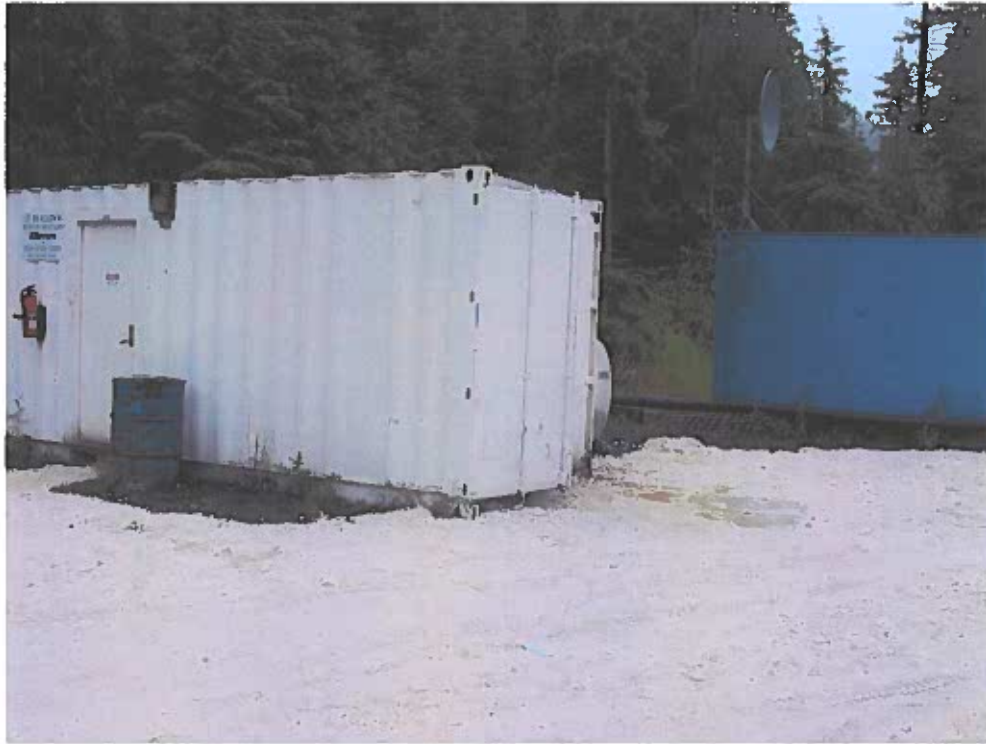
July 31, 2004 Calder Bay Facility, Camp Genset: Light brown stains in calcium carbonate show where petroleum contamination was present.

Contaminated soil was excavated from accessible areas in front of and alongside the genset and tank in September 2004. Samples G-1 and G-2 had been collected in these same areas during the July 2004 site inspection. Approximately five cubic yards of material was removed with a rubber-tired backhoe and placed into the biocell. The excavated material was coarse crushed rock and soil that transitioned to shotrock or fractured bedrock within 12-18" of the original surface. Excavation below that transition was very difficult. Shallow groundwater was encountered just below the pad surface, roughly at the transition to shotrock. Petroleum-impacted soil immediately around and beneath the genset connex and associated tank could not be removed without complete decommissioning and relocation of the genset and therefore this material was not removed.

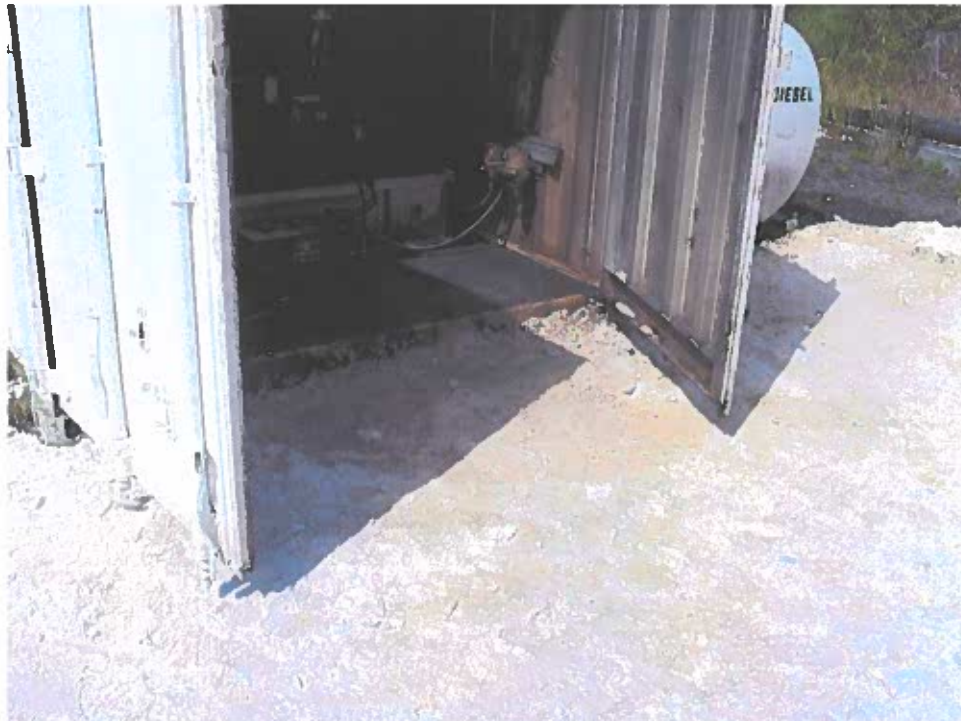
July 31, 2004 Calder Bay Facility, Camp Genset: Close up view of surface staining.

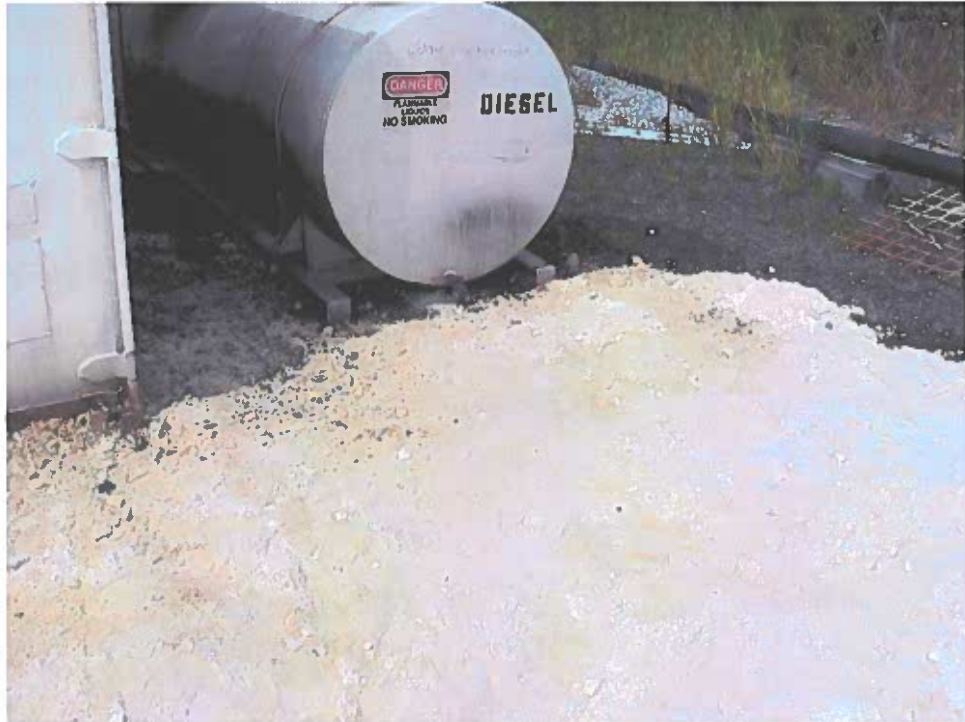
July 31, 2004 Calder Bay Facility, Camp Genset:  
Close up view of surface staining.

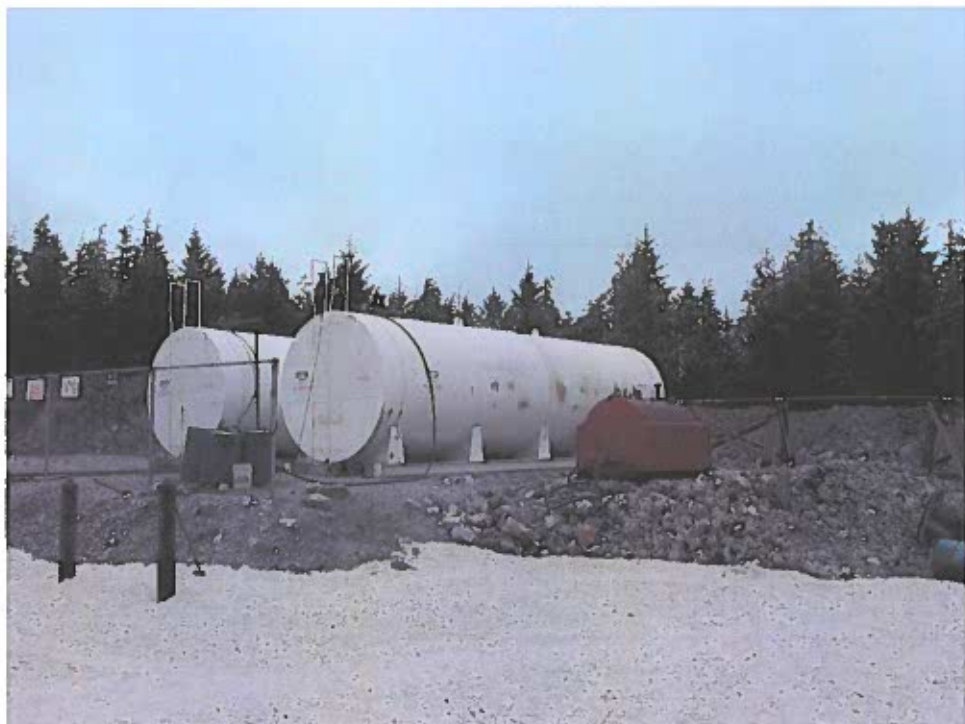
July 31, 2004 Calder Bay Facility, Two 20,000-Gallon Tanks: Surface contamination was observed in front of the right tank extending down the slope to the calcium carbonate in the foreground.

In September 2004, approximately five cubic yards of petroleum-contaminated material was excavated at the location of Sample T-1 (collected during the July site inspection). The material was removed to a depth of approximately 10" in an area downhill from the two 20,000-gallon tanks, near the drum storage area. The excavated material was coarse crushed or broken rock that transitioned to shotrock or fractured bedrock within 12-18" of the original surface. Excavation in the area was very difficult. Prior to this cleanup effort, 25 cubic yards of contaminated material had been removed from the site, of which 10 cubic yards were stored adjacent to the tank site and 15 cubic yards had been taken to the selected biocell location.

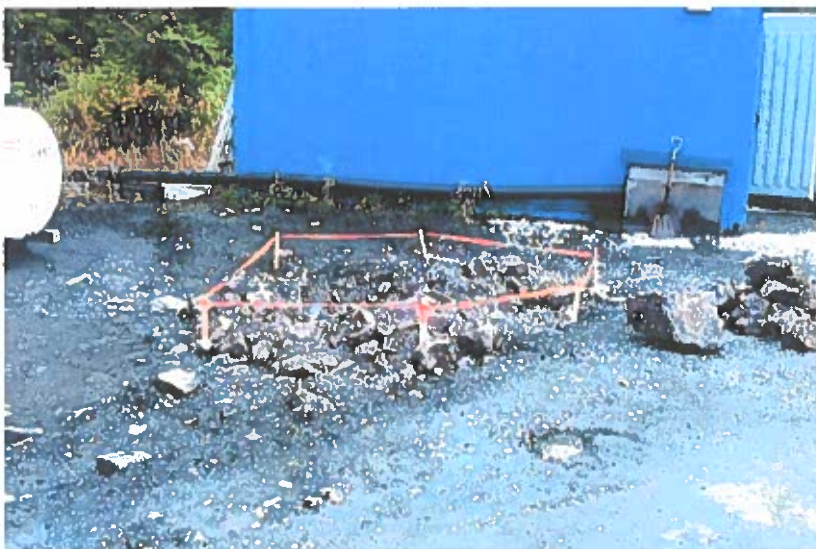
October 9, 2004; Calder Bay Facility, Camp Genset:  
Test hole below final excavation to find bedrock or groundwater. Final excavation had stopped at shot rock.

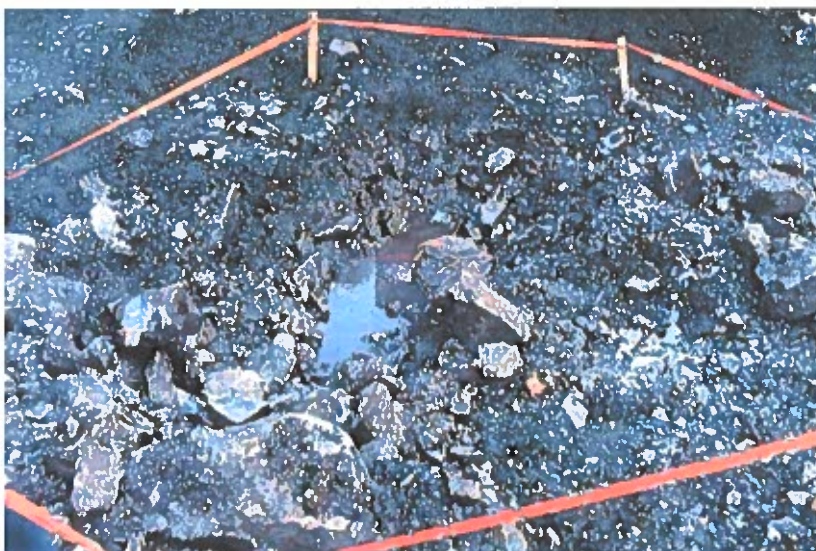
October 9, 2004; Calder Bay Facility, Camp Genset:  
Close up of Test hole below final excavation, note groundwater.

Groundwater at the site is not used for drinking, and although it was encountered in the excavation, it was not sampled. No natural surface water streams are present near the camp genset cleanup area, but a ditch runs along the perimeter of the pad and collects surface water runoff from the pad. Some petroleum contamination was observed in the ditch and was collected with sorbant pads and boom. The ditch does not discharge to surface water, and therefore no petroleum contamination is likely to exit the site.

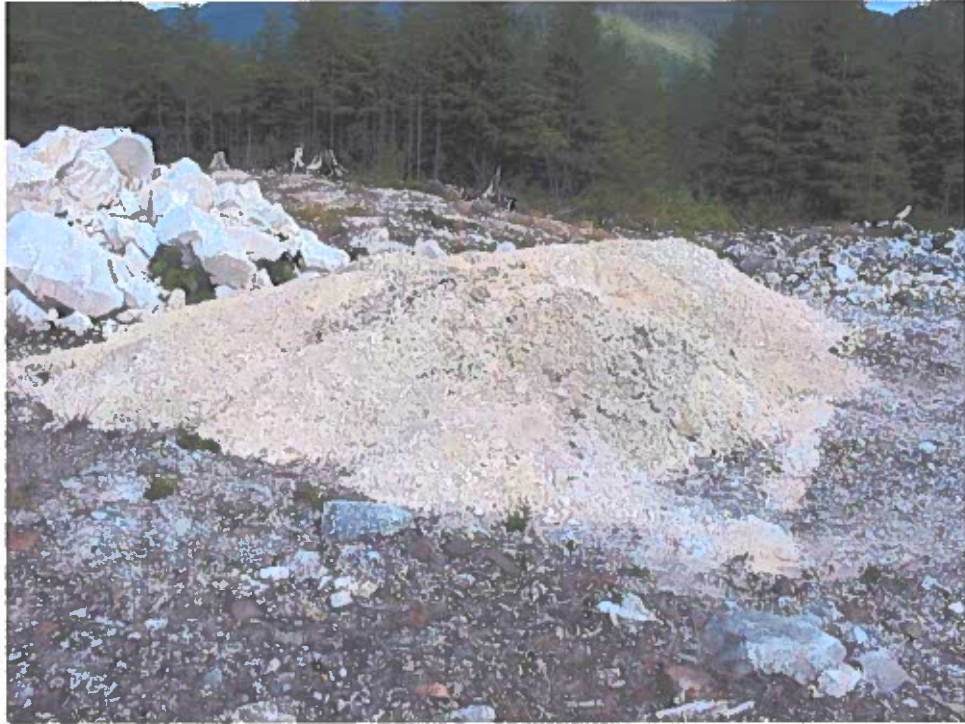
**July 31, 2004 Calder Bay Facility, Biocell Site:  
Fifteen cubic yards of diesel contaminated soil stockpiled on site.**

The site of the biocell was inspected during the July field visit. The site is located approximately ½ mile by road from the marine vessel dock, in a rock pit. Approximately 15 cubic yards of petroleum-contaminated soil previously excavated from the 20,000-gallon storage tank area was already stored at the site. A characterization sample (C-1) of this material was collected and found to have 4,780 mg/kg DRO.

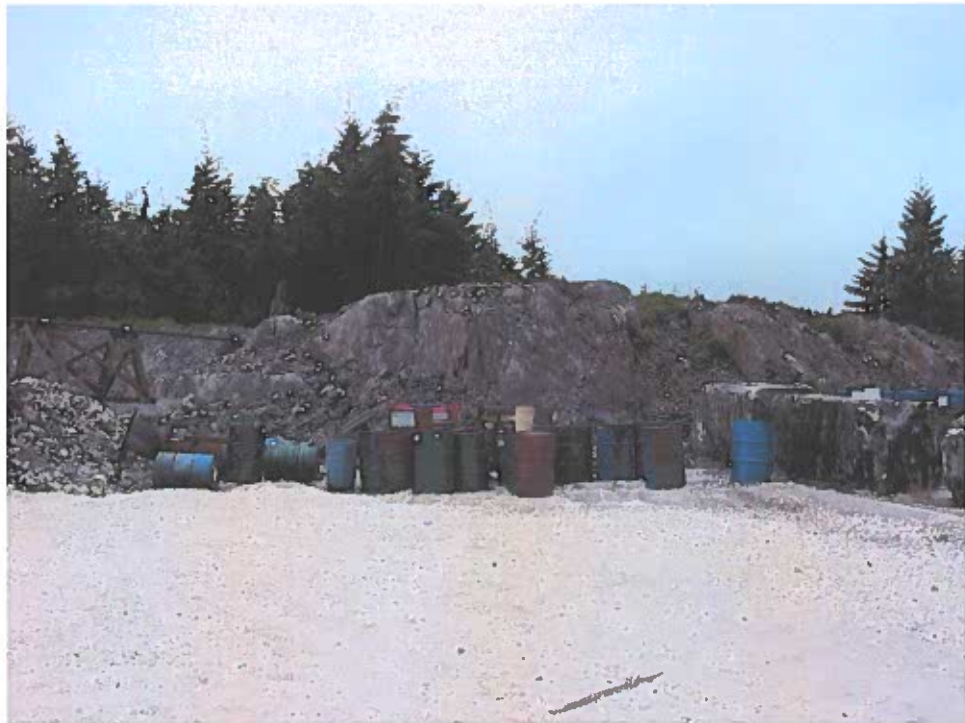
**July 31, 2004 Calder Bay Facility, drum stockpile:  
Portion of the 80 stockpiled drums that were consolidated and  
shipped out for recycling.**

In late August 2004, Larry Wilkinson of CDI returned to Calder and consolidated drum liquids based upon type, reducing the number requiring off-site shipment and disposal to 51 full or partially full drums. Fourteen new drums were shipped to the site for containerizing some of the liquids. All drums with liquids were then labeled, banded and palletized, and loaded with the empty drums onto the Sea Truck landing craft. They were then transported to Craig, Alaska where the empty drums were disposed of at the Klawock Landfill and the drums containing liquids were shipped to Seattle for treatment and recycling. Waste manifest paperwork is enclosed in Appendix D.

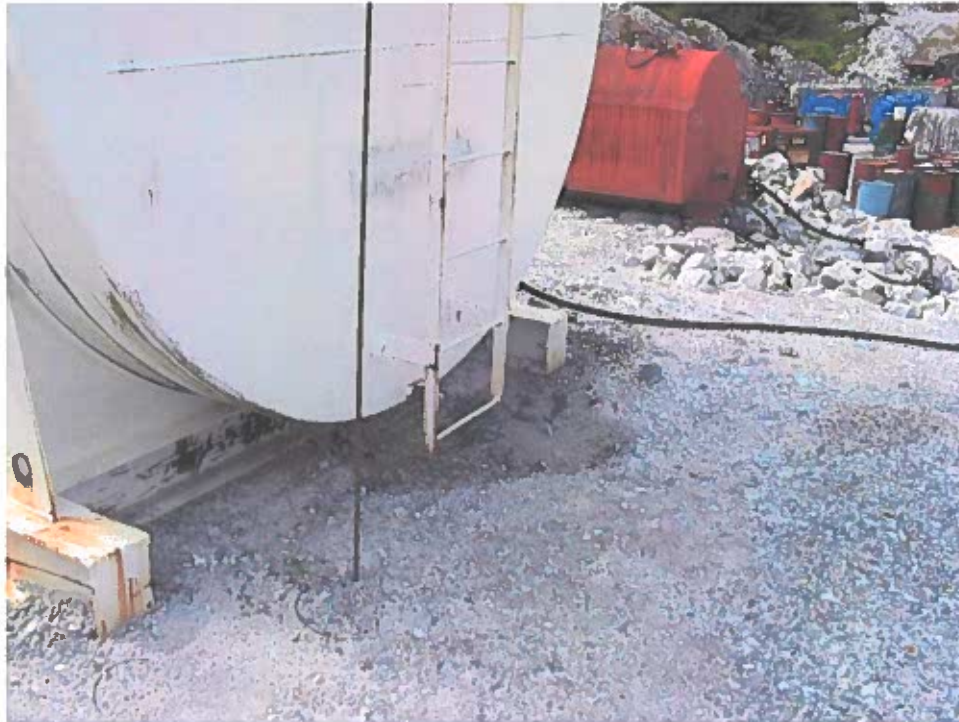
July 31, 2004 Calder Bay Facility, Two 20,000-Gallon Tanks:  
Close up view of surface contamination.

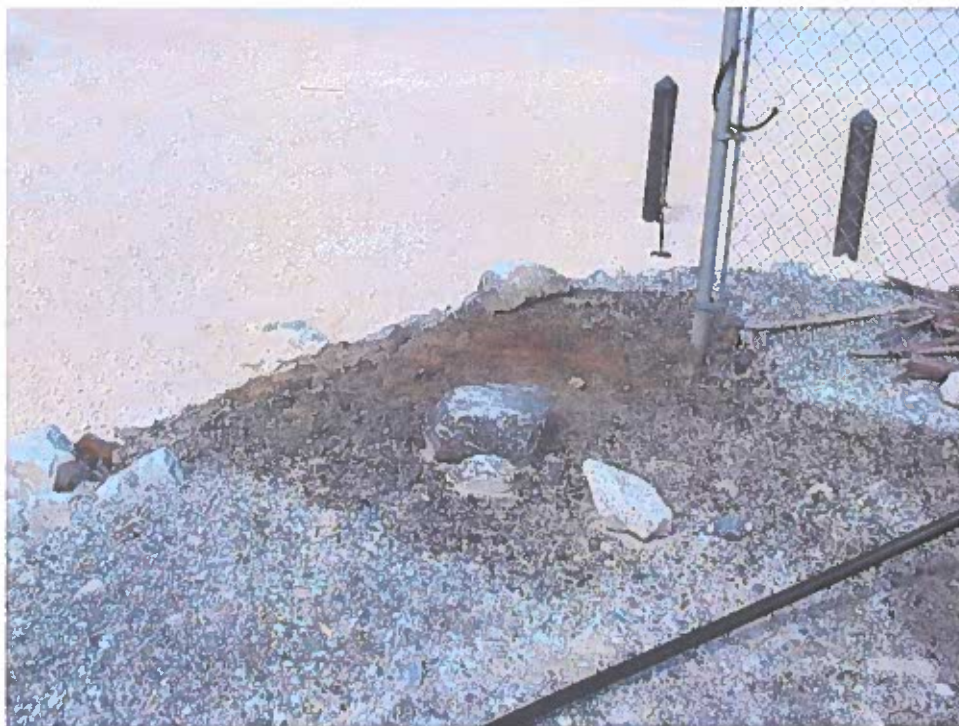
July 31, 2004 Calder Bay Facility, Two 20,000-Gallon Tanks:  
Close up view of surface contamination extending down  
the slope to the calcium carbonate.

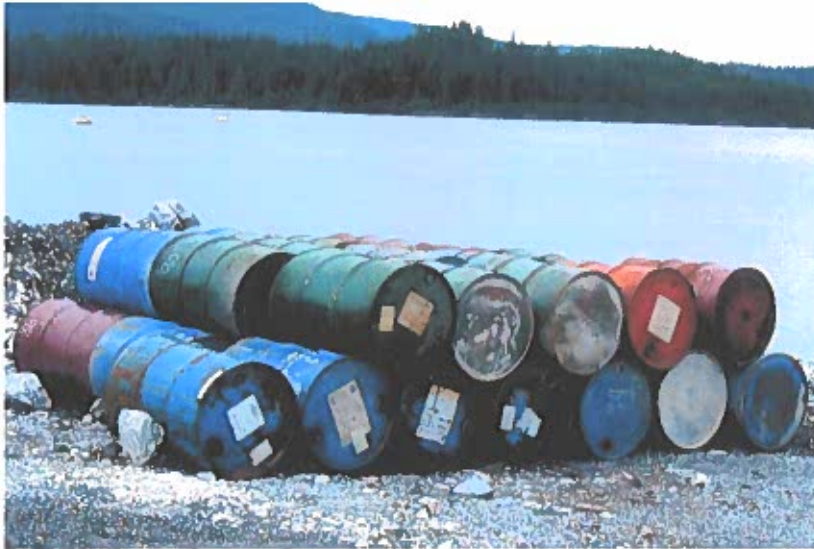
September 10, 2004; Calder Bay Facility, Drum Stockpile: Ready for pick up by landing craft.

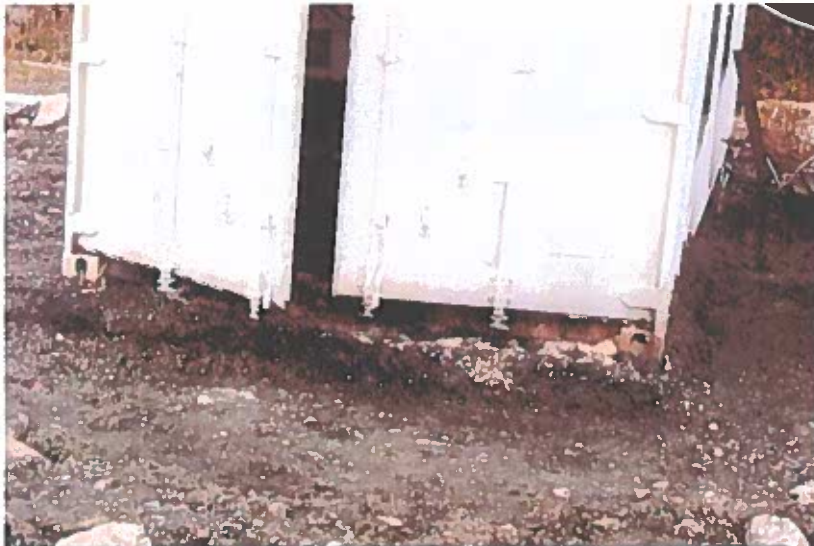
September 2004; Calder Bay Facility, Camp Genset: Close up view showing final depth of excavation of contaminated soil. Contamination left in place beneath genset.

Contamination immediately beneath the genset and associated 500-gallon tank remains, and cannot be removed without complete decommissioning of the generator system.

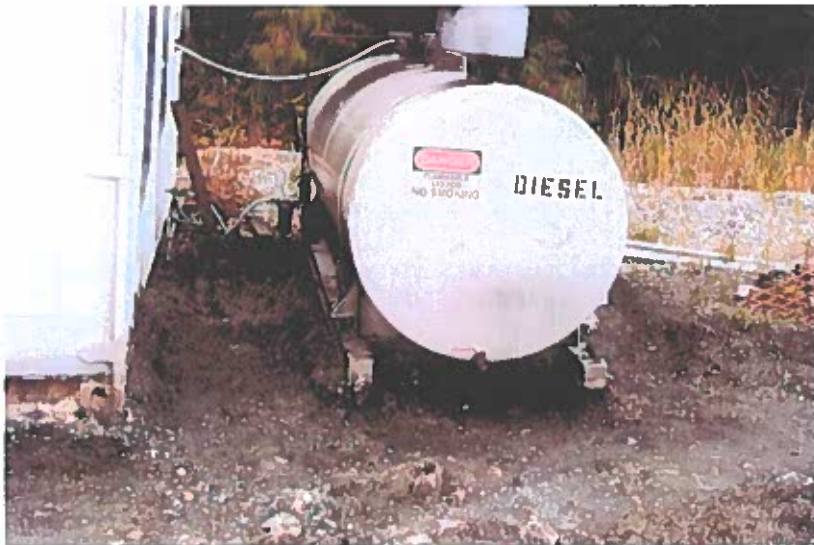
September 2004; Calder Bay Facility, Camp Genset: Close up view showing final depth of excavation of contaminated soil. Contamination left in place beneath fuel tank.

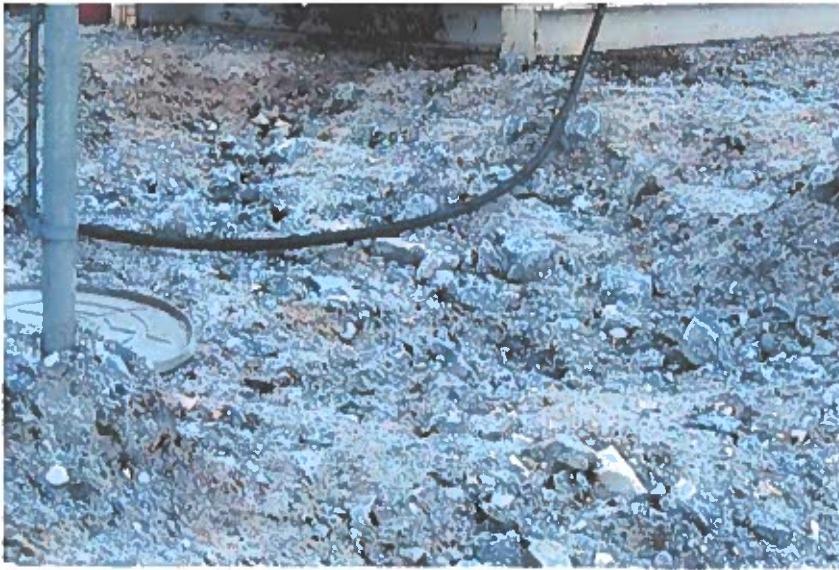
October 8, 2004;  
Calder Bay Facility,  
Two 20,000-Gallon  
Tanks: Close up view  
showing final depth  
of excavation of  
contaminated soil.  
Note prominence of  
large shot rock  
precluding additional  
excavation.

Based on confirmation sample results collected from the excavation, some DRO contamination still remains at the fueling station/former drum storage area site, but was reduced from a high of 1,640 mg/kg to 888 mg/kg. The concentration of 888 mg/kg was 21? attributed to minor surface contamination left behind from several drums previously stored at this location, and therefore the source has been adequately removed. The other confirmation sample collected at this site was 27.2 mg/kg, well below the Method Two of 230 mg/kg.

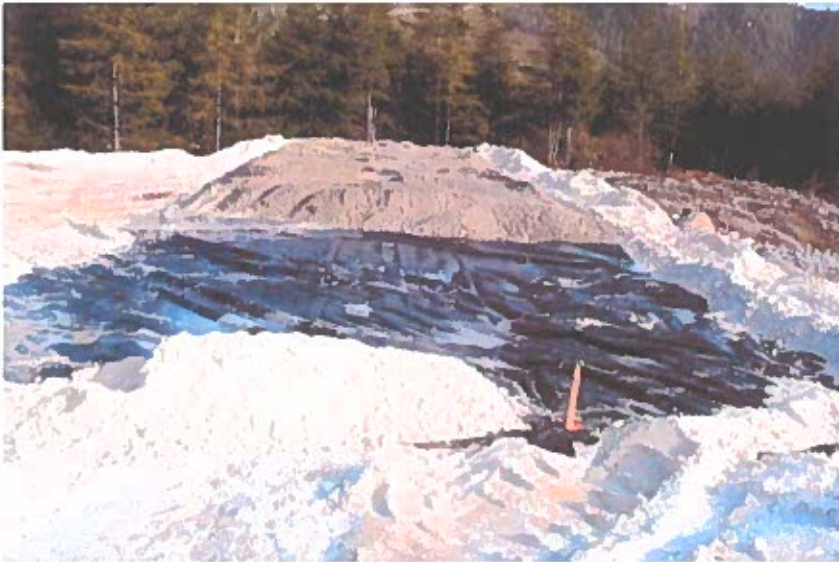
September 2004;  
Biocell: This view  
shows biocell  
construction elements.  
Cell is about 50%  
complete.

In mid-September 2004, the biocell was constructed with a pad of clean material underlying a 20-mil liner. The dimensions for the cell were 25 feet by 100 feet. Contaminated material totaling approximately 45 cubic yards from the two excavations as well as the material previously excavated and stockpiled at the biocell site was placed into the cell, thoroughly mixed, and then roughly graded for a final maximum depth of 26" throughout. The cell slopes to the northwest. A collection sump was dug at the northwest corner to collect water that might drain from the cell. Sorbant material was placed in this pit to collect any accumulated petroleum product.

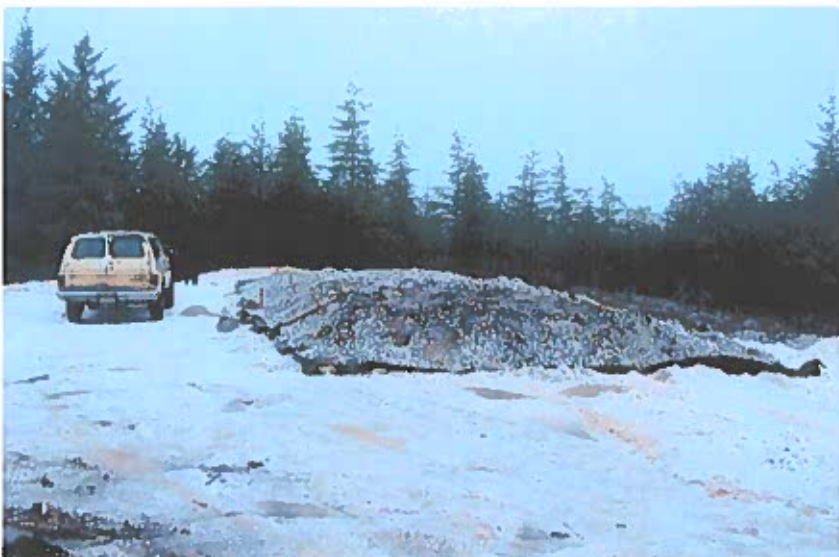
October 9, 2004;  
Biocell: This view  
shows completed  
biocell after about one  
month of operation.  
No seepage of oil was  
noted from cell.

Levels of DRO in the biocell are approximately 1,000 mg/kg and are expected to decline over the next several months. A course of fertilizer will be incorporated into the soil with an additional tilling, and then the cell will be covered for the winter and re-sampled in the spring.
