# Remedial Excavation and Soil Stockpile Sampling Report

Calder Limestone Mine

Prince of Wales Island, Alaska

HydroCon Project Number: 2015-010

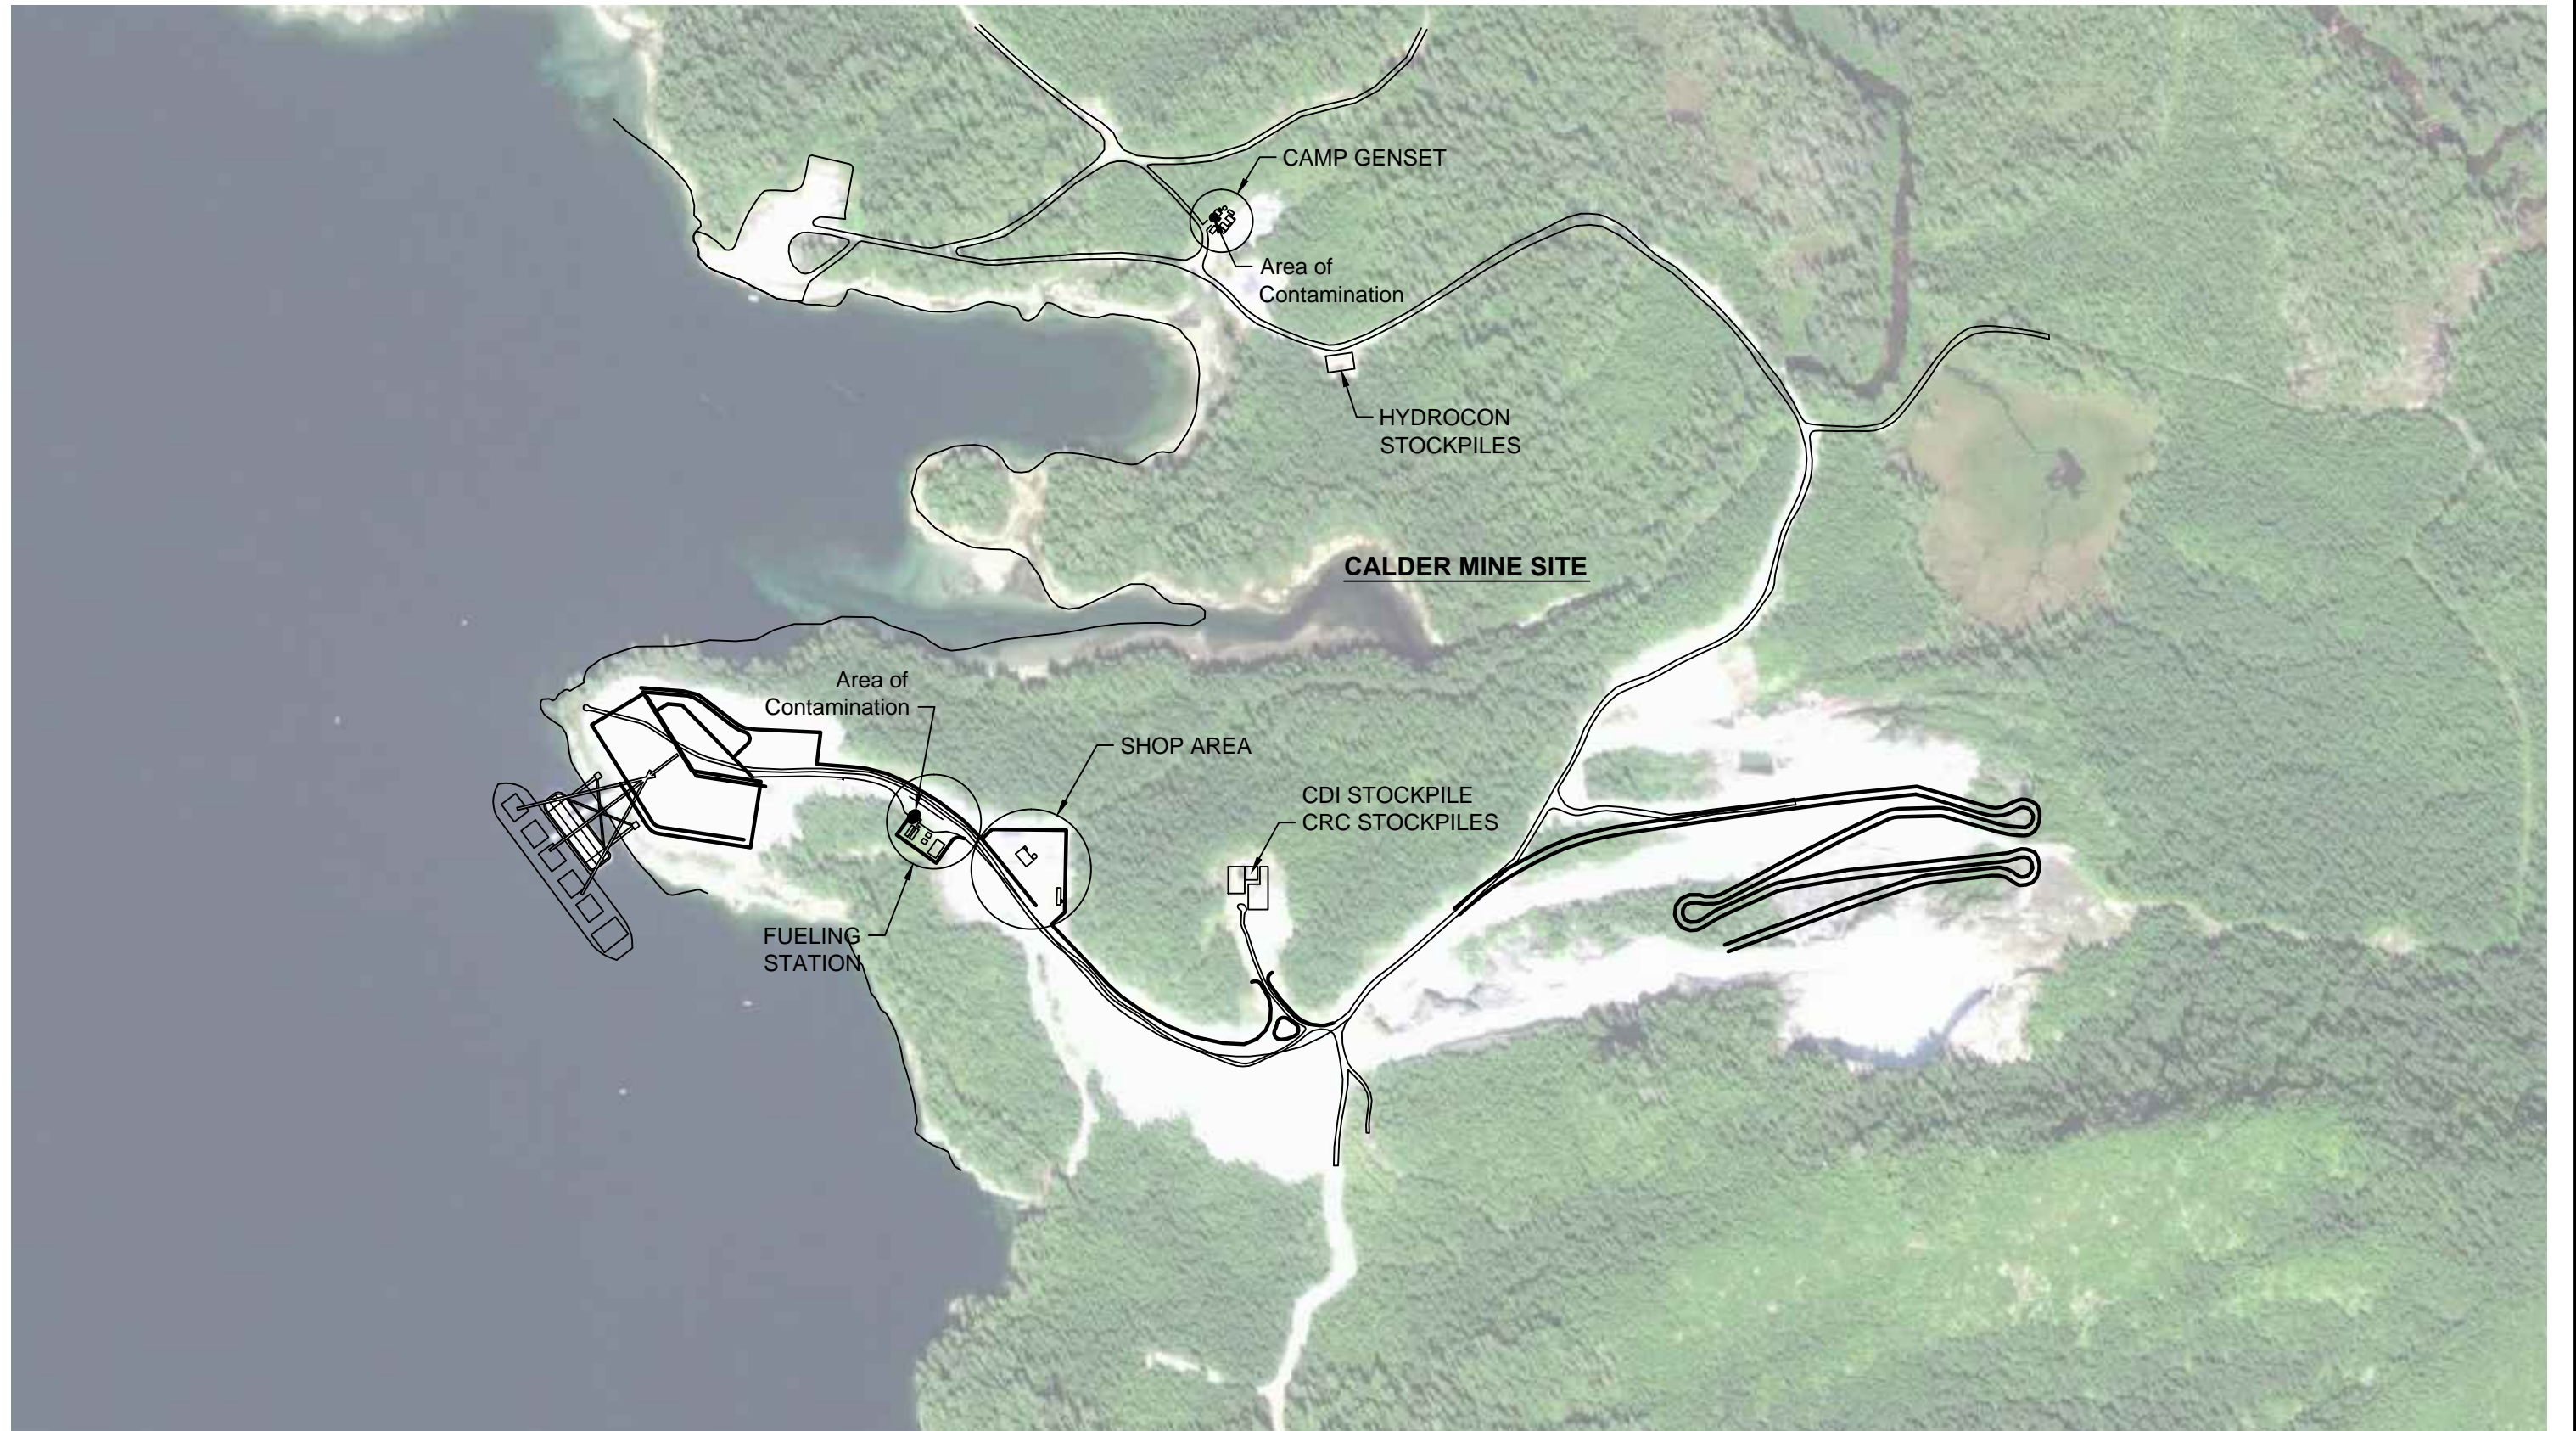
FIGURE 2  
SITE FEATURES

In July 2004, Carson Dorn, Inc. (CDI) conducted a site assessment of the subject site. During the assessment, diesel-contaminated soils were observed adjacent to the Camp Generator, downhill from the two 18,000-gallon diesel aboveground storage tanks (ASTs), also known as the Fueling Station, and in an existing stockpile of soil. CDI also noted the presence of a drum storage area west of the Fueling Station. These and other site features are shown on Figure 2.

All PCS removed from the remedial excavations was transported to the newly constructed Bio Cell area (referred to as the "HydroCon Stockpile") shown on Figure 2. This soil stockpile is located on relatively flat ground with no surface water bodies within 100 feet. Approximately 380 cubic yards of PCS was placed on top of 30-mil geomembrane liners in approximate 3-foot lifts.

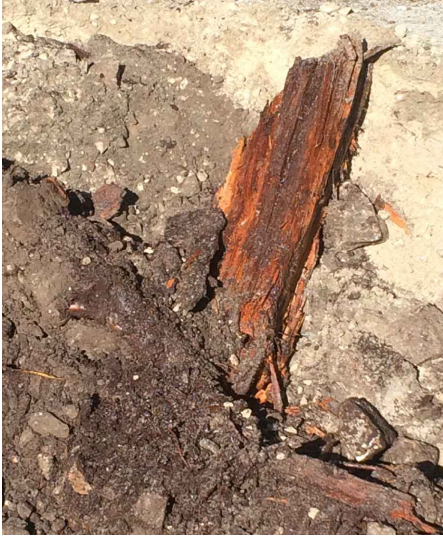
Soil exhibiting strong diesel odor, visible staining and PID readings up to 250 ppm was observed in the excavation. The soil within the excavation was fill consisting of gravel and cobbles in the upper 2 feet. The soil underlying the fill consisted of fine sand and low to medium plastic fines and abundant organic material, wood debris, and logs. Water seeping in from the drainage ditch was observed when the excavation reached a depth of approximately 6 feet bgs. Minimal accumulation of water occurred on the excavation floor and was left in place. The excavation was advanced to a depth of 7 feet bgs.

Photo 1  
Camp Generator Remedial Excavation soil conditions.

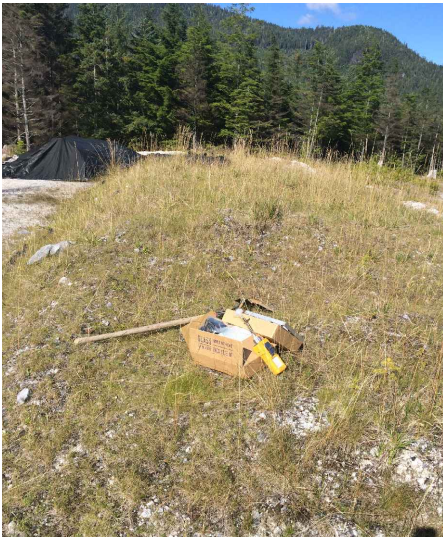
Photo 2  
Calder Stockpile Sampling.

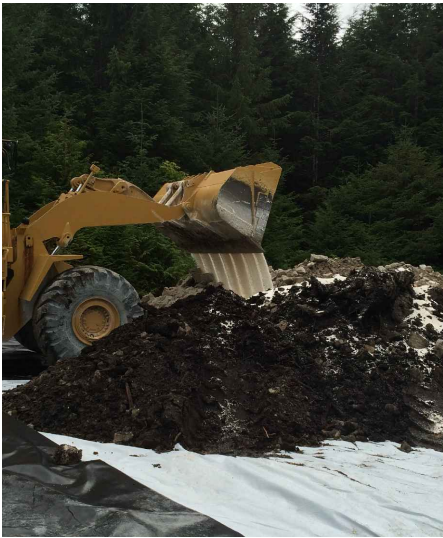
At the completion of remedial excavation the stockpile was fertilized using 1,600 pounds of urea and 400 pounds of phosphorus potassium fertilizer mix. The fertilizer was mixed into the stockpiled soil pile using an excavator bucket.

Photo 3  
HydroCon Stockpile Fertilizer Application.

- Perform monthly tilling using the backhoe bucket as weather allows.
- Place the plastic liner over the stockpile after the conclusion of each tilling event.
- Perform supplemental fertilizer application at the beginning of next summer using the same volume and fertilizer mix as was applied in the first batch.
- Perform confirmation soil sampling next summer.

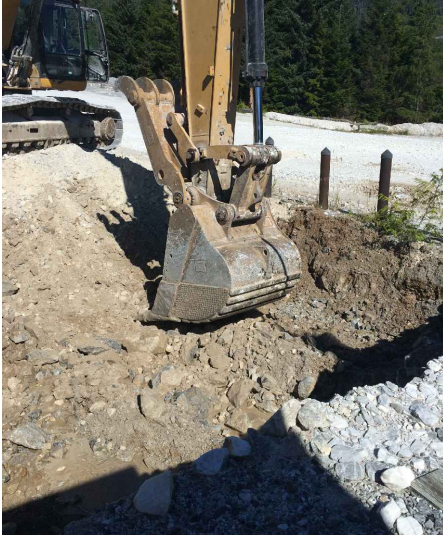
Stained soil was present on the north side of the western-most AST and extended north towards the road used to haul limestone to the crushing area and loading dock. Heavily stained soil that exhibited strong diesel odor, high PID readings (over 500 ppm) were observed in soil down to the maximum depth excavated (7 feet bgs). The composition of the soil in this area of the site was a mixture of sand and fine grained soil and decomposed limestone bedrock. There was no wood, logs, or other organic material observed in this soil. Perched water was encountered at a depth of approximately 7 feet bgs. The extent of the remedial excavation is shown on Figure 4.

Photo 4  
Fueling Station Remediation Excavation.

- Temporarily disconnect the product line that runs from the ASTs to the dispenser to access the PCS to the east.
- Temporarily close the haul road to gain access to the remaining PCS to the south.
- Perform additional remedial excavation to remove the PCS to the west.
- Collect confirmation soil samples from the sidewalls and floor of the remedial excavation to demonstrate removal of PCS below the respective CULs.
- A small pocket of PCS appears to extend under the western-most AST. Moving this tank is not practical. HydroCon recommends leaving this contamination in place.

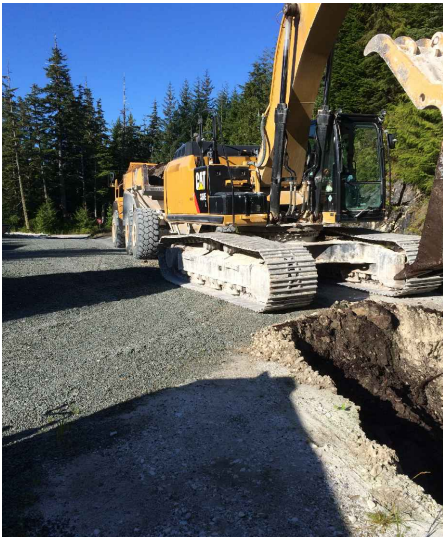
Photo 5  
Camp Generator Remedial Excavation.

- Perform limited remedial excavation near sample locations S2-5 and S8-5.
- Temporarily move the large and small generators to gain access to PCS north and east of the remedial excavation.
- Collect confirmation soil samples to demonstrate removal of PCS above the respective CULs.
