# Remedial Excavation and Soil Sampling Report

Calder Limestone Mine  
Prince of Wales Island, Alaska  
HydroCon Project Number: 2015-010

Prepared for:  
Columbia River Carbonates  
P.O. Box 2350  
Woodland, Washington 98674

May 26, 2016

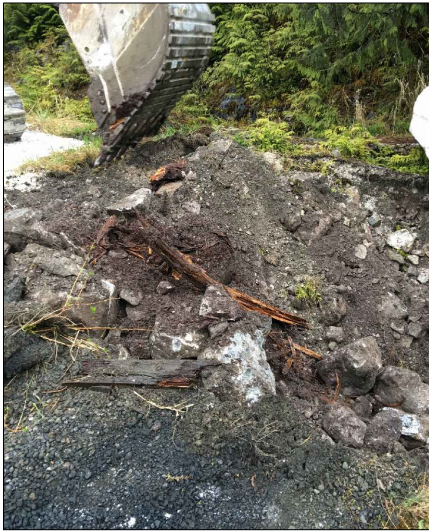
PHOTO 1  
View of supplemental remedial excavation, facing north. Notice significant wood debris.

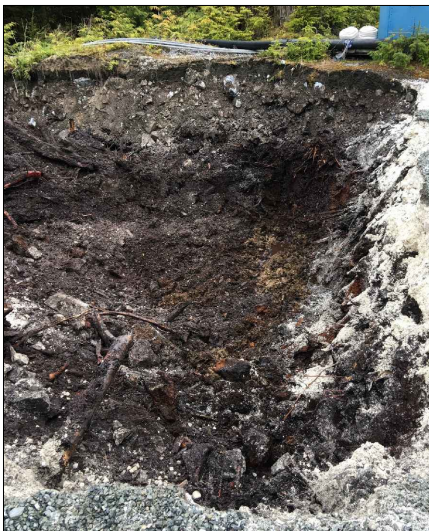
PHOTO 2  
View of southern (right side of photo) and western excavation events. Note proximity of blue water supply treatment conex(R) (blue in upper right corner).

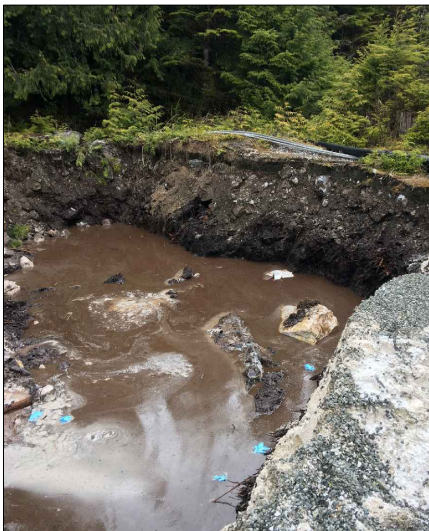
PHOTO 3  
Perched water (trapped in voids of initial excavation pit) entered the excavation as it was expanded southwest.

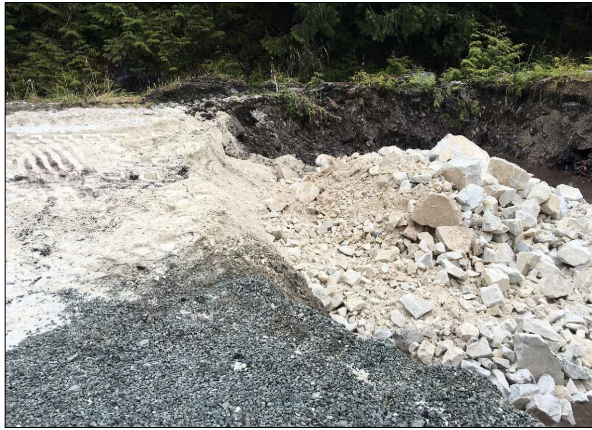
PHOTO 4  
View of excavation being backfilled.

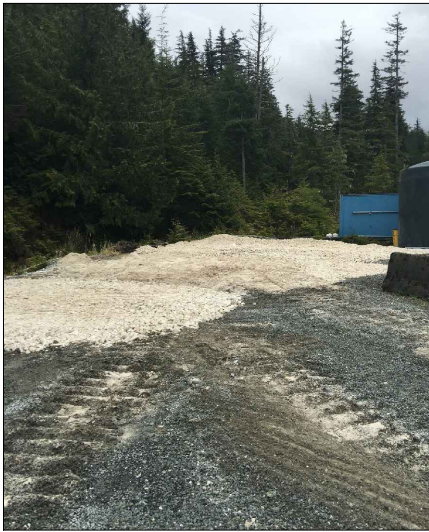
PHOTO 5  
View of excavation completely backfilled. Note close proximity of backfilled excavation to water supply treatment conex(R) (blue) and water supply storage tank (black).

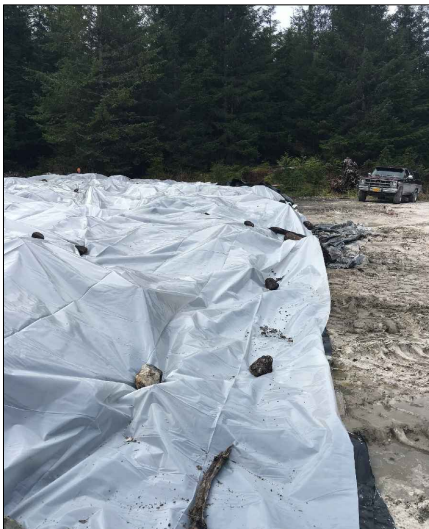
PHOTO 6  
Typical view of "HydroCon stockpile covered with plastic.

- Monthly tilling of the stockpile should be completed, using the backhoe bucket, as weather allows.
- Place the plastic liner over the stockpile after the conclusion of each tilling event.
- Perform confirmation soil sampling at the end of the summer 2016. Based on the volume of the stockpile, a total of 44 samples should be collected. See Appendix C for specific details regarding stockpile sampling.
- Should the results of the sampling indicate concentrations still exceed ADEC CULs, a supplemental fertilizer application (using the same volume and fertilizer mix as was applied in the first batch) should be completed in the Spring 2017 followed by monthly tilling. Confirmation soil sampling will be performed in the end of summer 2017.
