Supplemental Site Characterization and Soil Stockpile Sampling

Calder Limestone Mine

Prince of Wales Island, Alaska

HydroCon Project Number: 2015-010

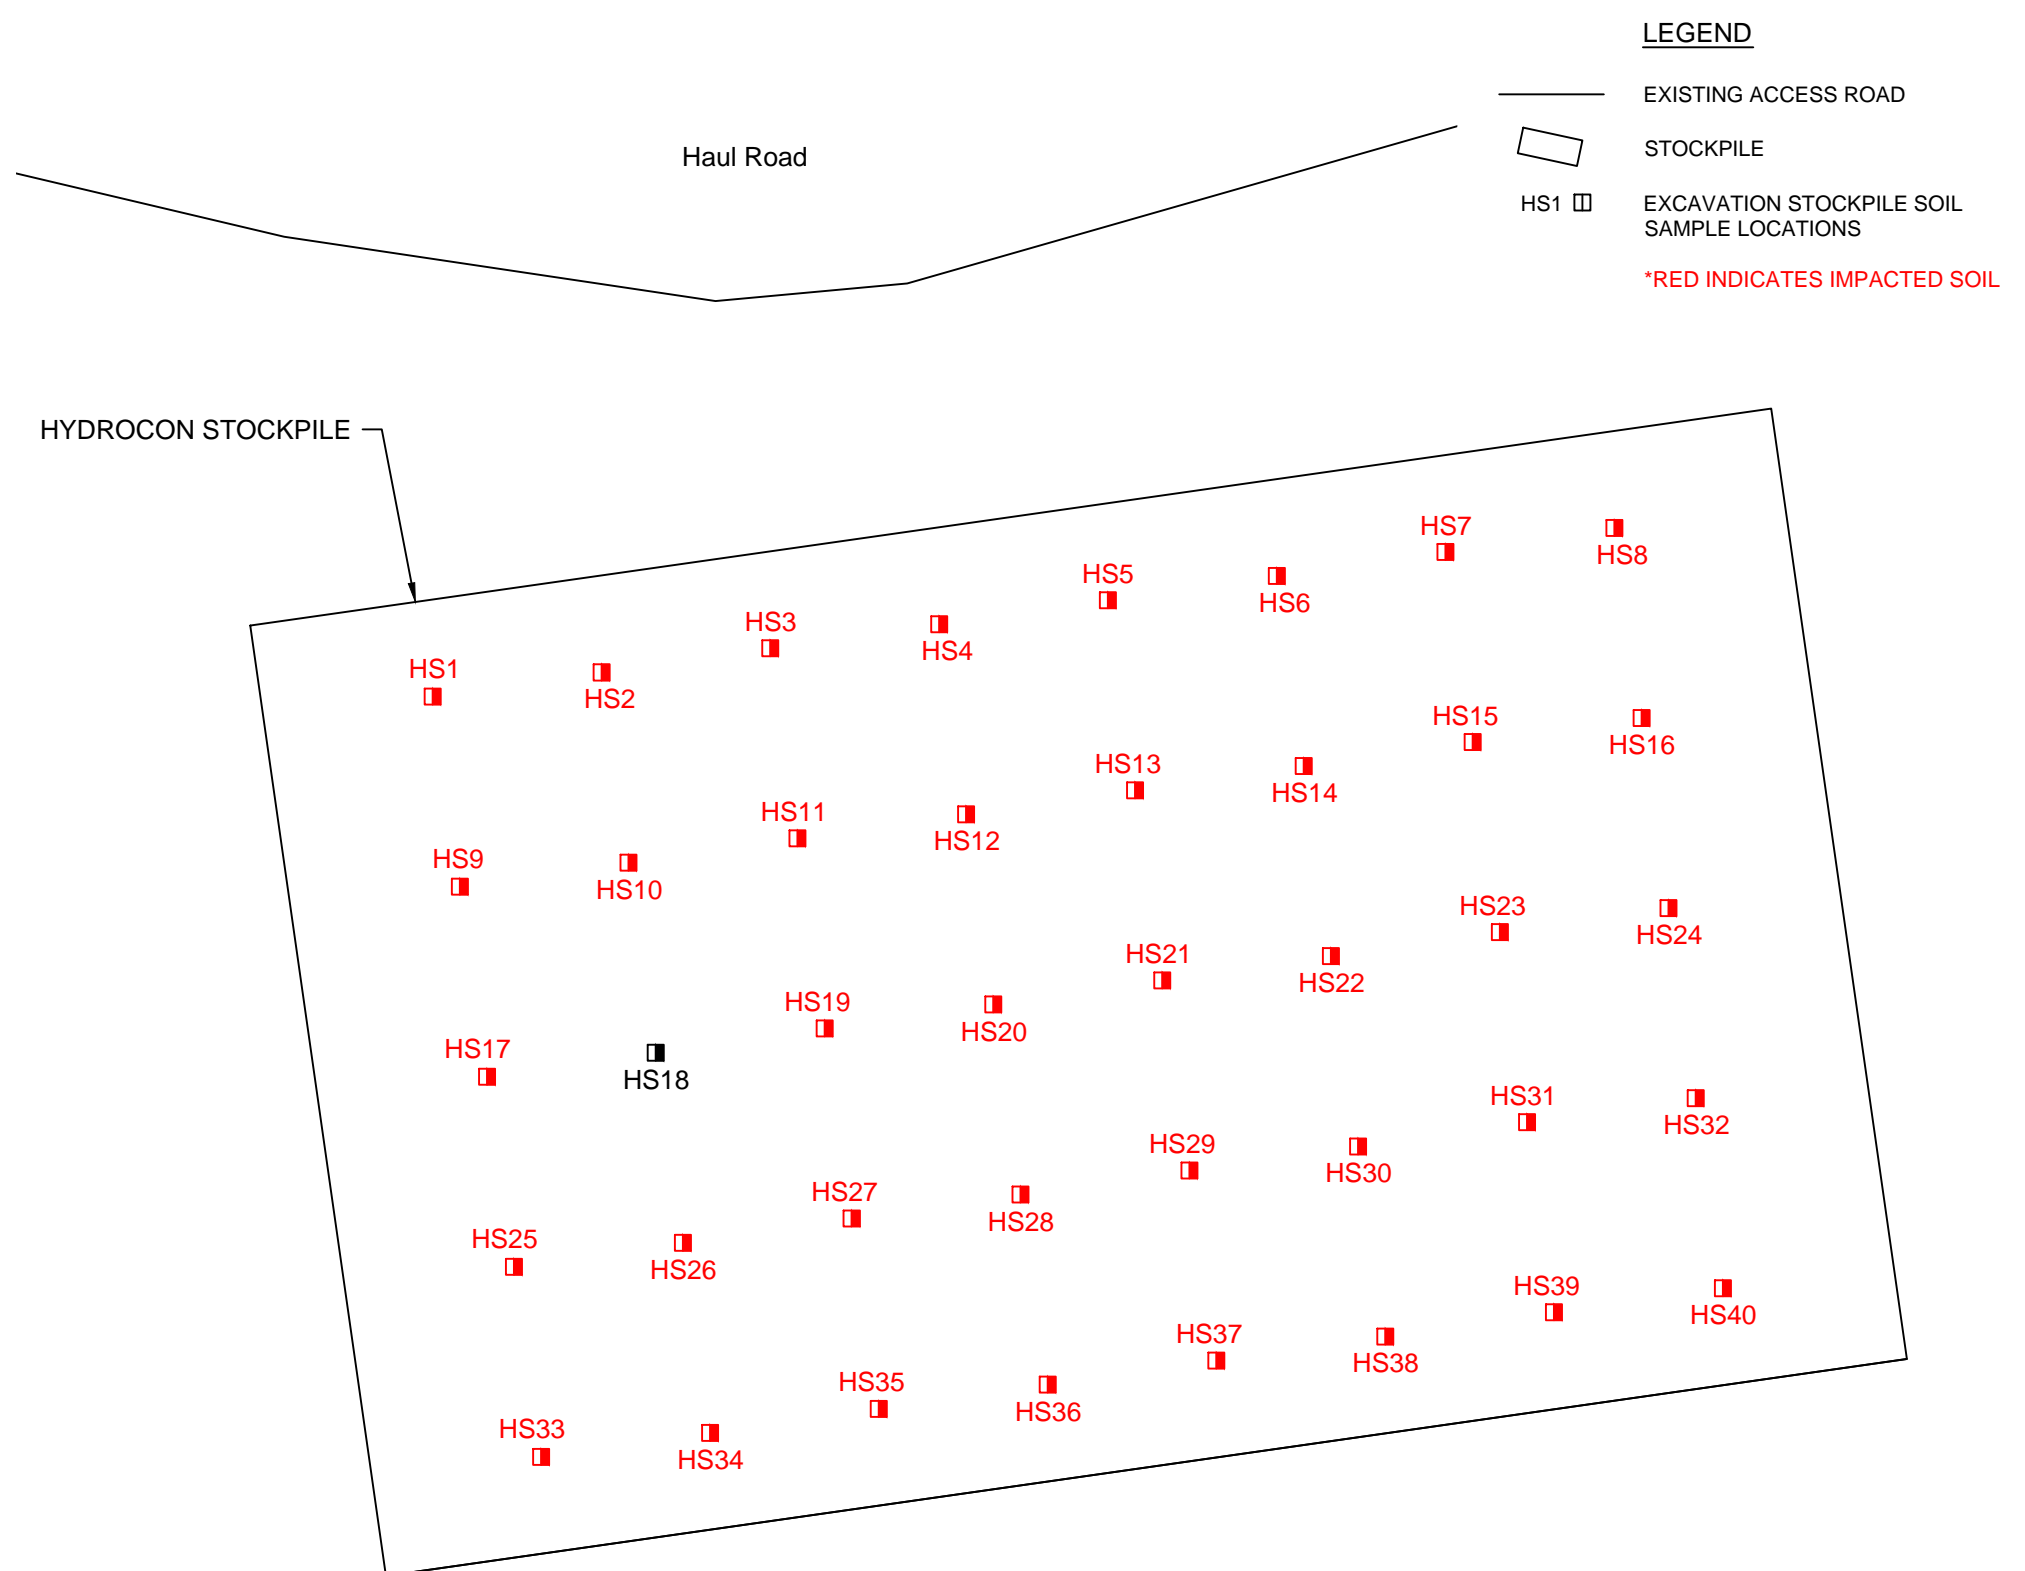
FIGURE 5
 HYDROCON STOCKPILE
 SAMPLE LOCATIONS
 CALDER MINE
 PRINCE OF WALES ISLAND
 ALASKA

The composition of the soil includes a mixture of cobbles and boulders along with granular and fine grained soil along with abundant wood debris. HydroCon collected forty soil samples from the stockpile (HS-1 through HS-40). Four samples (HS-1, HS-12, HS-26, and HS-40) were analyzed for BTEX (Figure 5).

Soil analytical results indicated that all but one sample (HS-18) exceeded the CUL for DRO. There was no detection of BTEX above the laboratory's MRLs in the four samples analyzed. Results are shown on Figure 5.

This was the first sampling event of the HydroCon Stockpile. The concentration of DRO in the stockpile remains above the cleanup level. As a result, HydroCon recommends the following actions:

- A supplemental fertilizer application should be applied. The stockpile is approximately 400 cubic yards in size. Therefore, approximately 1,600 pounds of Urea and 400 pounds of phosphorus potassium blend should be applied to the stockpile.
- Monthly tilling of the stockpile should be completed during the mining season, using the backhoe bucket, as weather allows.
- Place the plastic liner over the stockpile after the conclusion of each tilling event.
- Perform confirmation soil sampling in the summer 2017.

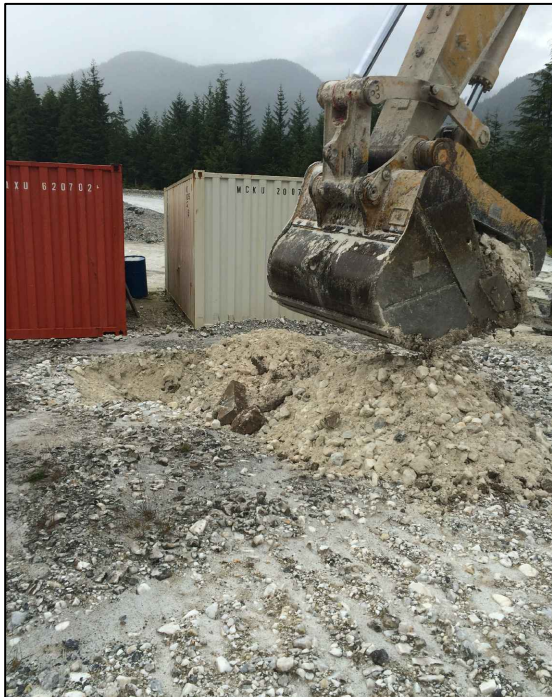
PHOTO 2
Test Pit TP-3.

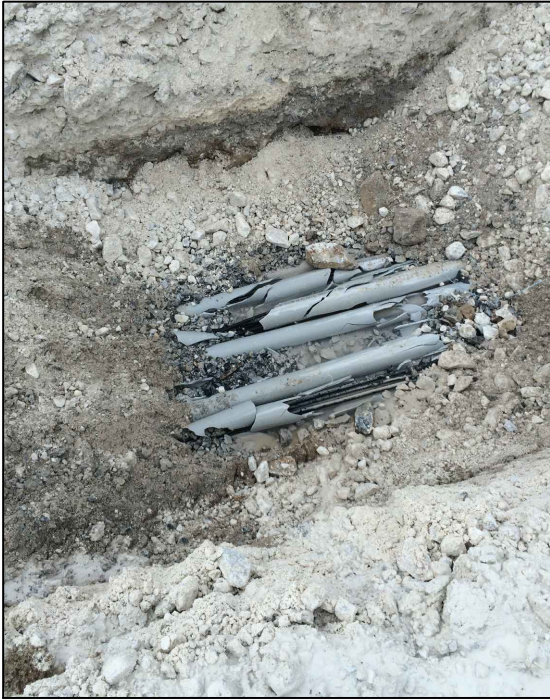
Results of the field screening indicated that a faint petroleum hydrocarbon odor was observed in soil excavated from test pits TP-2 and TP-4. A PID reading above 1 ppm was observed in two soil samples (4.0 ppm in sample TP2-3 and 2.0 ppm in sample TP4-4).

PHOTO 3
Test Pit TP-2. Buried power lines
encountered during excavation.

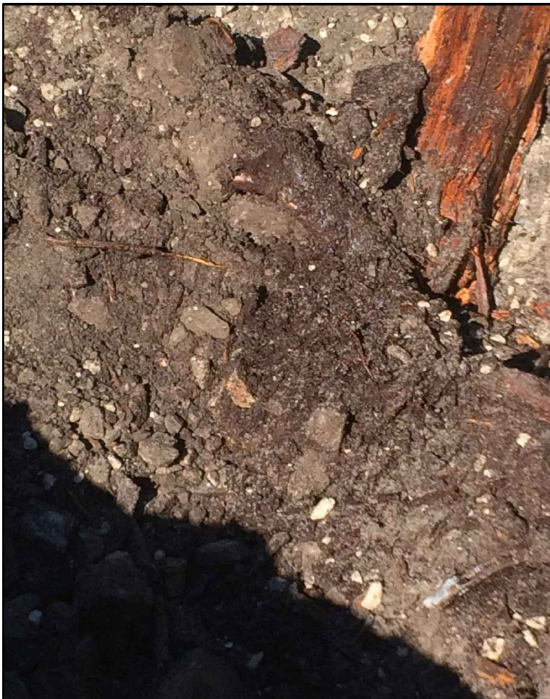
PHOTO 4
Hydrocon Stockpile.
Abundant wood debris in stockpile.

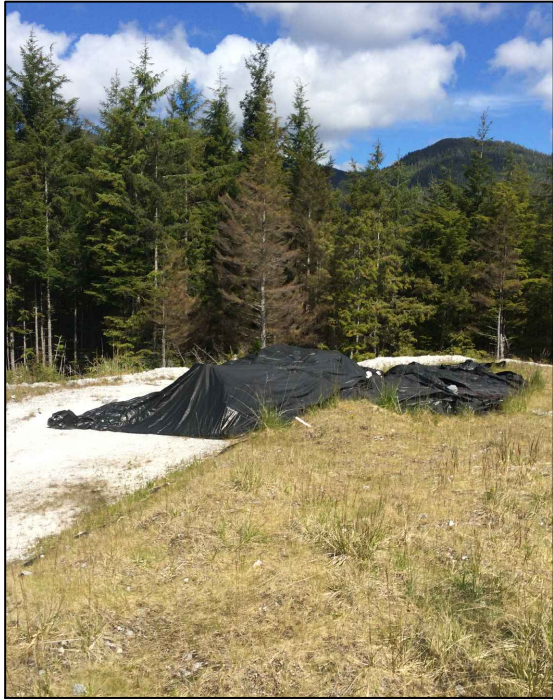
PHOTO 5
CDI Stockpile
