# Soil and Groundwater Sampling Report - 2018

Calder Limestone Mine

Calder Bay, Prince of Wales Island, Alaska

Hazard Identification Number 4069

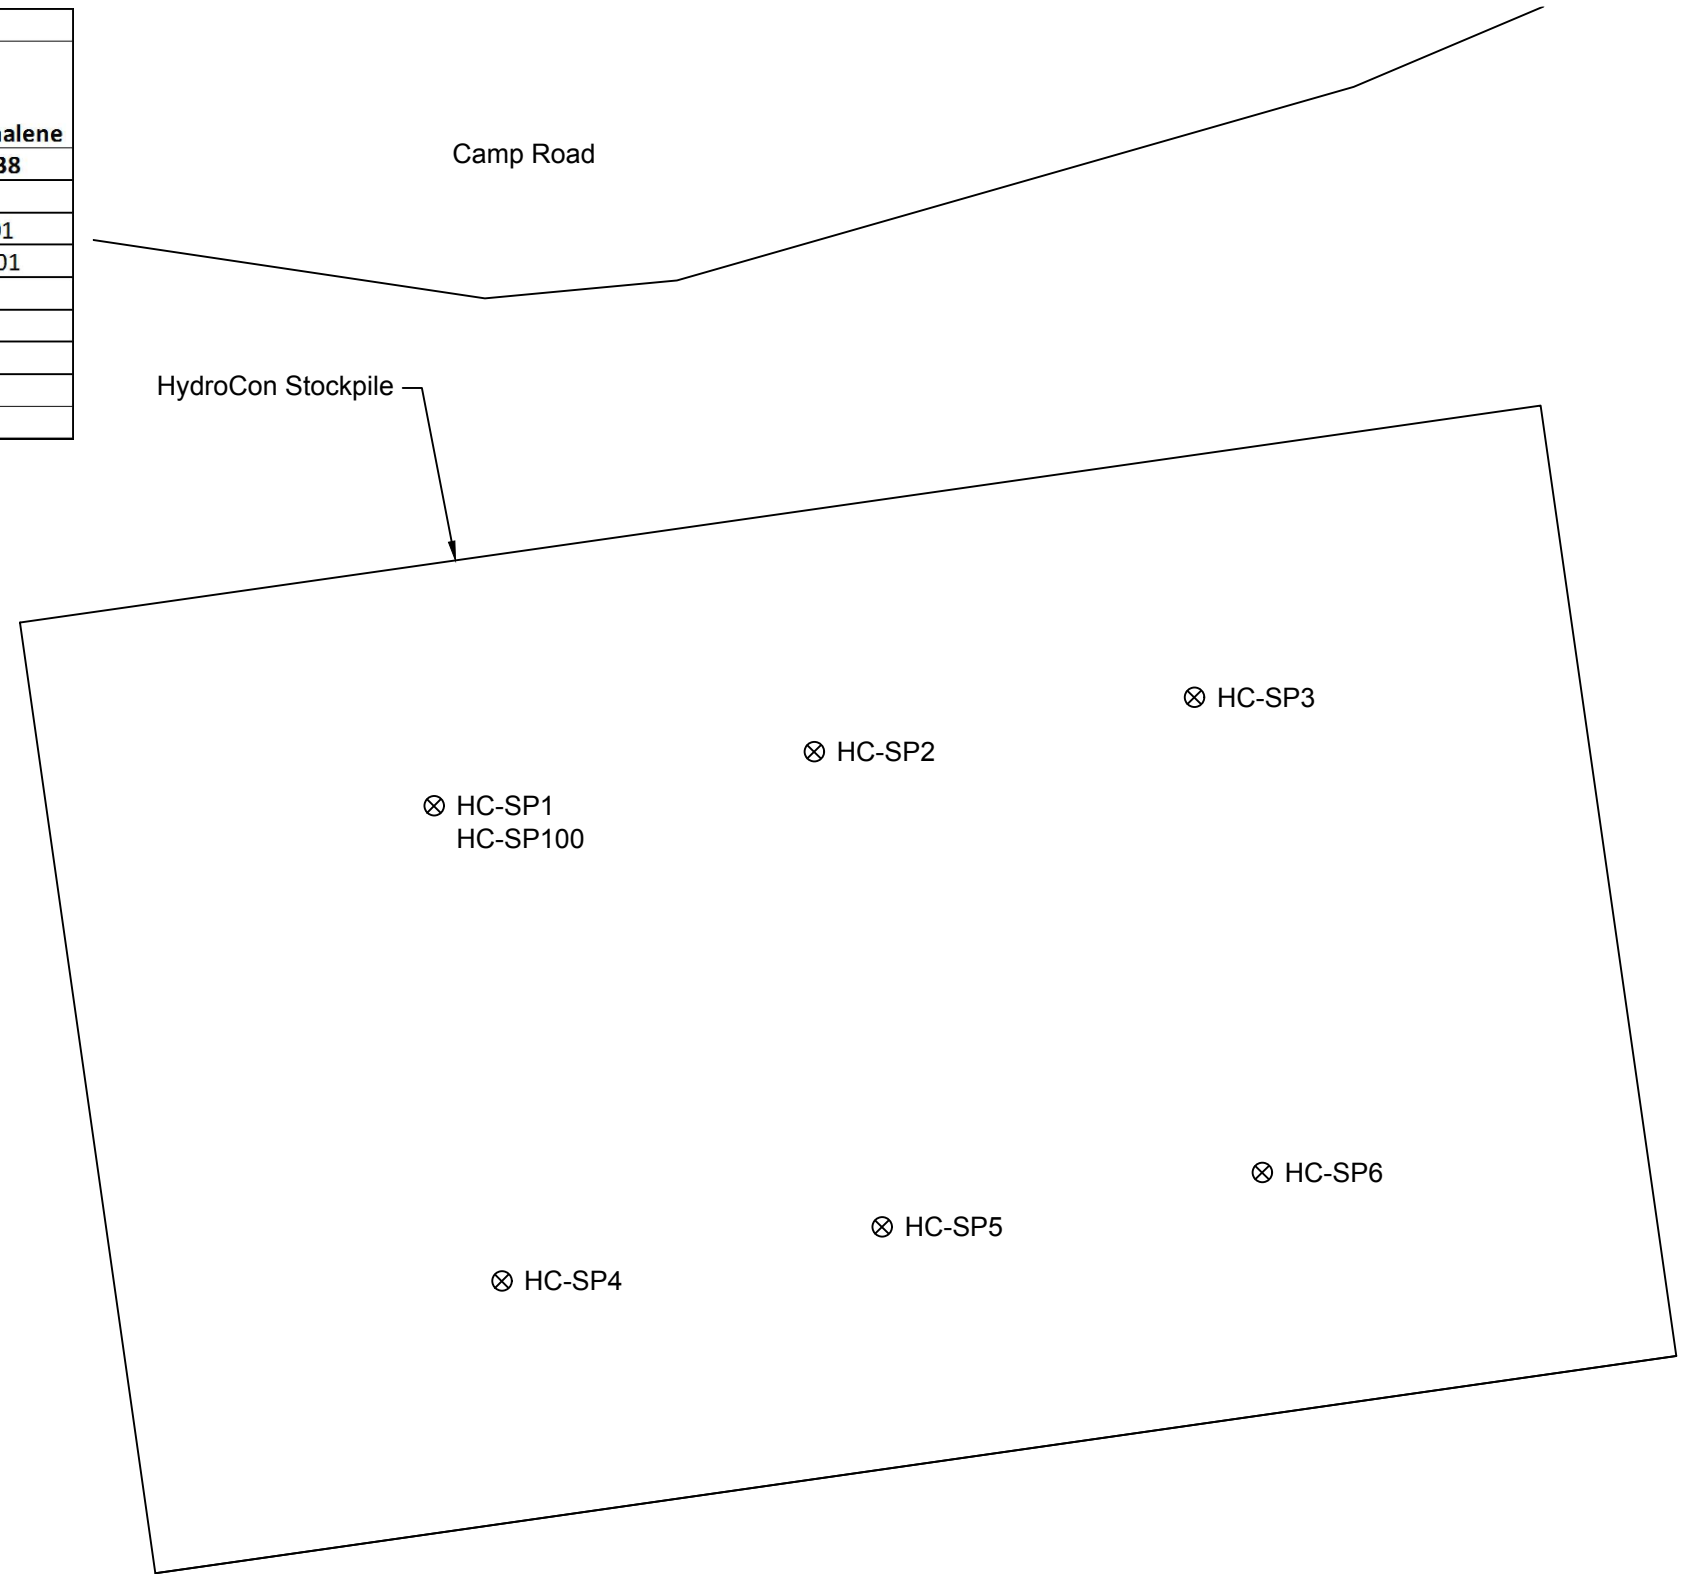
FIGURE 7  
 HYDROCON STOCKPILE  
 SAMPLE LOCATIONS  
 CALDER MINE  
 PRINCE OF WALES ISLAND  
 ALASKA

Each sample collected from the HydroCon stockpile had DRO ranging from 220 to 460 mg/kg. Six of the seven samples had DRO concentrations that slightly exceeded the ADEC Method 2 cleanup level. It should be noted that a significant reduction in DRO concentrations was seen in this stockpile compared to the previous sampling results. RRO was detected in each sample at concentrations ranging from 170 to 440 mg/kg. These concentrations are well below the ADEC Method 2 cleanup level. Very low concentrations of naphthalene, phenanthrene, and pyrene were detected in the two samples submitted for PAH analysis. All of the PAH compounds that were detected above their respective MRL in the samples were below their respective ADEC Method 2 cleanup level.

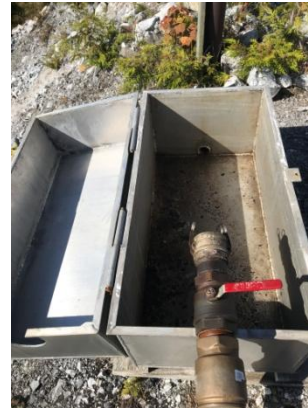
**Photo #2** Header Spill Containment

**CS11** – This sample was collected on the western end of the fuel header. A large stainless containment box has been constructed to capture minor spills that may occur during fueling. The historic sample collected at this location was named Fuel Header. The soil in this location is composed of compact sandy gravel fill. The native material in this area of the site is limestone bedrock. There was no field indication of contamination present with a PID reading of 0.8 ppm. A soil sample (CS11-1) was collected at approximately 1 foot bgs. The sample was submitted for DRO and RRO analysis.

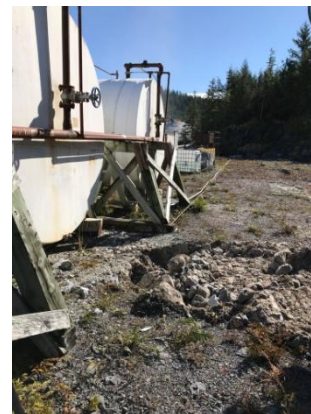
**Photo #6** CS6 Sample Location

**CS6** – This sample was collected on the south end of the western-most 18,000 gallon AST. The historic sample collected at this location was named Twin AST-2. The soil in this location is composed of sandy gravel with silt fill. The native material in this area of the site is limestone bedrock. There was field indication of contamination from ground surface to approximately 1 foot bgs including slight petroleum staining, faint odor, and a PID reading of 3.7 ppm. A soil sample (CS6-1) was collected at approximately 1 foot bgs. The sample was submitted for DRO and RRO analysis.

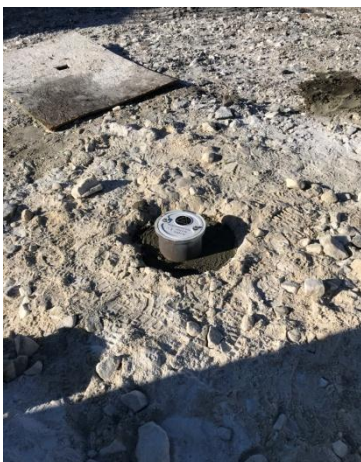
**Photo #11** Monitoring Well MW-1

Groundwater analytical results indicate that the concentration of DRO exceeds the ADEC Method 2 cleanup level. The majority of soil contamination at the Fueling Station area has been removed by remedial excavation. However, residual contamination was left in place due to the presence of the ASTs, product lines, and dispenser pump. This is the likely source of groundwater contamination observed in MW-1.

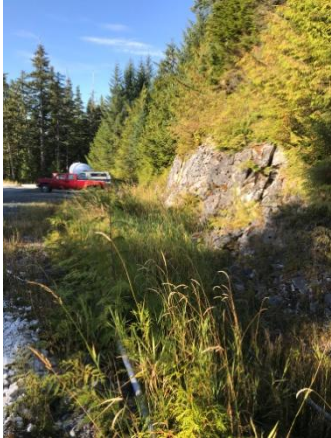
**Photo #19** Drainage Ditch in Camp Area  
SW-1 Sample Location

HydroCon collected a surface water sample from the drainage ditch that's located north of the remedial excavation at the Camp Generator area. Laboratory prepared bottles were filled by submerging the sample container under the water line until the bottle was full. A new pair of gloves was used to collect the sample. It should be noted that the water level in the drainage ditch was low and some sediment entered the duplicate sample bottle during sample collection.
