2021 Site Investigation Report – **DRAFT Final**

Calder Limestone Mine

Calder Bay, Prince of Wales Island, Alaska

Hazard Identification Number 4069

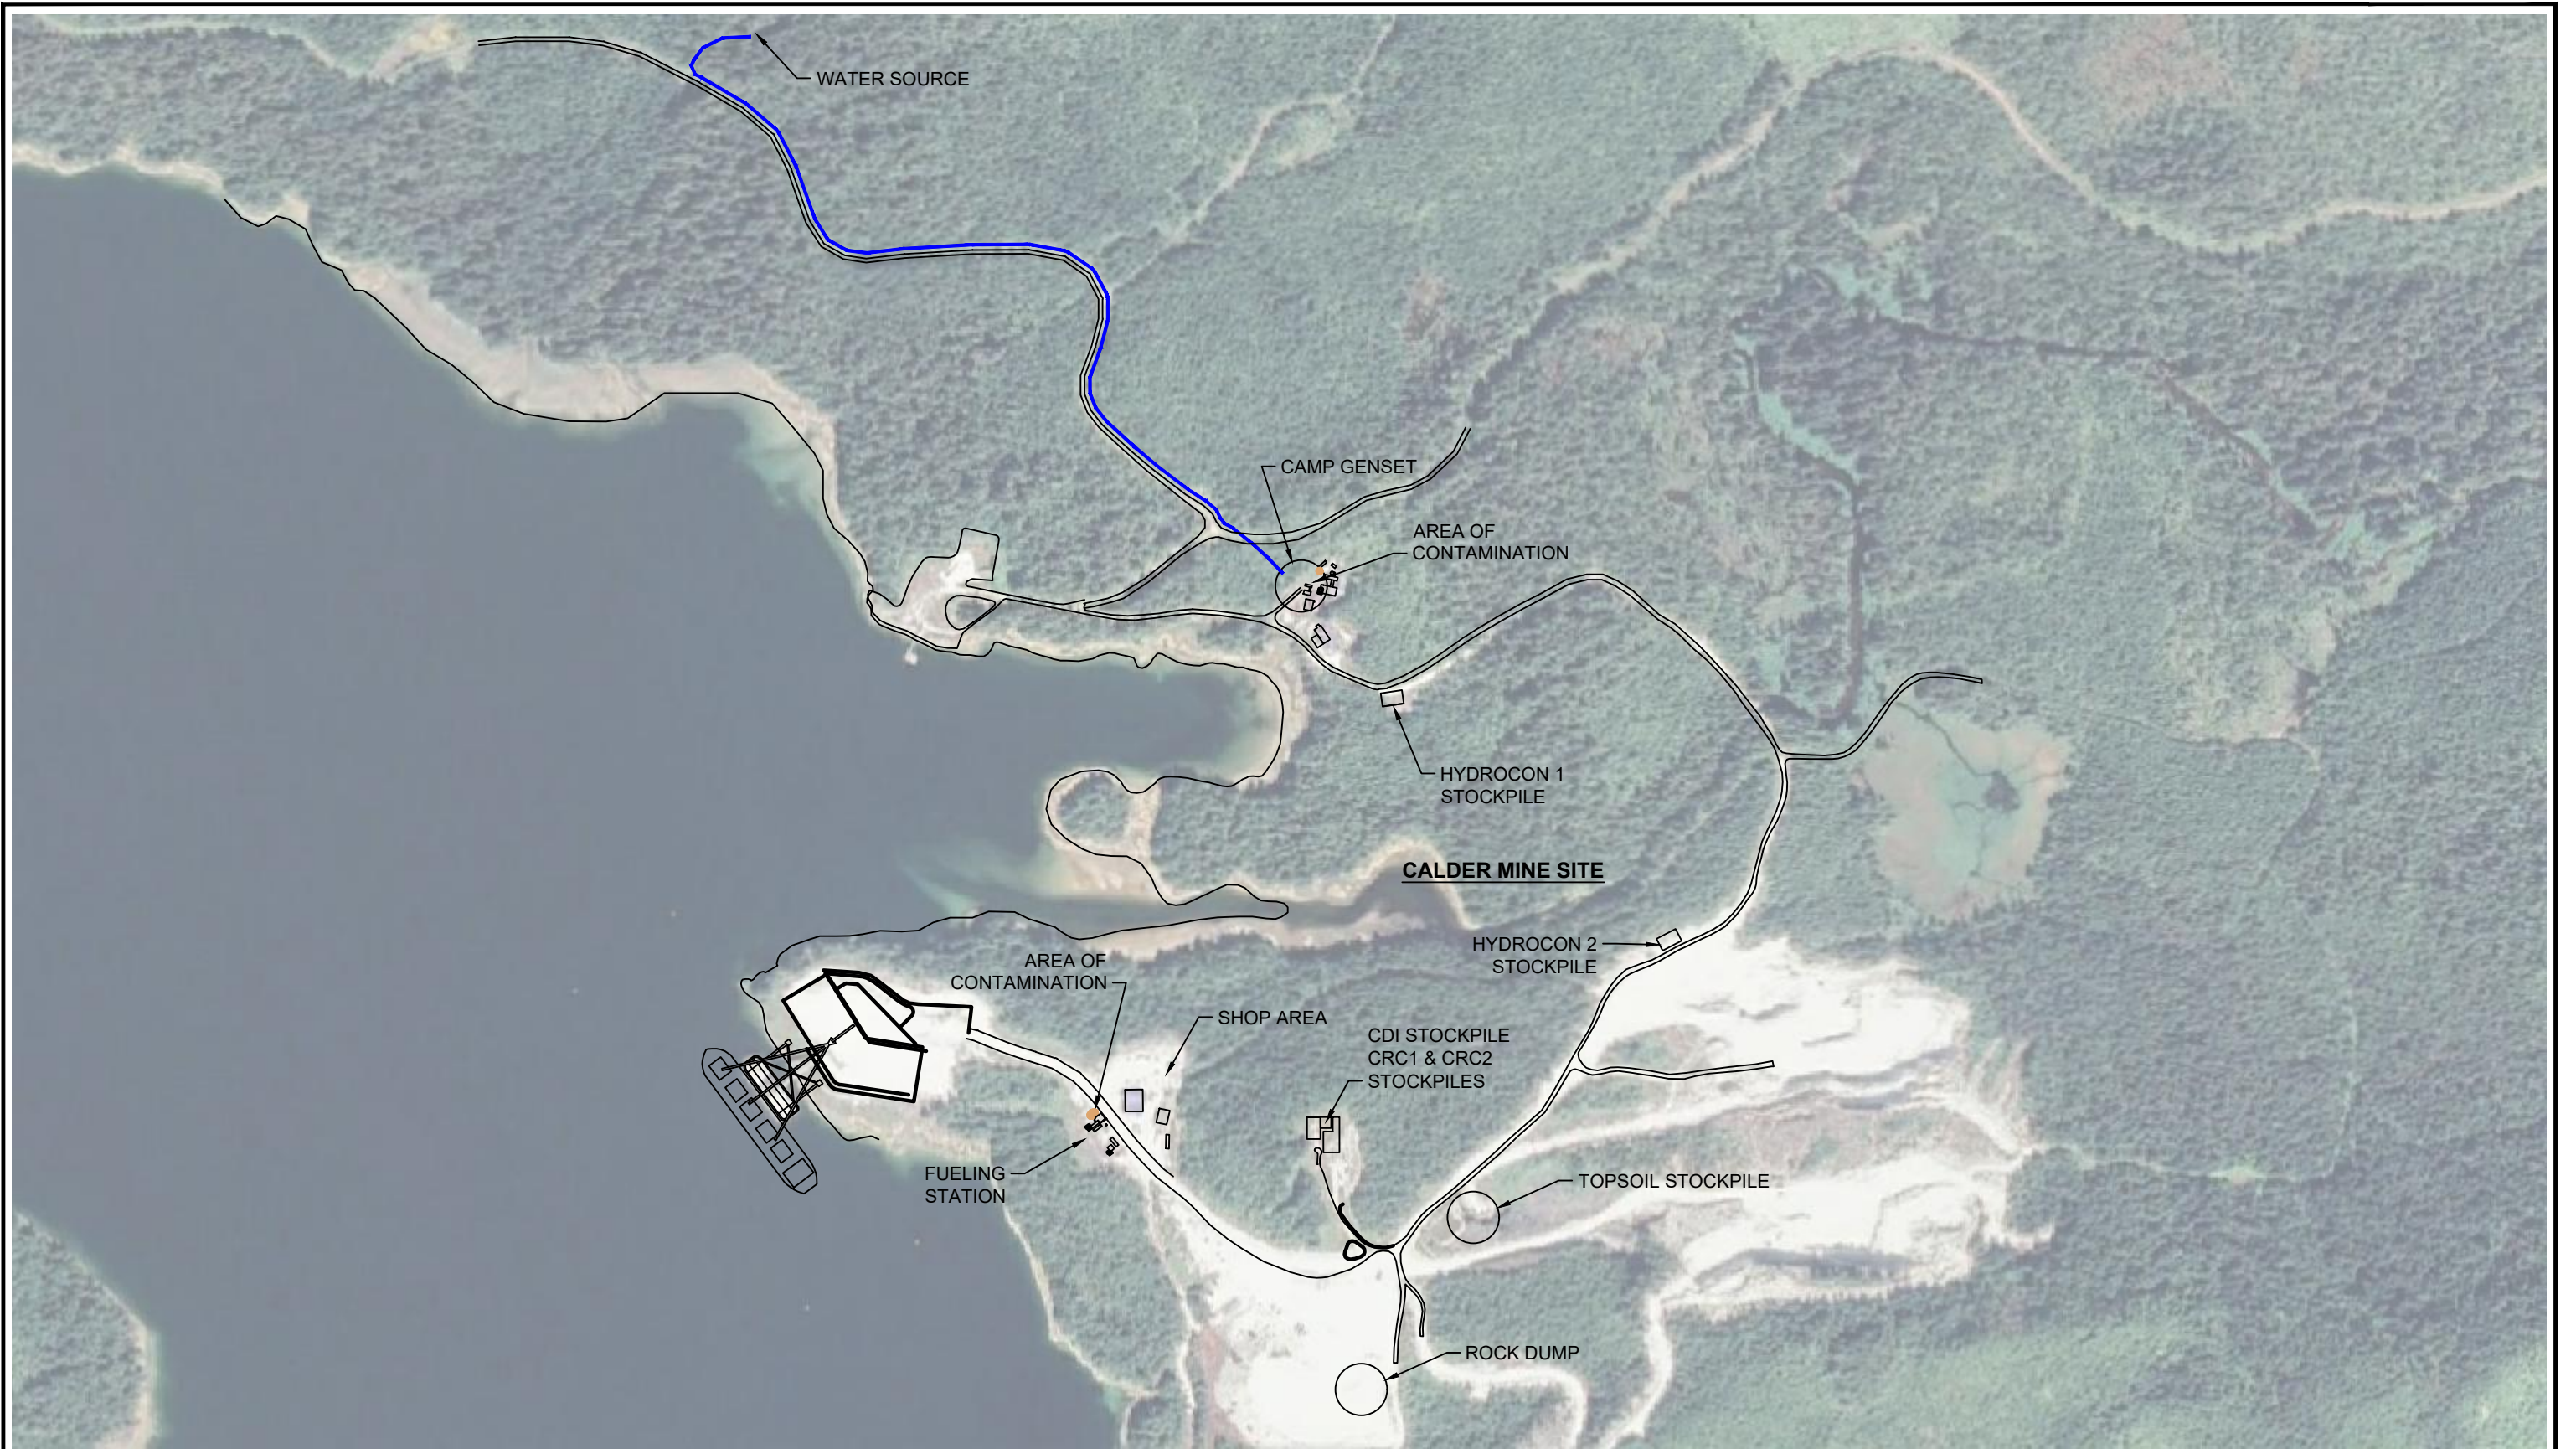
FIGURE 2
SITE FEATURES

The site is located in the northwest portion of the Prince of Wales Island in Alaska (Figure 1). It is currently operating as a calcium carbonate mine, owned and operated by Columbia River Carbonates (CRC). The site includes an open-pit calcium carbonate mine, loading/barge area, fueling station, shop area, and camp site. Additional site improvements include gravel access roadways, diesel power generators, and a potable water storage/treatment system (Figure 3).

The potable water supply for the site comes from a spring located in the uplands above the Camp area (Figure 2). Water from the spring is routed via piping to a water treatment system consisting of poly storage tanks and a filtration system prior to use at the Camp. The location of this system is shown on Figure 3.

In July 2004, Carson Dorn, Inc. (CDI) conducted a site assessment of the subject site. During the assessment, diesel contaminated soils were observed adjacent to the Camp Generator, downhill from the two 20,000-gallon diesel aboveground storage tanks (ASTs), also known as the Fueling Station, and in an existing stockpile of soil. CDI also noted the presence of a drum storage area west of the Fueling Station. These and other site features are shown on Figure 2.

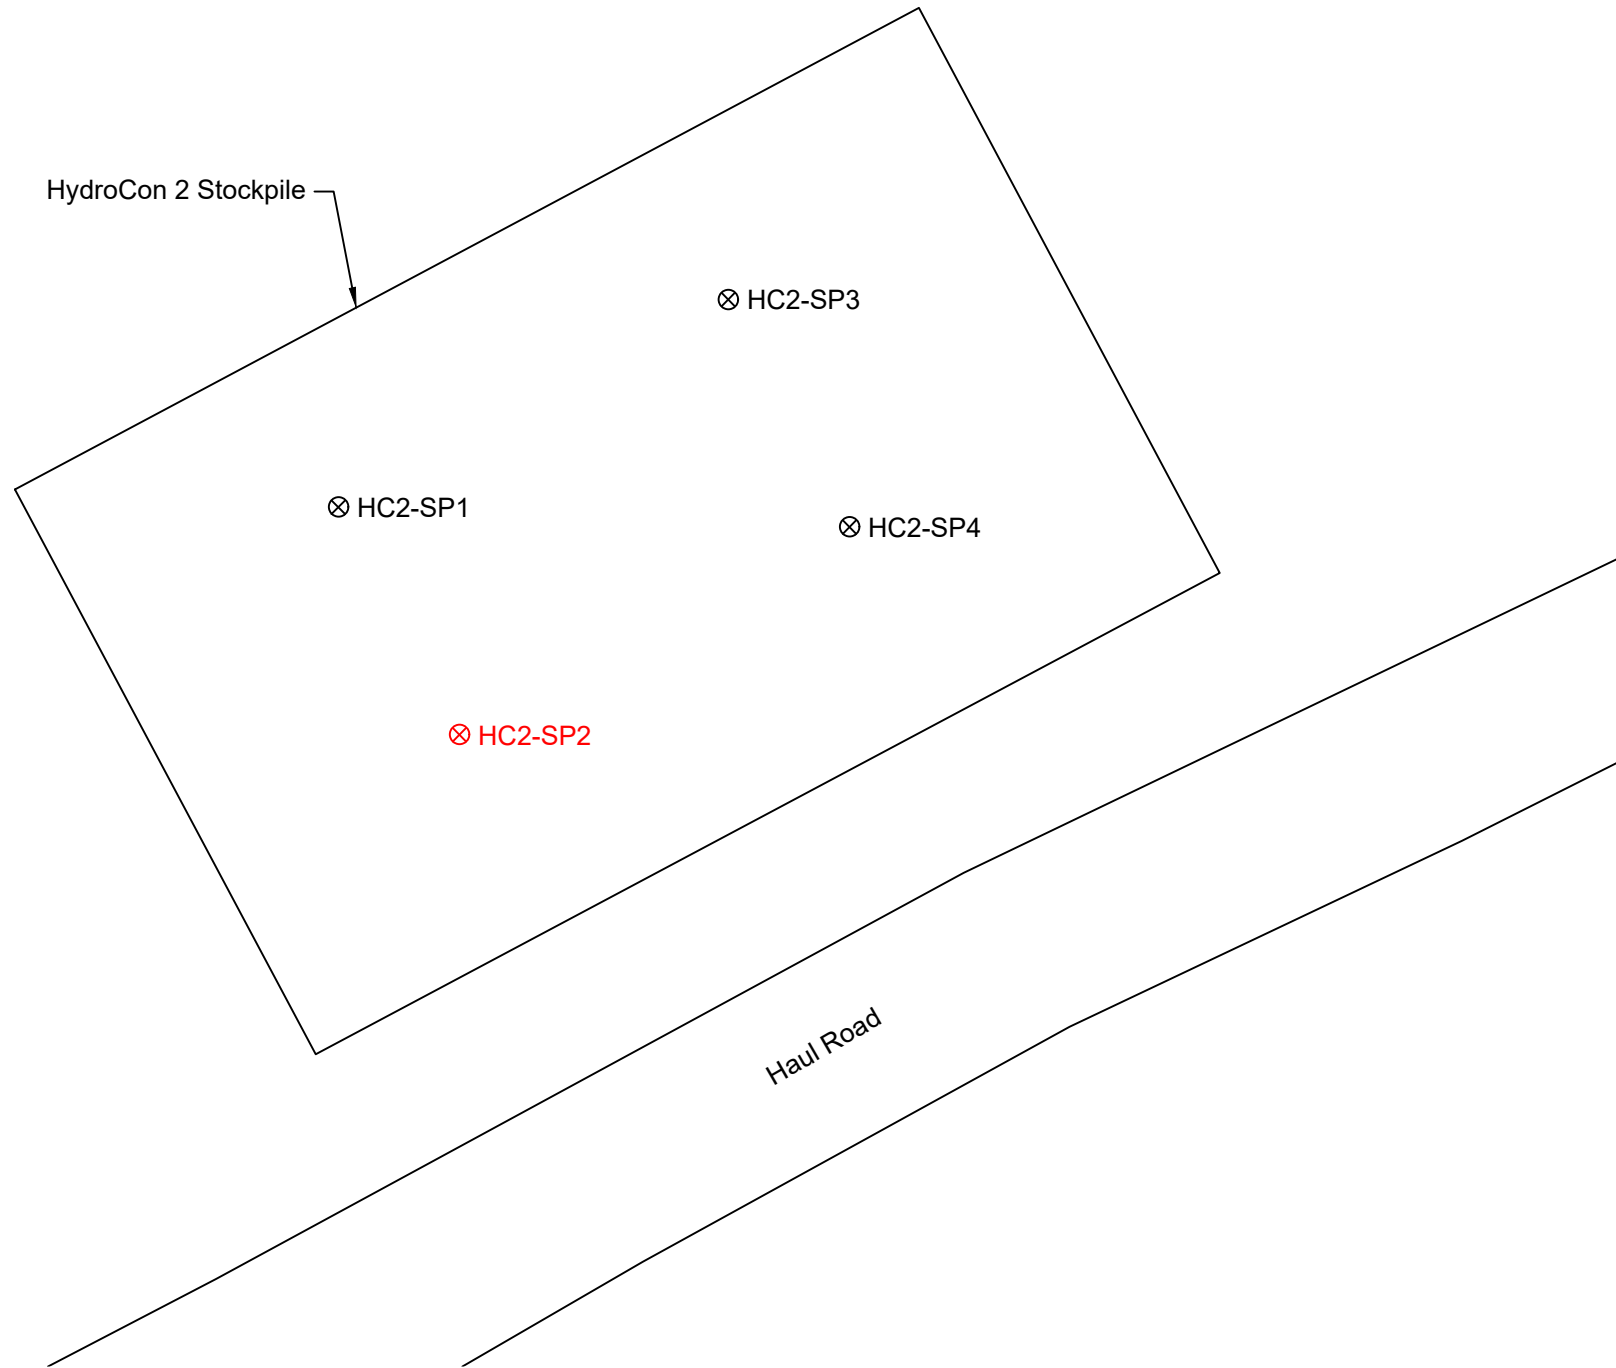
HydroCon collected soil samples from the active stockpile (HydroCon2) to assess remediation progress (Figure 5). Field screening using a PID was performed to assess potential areas of elevated contamination (i.e., “hot spots”). Each stockpile was potholed at approximate 10-foot intervals using a shovel and PID measurements were taken. Results of the field screening indicated that PID readings ranged from 1.0 to 3.2 ppm. It should be noted that fertilizer was observed in the stockpiled soil and may be responsible for some of the PID readings. Results of the screening are documented in the field notes (Attachment B). Soil samples were collected at approximately 1-foot bgs using a clean shovel. A new pair of nitrile gloves were used to place the samples into the laboratory prepared glass sample jars. A duplicate sample (HC2-D) was collected from the HC2-SP3 location.

Soil Analytical Results (mg/kg)				
		AK 101	AK 102	AK103
Field ID	Date	GRO	DRO	RRO
ADEC Method 2 - Over 40" Zone		230	230	9,700
HydroCon2 Stockpile				
HC2-SP1	9/29/2021	<5	160 x	390
HC2-SP2	9/29/2021	<5	440	79 x
HC2-SP3	9/29/2021	<5	28	<25
HC2-D (Dupe HC2-SP3)	9/29/2021	<5	25	<25
HC2-SP4	9/29/2021	<5	69 x	140

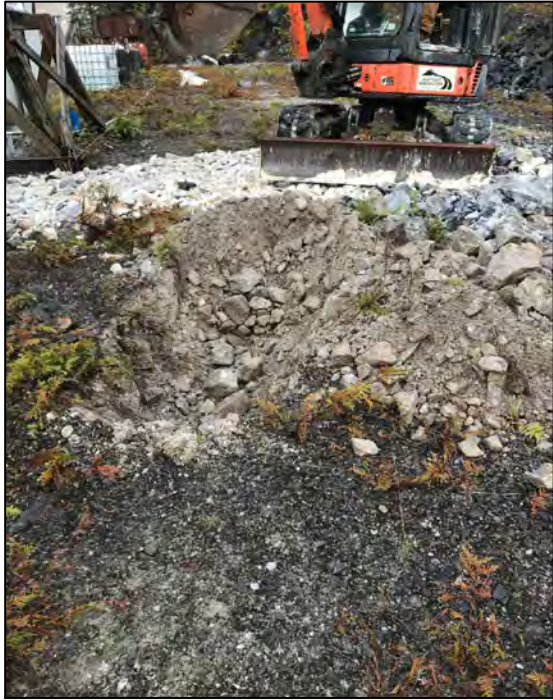
PHOTO 1
CS 6 Remedial Excavation.

In 2021, HydroCon successfully removed the remaining accessible contamination at the site (CS-6). Three groundwater monitoring wells (MW-4 through MW-6) were installed in the Camp Area to assess groundwater conditions. Groundwater samples were collected from each well and analyzed for a thorough list of analyses. Analytical results indicated that low concentrations of DRO and five SVOCs below their respective CULs were detected in one or more of the samples. This indicates that the remedial excavations performed in the Camp Area has been successful at protecting groundwater. Although there are some localized soil sampling locations that have contamination above the CUL and are inaccessible to excavation, they are not adversely affecting groundwater quality.

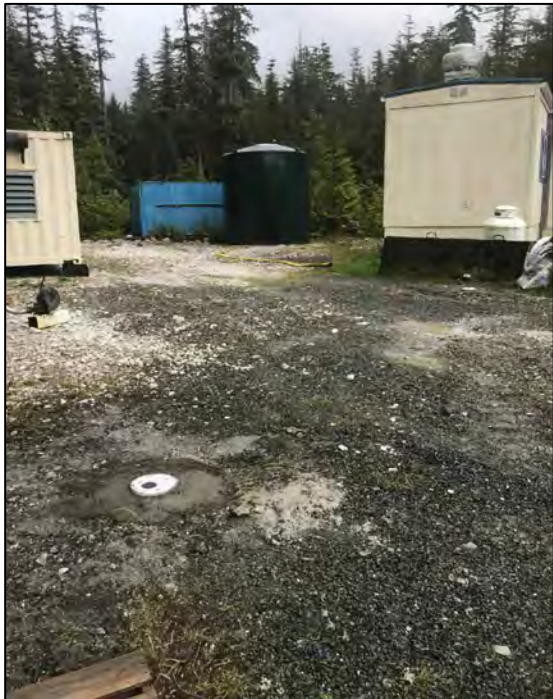
PHOTO 2
MW-4 & MW-5.

On September 28, 2021 three wells (MW-4 through MW-6) were installed at the site using the air rotary drilling method. Each boring was drilled to a depth of approximately 14 feet bgs. Since remedial excavation and extensive soil sampling has been performed in this area no soil samples were collected for laboratory analysis. Drill cuttings were examined continuously during the drilling process for lithologic identification, field screening purposes and moisture observation.

Each boring was completed as a 2-inch diameter monitoring well. The wells are constructed with a 10-foot length of 0.010-inch slotted pre-packed well screen, a threaded bottom cap, and 2-inch diameter solid PVC well casing. Graded (8-12) silica sand was used as a supplemental filter pack to the pre-packed well screen (which is constructed with a stainless-steel mesh screen filled with graded silica sand over the entire length of the well screen). The mesh screen is attached to the well screen section by stainless steel fittings. The filter pack was placed from the bottom of the borehole to approximately 1 foot above the top of the well screen. Hydrated bentonite seal was placed from the top of the sand pack to 1-foot bgs. A flush-grade monument was cemented in place over the top of each well.
