**SITE RECONNAISSANCE
REPORT**

**LIME VILLAGE, ALASKA
*DRAFT***

**Contract No. 18-5001-10
Project No. 22044**

Prepared for:
**Alaska Department of Environmental Conservation
Aboveground Storage Tank Program
410 Willoughby Avenue, Suite 105
Juneau, Alaska 99801-5207**

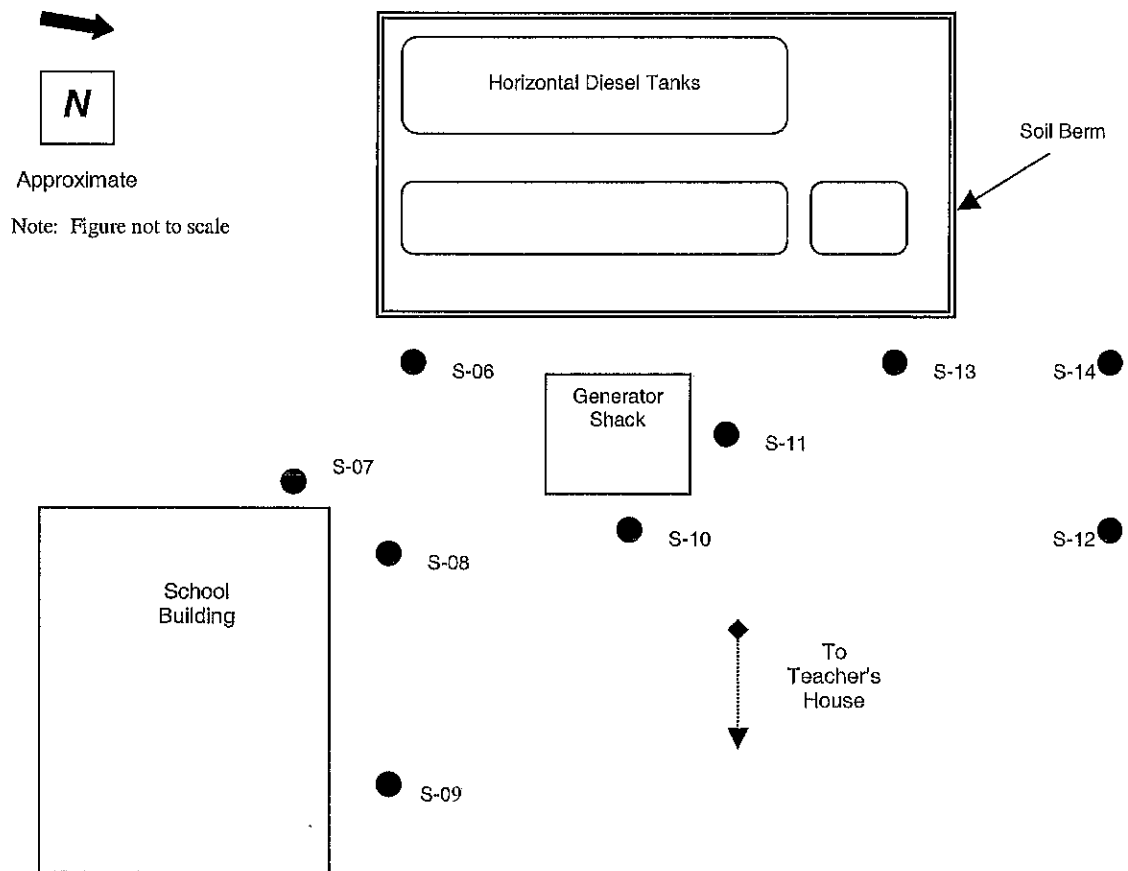
Figure 3-3 Layout of the Iditarod Area School District Tank Farm Area

Soil Sample Collection. Several soil samples were collected in the area downhill from the tank farm and around the school area. A PID to be used for evaluating the soil was dysfunctional, possibly because of freezing conditions, and could not be used to evaluate the soil. The odor of the soil samples collected at various depths was recorded in the field notebook, and several samples were collected along the length of the soil column to gain an understanding of potential contamination with depth of soil. The location of each soil sample is described below, and is depicted in Figure 3-3.

Sample LMV-S-14 was collected at approximately 2 feet bgs, approximately 10 feet north of the northeast corner of the tank farm. It was used for a PetroFlag assay.

The analytical results indicate that contamination exceeding ADEC Method Two soil cleanup levels for DRO contamination is found at depths of at least 5 feet bgs in the area north of the southwest corner of the building and immediately east of the generator shack. Further, the presence of odor in the soils and the results of PetroFlag assays indicate there is petroleum contamination near the ground surface and extending to at least 5 feet bgs.

It is recommended that additional sampling be performed in the area north of the school and east of the generator shack, to identify the extent of contamination and the depth at which the contamination exceeds cleanup levels. The samples should be analyzed for DRO. It is also recommended that additional soil sampling and laboratory analysis be performed after the tank

farm is decommissioned to evaluate the DRO concentrations in soil beneath the tank farm area. Site reconnaissance sampling of areas downgradient and near the tank farm indicated relatively minor DRO concentrations near the southeast corner of the tank farm. No detectable DRO was found at the northeast corner of the tank farm. Because a previous study indicated that DRO contamination was present in the area between the generator shed and the existing tank farm, this area should also be sampled when it is cleared.

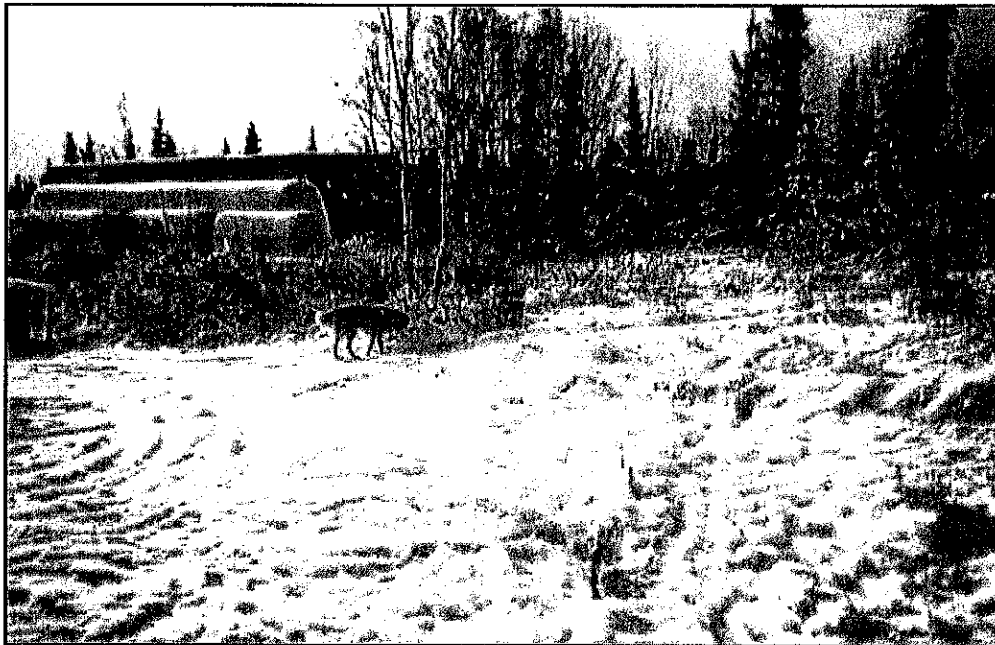
Photograph 3. Iditarod Area School District Tank Farm

Located at GPS coordinates North 61° 21' 18.7" West 155° 26' 13.1", the Iditarod Area School District Tank Farm site (Figure 2-1 and Photographs 3 and 4) consists of three horizontal tanks in a bermed area adjacent to (approximately 50 feet from) the Lime Village School. The general tank farm area includes the school building, located downhill to the west of the tank farm, and a generator shack, located near the base of the tank farm, downhill and west of the tank farm (see Figure 3-3). The foundation of the generator shack is nearly the same as that of the school's.

Facing south-southwest. Taken from north of the tank farm.

The tanks are in the upper left of the photograph.

Note the slope of the ground, which rises to the southwest (toward the back of the photograph).

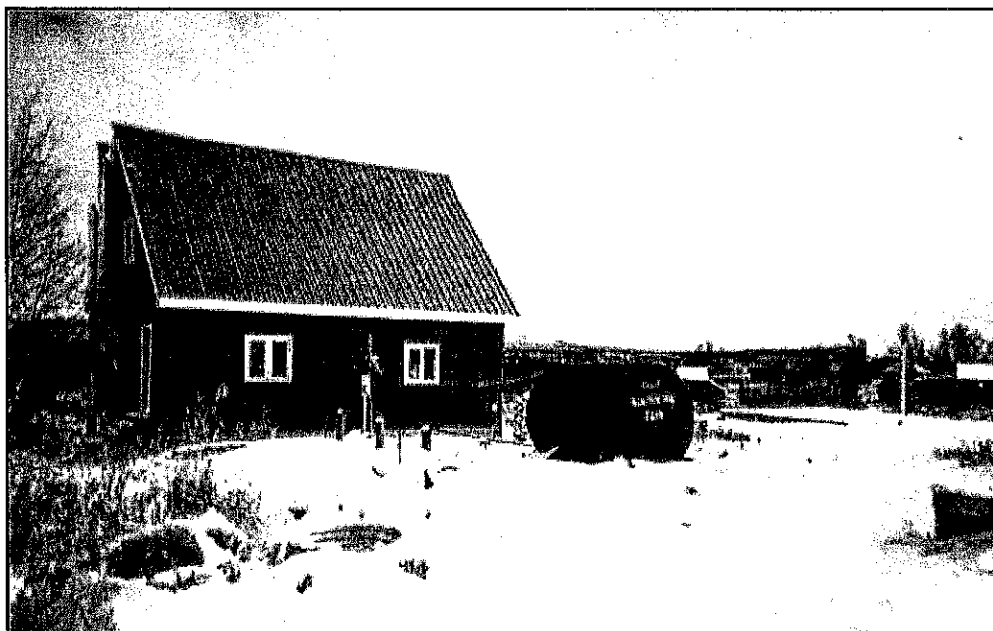
Photograph 6. Iditarod Area School District Teacher Housing Tank

Located downhill from the school area, the Teacher Housing area of the Iditarod Area School District consists of an open area west of the school teacher's house (Figures 2-1 and 3-3 and Photograph 6). Although this area was not intended to be part of the site reconnaissance, samples from this area were collected and analyzed with the PetroFlag kit to provide a preliminary indication of the condition of the soils. It was reported that a tank in the area had

Facing east-southeast. Taken from west of the tank.

The black tank in the center of the photograph holds 1,000 gallons of heating fuel (diesel No. 1). Note the septic system southwest of the tank (bottom right of the photograph).

The results of the PetroFlag assay indicate a residual petroleum concentration may be present at a depth of 2 feet bgs. On the basis of these preliminary results and uncertainty about the fate of the soil at the site, it is recommended that additional sampling be performed around the area at a depth of 4 to 5 feet bgs to more completely evaluate the condition of the soils and determine whether soils of the area exceed DRO cleanup levels. Table 3-7 provides rationale for additional sampling.

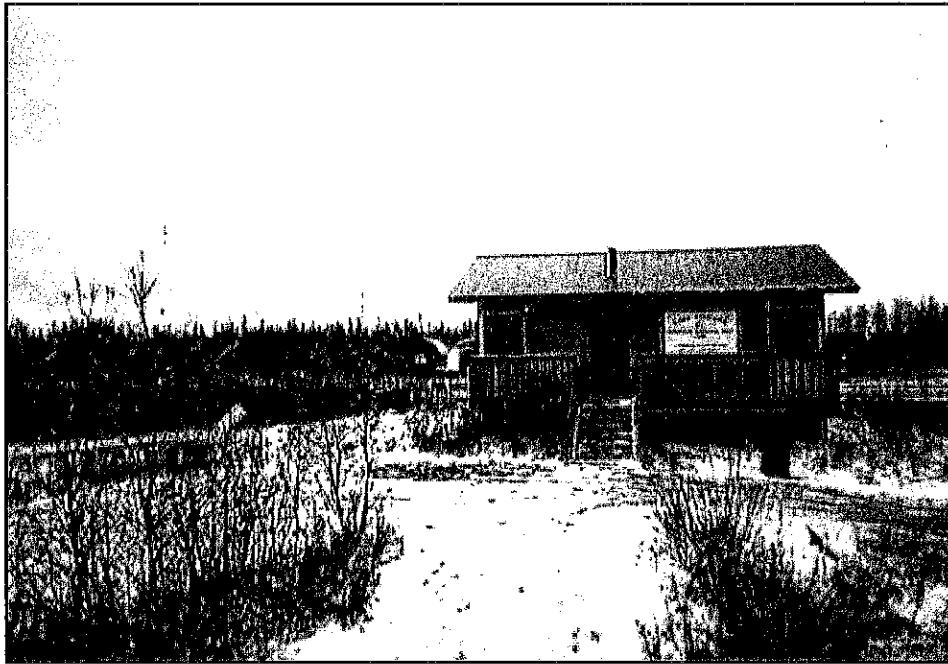
Photograph 7. Lime Village Traditional Council Community Watering Point
Facing east. Taken from the west side of the building.
The Stony River is located east of (beyond) the building. The well is on the north side of the building.
