**Figure ES-1**  
**1,4-Dioxane Concentration**  
**Summary Figure**  
 Comprehensive RFI Report  
 Former Tuboscope Site  
 Prudhoe Bay, Alaska

**Figure ES-2**  
**Chlorinated Solvents**  
**Summary Figure**  
 Comprehensive RFI Report  
 Former Tuboscope Site  
 Prudhoe Bay, Alaska

**Figure ES-3  
Hydrocarbons  
Summary Figure**  
Comprehensive RFI Report  
Former Tuboscope Site  
Prudhoe Bay, Alaska

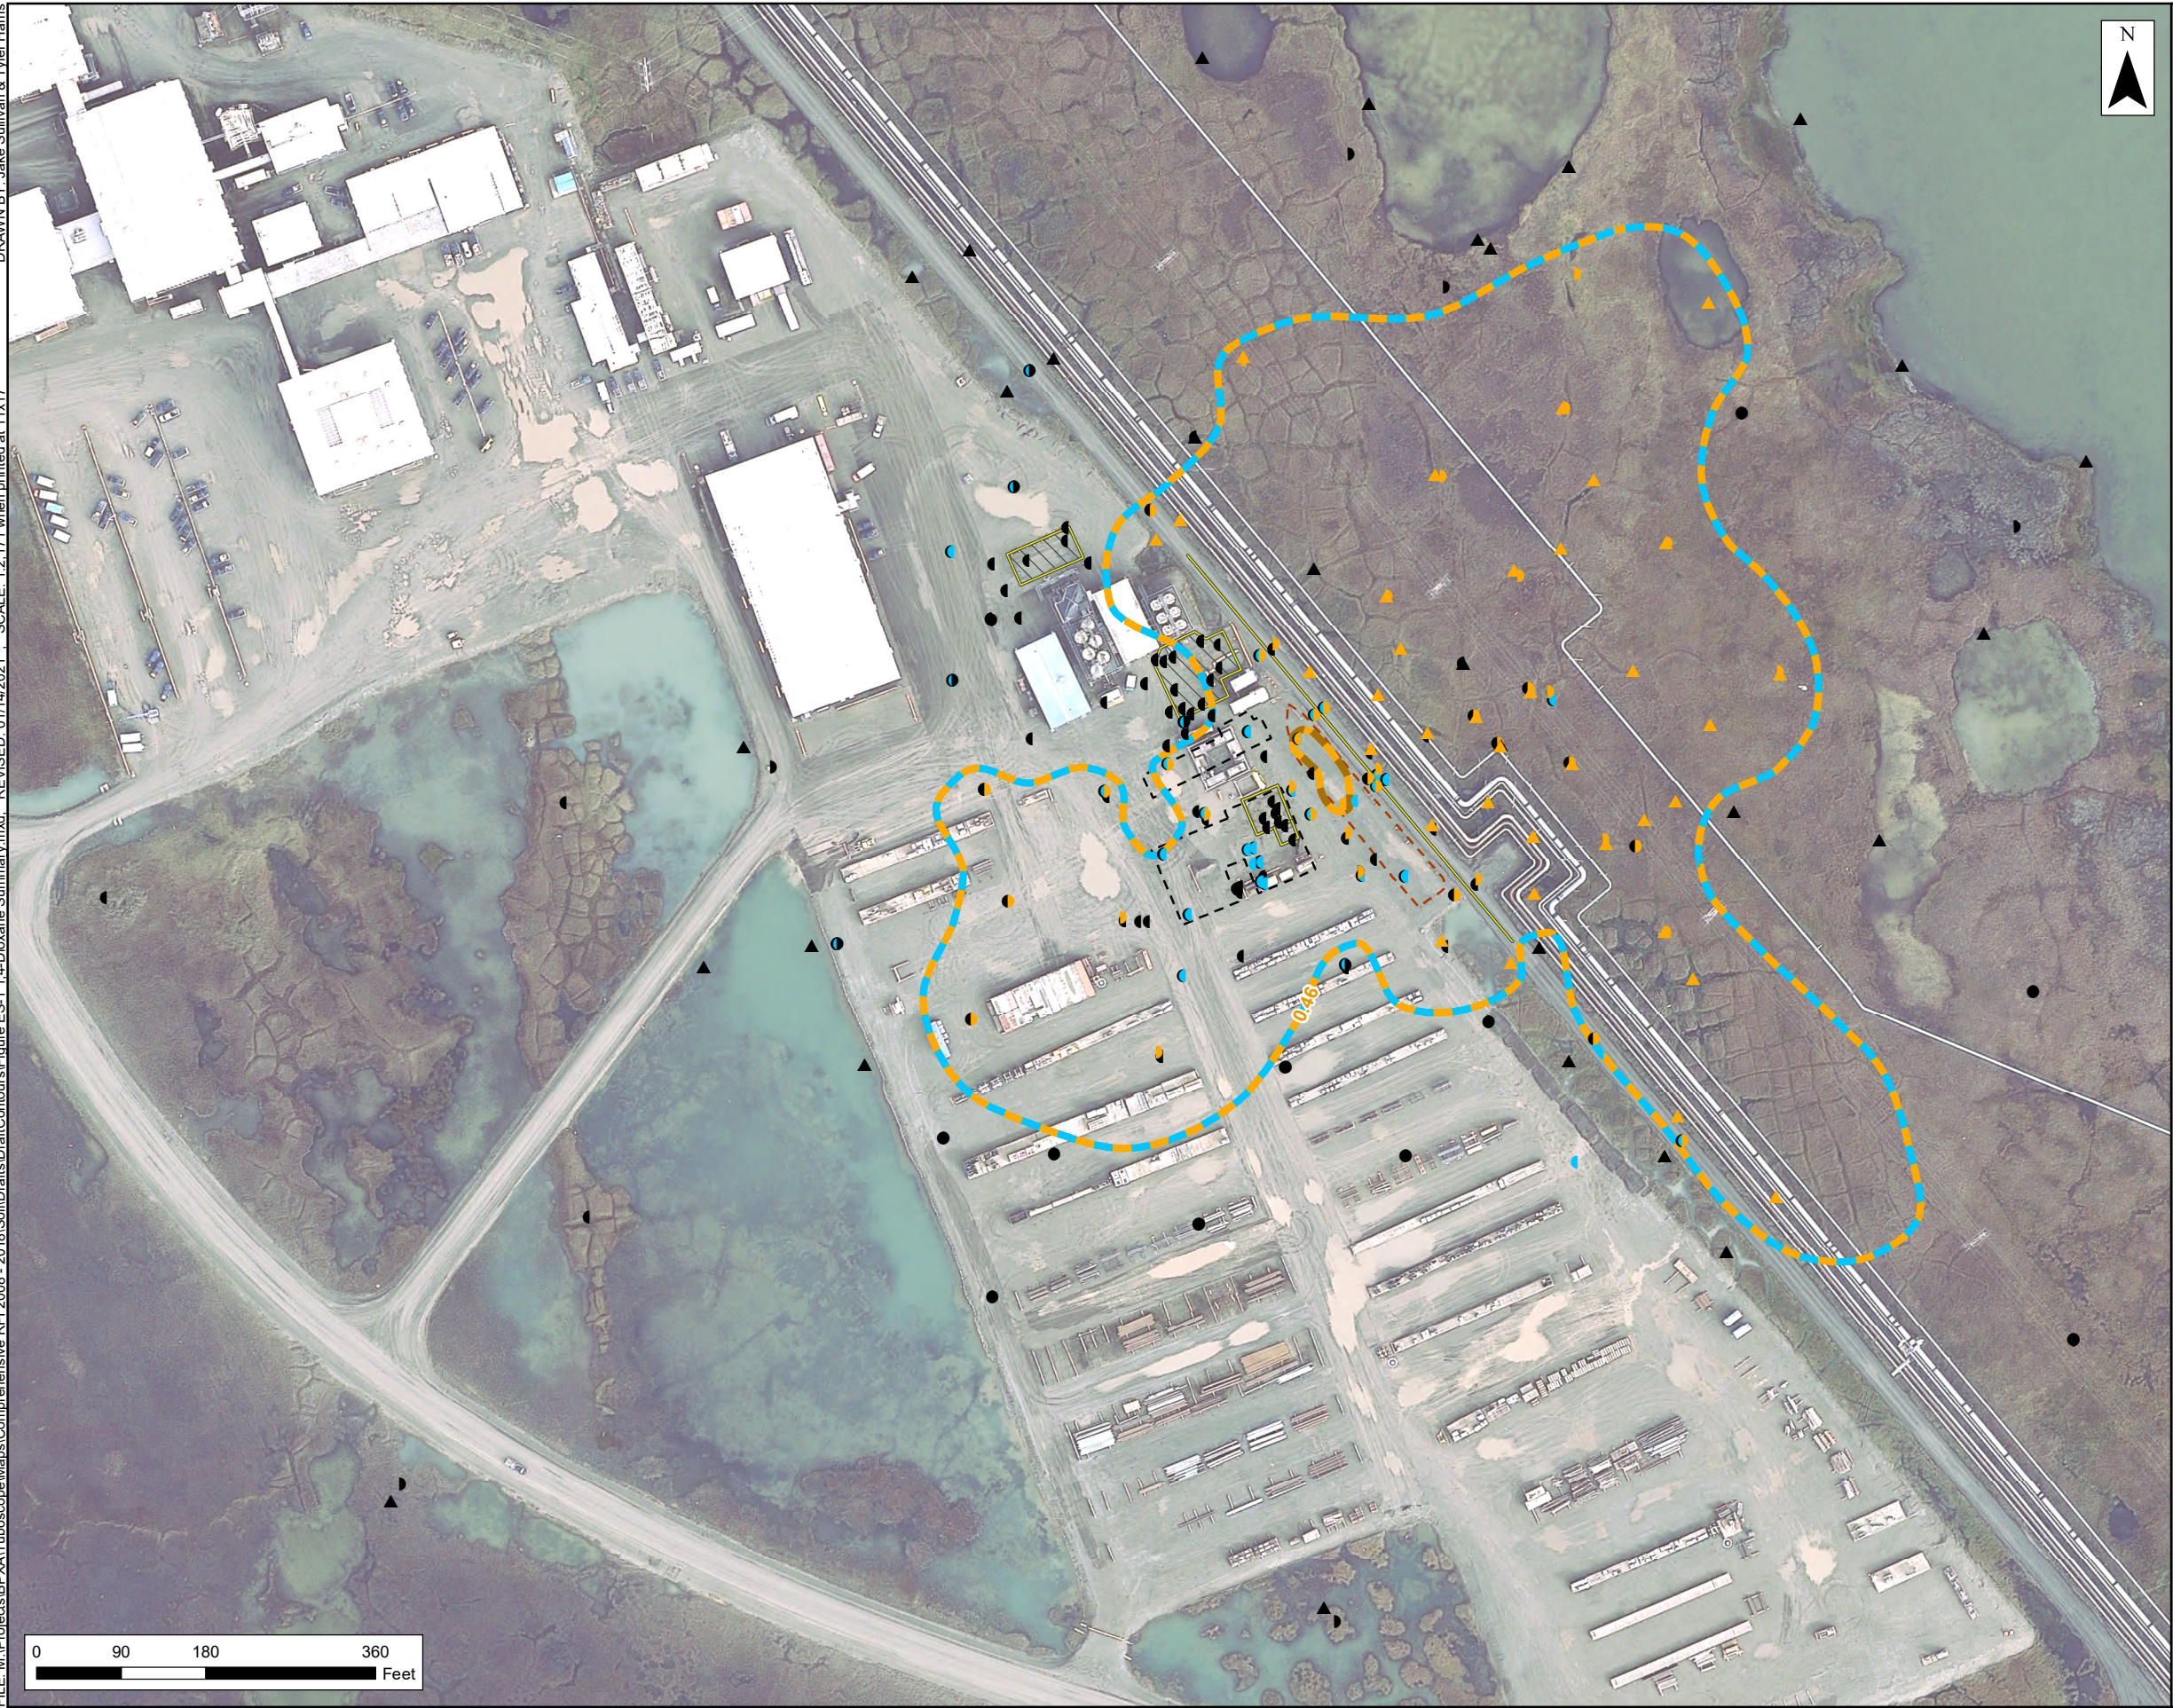
Figure shows the extent of 1,4-dioxane in soil, suprapermafrost groundwater, and surface water.

Lowest Tier II Action Level for 1,4-Dioxane In Soil: 2.8 milligrams per kilogram (mg/kg)

Lowest Tier II Action Level for 1,4-Dioxane in Groundwater : 0.46 micrograms per liter (ug/L).

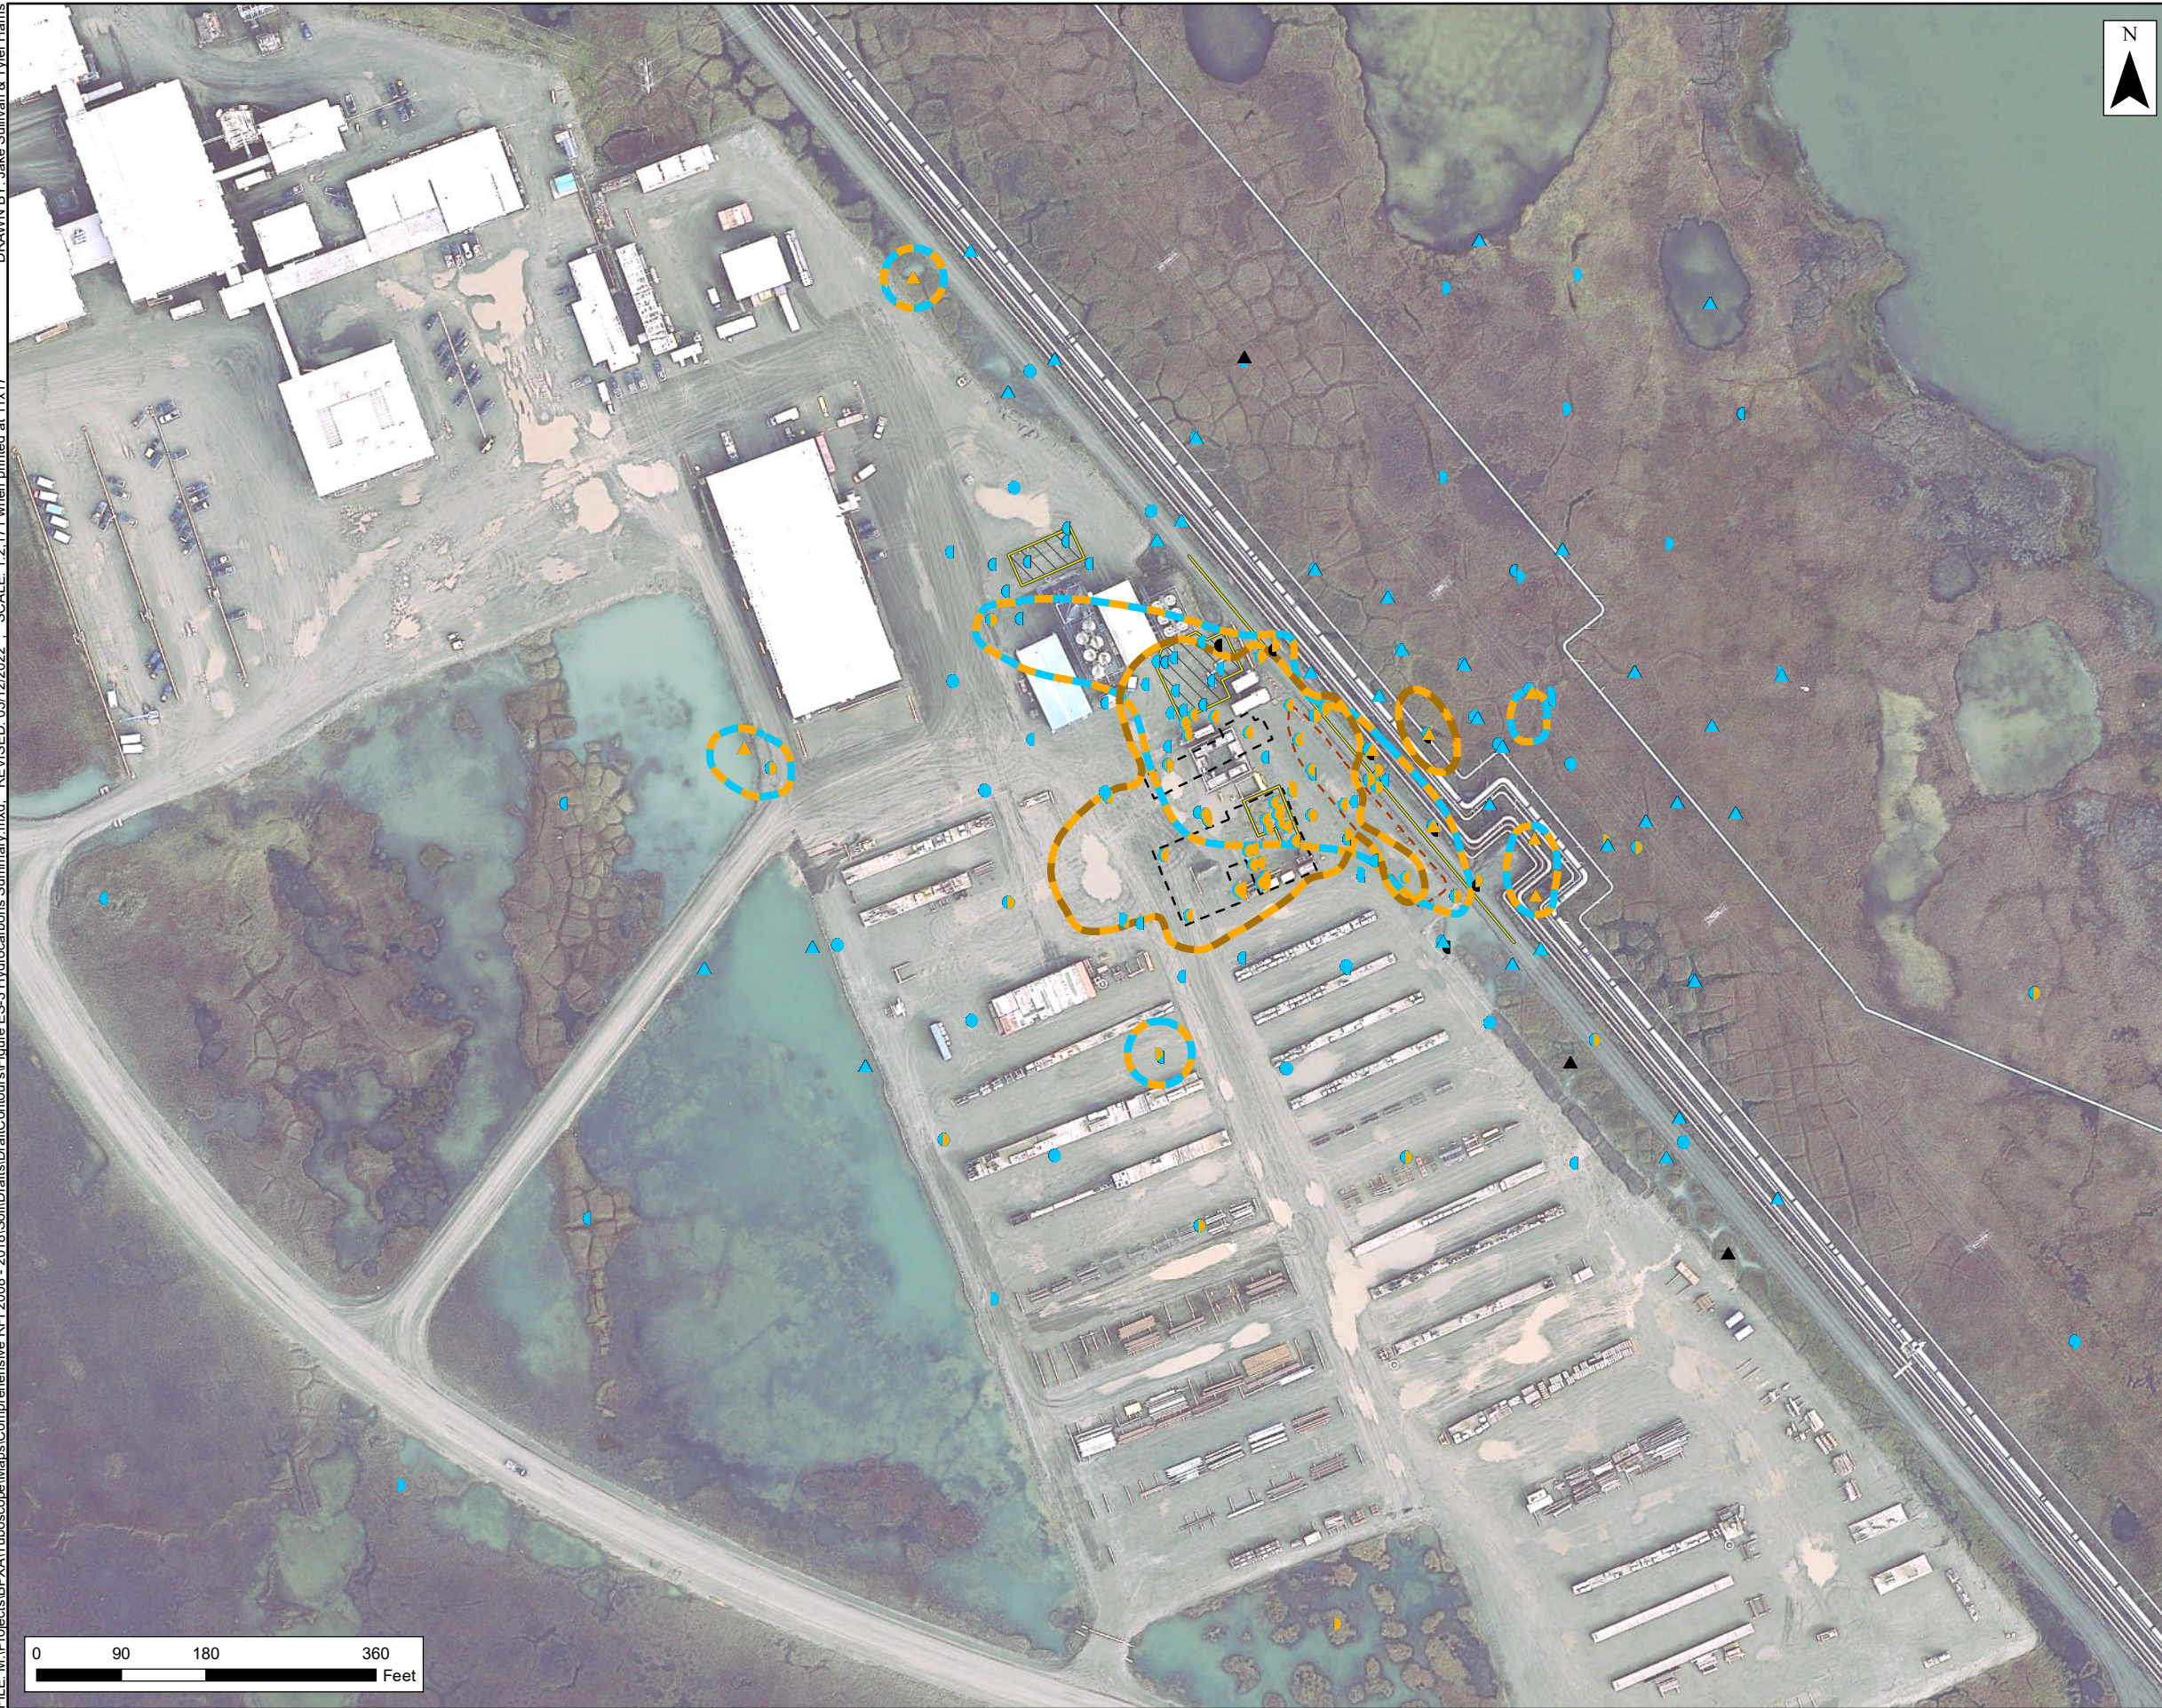
This figure shows the extent of petroleum hydrocarbon constituents present at concentrations greater than the lowest Tier II Action Level and is based on the following constituents: BTEX compounds (benzene, toluene, ethylbenzene, xylenes), polycyclic aromatic hydrocarbons (2-methylnaphthalene, benzo(a)anthracene, benzo(a)pyrene, benzo(b)fluoranthene, benzo(e)pyrene, benzo(g,h,i)perylene, benzo(g,h,i)perylene, benzo(k)fluoranthene, dibenz(a,h)anthracene, indeno(1,2,3-cd)pyrene, and naphthalene), 1,2,4-trimethylbenzene, 1,3,5-trimethylbenzene, isopropylbenzene, n-propylbenzene, and p-isopropyltoluene, isopropylbenzene, dibenzofuran.
